한남고속선영제1교-토공노반-4(79.784~79.794km, L=10.4m)

| 시행사 | 영역 | 영역명 | 용역사 | 단면 | | 구분 | |
|---|---|---|---|---|---|---|---|
| KORAIL<br>한국철도공사<br>KOREA RAILROAD | 2017년도 호남고속선 오송~광주승정간 콘크리트케도 점검공역<br>(재)한국건설품질연구원 | (주)한국구조물안전연구원<br>(주)한국국토안전연구원<br>(재)한국건설품질연구원 | 이 박 영<br>김 경 기<br>윤 석 기 | | 0220 (0.3m이하 : 복식) | 점목도상판리 | |

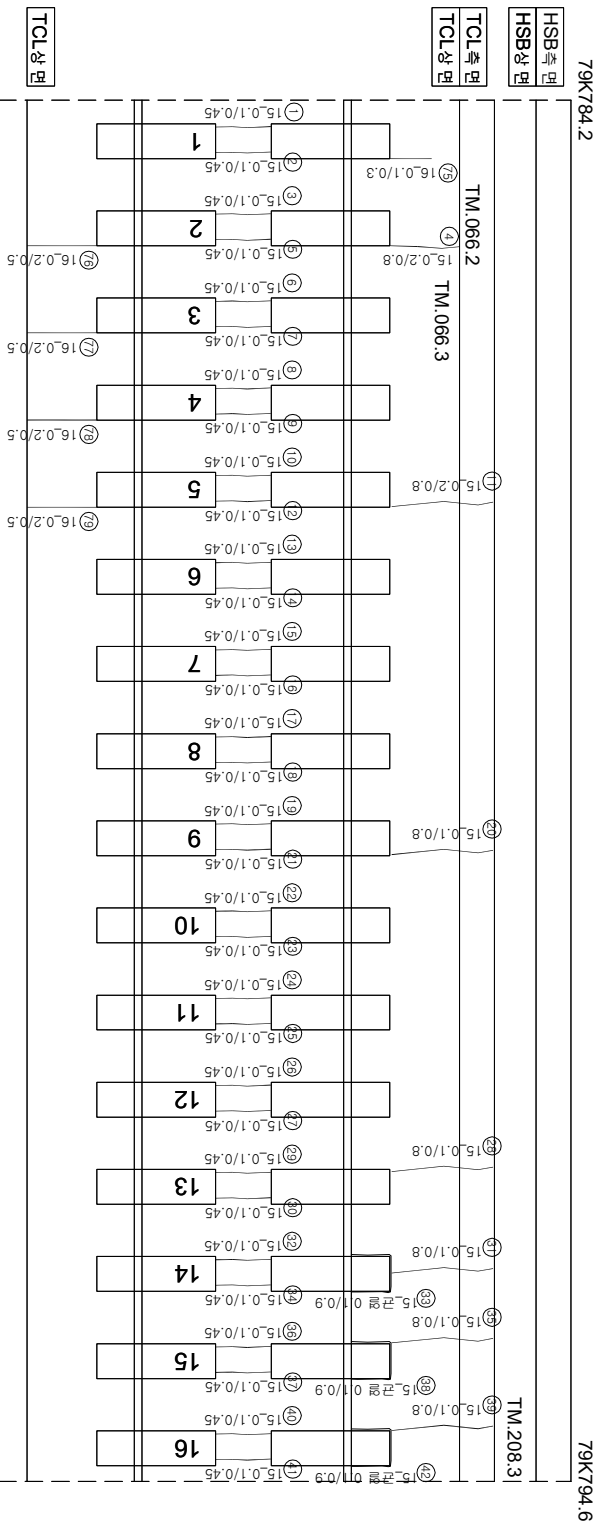
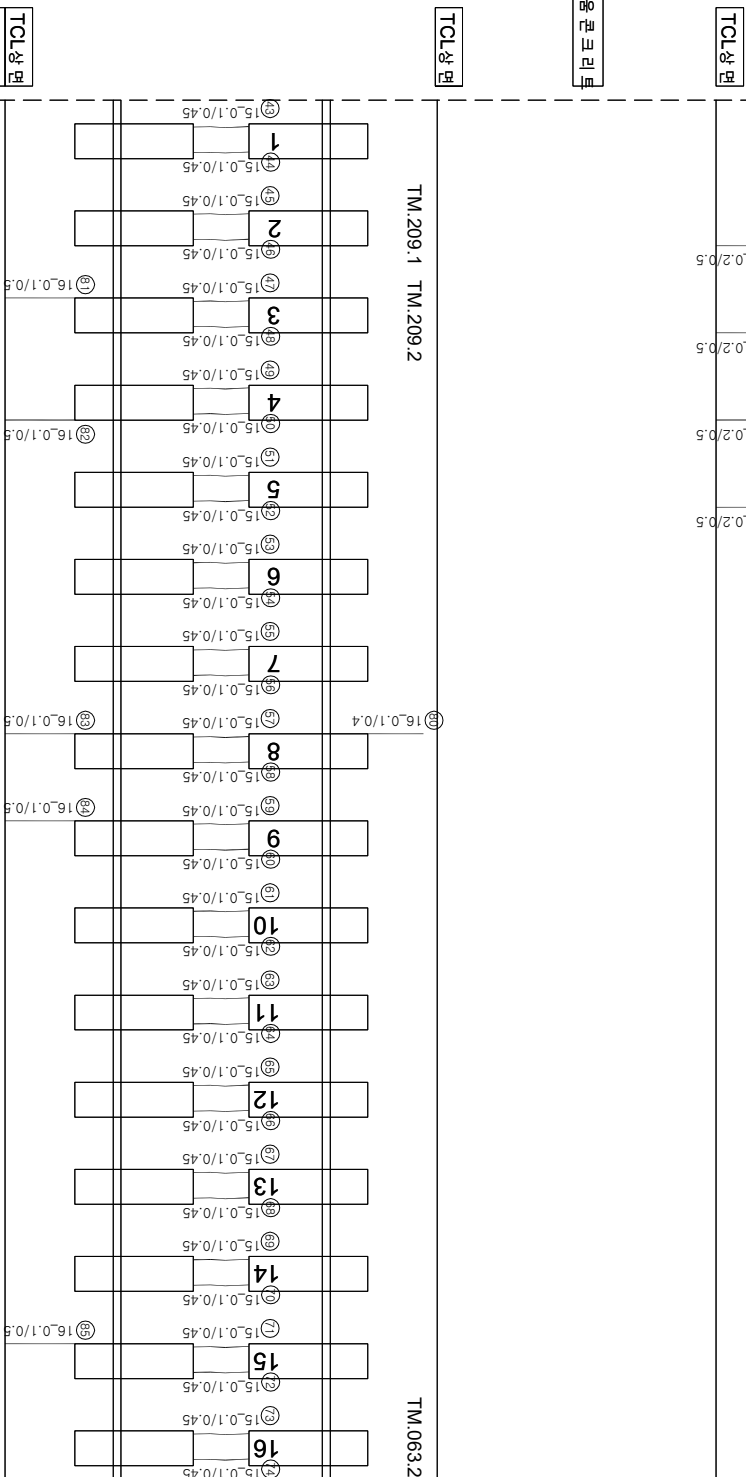
| 연번 | 순상 | 목 | 연결 | 비고 | 연번 | 순상 | 목 | 연결 | 비고 |
|---|---|---|---|---|---|---|---|---|---|
| 1 | 균열 | 0.1 mm | 0.45 m | | 51 | 균열 | 0.1 mm | 0.45 m | |
| 2 | 균열 | 0.1 mm | 0.45 m | | 52 | 균열 | 0.1 mm | 0.45 m | |
| 3 | 균열 | 0.1 mm | 0.45 m | | 53 | 균열 | 0.1 mm | 0.45 m | |
| 4 | 균열 | 0.2 mm | 0.8 m | | 54 | 균열 | 0.1 mm | 0.45 m | |
| 11 | 균열 | 0.2 mm | 0.8 m | | 61 | 균열 | 0.1 mm | 0.45 m | |
| 26 | 균열 | 0.1 mm | 0.45 m | | 76 | 균열 | 0.2 mm | 0.5 m | |
| 33 | 관개부 균열 | 0.1 mm | 0.9 m | | 83 | 균열 | 0.1 mm | 0.5 m | |
| 38 | 관개부 균열 | 0.1 mm | 0.9 m | | | | | | |
| 42 | 관개부 균열 | 0.1 mm | 0.9 m | | | | | | |
