# 48. G90\_와룡1터널\_토공노반

| 점검 일자 | 2017. 07.12~2017. 10.25 |

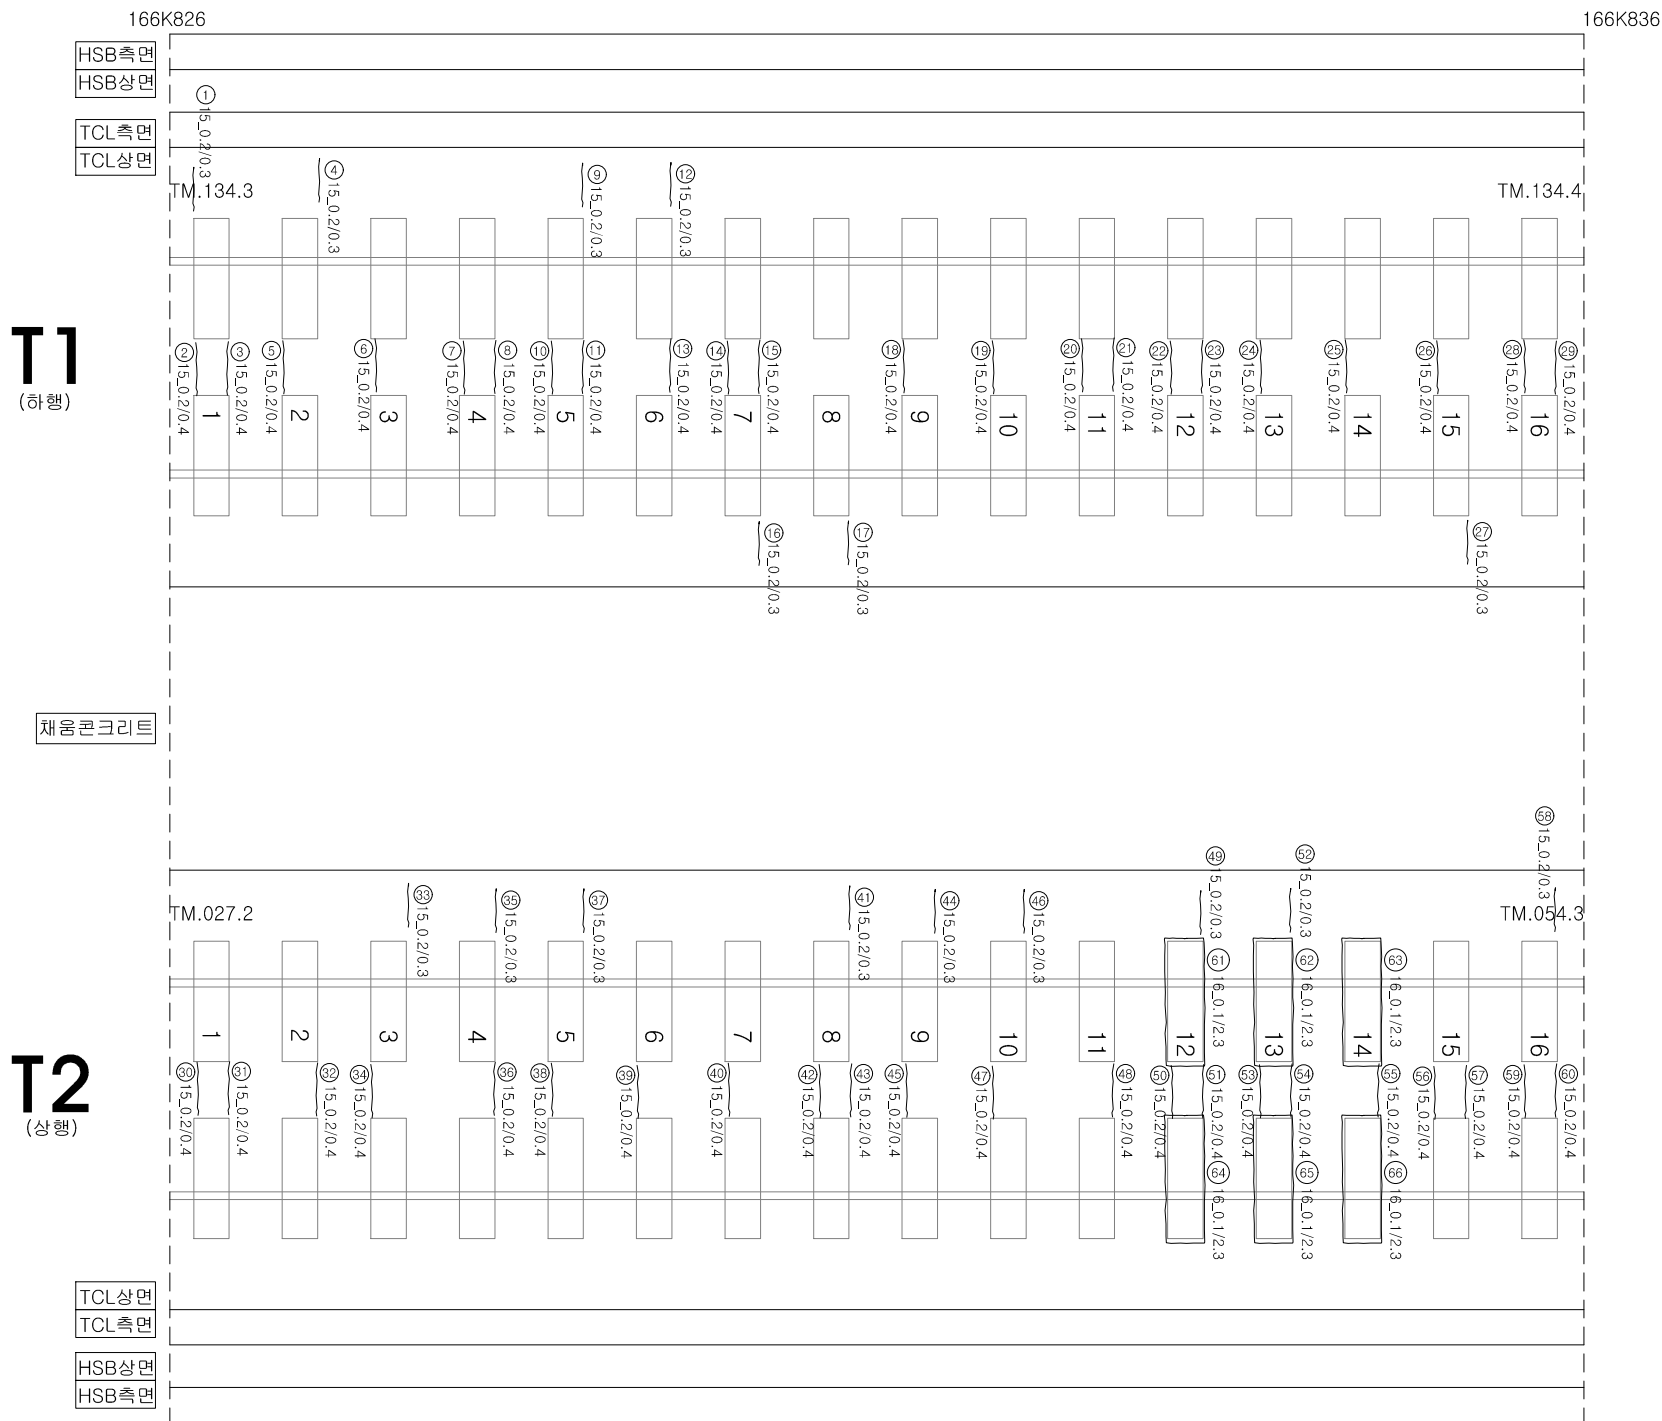
외관조사망도 번호  
G90와룡1터널\_토공노반\_28(166.826~166.836km, L=10m)

| 연번 | 손상 | 폭 | 연장 | 비고 | 연번 | 손상 | 폭 | 연장 | 비고 |
|---|---|---|---|---|---|---|---|---|---|
| 1 | 균열 | 0.2 mm | 0.3 m | | 31 | 균열 | 0.2 mm | 0.4 m | |
| 2 | 균열 | 0.2 mm | 0.4 m | | 32 | 균열 | 0.2 mm | 0.4 m | |
| 3 | 균열 | 0.2 mm | 0.4 m | | 33 | 균열 | 0.2 mm | 0.3 m | |
| 4 | 균열 | 0.2 mm | 0.3 m | | 34 | 균열 | 0.2 mm | 0.4 m | |
| 5 | 균열 | 0.2 mm | 0.4 m | | 35 | 균열 | 0.2 mm | 0.3 m | |
| 6 | 균열 | 0.2 mm | 0.4 m | | 36 | 균열 | 0.2 mm | 0.4 m | |
| 7 | 균열 | 0.2 mm | 0.4 m | | 37 | 균열 | 0.2 mm | 0.3 m | |
| 8 | 균열 | 0.2 mm | 0.4 m | | 38 | 균열 | 0.2 mm | 0.4 m | |
| 9 | 균열 | 0.2 mm | 0.3 m | | 39 | 균열 | 0.2 mm | 0.4 m | |
| 10 | 균열 | 0.2 mm | 0.4 m | | 40 | 균열 | 0.2 mm | 0.4 m | |
| 11 | 균열 | 0.2 mm | 0.4 m | | 41 | 균열 | 0.2 mm | 0.3 m | |
| 12 | 균열 | 0.2 mm | 0.3 m | | 42 | 균열 | 0.2 mm | 0.4 m | |
| 13 | 균열 | 0.2 mm | 0.4 m | | 43 | 균열 | 0.2 mm | 0.4 m | |
| 14 | 균열 | 0.2 mm | 0.4 m | | 44 | 균열 | 0.2 mm | 0.3 m | |
| 15 | 균열 | 0.2 mm | 0.4 m | | 45 | 균열 | 0.2 mm | 0.4 m | |
| 16 | 균열 | 0.2 mm | 0.3 m | | 46 | 균열 | 0.2 mm | 0.3 m | |
| 17 | 균열 | 0.2 mm | 0.3 m | | 47 | 균열 | 0.2 mm | 0.4 m | |
| 18 | 균열 | 0.2 mm | 0.4 m | | 48 | 균열 | 0.2 mm | 0.4 m | |
| 19 | 균열 | 0.2 mm | 0.4 m | | 49 | 균열 | 0.2 mm | 0.3 m | |
| 20 | 균열 | 0.2 mm | 0.4 m | | 50 | 균열 | 0.2 mm | 0.4 m | |
| 21 | 균열 | 0.2 mm | 0.4 m | | 51 | 균열 | 0.2 mm | 0.4 m | |
| 22 | 균열 | 0.2 mm | 0.4 m | | 52 | 균열 | 0.2 mm | 0.3 m | |
| 23 | 균열 | 0.2 mm | 0.4 m | | 53 | 균열 | 0.2 mm | 0.4 m | |
| 24 | 균열 | 0.2 mm | 0.4 m | | 54 | 균열 | 0.2 mm | 0.4 m | |
| 25 | 균열 | 0.2 mm | 0.4 m | | 55 | 균열 | 0.2 mm | 0.4 m | |
| 26 | 균열 | 0.2 mm | 0.4 m | | 56 | 균열 | 0.2 mm | 0.4 m | |
| 27 | 균열 | 0.2 mm | 0.3 m | | 57 | 균열 | 0.2 mm | 0.4 m | |
| 28 | 균열 | 0.2 mm | 0.4 m | | 58 | 균열 | 0.2 mm | 0.3 m | |
| 29 | 균열 | 0.2 mm | 0.4 m | | 59 | 균열 | 0.2 mm | 0.4 m | |
| 30 | 균열 | 0.2 mm | 0.4 m | | 60 | 균열 | 0.2 mm | 0.4 m | |
| 31 | 균열 | 0.2 mm | 0.4 m | | 61 | 경계부 균열 | 0.1 mm | 2.3 m | |
