# 56. G94\_마령제2고가\_토공노반

## 5-2공구

| 점검 일자 | 2017. 07.12~2017. 10.25 |

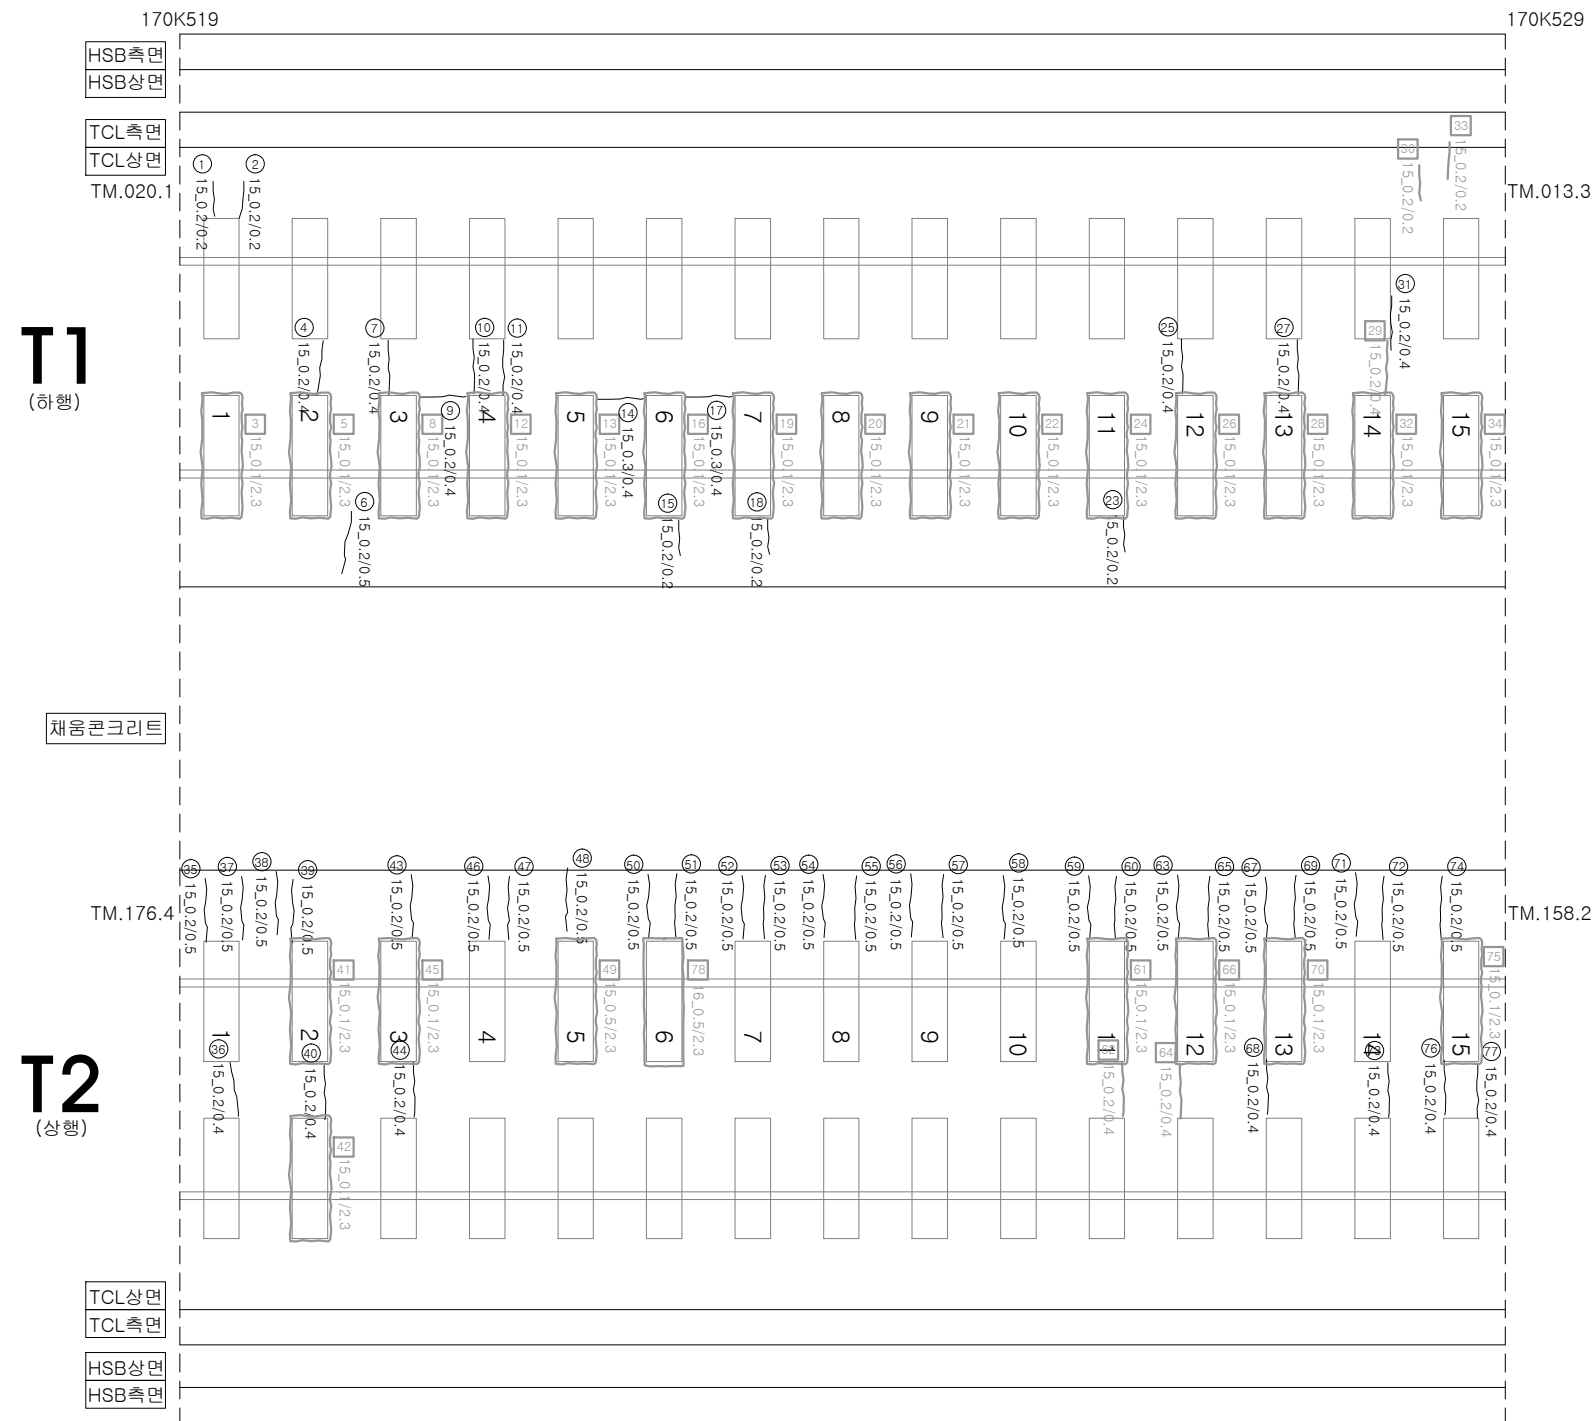
외관조사망도 번호  
G94\_마령제2고가\_토공노반\_3(170.519~170.529 km, L=10m)

| 연번 | 손상 | 폭 | 연장 | 비고 | 연번 | 손상 | 폭 | 연장 | 비고 | | |
|---|---|---|---|---|---|---|---|---|---|---|---|
| 1 | 균열 | 0.2 | mm | 0.2 m | 56 | 균열 | 0.2 | mm | 0.5 m | | |
| 3 | 경계부 균열 | 0.1 | mm | 2.3 m | 17보수 | 58 | 균열 | 0.2 | mm | 0.5 m | |
| 14 | 균열 | 0.3 | mm | 0.4 m | | 69 | 균열 | 0.2 | mm | 0.5 m | |
| 23 | 균열 | 0.2 | mm | 0.2 m | | 78 | 경계부 균열 | 0.5 | mm | 2.3 m | 17보수 |
| 49 | 경계부 균열 | 0.5 | mm | 2.3 m | 17보수 | | | | | | |

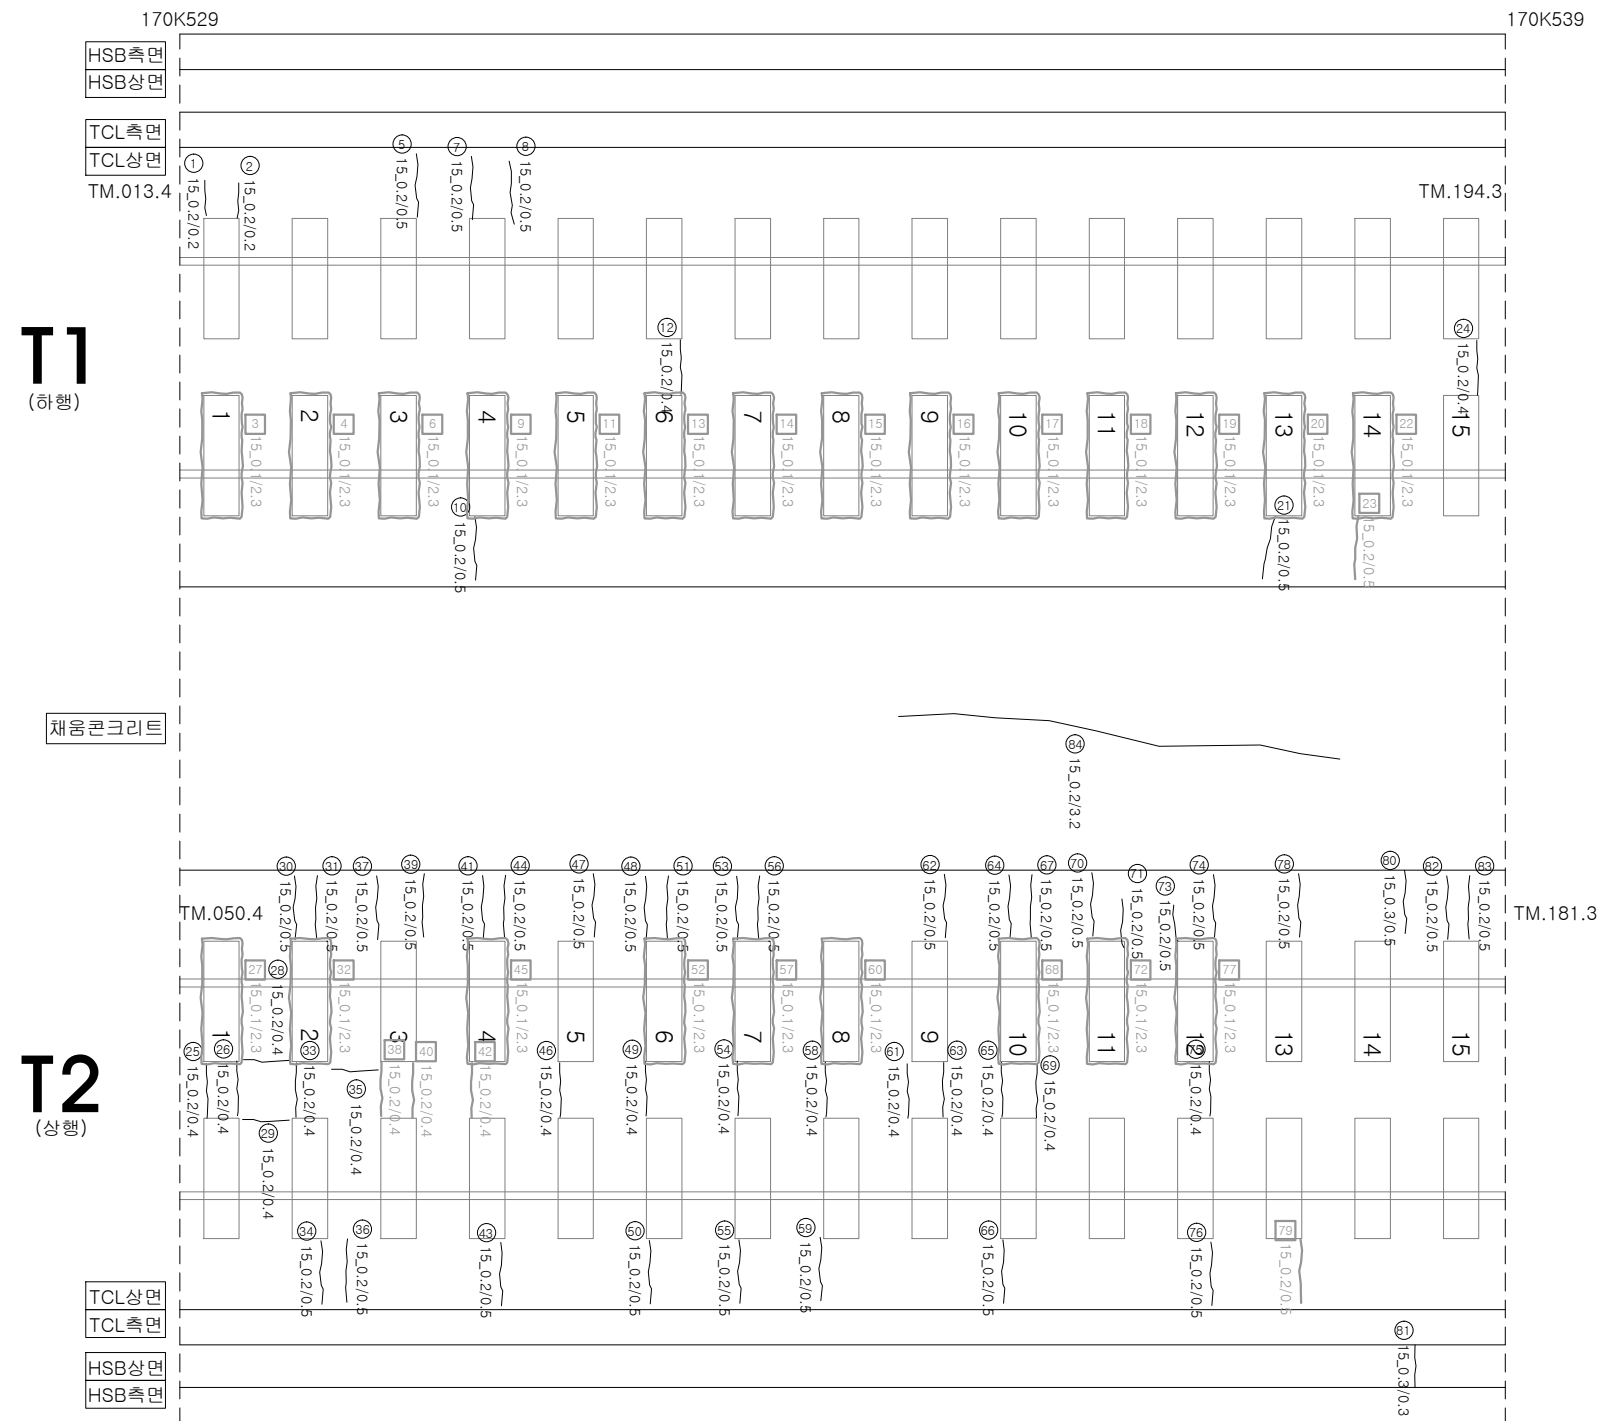
외관조사망도 번호  
G94\_마령제2고가\_토공노반\_4(170.529~170.539 km, L=10m)

| 연번 | 손상 | | 폭 | | 연장 | 비고 | 연번 | 손상 | | 폭 | | 연장 | 비고 |
|---|---|---|---|---|---|---|---|---|---|---|---|---|---|
| 1 | 균열 | 0.2 | mm | 0.2 | m | | 56 | 균열 | 0.2 | mm | 0.5 | m | |
| 3 | 경계부 균열 | 0.1 | mm | 2.3 | m | 17보수 | 58 | 균열 | 0.2 | mm | 0.4 | m | |
| 25 | 균열 | 0.2 | mm | 0.4 | m | | 80 | 균열 | 0.3 | mm | 0.5 | m | |
| 26 | 균열 | 0.2 | mm | 0.4 | m | | 81 | 균열 | 0.3 | mm | 0.3 | m | |
| 29 | 균열 | 0.2 | mm | 0.4 | m | | 84 | 균열 | 0.2 | mm | 3.2 | m | |

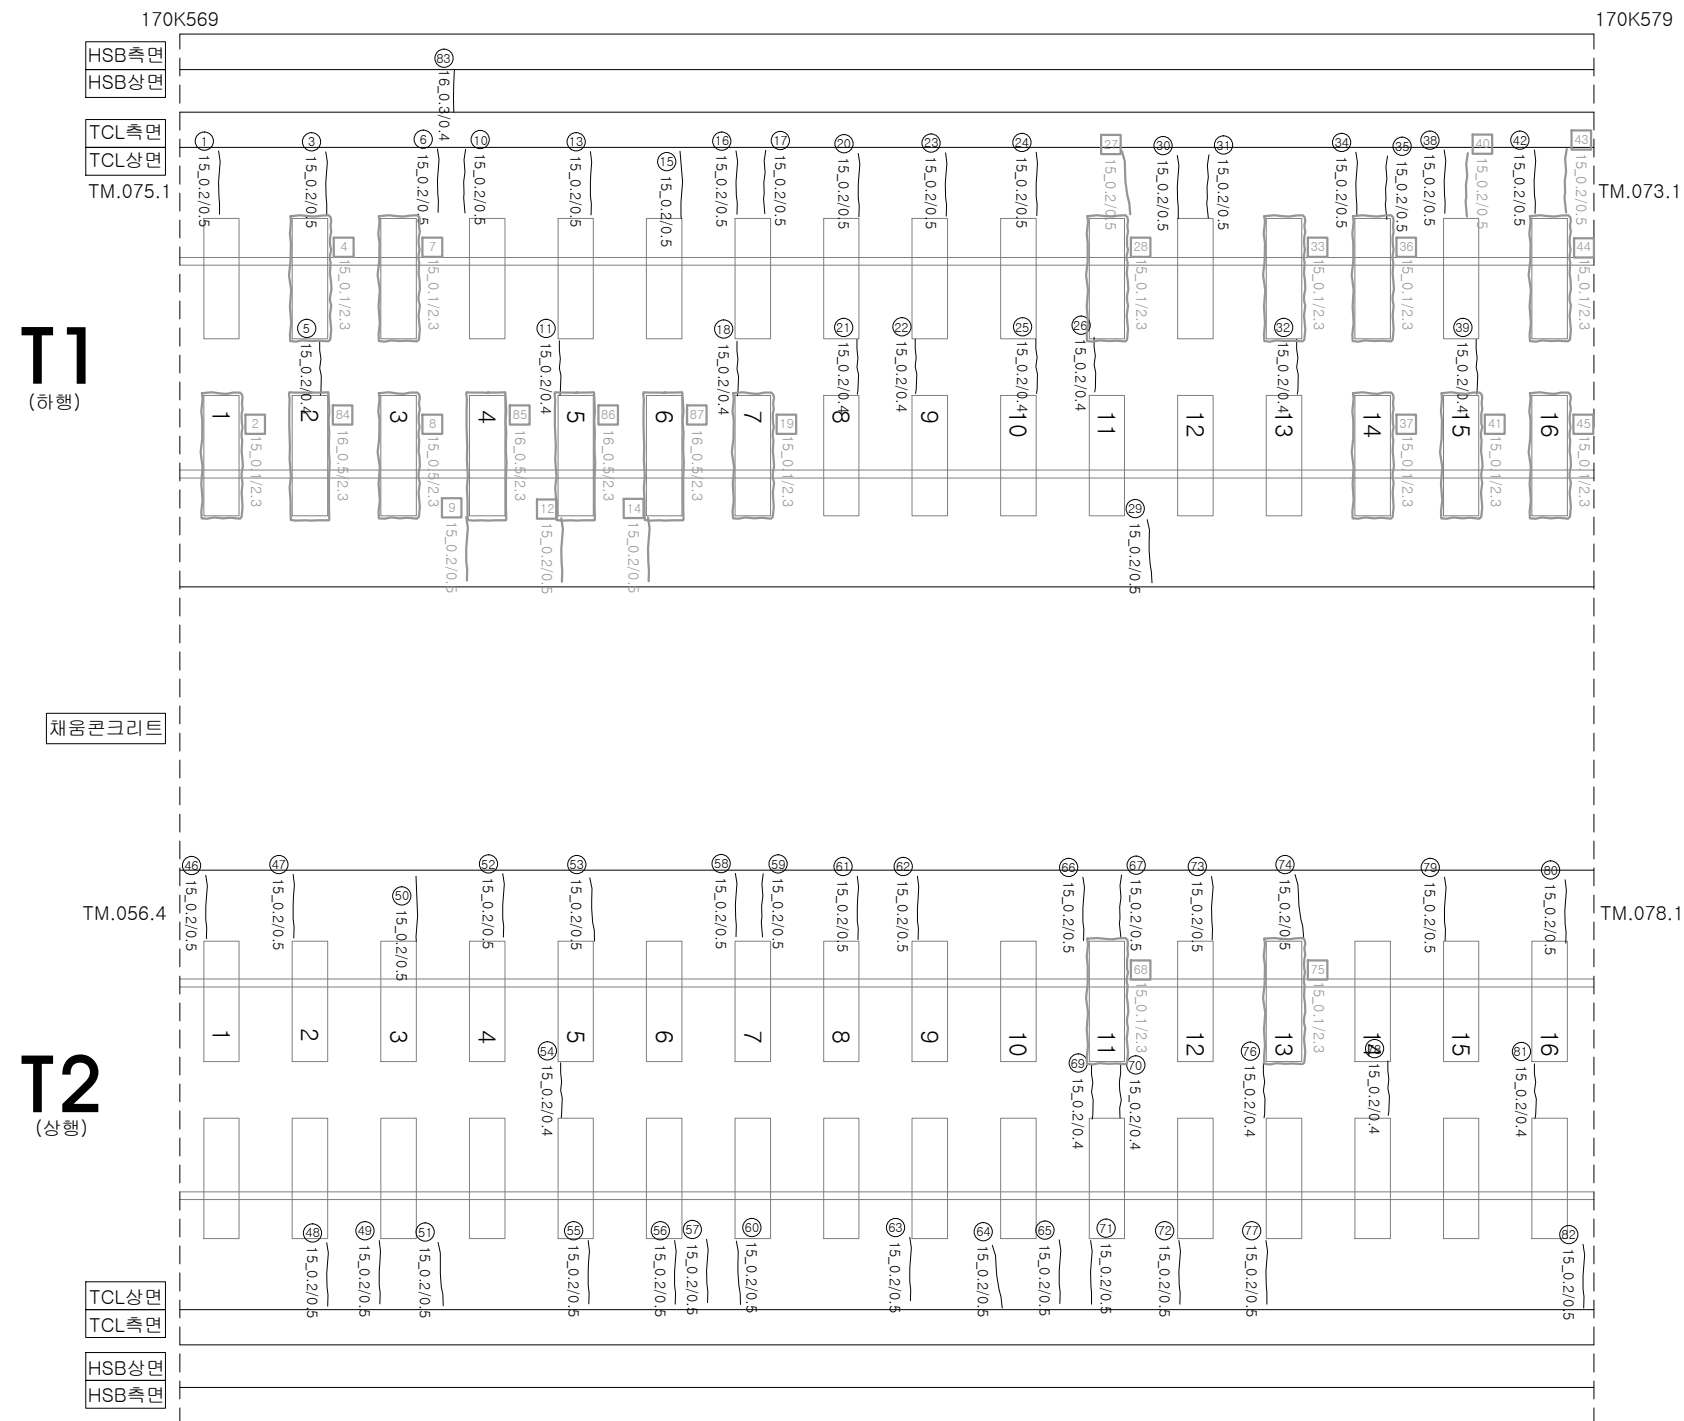
외관조사망도 번호  
G94\_마령제2고가\_토공노반\_8(170.569~170.579 km, L=10m)

| 연번 | 손상 | 폭 | 연장 | 비고 | 연번 | 손상 | 폭 | 연장 | 비고 | | | |
|---|---|---|---|---|---|---|---|---|---|---|---|---|
| 1 | 균열 | 0.2 | mm | 0.5 | m | 56 | 균열 | 0.2 | mm | 0.5 | m | |
| 2 | 경계부 균열 | 0.1 | mm | 2.3 | m | 17보수 | 57 | 균열 | 0.2 | mm | 0.5 | m |
| 8 | 경계부 균열 | 0.5 | mm | 2.3 | m | 17보수 | 63 | 균열 | 0.2 | mm | 0.5 | m |
| 28 | 경계부 균열 | 0.1 | mm | 2.3 | m | 17보수 | 83 | 균열 | 0.3 | mm | 0.4 | m |
| 29 | 균열 | 0.2 | mm | 0.5 | m | 84 | 경계부 균열 | 0.5 | mm | 2.3 | m | 17보수 |
