# 2017년도 호남고속선 오송-광주송정간 콘크리트 궤도 점검용역

- 외관조사망도 -

2017. 11.

# 61. U33\_신통터널

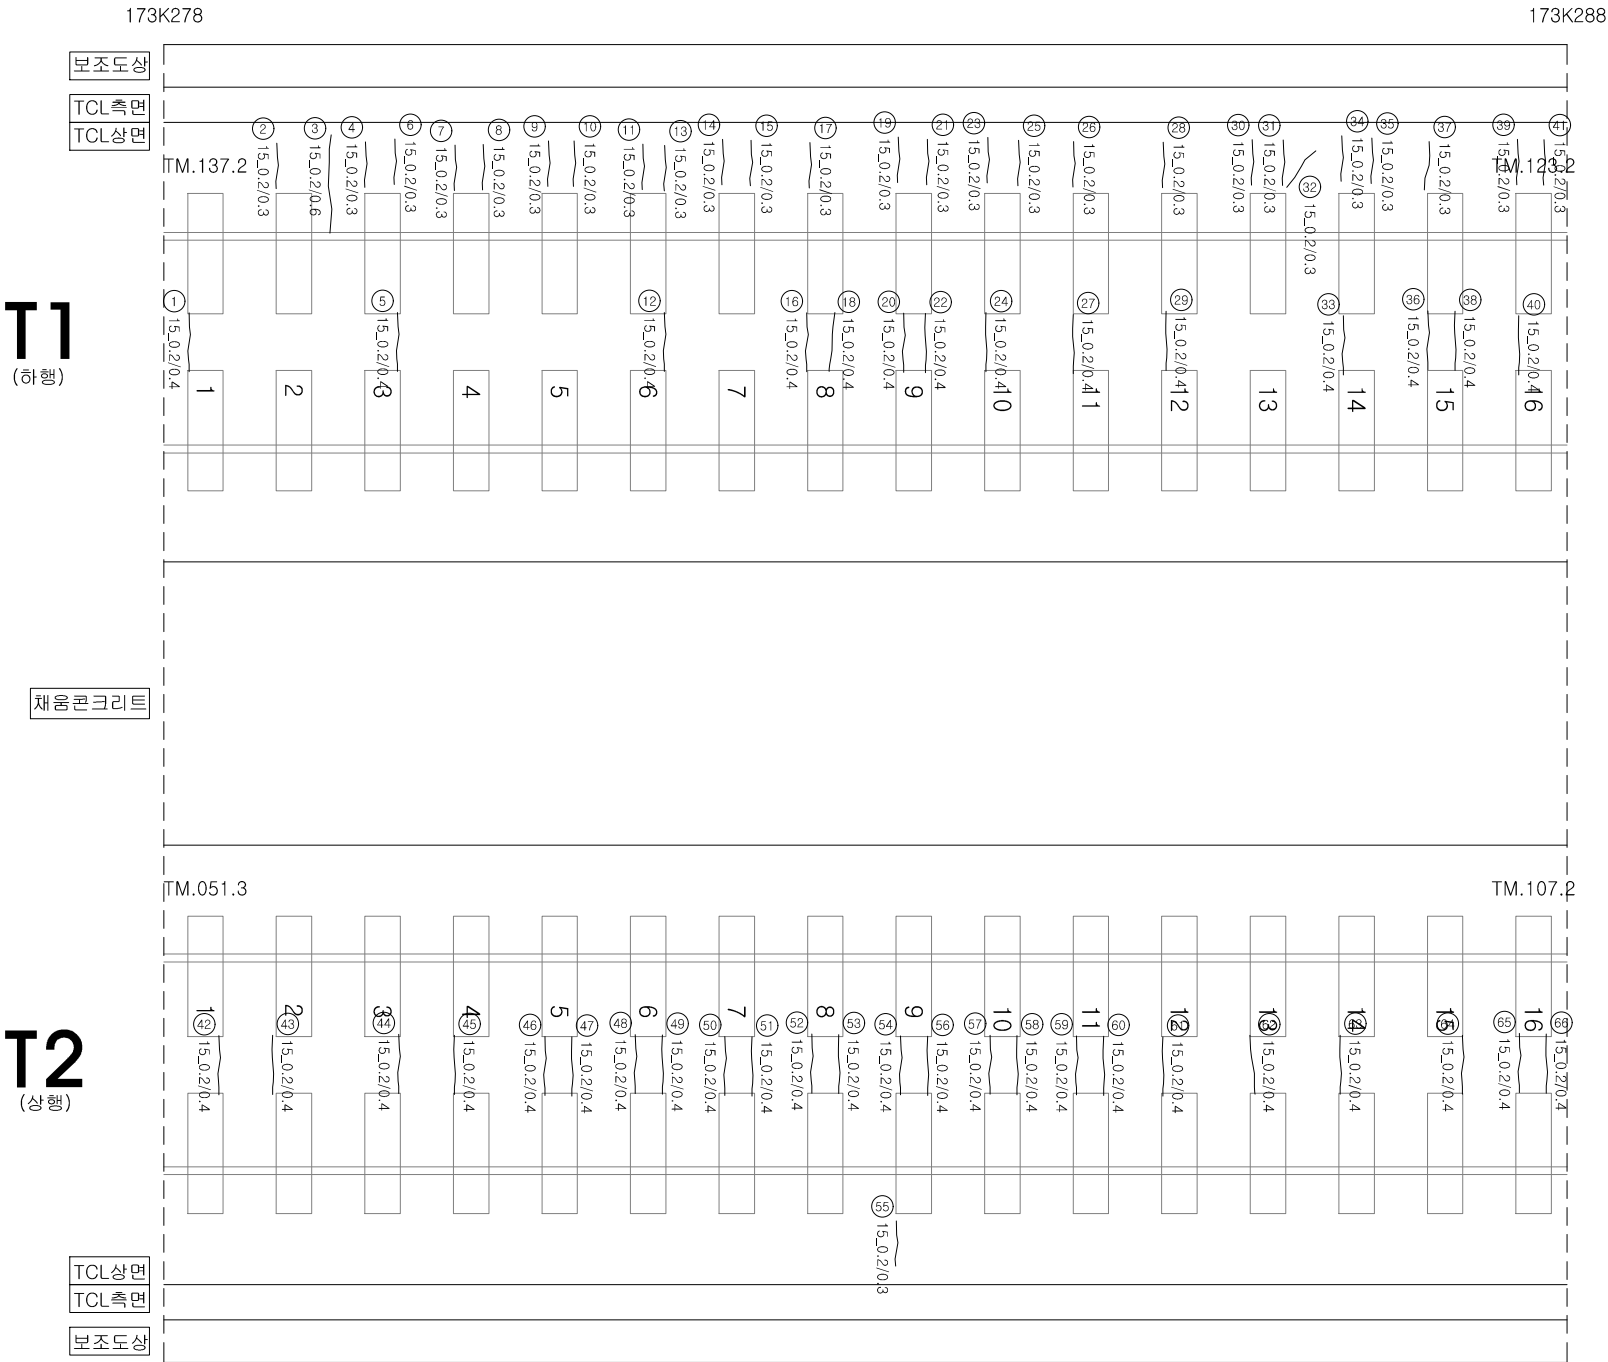
외관조사망도 번호  
U33신룡터널\_ 24(173.278~173.288km, L=10m)

| 연번 | 손상 | 폭 | 연장 | 비고 | 연번 | 손상 | 폭 | 연장 | 비고 |
| 1 | 균열 | 0.2 mm | 0.4 m | | 56 | 균열 | 0.2 mm | 0.4 m | |
| 2 | 균열 | 0.2 mm | 0.3 m | | 57 | 균열 | 0.2 mm | 0.4 m | |
| 3 | 균열 | 0.2 mm | 0.6 m | | 58 | 균열 | 0.2 mm | 0.4 m | |
| 4 | 균열 | 0.2 mm | 0.3 m | | 59 | 균열 | 0.2 mm | 0.4 m | |
| 5 | 균열 | 0.2 mm | 0.4 m | | 60 | 균열 | 0.2 mm | 0.4 m | |
| 6 | 균열 | 0.2 mm | 0.3 m | | 61 | 균열 | 0.2 mm | 0.4 m | |
| 7 | 균열 | 0.2 mm | 0.3 m | | 62 | 균열 | 0.2 mm | 0.4 m | |
| 8 | 균열 | 0.2 mm | 0.3 m | | 63 | 균열 | 0.2 mm | 0.4 m | |
| 9 | 균열 | 0.2 mm | 0.3 m | | 64 | 균열 | 0.2 mm | 0.4 m | |
| 10 | 균열 | 0.2 mm | 0.3 m | | 65 | 균열 | 0.2 mm | 0.4 m | |
| 11 | 균열 | 0.2 mm | 0.3 m | | 66 | 균열 | 0.2 mm | 0.4 m | |
| 12 | 균열 | 0.2 mm | 0.4 m | | | | | | |
| 13 | 균열 | 0.2 mm | 0.3 m | | | | | | |
| 14 | 균열 | 0.2 mm | 0.3 m | | | | | | |
| 15 | 균열 | 0.2 mm | 0.3 m | | | | | | |
| 16 | 균열 | 0.2 mm | 0.4 m | | | | | | |
| 17 | 균열 | 0.2 mm | 0.3 m | | | | | | |
| 18 | 균열 | 0.2 mm | 0.4 m | | | | | | |
| 19 | 균열 | 0.2 mm | 0.3 m | | | | | | |
| 20 | 균열 | 0.2 mm | 0.4 m | | | | | | |
| 21 | 균열 | 0.2 mm | 0.3 m | | | | | | |
| 22 | 균열 | 0.2 mm | 0.4 m | | | | | | |
| 23 | 균열 | 0.2 mm | 0.3 m | | | | | | |
| 24 | 균열 | 0.2 mm | 0.4 m | | | | | | |
| 25 | 균열 | 0.2 mm | 0.3 m | | | | | | |
| 26 | 균열 | 0.2 mm | 0.3 m | | | | | | |
| 27 | 균열 | 0.2 mm | 0.4 m | | | | | | |
| 28 | 균열 | 0.2 mm | 0.3 m | | | | | | |
| 29 | 균열 | 0.2 mm | 0.4 m | | | | | | |
| 30 | 균열 | 0.2 mm | 0.3 m | | | | | | |
| 31 | 균열 | 0.2 mm | 0.3 m | | | | | | |
| 32 | 균열 | 0.2 mm | 0.3 m | | | | | | |
| 33 | 균열 | 0.2 mm | 0.4 m | | | | | | |
| 34 | 균열 | 0.2 mm | 0.3 m | | | | | | |
| 35 | 균열 | 0.2 mm | 0.3 m | | | | | | |
| 36 | 균열 | 0.2 mm | 0.4 m | | | | | | |
| 37 | 균열 | 0.2 mm | 0.3 m | | | | | | |
| 38 | 균열 | 0.2 mm | 0.4 m | | | | | | |
| 39 | 균열 | 0.2 mm | 0.3 m | | | | | | |
| 40 | 균열 | 0.2 mm | 0.4 m | | | | | | |
| 41 | 균열 | 0.2 mm | 0.3 m | | | | | | |
| 42 | 균열 | 0.2 mm | 0.4 m | | | | | | |
| 43 | 균열 | 0.2 mm | 0.4 m | | | | | | |
| 44 | 균열 | 0.2 mm | 0.4 m | | | | | | |
| 45 | 균열 | 0.2 mm | 0.4 m | | | | | | |
| 46 | 균열 | 0.2 mm | 0.4 m | | | | | | |
| 47 | 균열 | 0.2 mm | 0.4 m | | | | | | |
| 48 | 균열 | 0.2 mm | 0.4 m | | | | | | |
| 49 | 균열 | 0.2 mm | 0.4 m | | | | | | |
| 50 | 균열 | 0.2 mm | 0.4 m | | | | | | |
| 51 | 균열 | 0.2 mm | 0.4 m | | | | | | |
| 52 | 균열 | 0.2 mm | 0.4 m | | | | | | |
| 53 | 균열 | 0.2 mm | 0.4 m | | | | | | |
| 54 | 균열 | 0.2 mm | 0.4 m | | | | | | |
| 55 | 균열 | 0.2 mm | 0.3 m | | | | | | |
