| 노 선 명 |
|---|
| 2018년도 하반기 호남고속선 오송-정읍간 황룡고가외<br>48개소 (옹벽2개) 구조물 하자(정기, 정밀)점검 용역 |

점 검 기 관  
(재)한국건설품질연구원  
(주)한국국토안전연구원  
(주)한국구조물안전연구원

거더 내부 외관조사망도

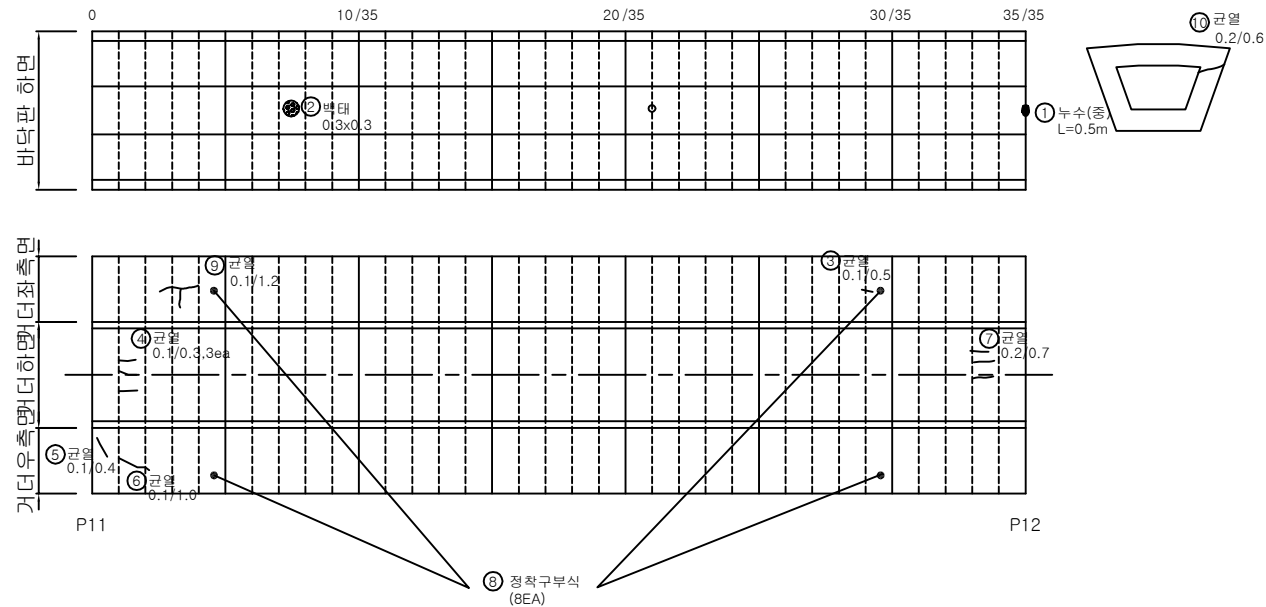
ID 거더 내부 (S12)

| 순<br>상<br>번<br>호 | 손 상 현 황 | 손상규모 | | | 손상물량 | 비고 |
|---|---|---|---|---|---|---|
| 1 | 누수(중) | - | 0.5m | 1 | 0.50m | 기존 |
| 2 | 벽태 | 0.3 m | 0.3 m | 1 | 0.09 m <sup>2</sup> | 기존 |
| 3 | 균열 | 0.1mm | 0.5m | 1 | 0.50m | 기존 |
| 4 | 균열 | 0.1mm | 0.5m | 3 | 1.50m | 기존 |
| 5 | 균열 | 0.1mm | 0.4m | 1 | 0.40m | 기존 |
| 6 | 균열 | 0.1mm | 1.0m | 1 | 1.00m | 기존 |
| 7 | 균열 | 0.2mm | 0.7m | 1 | 0.70m | 기존 |
| 8 | 정착구부식 | - | - | 8 | 8 EA | 기존 |
| 9 | 균열 | 0.1mm | 1.2m | 1 | 1.20m | 기존 |
| 10 | 균열 | 0.2mm | 0.6m | 1 | 0.60m | 기존 |

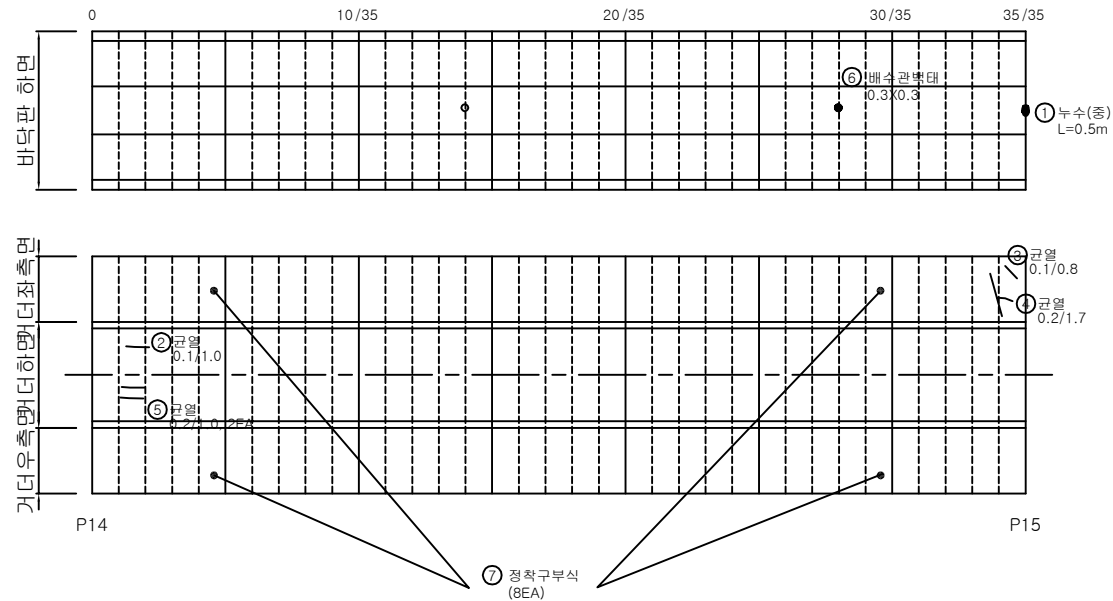
ID 거더 내부 (S15)

| 순상<br>번호 | 순상원형 | 순상규모 | | | 순상물량 | 비고 |
|---|---|---|---|---|---|---|
| 1 | 누수(중) | - | 0.5m | 1 | 0.50m | 기존 |
| 2 | 균열 | 0.1mm | 1.0m | 1 | 1.00m | 기존 |
| 3 | 균열 | 0.1mm | 0.8m | 1 | 0.80m | 기존 |
| 4 | 균열 | 0.2mm | 1.7m | 1 | 1.70m | 기존 |
| 5 | 균열 | 0.2mm | 1.0m | 2 | 2.00m | 기존 |
| 6 | 정착구부식 | - | - | 8 | 8 EA | 기존 |
| 7 | 배수관벽대 | 0.3m | 0.3m | 1 | 0.09 m <sup>2</sup> | 기존 |
