# 교 면 포 장

가천교

[주] 우림 종합 엔지니어링

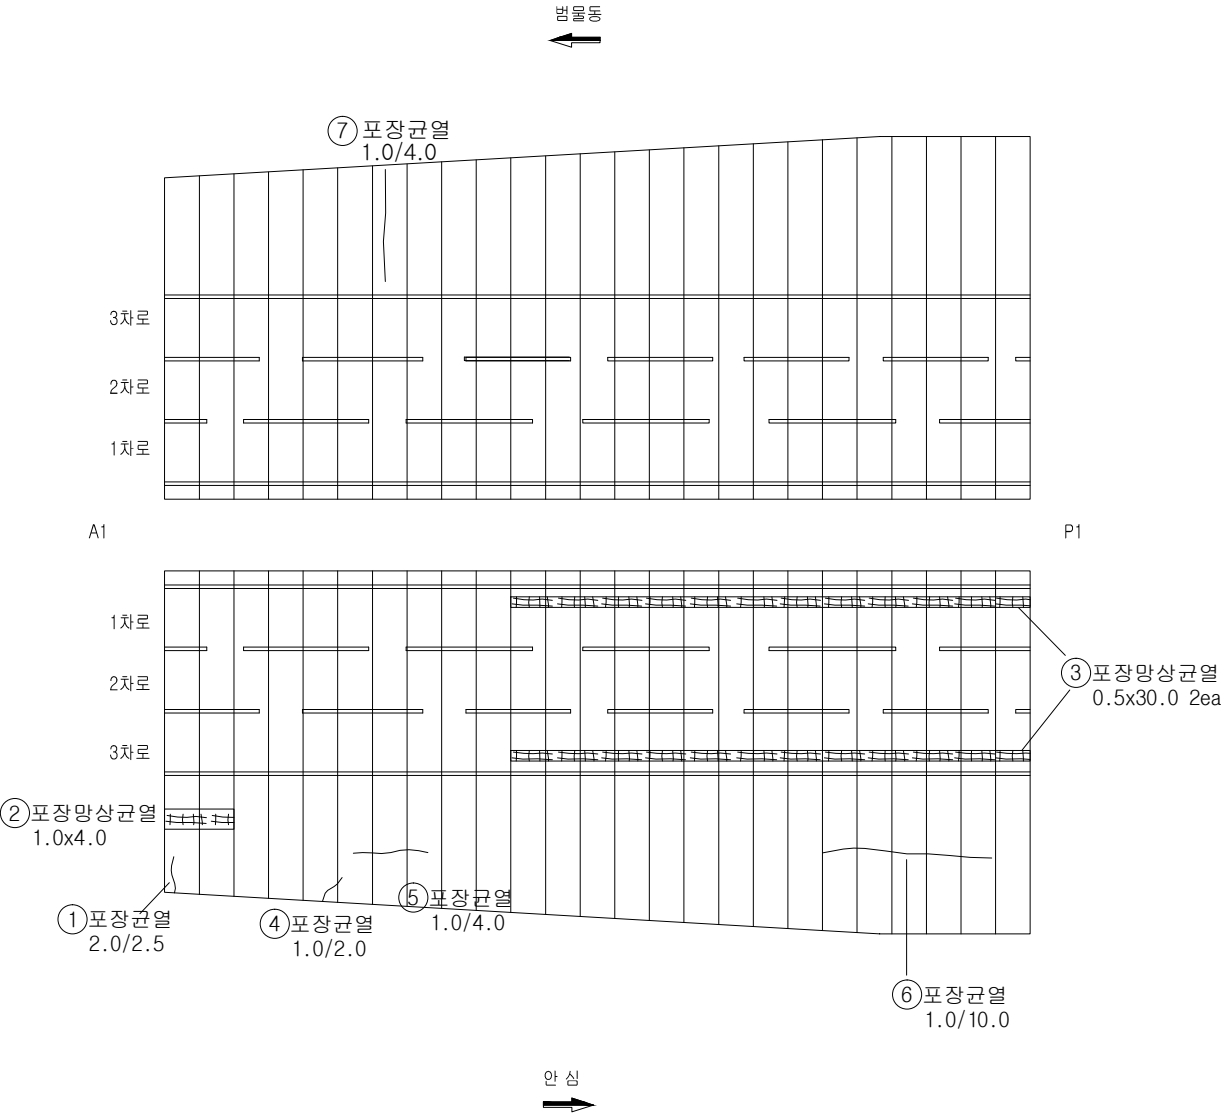
| 일련<br>번호 | 구<br>분 | 부재명<br>(위치) | 결함종류 | 결함규모 | | | | 개소 | 최종보수내역 | | 우선<br>순위 | 비고 |
|---|---|---|---|---|---|---|---|---|---|---|---|---|
| 1 | 구 | 교면포장 | 포장균열 | 2.0 | 2.5 | 2.50 | m | 1 | | | 3 | |
| 2 | 구 | 교면포장 | 포장망상균열 | | 1.0 | 4.0 | 4.00 | ㎡ | 1 | | - | |
| 4 | 구 | 교면포장 | 포장균열 | 1.0 | 2.0 | 2.00 | m | 1 | | | 3 | |
| 5 | 구 | 교면포장 | 포장균열 | 1.0 | 4.0 | 4.00 | m | 1 | | | 3 | |
| 6 | 구 | 교면포장 | 포장균열 | 1.0 | 10.0 | 10.00 | m | 1 | | | 3 | |
| 7 | 신 | 교면포장 | 포장균열 | 1.0 | 4.0 | 4.00 | m | 1 | | | 3 | |

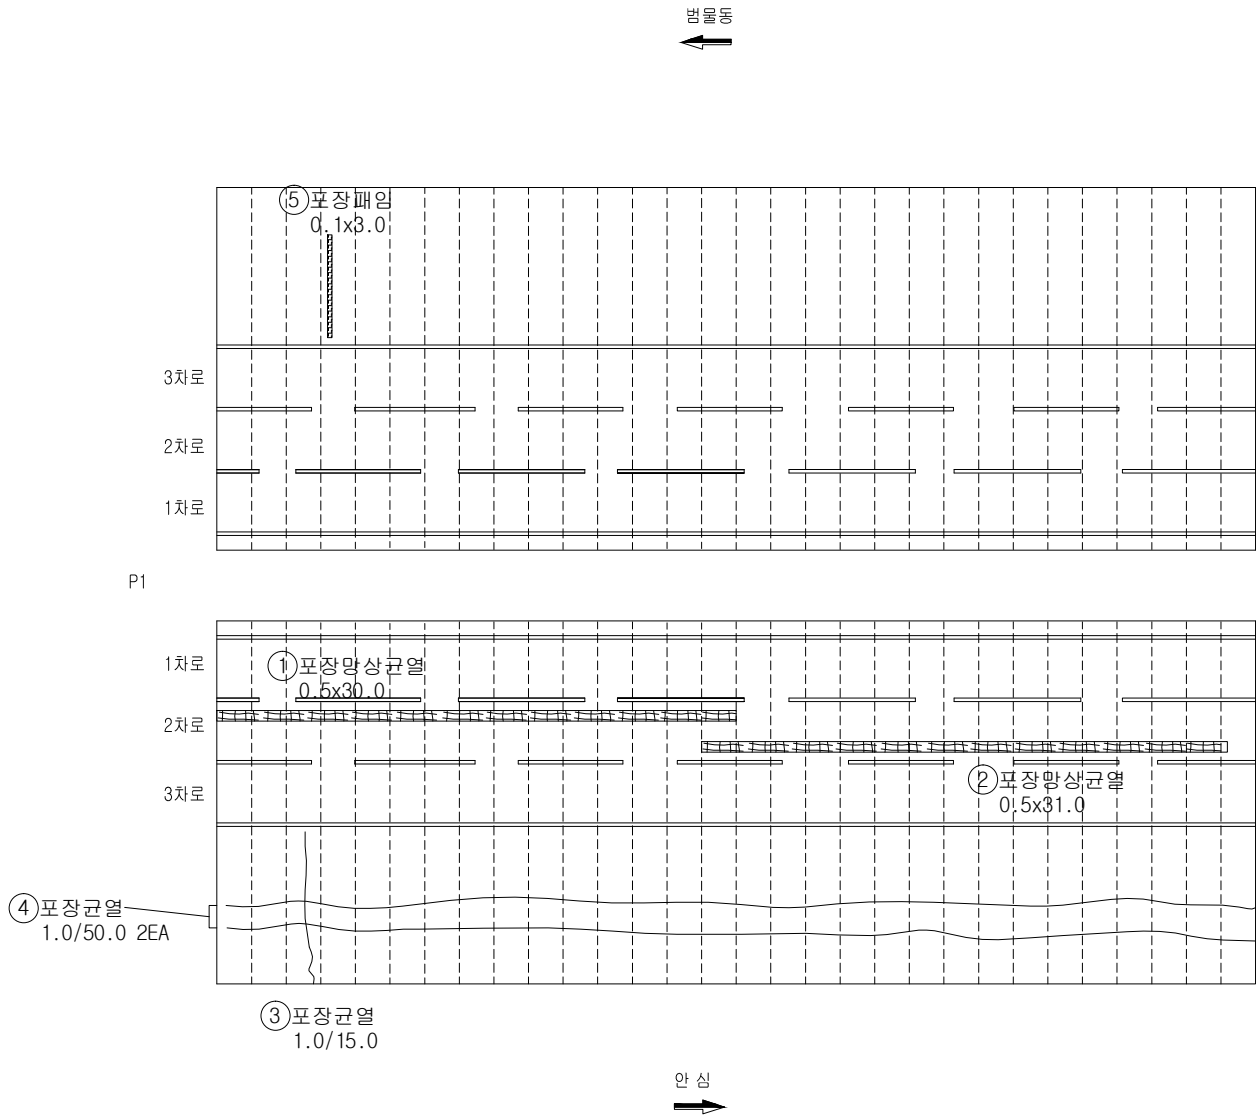
| 일련<br>번호 | 구<br>분 | 부재명<br>(위치) | 결함종류 | 결함규모 | | | | 개소 | 최종보수내역 | | | 우선<br>순위 | 비고 |
|---|---|---|---|---|---|---|---|---|---|---|---|---|---|
| 1 | 구 | 교면포장 | 망상균열 | | 0.5 | 30.0 | 15.00 | ㎡ | 1 | | | - | |
| 2 | 구 | 교면포장 | 망상균열 | | 0.5 | 31.0 | 15.50 | ㎡ | 1 | | | - | |
| 3 | 구 | 교면포장 | 포장균열 | 1.0 | 15.0 | 15.00 | m | 1 | | | | 3 | |
| 4 | 구 | 교면포장 | 포장균열 | 1.0 | 50.0 | 100.00 | m | 2 | | | | 3 | |

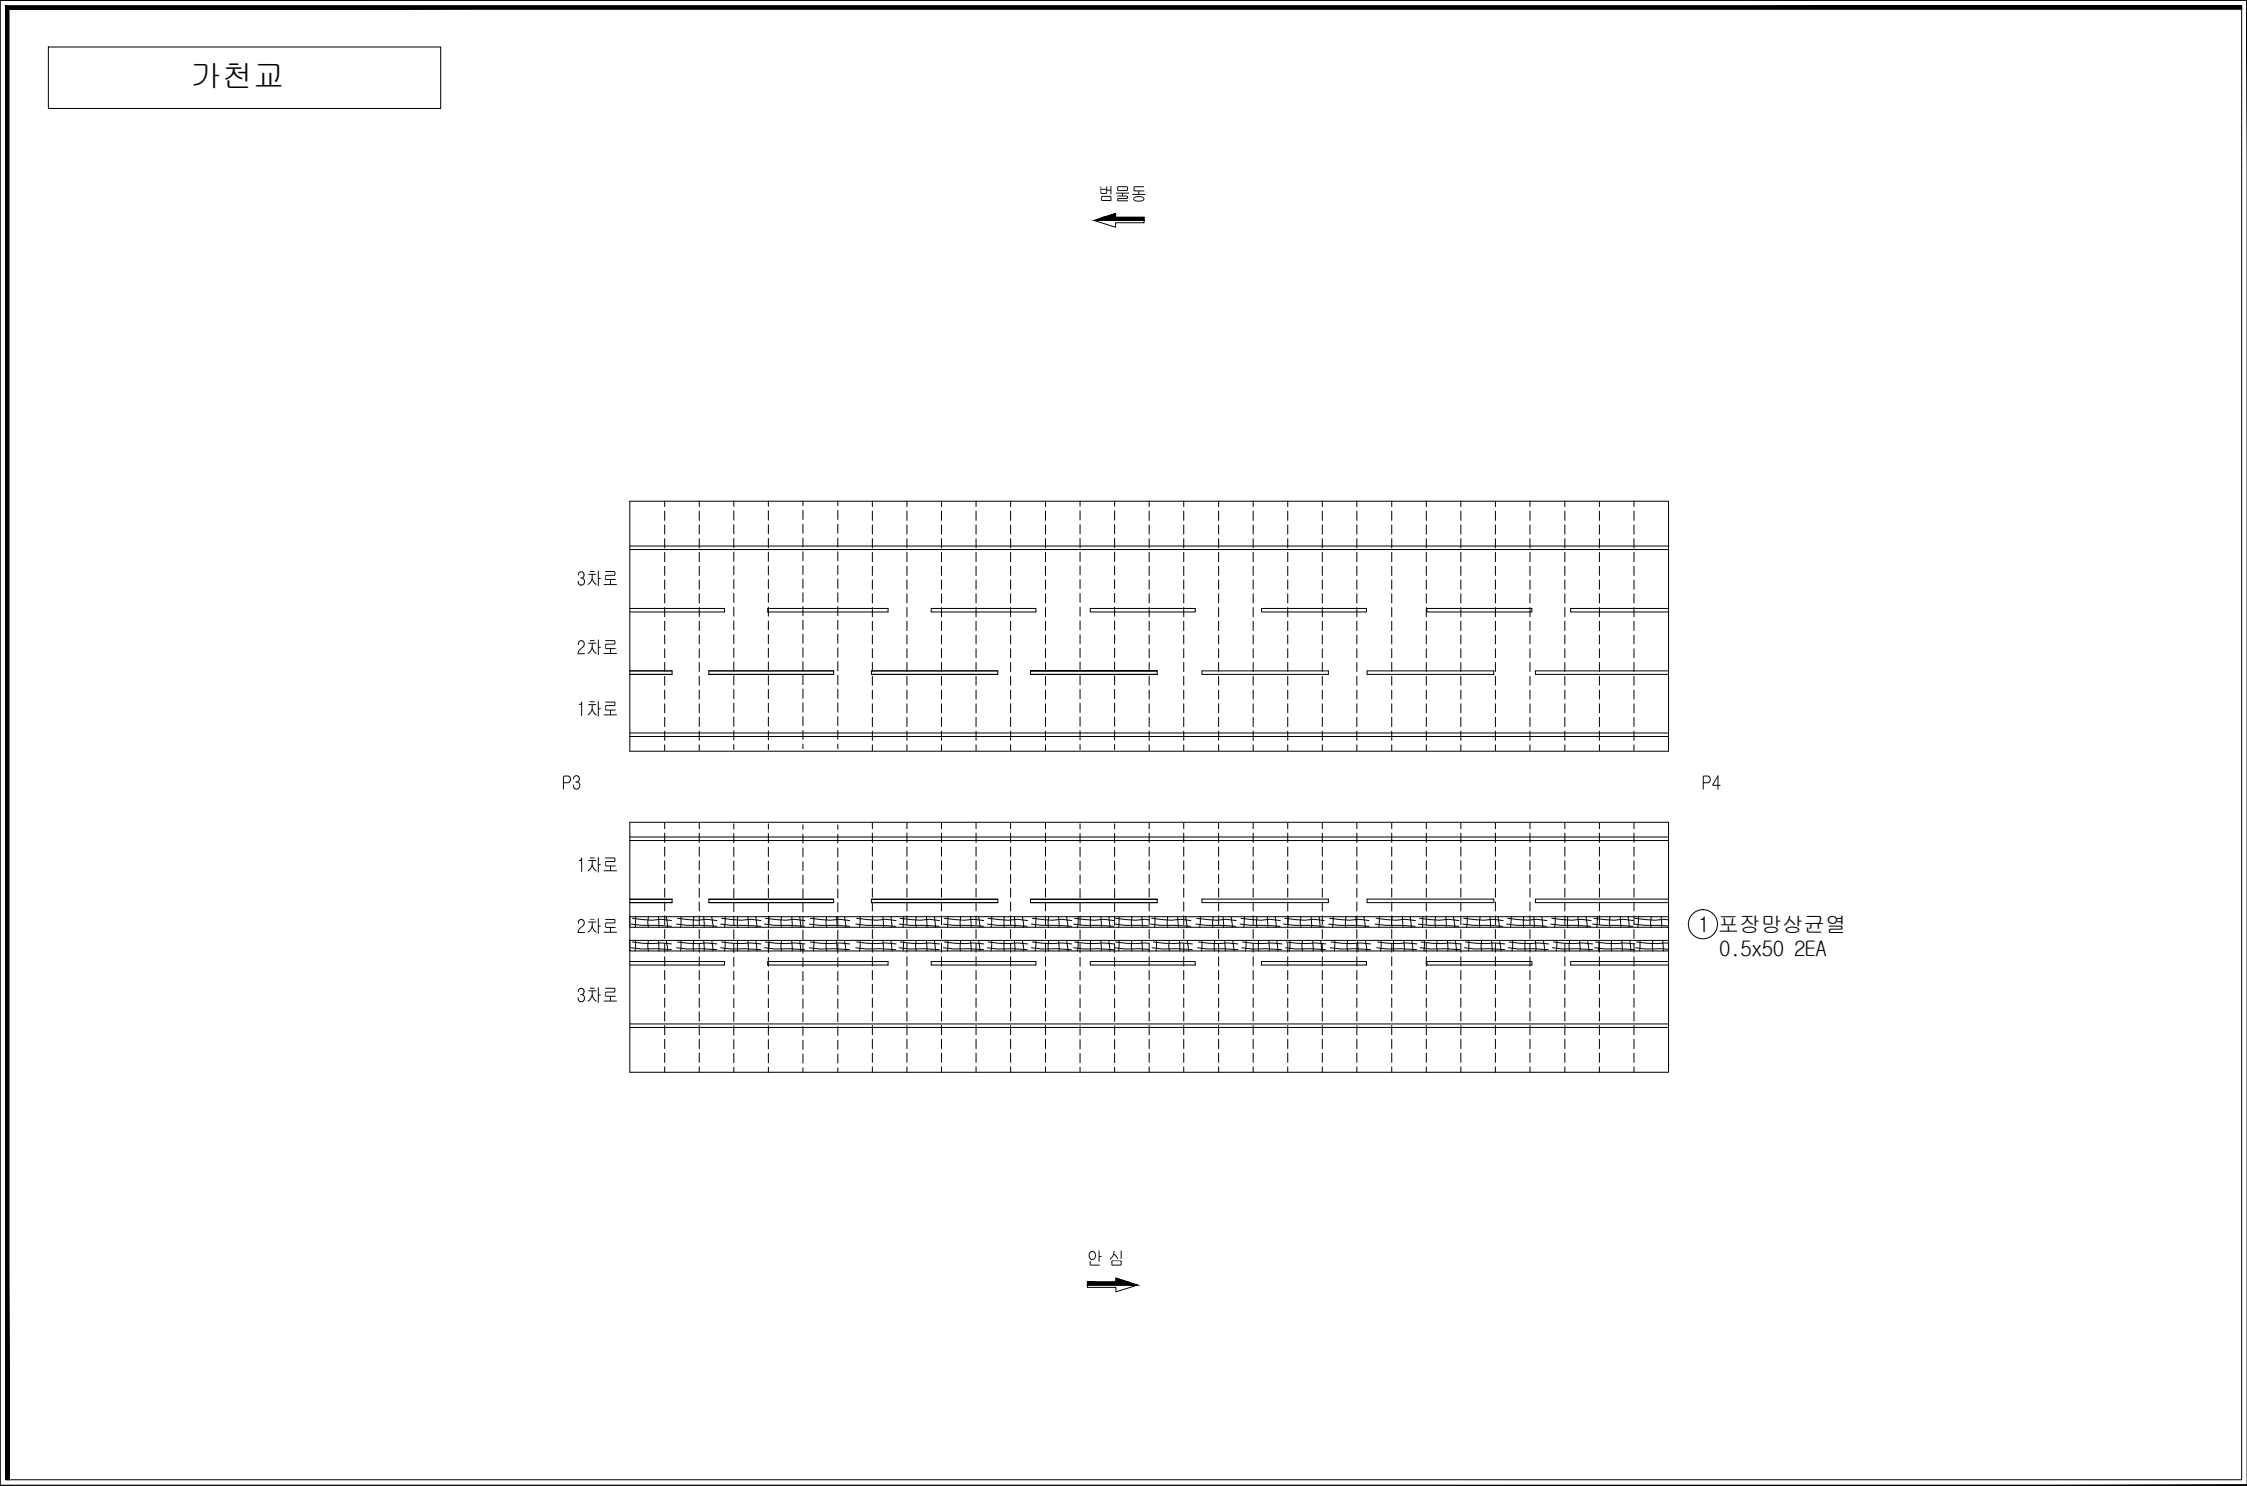
② 포장망상균열  
0.5x56.0 2EA

④포창균열  
1.0/3.0

⑥ 포장균열  
1.0/10.0

⑧포장균열  
3.0/8.0

| 손상물량표 | | | | | | | | | | | |
|---|---|---|---|---|---|---|---|---|---|---|---|
| 1 | 구 | 교면포장 | 포장망상균열 | 0.5 | 50.0 | 50.00 | m | 2 | | | - |

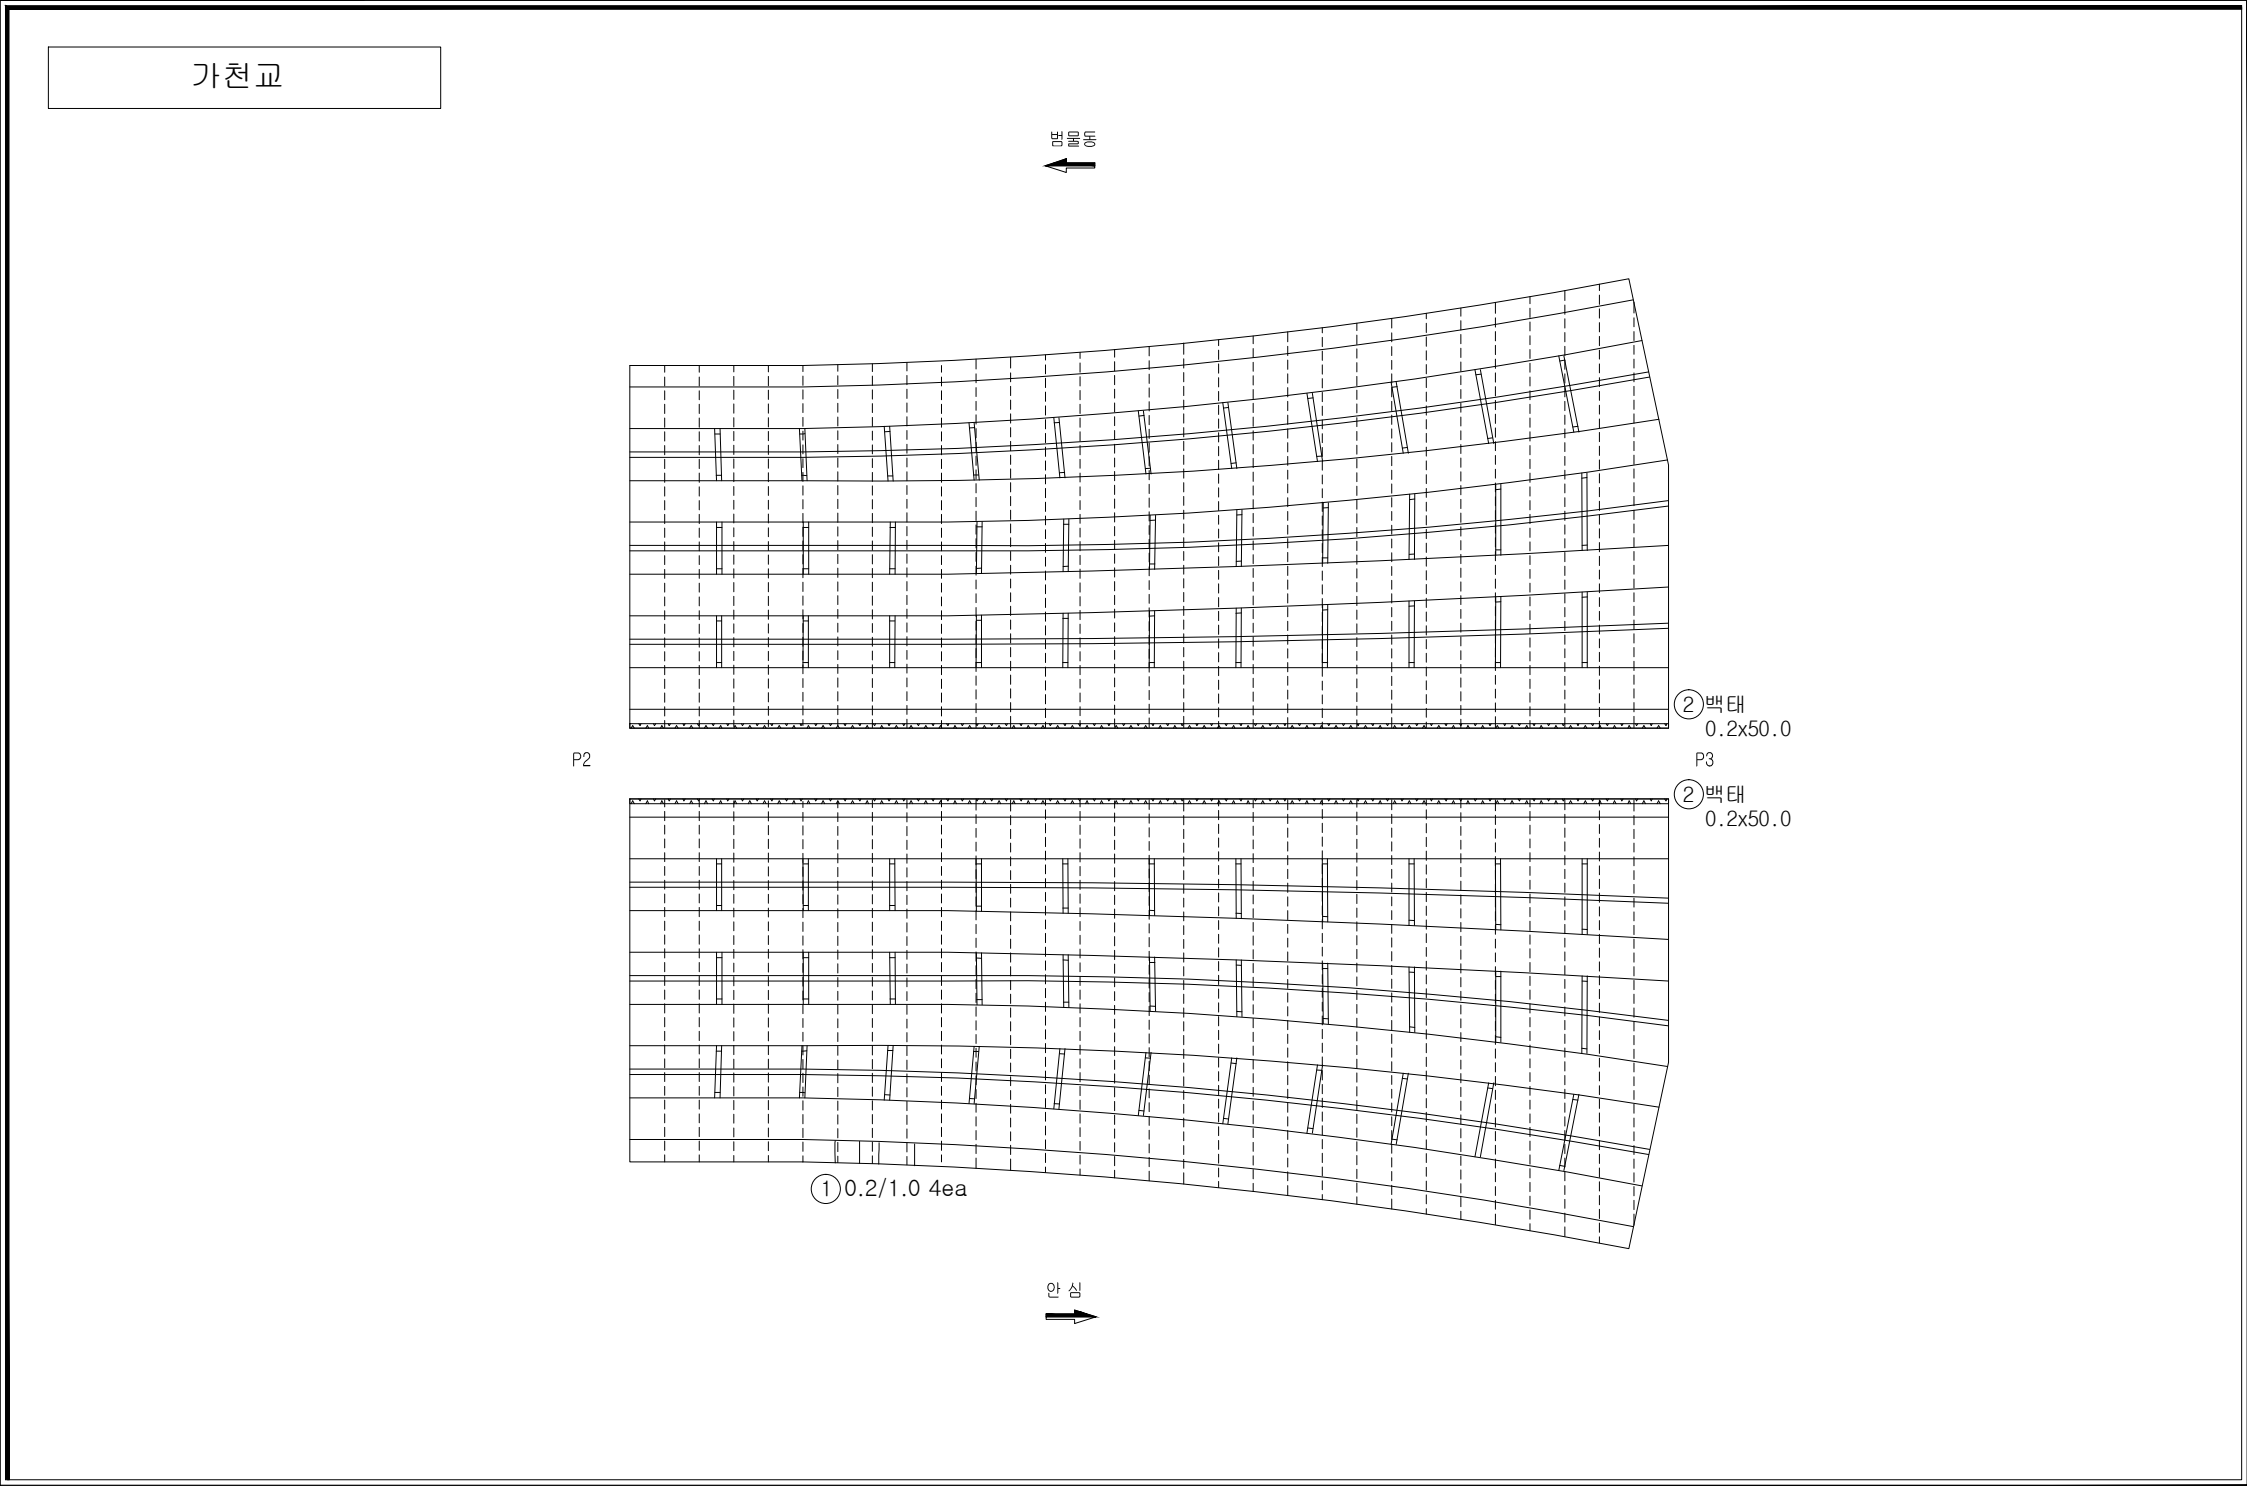
| 일련<br>번호 | 구<br>분 | 부재명<br>(위치) | 결함종류 | 결함 규모 | | | | | 최종보수내역 | | | 우선<br>순위 | 비고 |
|---|---|---|---|---|---|---|---|---|---|---|---|---|---|
| 1 | 신 | 바닥판아면 | 균열 | 0.2 | 1.0 | | 4.00 | m | 4 | | | 3 | |

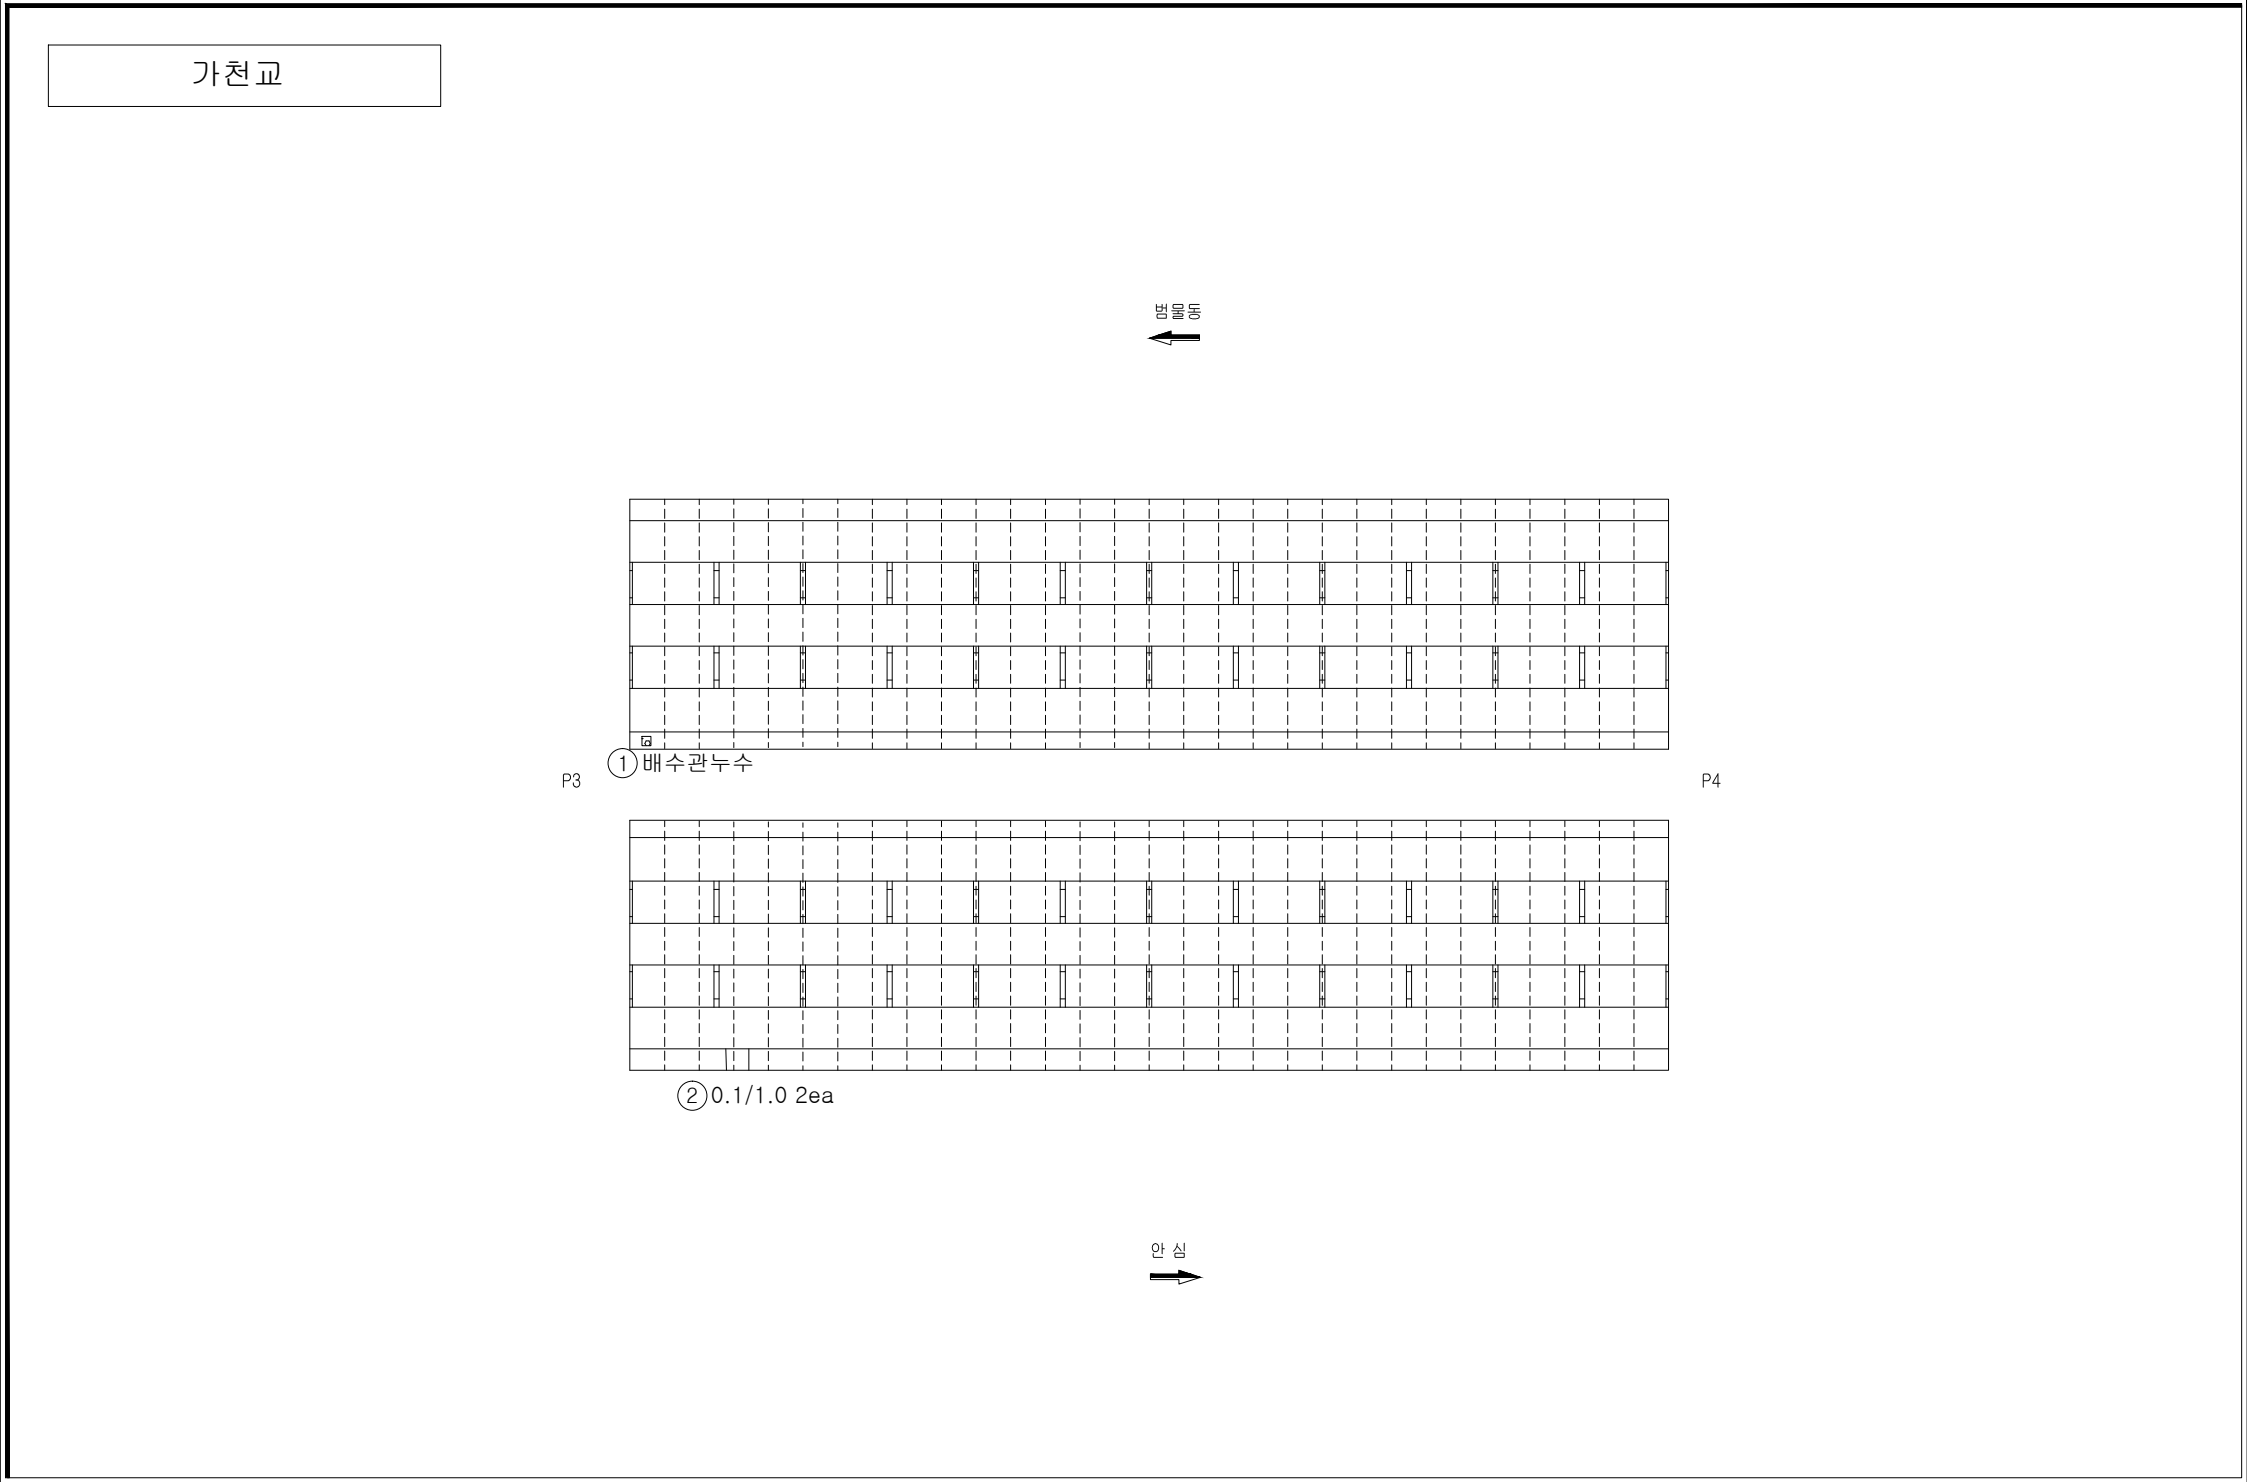
| 일련<br>번호 | 구<br>분 | 부재명<br>(위치) | 결함종류 | 결함구오 | | | | 개소 | 최종보수내역 | | 우선<br>순위 | 비고 |
|---|---|---|---|---|---|---|---|---|---|---|---|---|
| 1 | 구 | 배수시설 | 배수관누수 | | | | 1.00 | ea | 1 | | - | |
| 2 | 신 | 바닥판하면 | 균열 | 0.2 | 1.0 | | 2.00 | m | 2 | | 3 | |

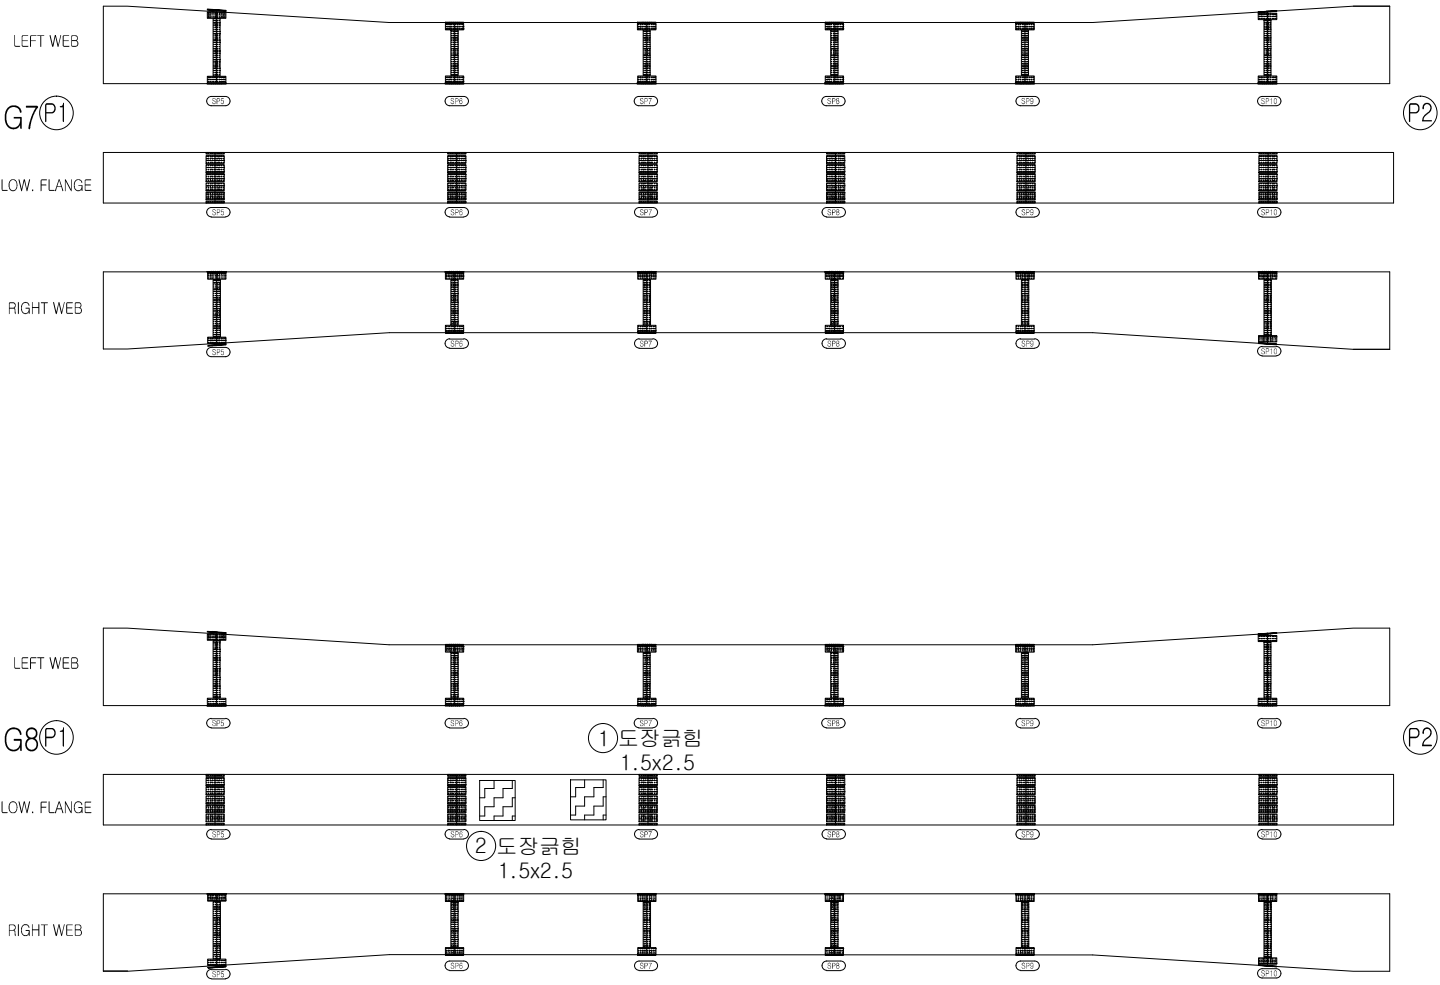
| 일련<br>번호 | 구<br>분 | 부재명<br>(위치) | 결함종류 | 결함 규모 | | | | 개소<br>년월 | 최종보수내역 | | 우선<br>순위 | 비고 |
|---|---|---|---|---|---|---|---|---|---|---|---|---|
| 1 | 구 | 주형외부 | 도장결함 | | 1.5 | 2.5 | 3.75 | ㎡ | 1 | | 1 | |
| 2 | 신 | 주형외부 | 도장결함 | | 1.5 | 2.5 | 3.75 | ㎡ | 1 | | 1 | |

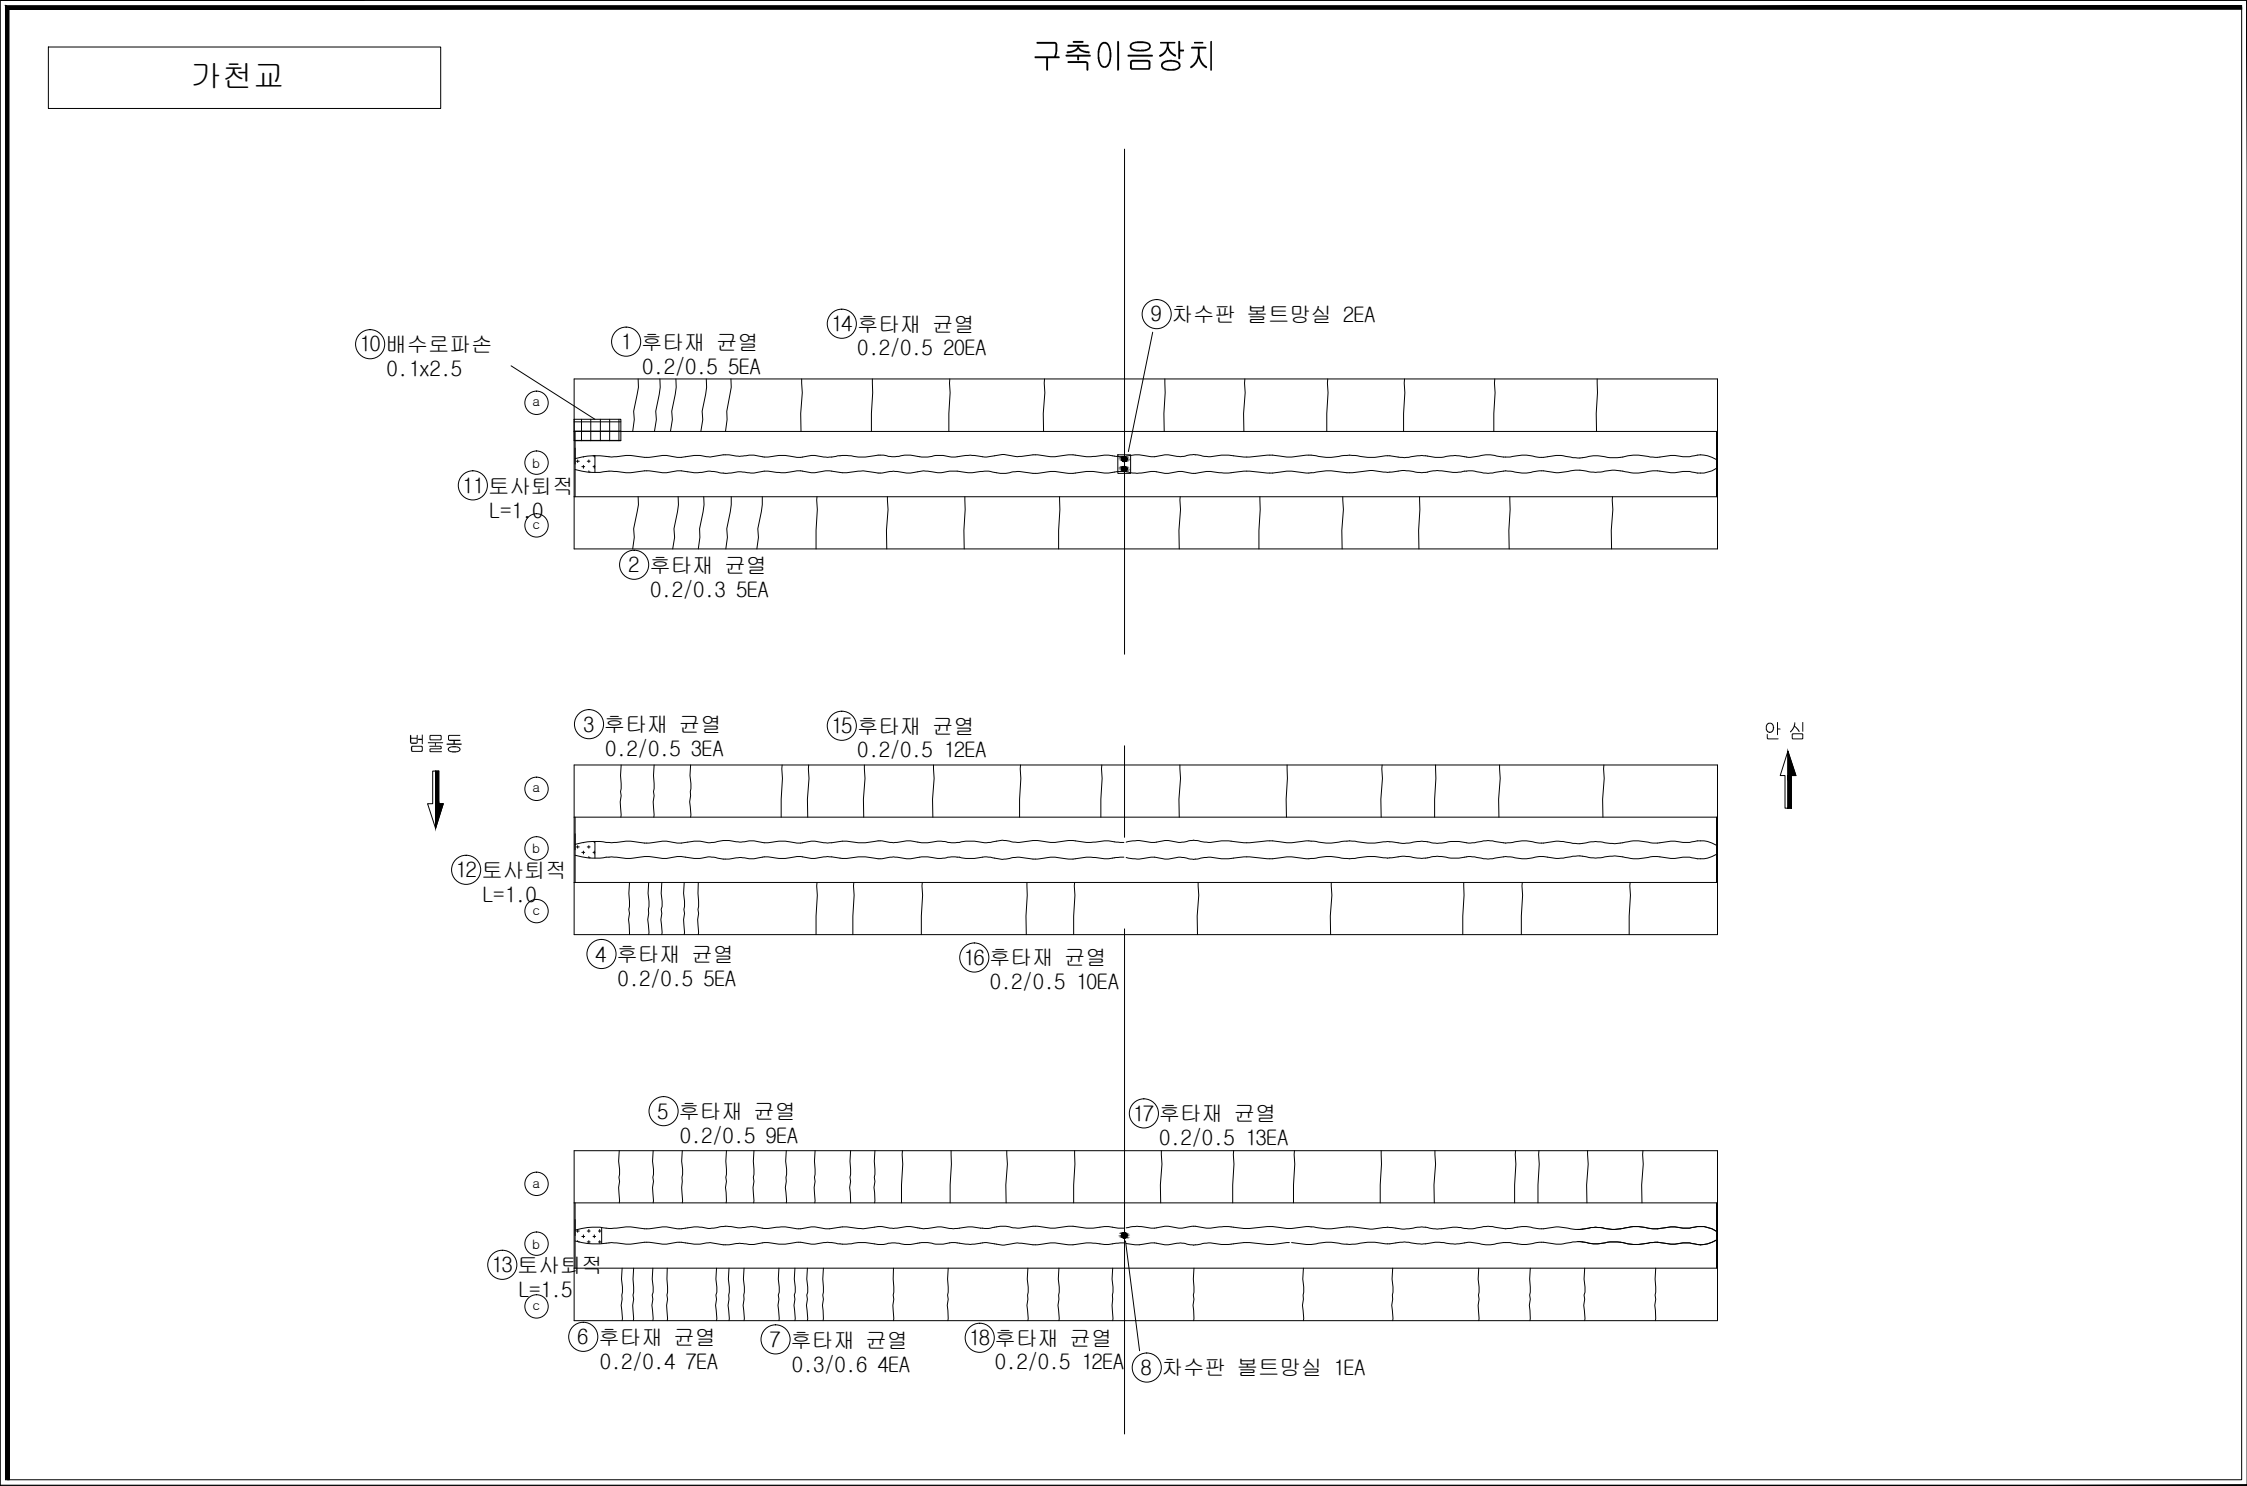
| 일련<br>번호 | 구<br>분 | 부재명<br>(위치) | 결함종류 | 결함구오 | | | | 최종보수내역 | | | 비고 |
|---|---|---|---|---|---|---|---|---|---|---|---|
| 1 | 구 | 신축이음 | 후타재 균열 | 0.2 | 0.5 | 5.50 | m | 5 | | | 3 |
| 2 | 구 | 신축이음 | 후타재 균열 | 0.2 | 0.3 | 3.00 | m | 5 | | | 3 |
| 3 | 구 | 신축이음 | 후타재 균열 | 0.2 | 0.5 | 6.00 | m | 3 | | | 3 |
| 4 | 구 | 신축이음 | 후타재 균열 | 0.2 | 0.5 | 2.50 | m | 5 | | | 3 |
| 5 | 구 | 신축이음 | 후타재 균열 | 0.2 | 0.5 | 6.00 | m | 9 | | | 3 |
| 6 | 구 | 신축이음 | 후타재 균열 | 0.2 | 0.4 | 4.00 | m | 7 | | | 3 |
| 7 | 구 | 신축이음 | 후타재 균열 | 0.3 | 0.6 | 2.40 | m | 4 | | | 2 |
| 14 | 신 | 신축이음 | 후타재 균열 | 0.2 | 0.5 | 10.00 | m | 20 | | | 3 |
| 15 | 신 | 신축이음 | 후타재 균열 | 0.2 | 0.5 | 6.00 | m | 12 | | | 3 |
| 16 | 신 | 신축이음 | 후타재 균열 | 0.2 | 0.5 | 5.00 | m | 10 | | | 3 |
| 17 | 신 | 신축이음 | 후타재 균열 | 0.2 | 0.5 | 6.50 | m | 13 | | | 3 |
| 18 | 신 | 신축이음 | 후타재 균열 | 0.2 | 0.5 | 6.00 | m | 12 | | | 3 |

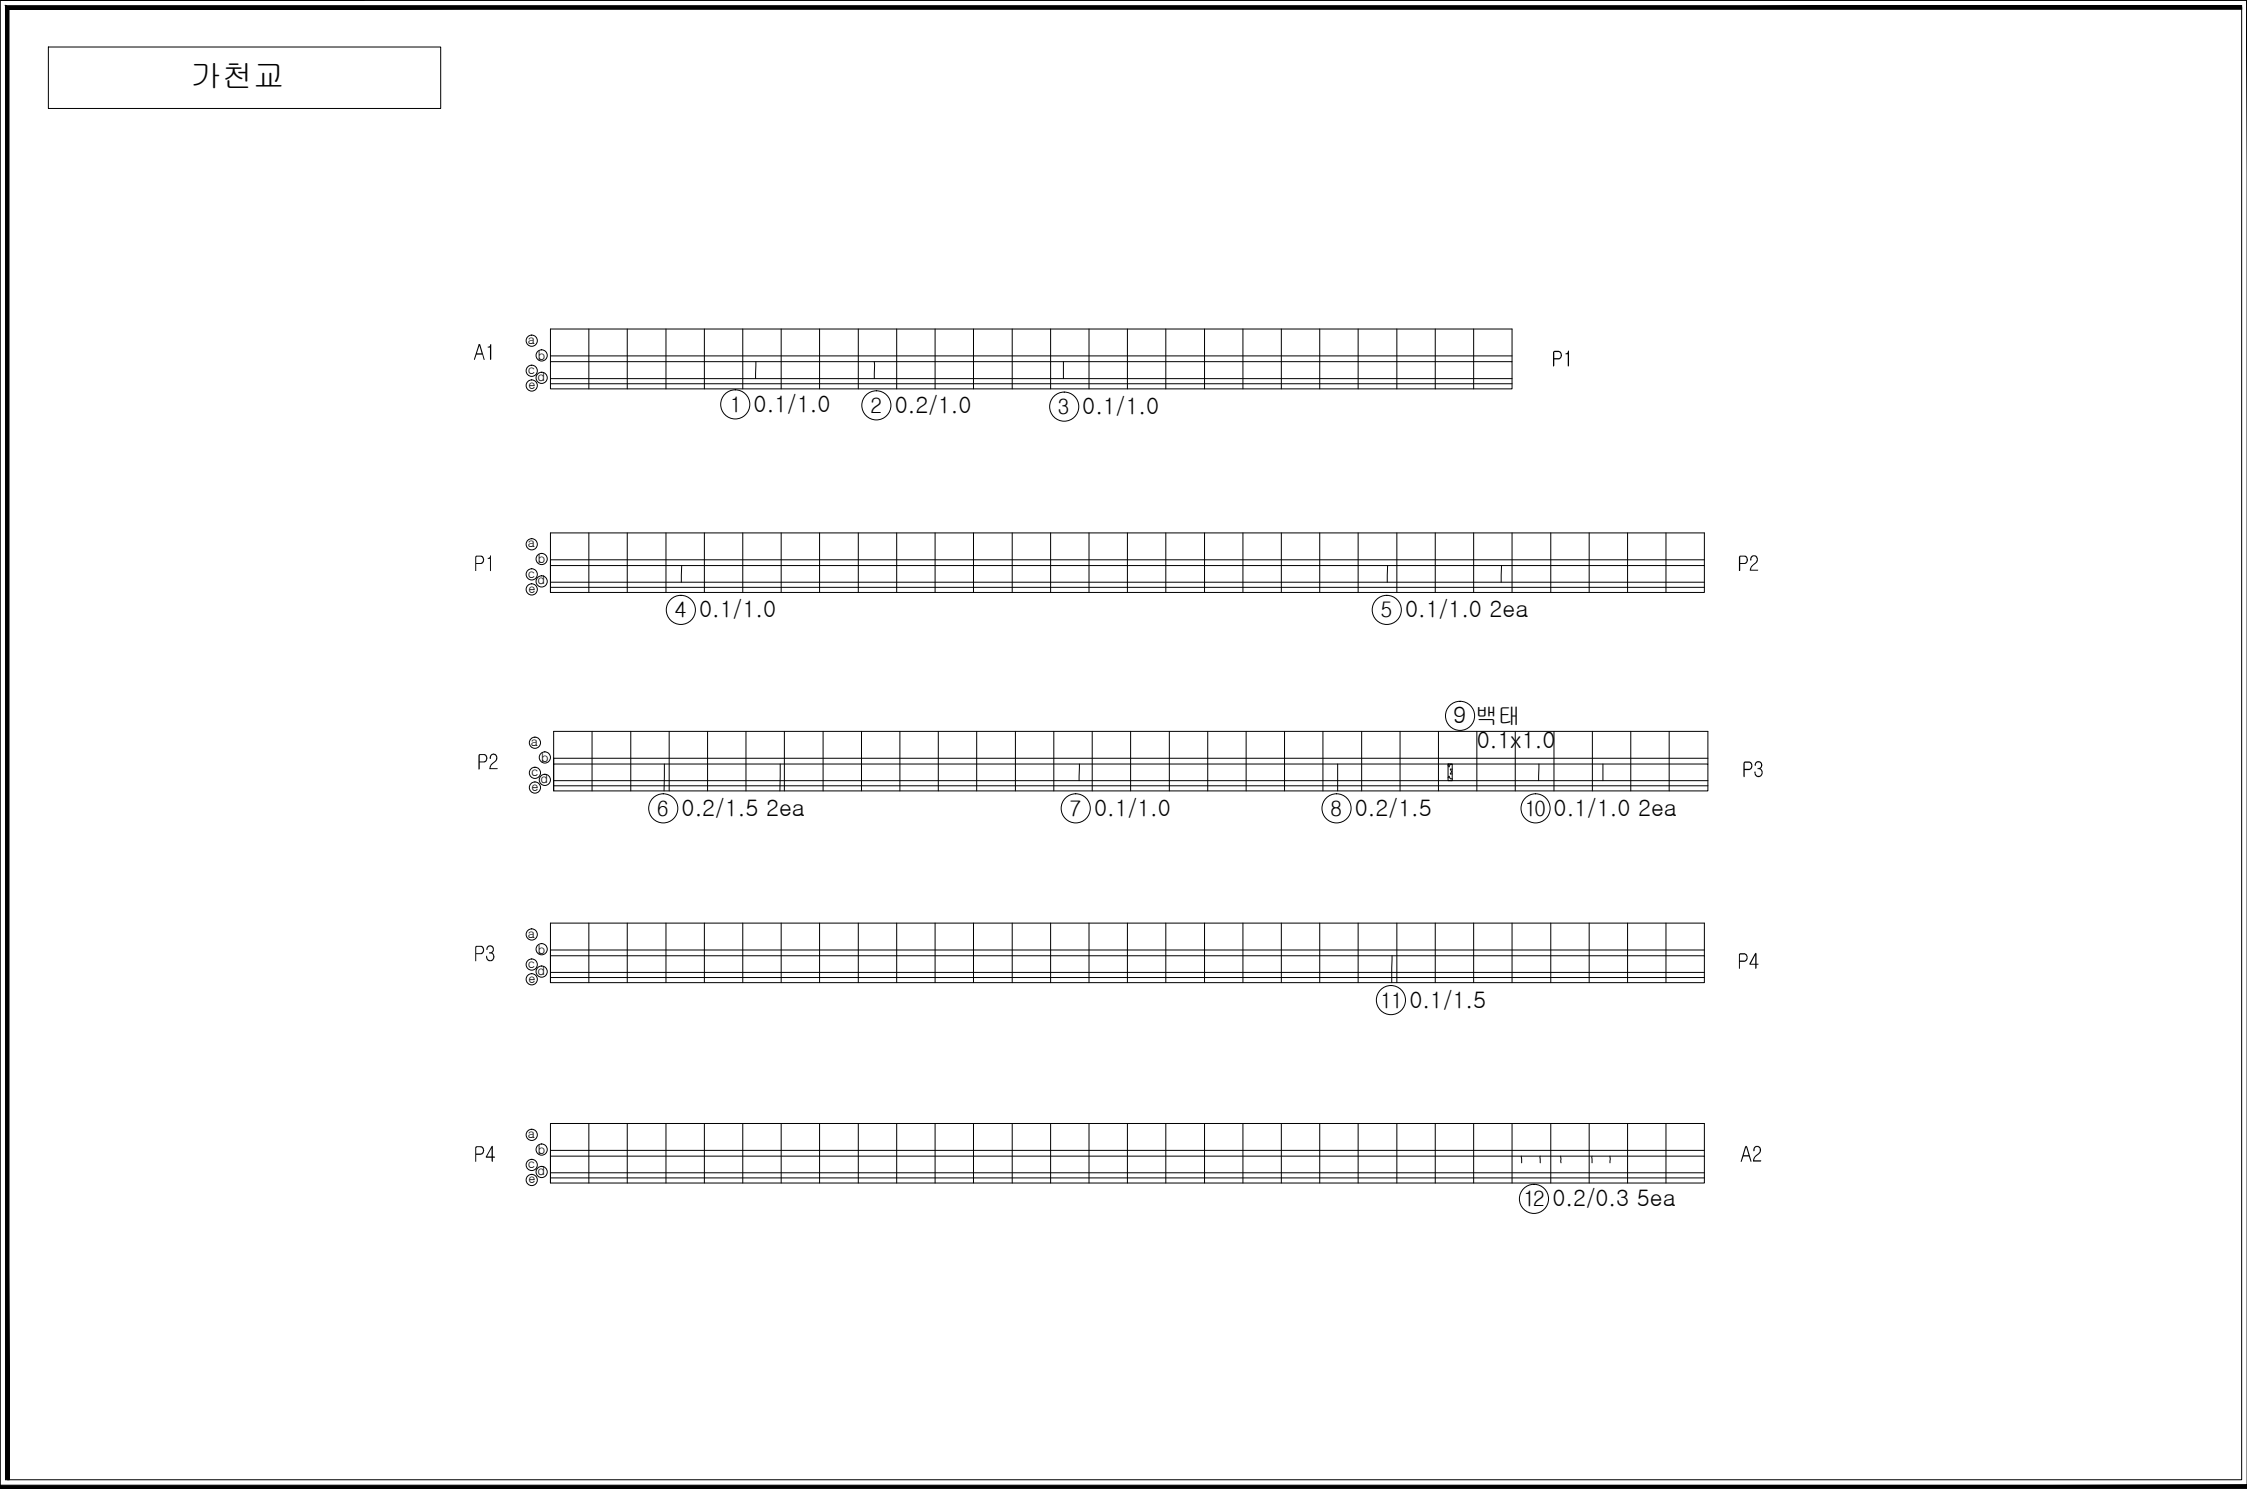
| 일련<br>번호 | 구<br>신 | 부재명<br>(위치) | 결함종류 | 결함규모 | | | | 최종보수내역 | | | 비고 |
|---|---|---|---|---|---|---|---|---|---|---|---|
| 1 | 신 | 방호벽 | 균열 | 0.1 | 1.0 | 1.00 | m | 1 | | | 2 |
| 2 | 신 | 방호벽 | 균열 | 0.2 | 1.0 | 1.00 | m | 1 | | | 2 |
| 3 | 신 | 방호벽 | 균열 | 0.1 | 1.0 | 1.00 | m | 1 | | | 2 |
| 4 | 신 | 방호벽 | 균열 | 0.1 | 1.0 | 1.00 | m | 1 | | | 2 |
| 5 | 신 | 방호벽 | 균열 | 0.1 | 1.0 | 2.00 | m | 2 | | | 2 |
| 6 | 신 | 방호벽 | 균열 | 0.2 | 1.5 | 3.00 | m | 2 | | | 2 |
| 7 | 신 | 방호벽 | 균열 | 0.1 | 1.0 | 1.00 | m | 1 | | | 2 |
| 8 | 신 | 방호벽 | 균열 | 0.2 | 1.5 | 1.50 | m | 1 | | | 2 |
| 10 | 신 | 방호벽 | 균열 | 0.1 | 1.0 | 2.00 | m | 2 | | | 2 |
| 11 | 신 | 방호벽 | 균열 | 0.1 | 1.5 | 1.50 | m | 1 | | | 2 |
| 12 | 신 | 방호벽 | 균열 | 0.2 | 0.3 | 1.50 | m | 5 | | | 2 |

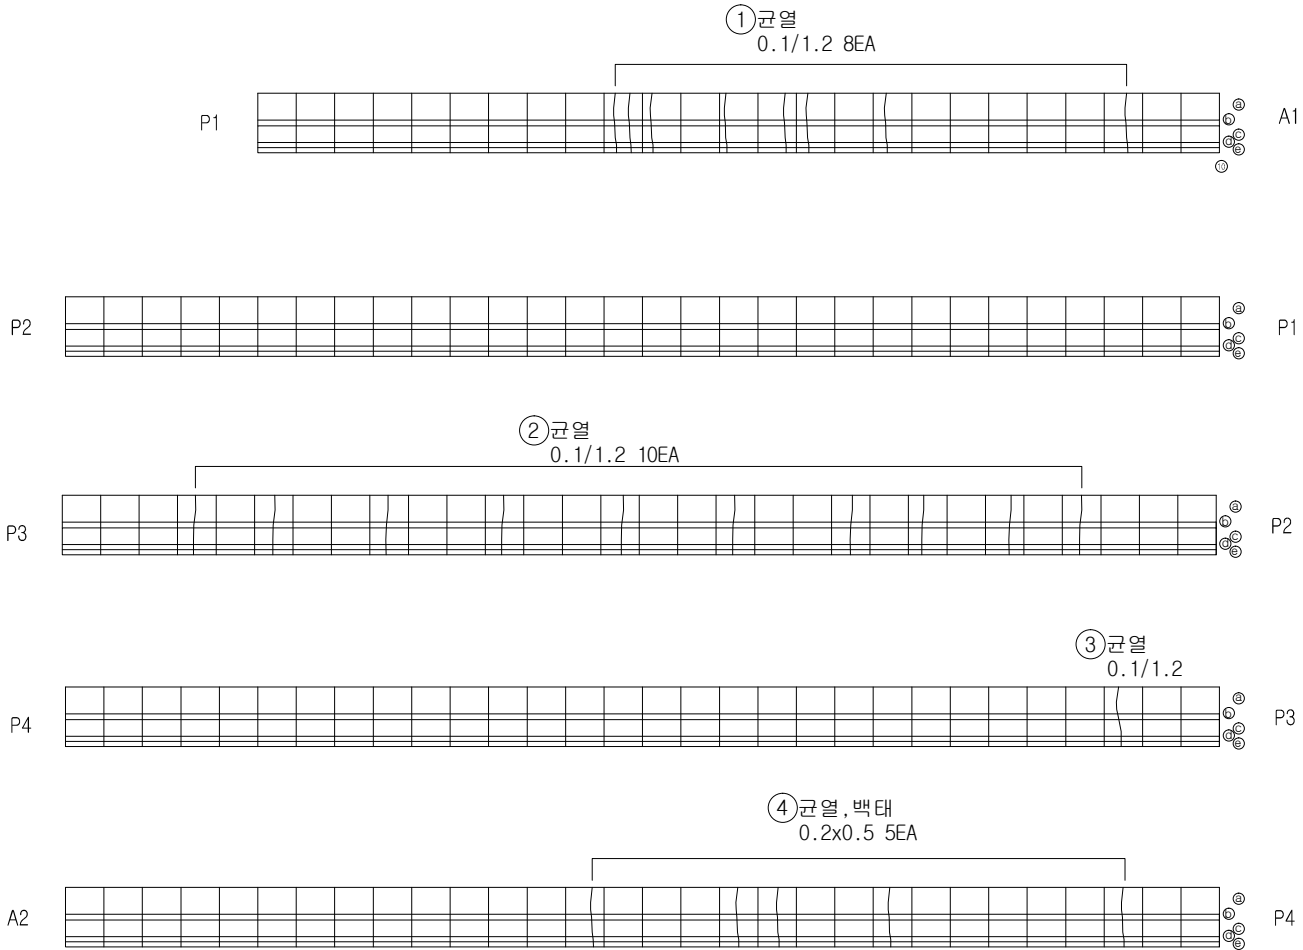
| 일련<br>번호 | 구 | 부재명<br>(위치) | 결함종류 | 결함구호 | | | | | | 최종보수내역 | | | 우선<br>순위 | 비고 |
|---|---|---|---|---|---|---|---|---|---|---|---|---|---|---|
| 1 | 구 | 방호벽 | 균열 | 0.1 | 1.2 | 9.60 | m | 8 | | | | 2 | | |
| 2 | 구 | 방호벽 | 균열 | 0.1 | 1.2 | 12.00 | m | 10 | | | | 2 | | |
| 3 | 구 | 방호벽 | 균열 | 0.1 | 1.2 | 1.20 | m | 1 | | | | 2 | | |
| 4 | 구 | 방호벽 | 균열,백태 | 0.2 | 0.5 | 0.50 | m² | 5 | | | | 2 | | |
