# 교 면 포 장

가천교

[주] 우림 종합 엔지니어링

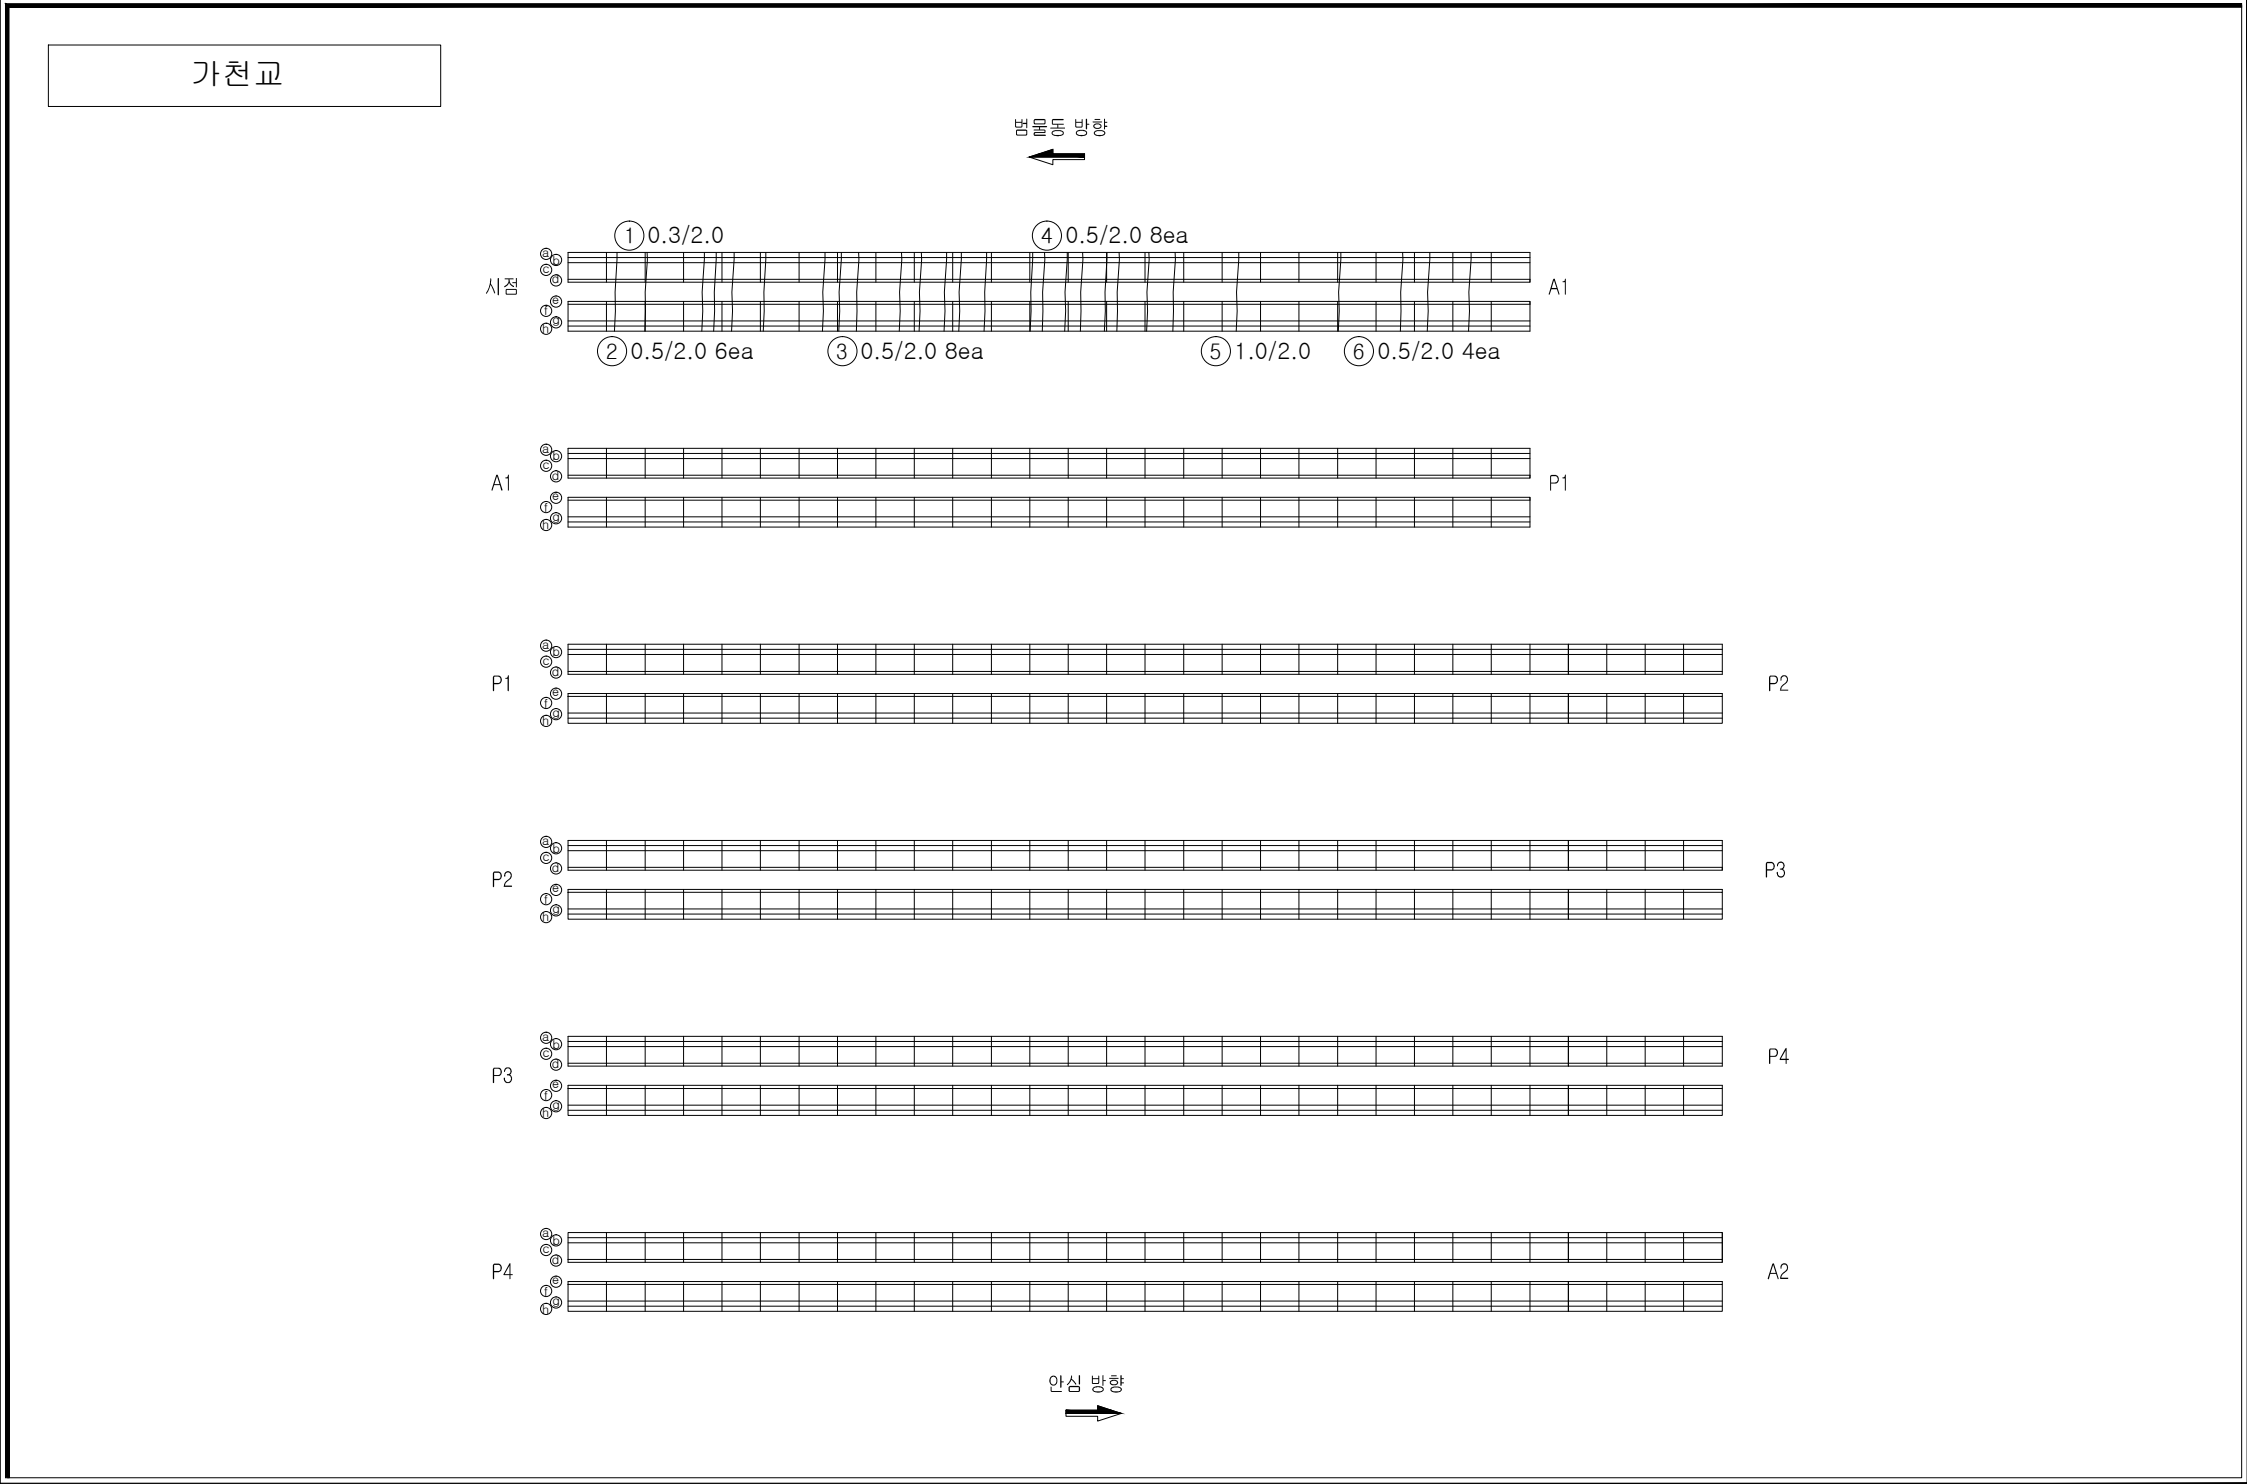
| 손상물량표 | | | | | | | | | | | | |
|---|---|---|---|---|---|---|---|---|---|---|---|---|
| 1 | 신 | 방호벽 | 균열 | 0.3 | 2.0 | 2.00 | m | 1 | | | | 1 |
| 2 | 신 | 방호벽 | 균열 | 0.5 | 2.0 | 12.00 | m | 6 | | | | 1 |
| 3 | 신 | 방호벽 | 균열 | 0.5 | 2.0 | 16.00 | m | 8 | | | | 1 |
| 4 | 신 | 방호벽 | 균열 | 0.5 | 2.0 | 16.00 | m | 8 | | | | 1 |
| 5 | 신 | 방호벽 | 균열 | 1.0 | 2.0 | 2.00 | m | 1 | | | | 1 |
| 6 | 신 | 방호벽 | 균열 | 0.5 | 2.0 | 8.00 | m | 4 | | | | 1 |

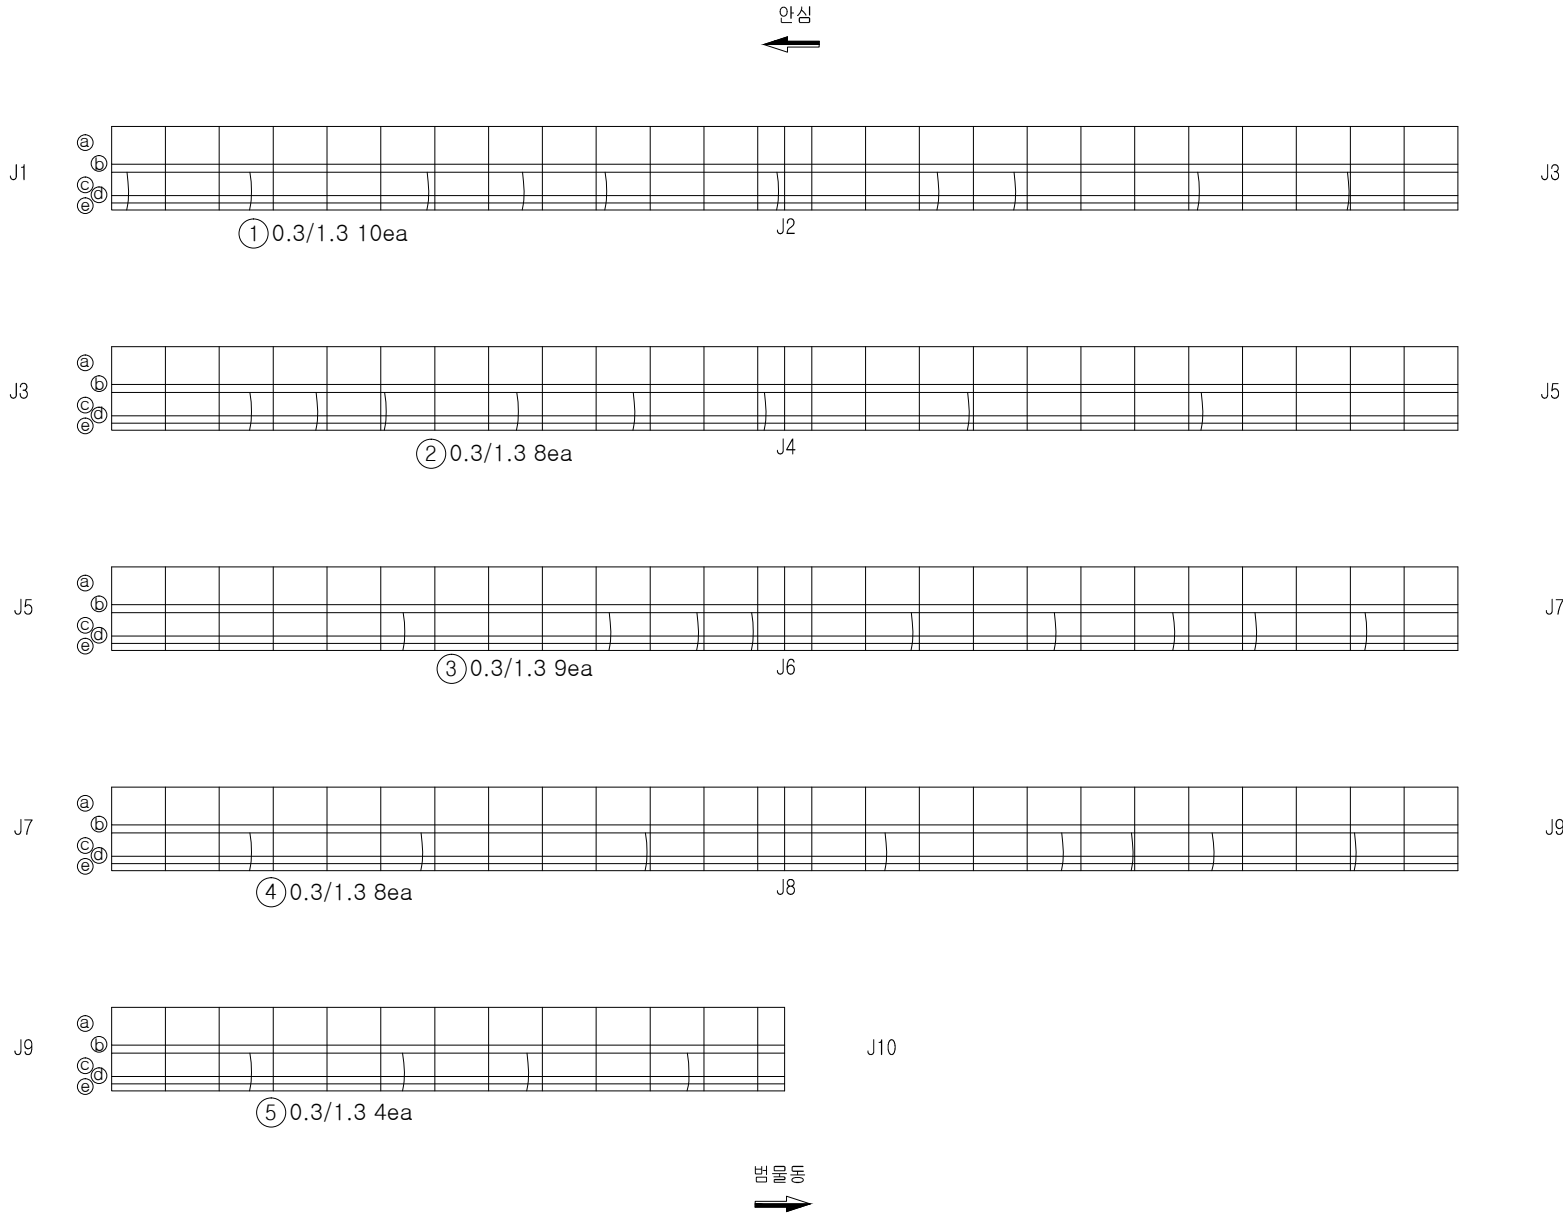
| 일련<br>번호 | 구<br>신 | 부재명<br>(위치) | 결함종류 | 결함규모 | | | | 개소 | 최종보수내역 | | 우선<br>순위 | 비고 |
|---|---|---|---|---|---|---|---|---|---|---|---|---|
| 1 | 신 | 방호벽 | 균열 | 0.3 | 1.3 | 13.00 | m | 10 | | | 1 | |
| 2 | 신 | 방호벽 | 균열 | 0.3 | 1.3 | 10.40 | m | 8 | | | 1 | |
| 3 | 신 | 방호벽 | 균열 | 0.3 | 1.3 | 11.70 | m | 9 | | | 1 | |
| 4 | 신 | 방호벽 | 균열 | 0.3 | 1.3 | 10.40 | m | 8 | | | 1 | |
| 5 | 신 | 방호벽 | 균열 | 0.3 | 1.3 | 5.20 | m | 4 | | | 1 | |

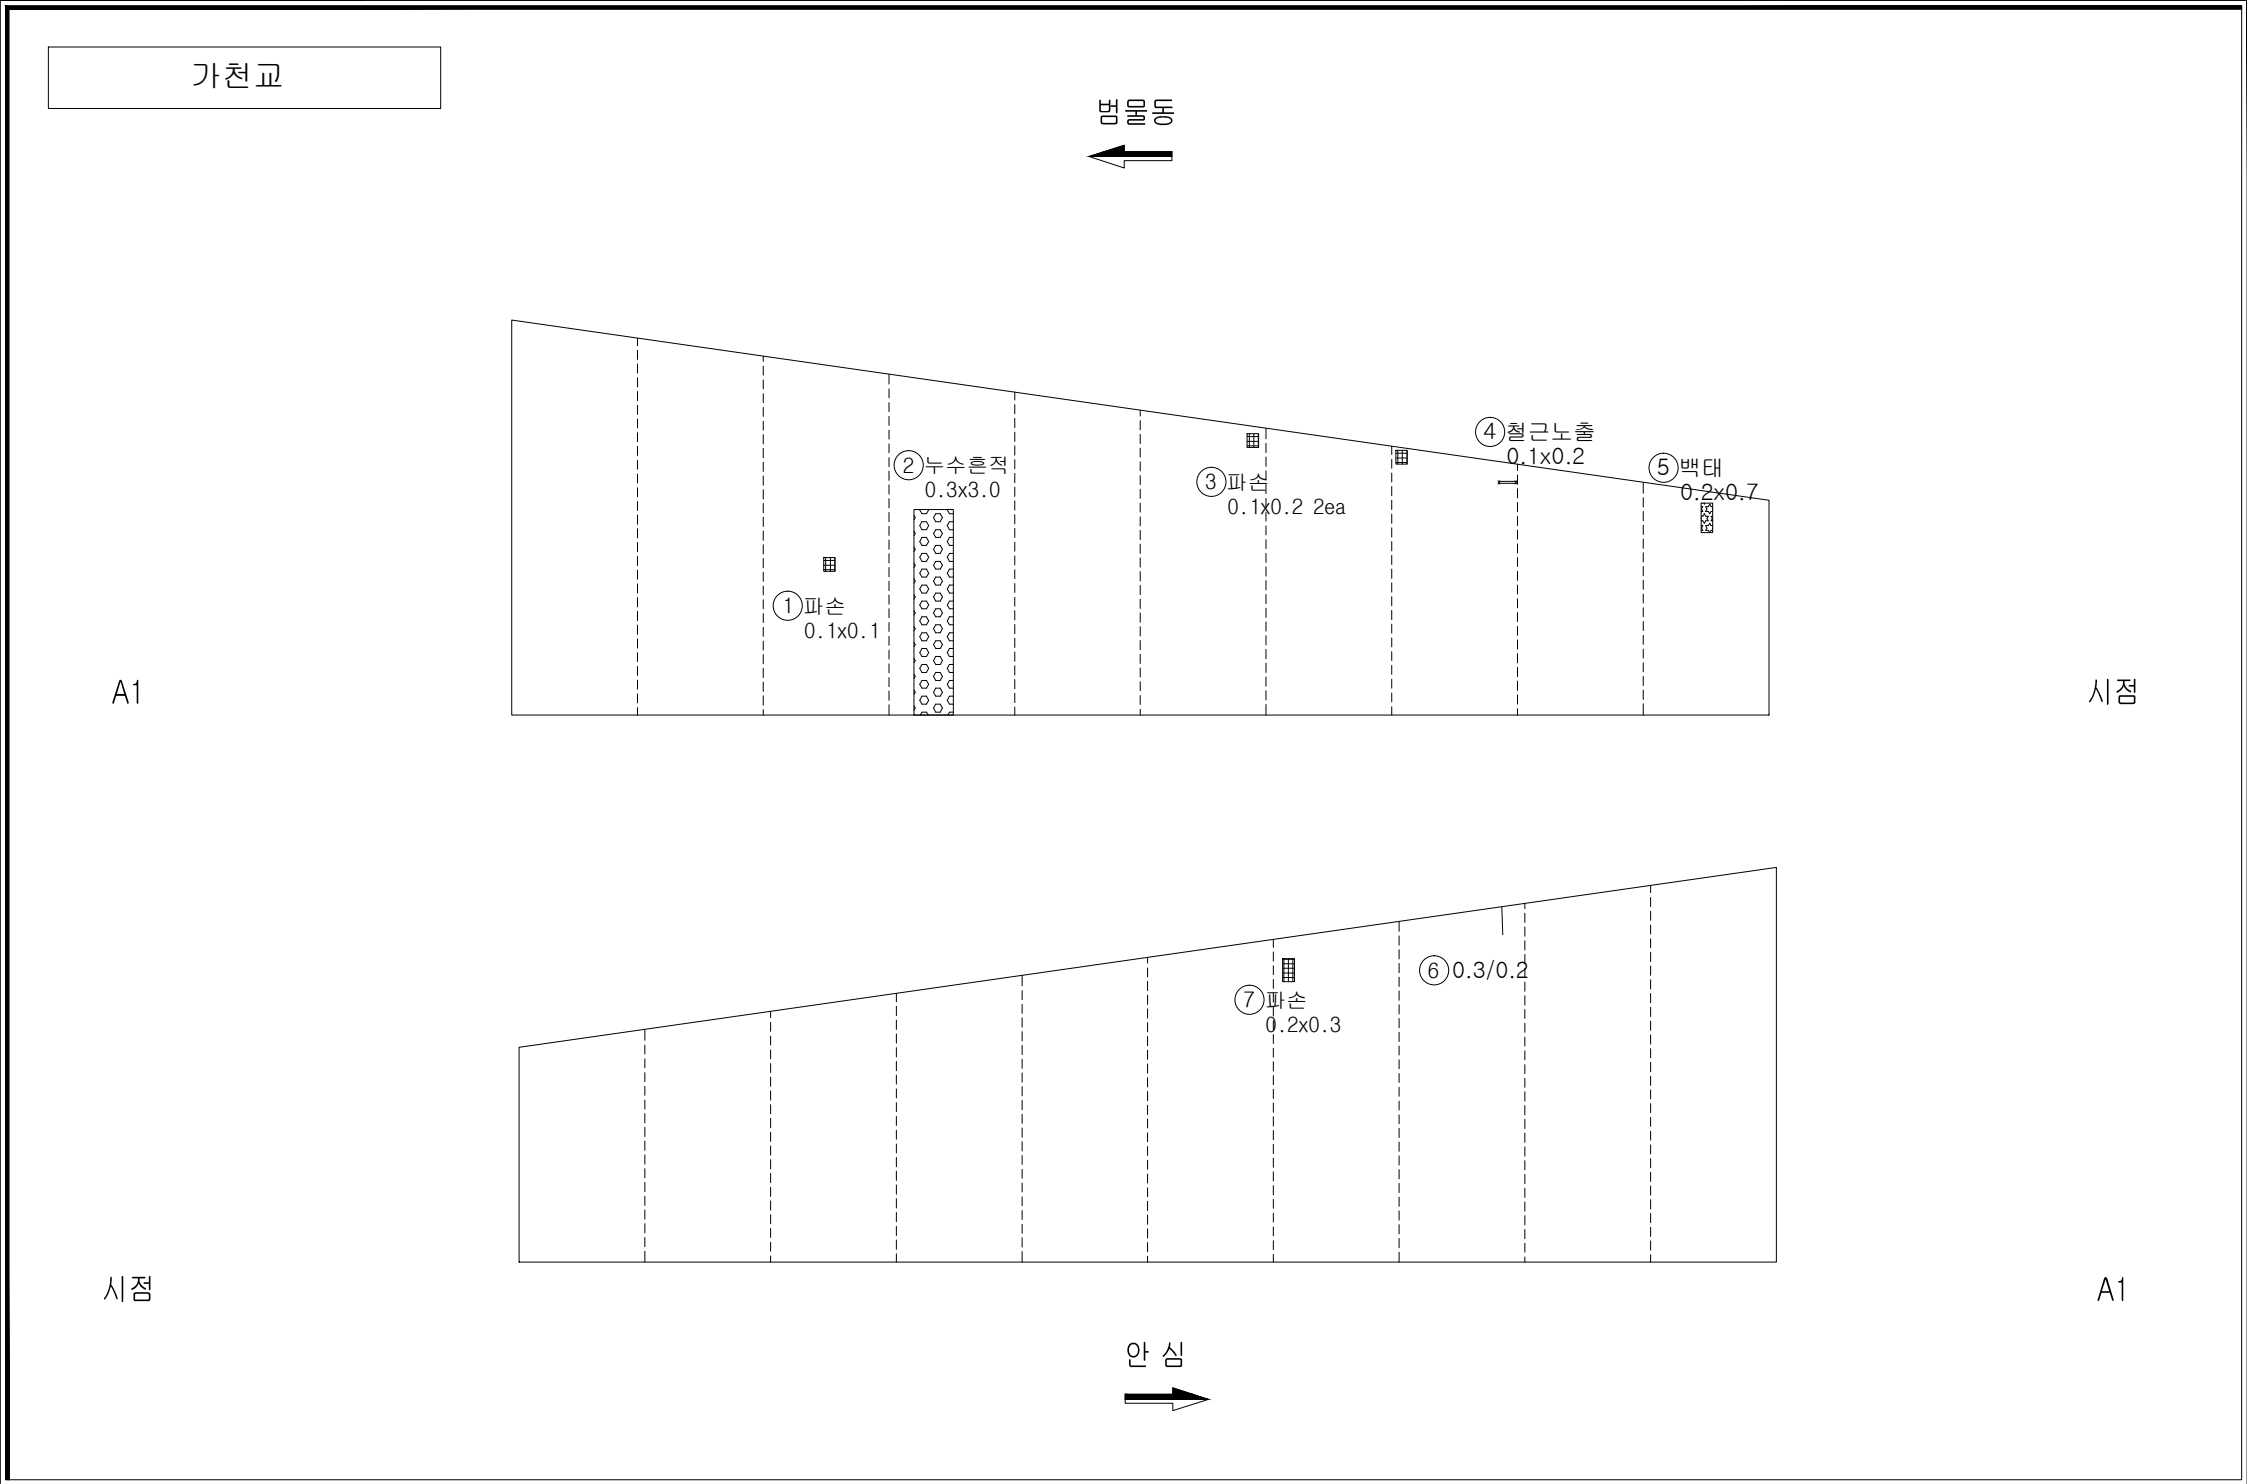
| 일련<br>번호 | 구<br>분 | 부재명<br>(위치) | 결함종류 | 결함 규모 | | | | 최종보수내역 | | | 우선<br>순위 | 비고 |
|---|---|---|---|---|---|---|---|---|---|---|---|---|
| 2 | 신 | 옹벽 | 누수흔적 | 0.3 | 3.0 | 0.90 | ㎡ | 1 | | | | 2 |
| 6 | 신 | 옹벽 | 균열 | 0.3 | 0.2 | 0.20 | m | 1 | | | | 1 |

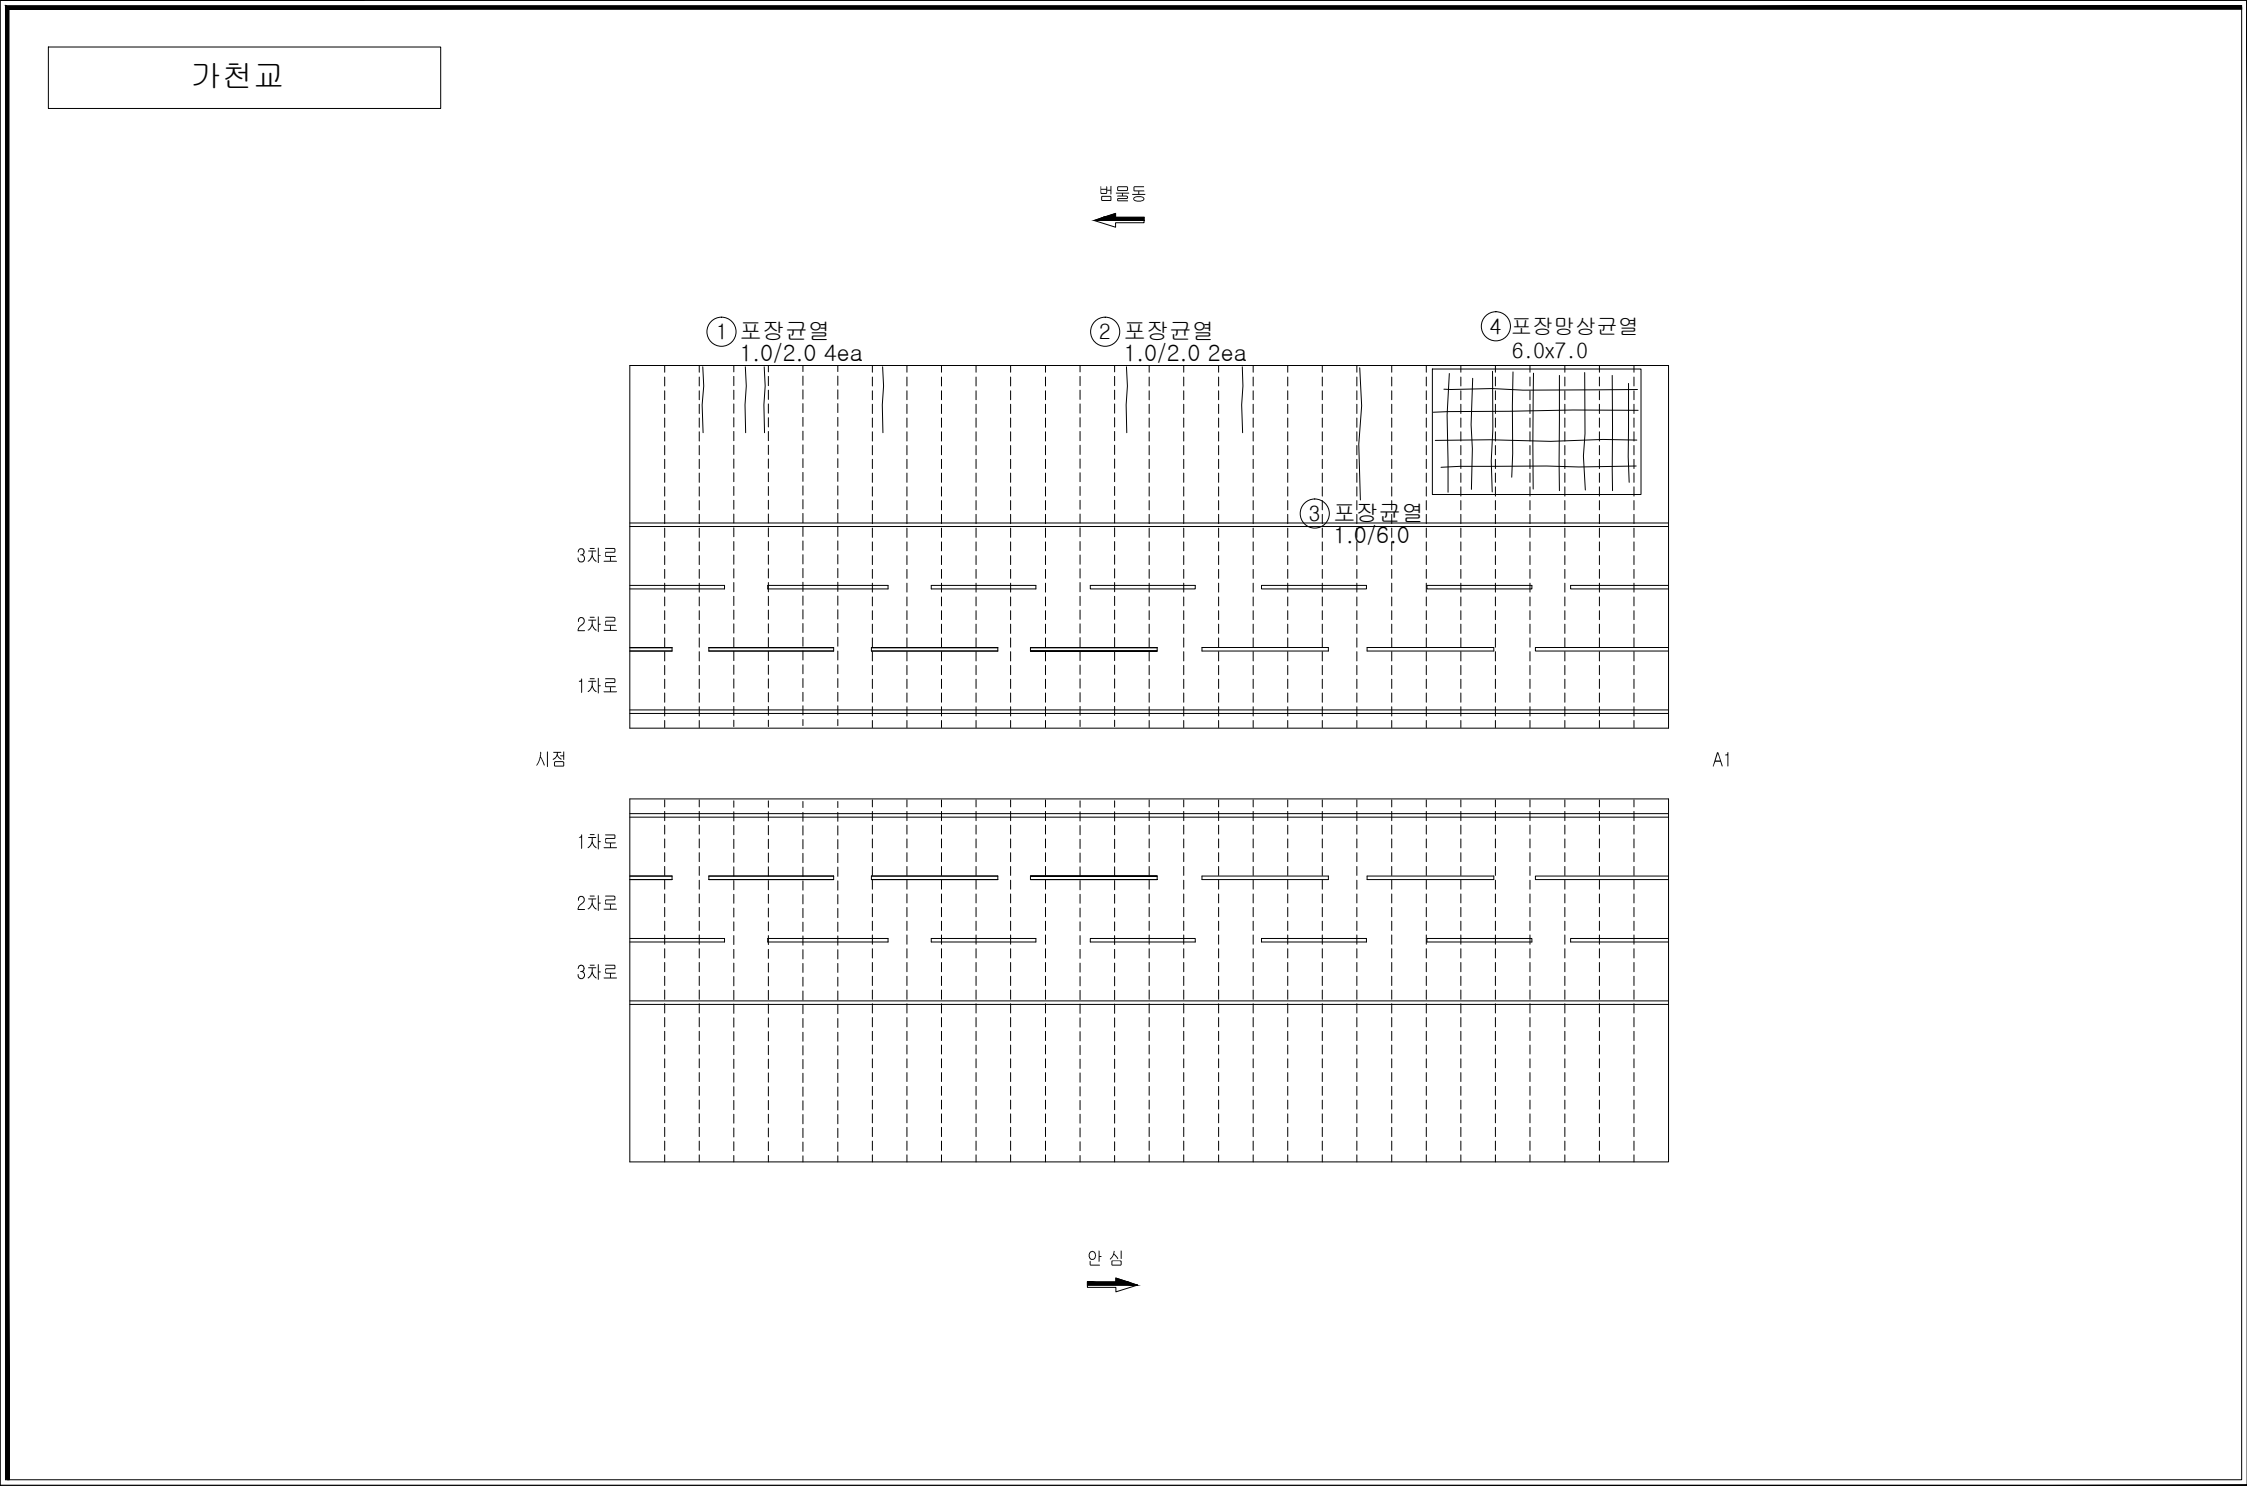
| 일련<br>번호 | 구<br>분 | 부재명<br>(위치) | 결함종류 | 결함규모 | | | | 최종보수내역<br>년월 | 우선<br>순위 | 비고 |
|---|---|---|---|---|---|---|---|---|---|---|
| 1 | 신 | 포장 | 포장균열 | 1.0 | 2.0 | 8.00 | m | 4 | | 3 |
| 2 | 신 | 포장 | 포장균열 | 1.0 | 2.0 | 4.00 | m | 2 | | 3 |
| 3 | 신 | 포장 | 포장균열 | 1.0 | 6.0 | 6.00 | m | 1 | | 3 |
| 4 | 신 | 포장 | 포장망상균열 | | 6.0 | 7.0 | 42.00 | m <sup>2</sup> | 1 | - |

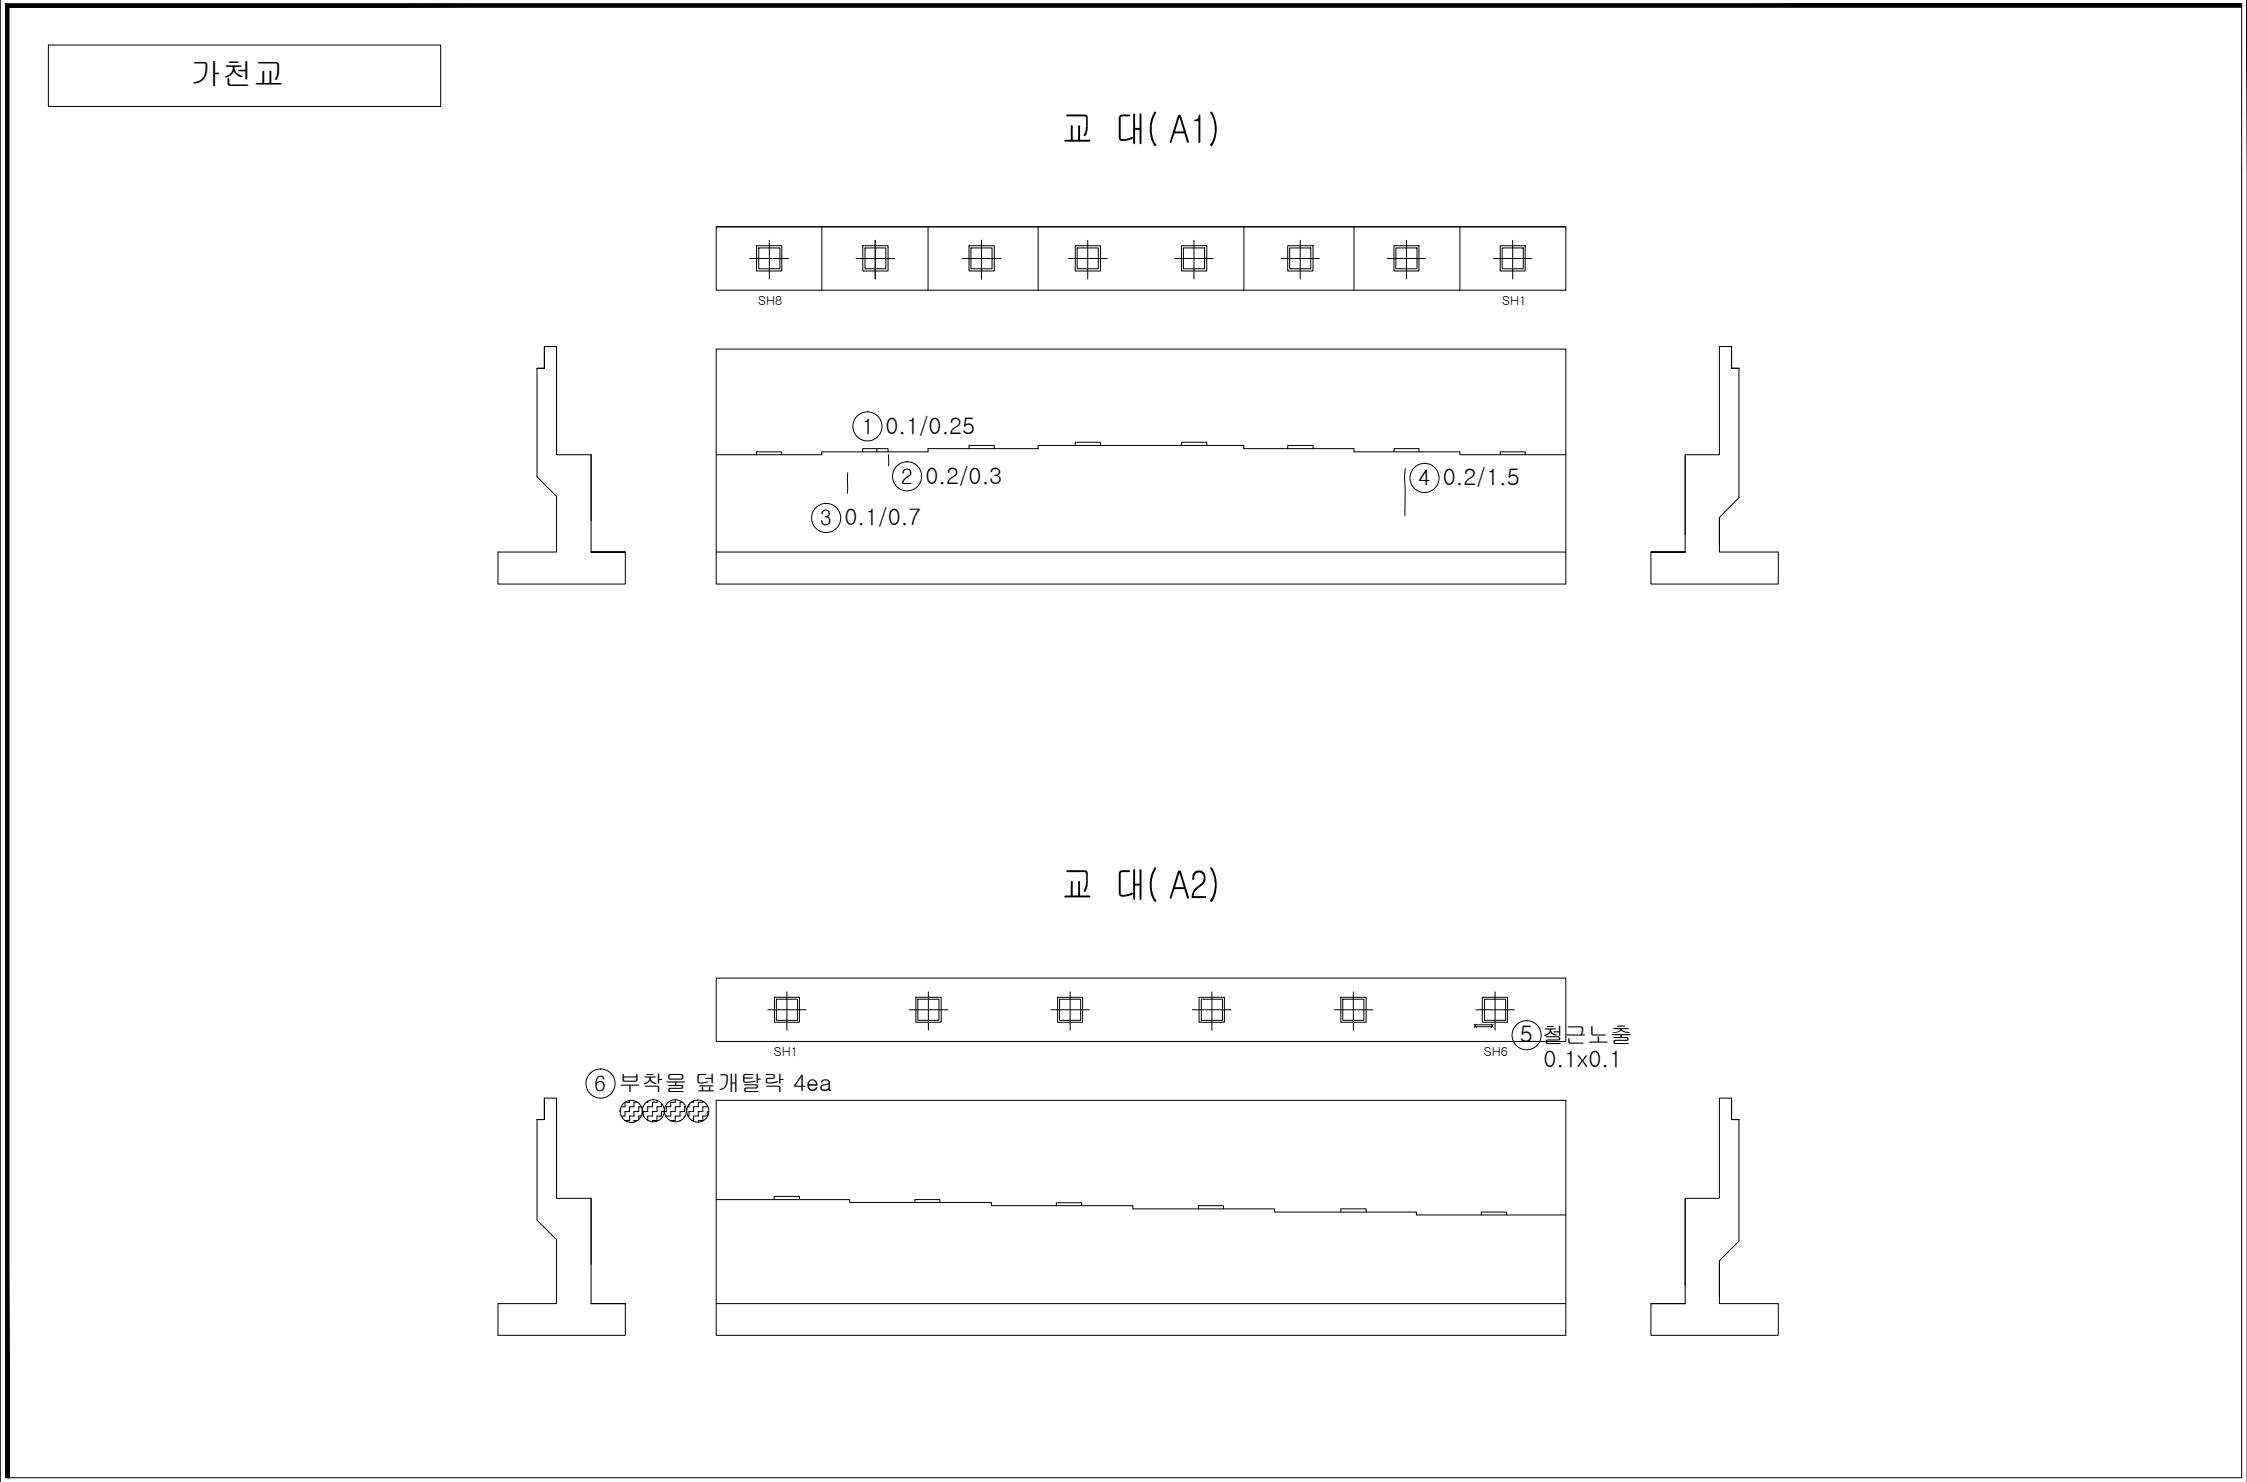
| 일련<br>번호 | 구<br>분 | 부재명<br>(위치) | 결함종류 | 결함구호 | | | | 개소 | 최종보수내역 | | 우선<br>순위 | 비고 |
|---|---|---|---|---|---|---|---|---|---|---|---|---|
| 1 | 신 | 교대 | 균열 | 0.1 | 0.25 | 0.25 | m | 1 | | | 2 | |
| 2 | 신 | 교대 | 균열 | 0.2 | 0.3 | 0.30 | m | 1 | | | 2 | |
| 3 | 신 | 교대 | 균열 | 0.1 | 0.7 | 0.70 | m | 1 | | | 2 | |
| 4 | 신 | 교대 | 균열 | 0.2 | 1.5 | 1.50 | m | 1 | | | 2 | |

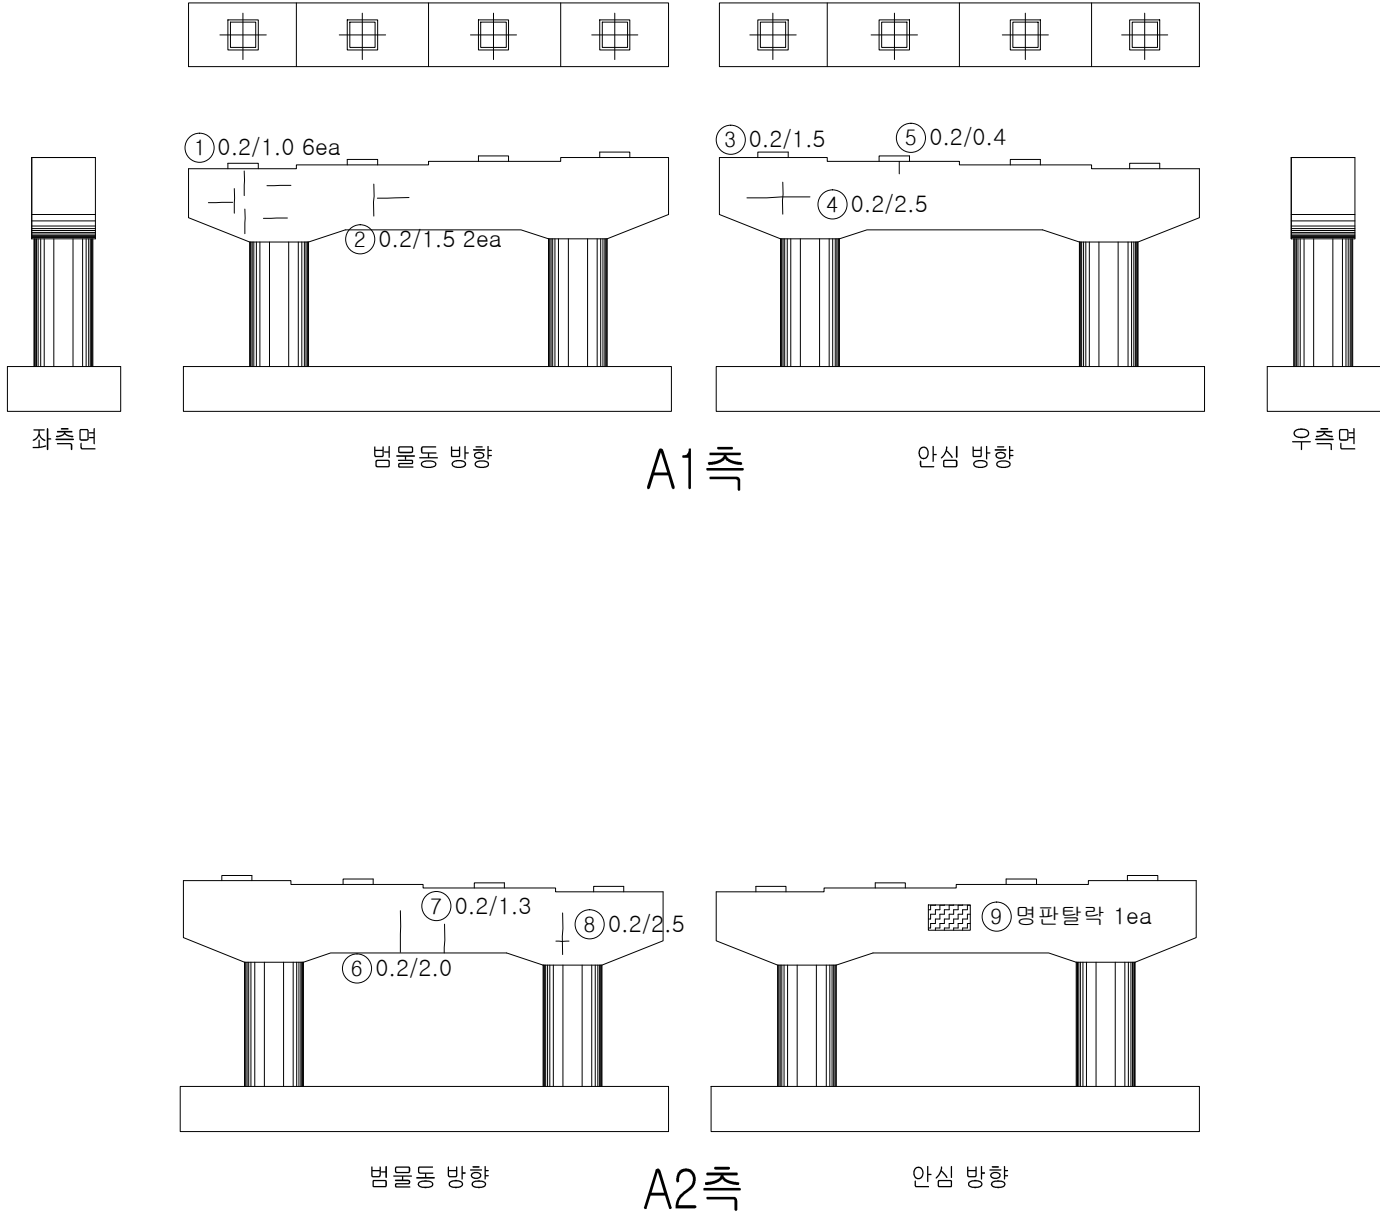
| 일련<br>번호 | 구<br>분 | 부재명<br>(위치) | 결함종류 | 결함규모 | | | | 최종보수내역 | | | 우선<br>순위 | 비고 |
|---|---|---|---|---|---|---|---|---|---|---|---|---|
| 1 | 신 | 교각 | 균열 | 0.2 | 1.0 | 6.00 | m | 6 | | | 2 | |
| 2 | 신 | 교각 | 균열 | 0.2 | 1.5 | 3.00 | m | 2 | | | 2 | |
| 3 | 신 | 교각 | 균열 | 0.2 | 1.5 | 1.50 | m | 1 | | | 2 | |
| 4 | 신 | 교각 | 균열 | 0.2 | 2.5 | 2.50 | m | 1 | | | 2 | |
| 5 | 신 | 교각 | 균열 | 0.2 | 0.4 | 0.40 | m | 1 | | | 2 | |
| 6 | 신 | 교각 | 균열 | 0.2 | 2.0 | 2.00 | m | 1 | | | 2 | |
| 7 | 신 | 교각 | 균열 | 0.2 | 1.3 | 1.30 | m | 1 | | | 2 | |
| 8 | 신 | 교각 | 균열 | 0.2 | 2.5 | 2.50 | m | 1 | | | 2 | |

\*교각의 콘크리트 구체 전반에 표면 망상균열(CW=0.1mm)이 간헐적 발생됨

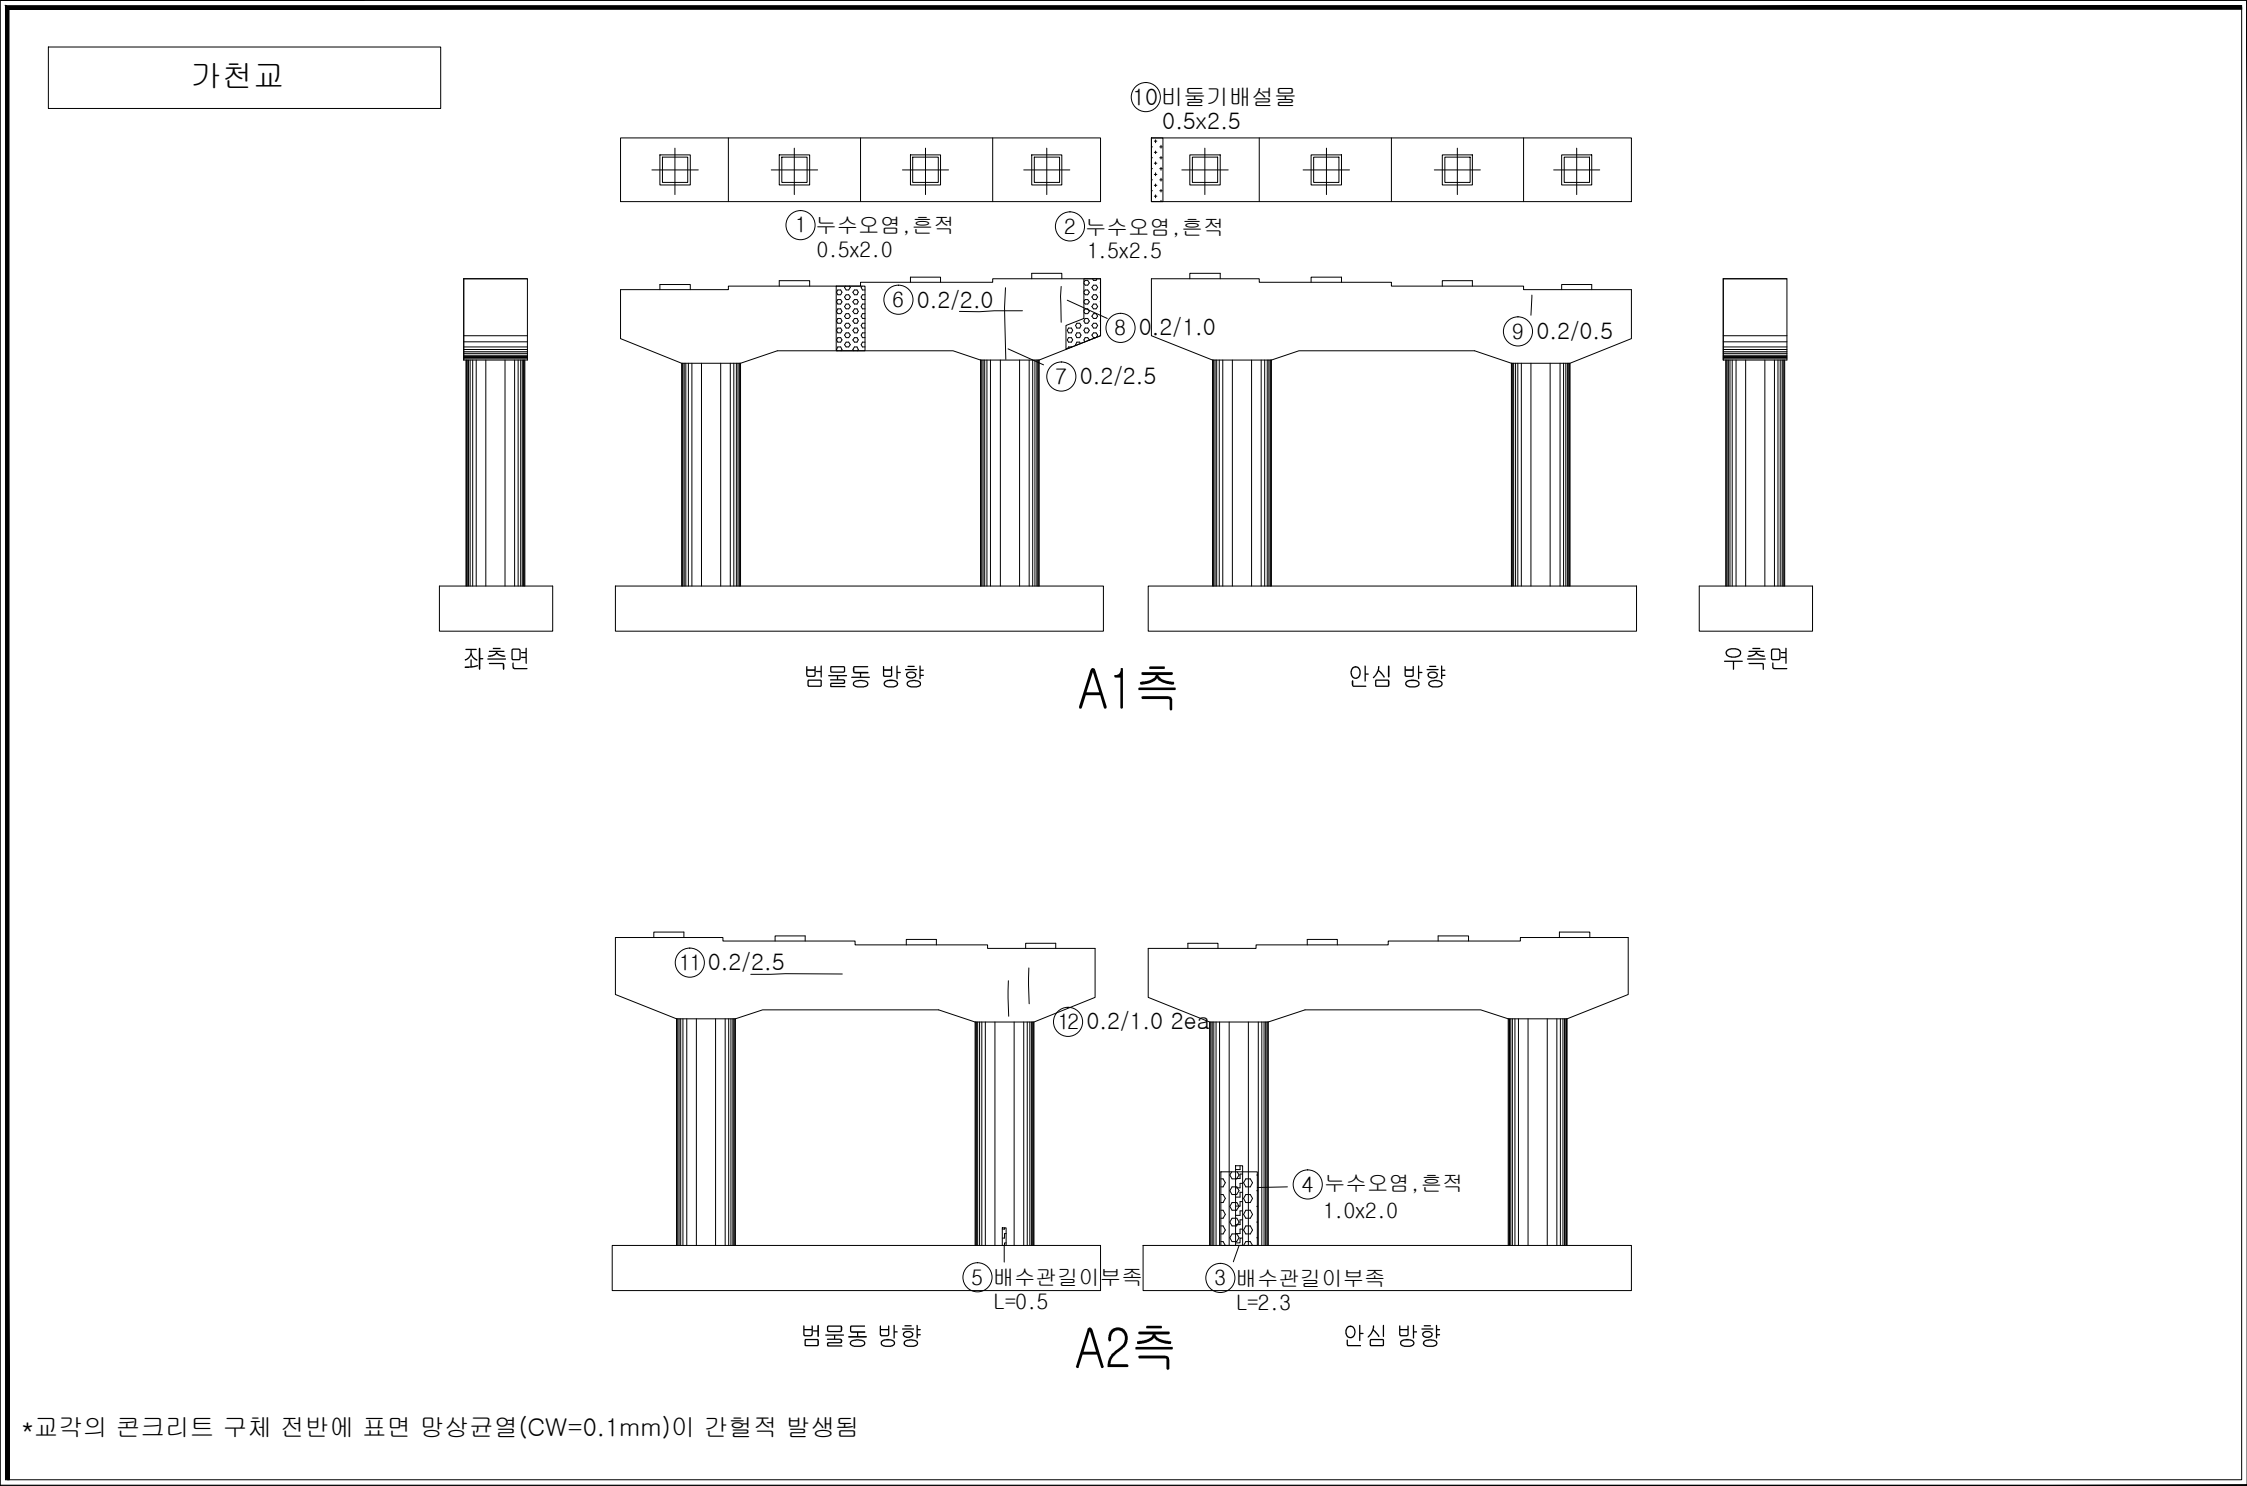
\*교각의 콘크리트 구체 전반에 표면 망상균열(CW=0.1mm)이 간헐적 발생됨

| 일련<br>번호 | 구<br>분 | 부재명<br>(위치) | 결함종류 | 결함구오 | | | | 개소 | 최종보수내역 | | 우선<br>순위 | 비고 |
|---|---|---|---|---|---|---|---|---|---|---|---|---|
| 6 | 신 | 교각 | 균열 | 0.2 | 2.0 | 2.00 | m | 1 | | | 2 | |

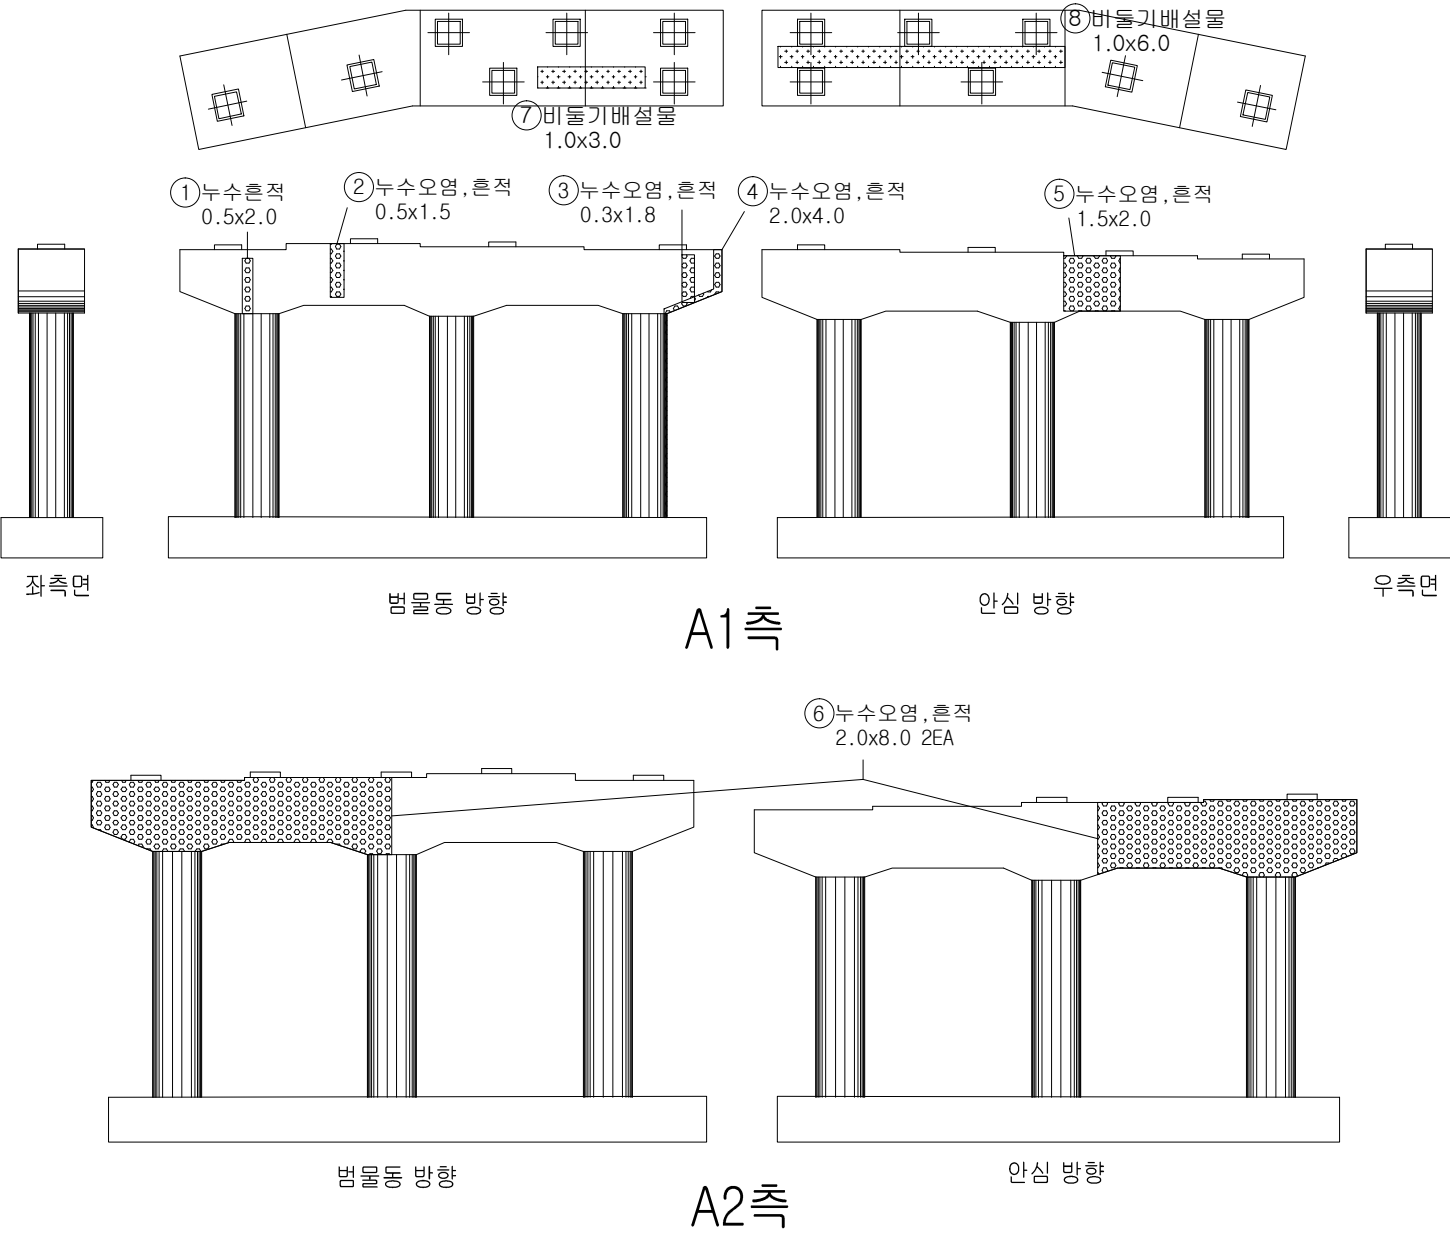
\*교각의 콘크리트 구체 전반에 표면 망상균열(CW=0.1mm)이 간헐적 발생됨
