# 교 면 포 장

가천교

[주] 우림 종합 엔지니어링

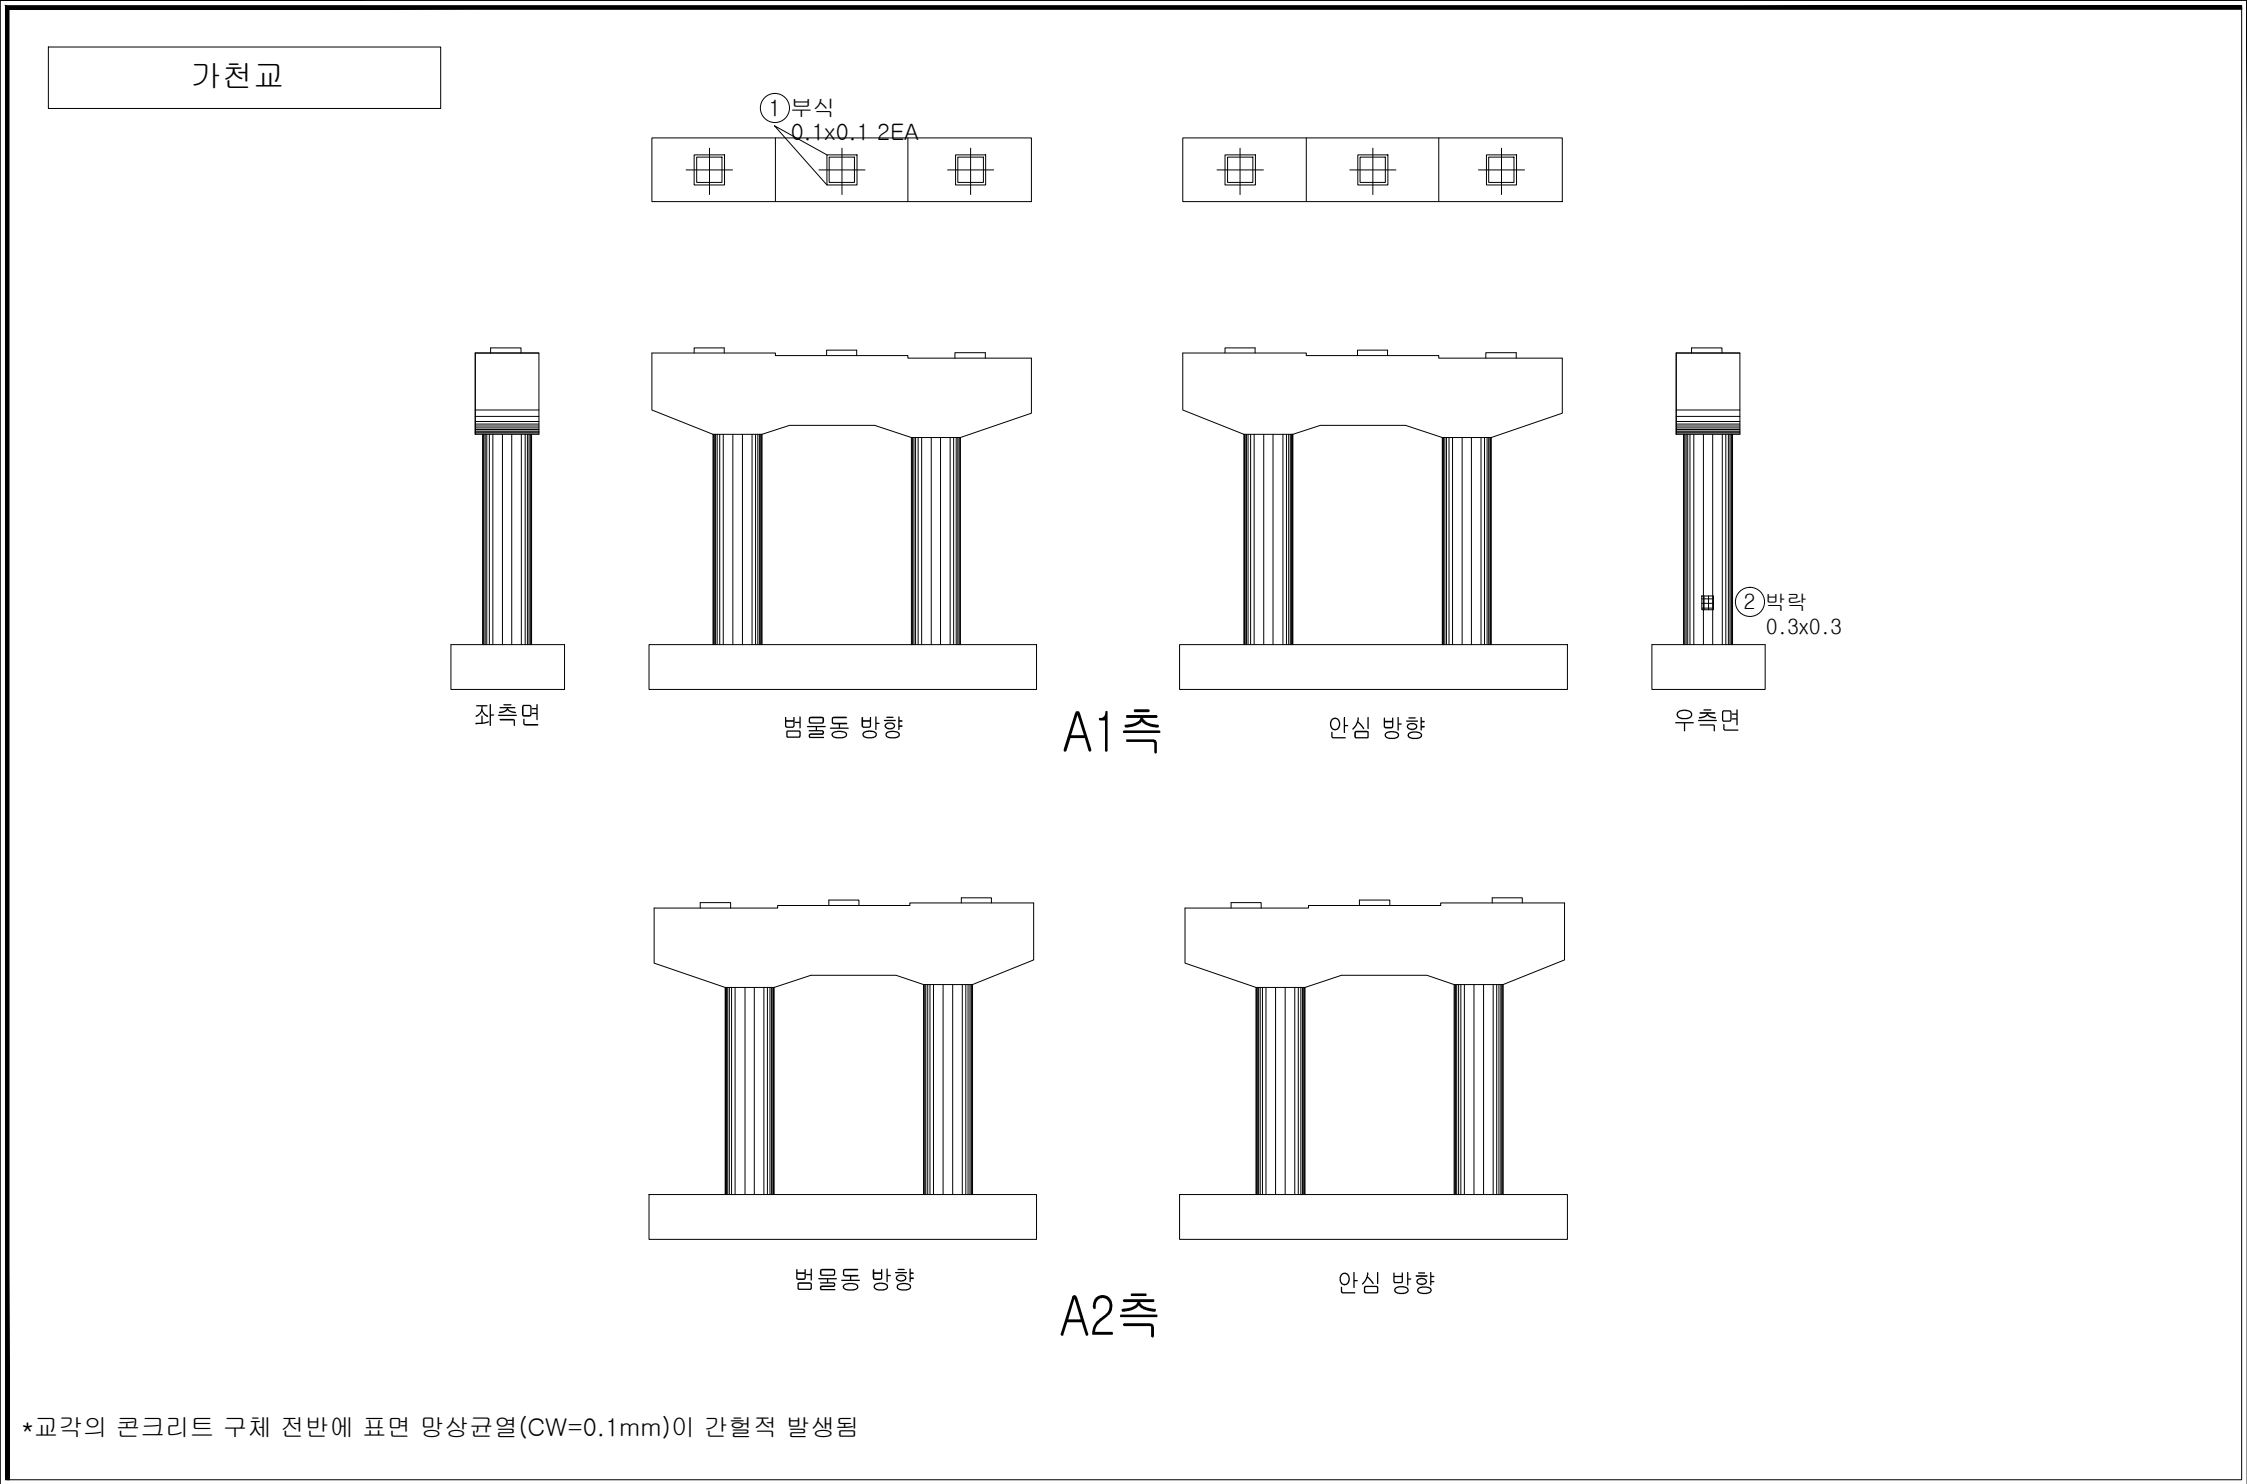
\*교각의 콘크리트 구체 전반에 표면 망상균열(CW=0.1mm)이 간헐적 발생됨
