| 01. 연지교 외관조사망도 |

2019년 상반기 시설물 정기안전점검 기술용역

# 연지교

2019. 06

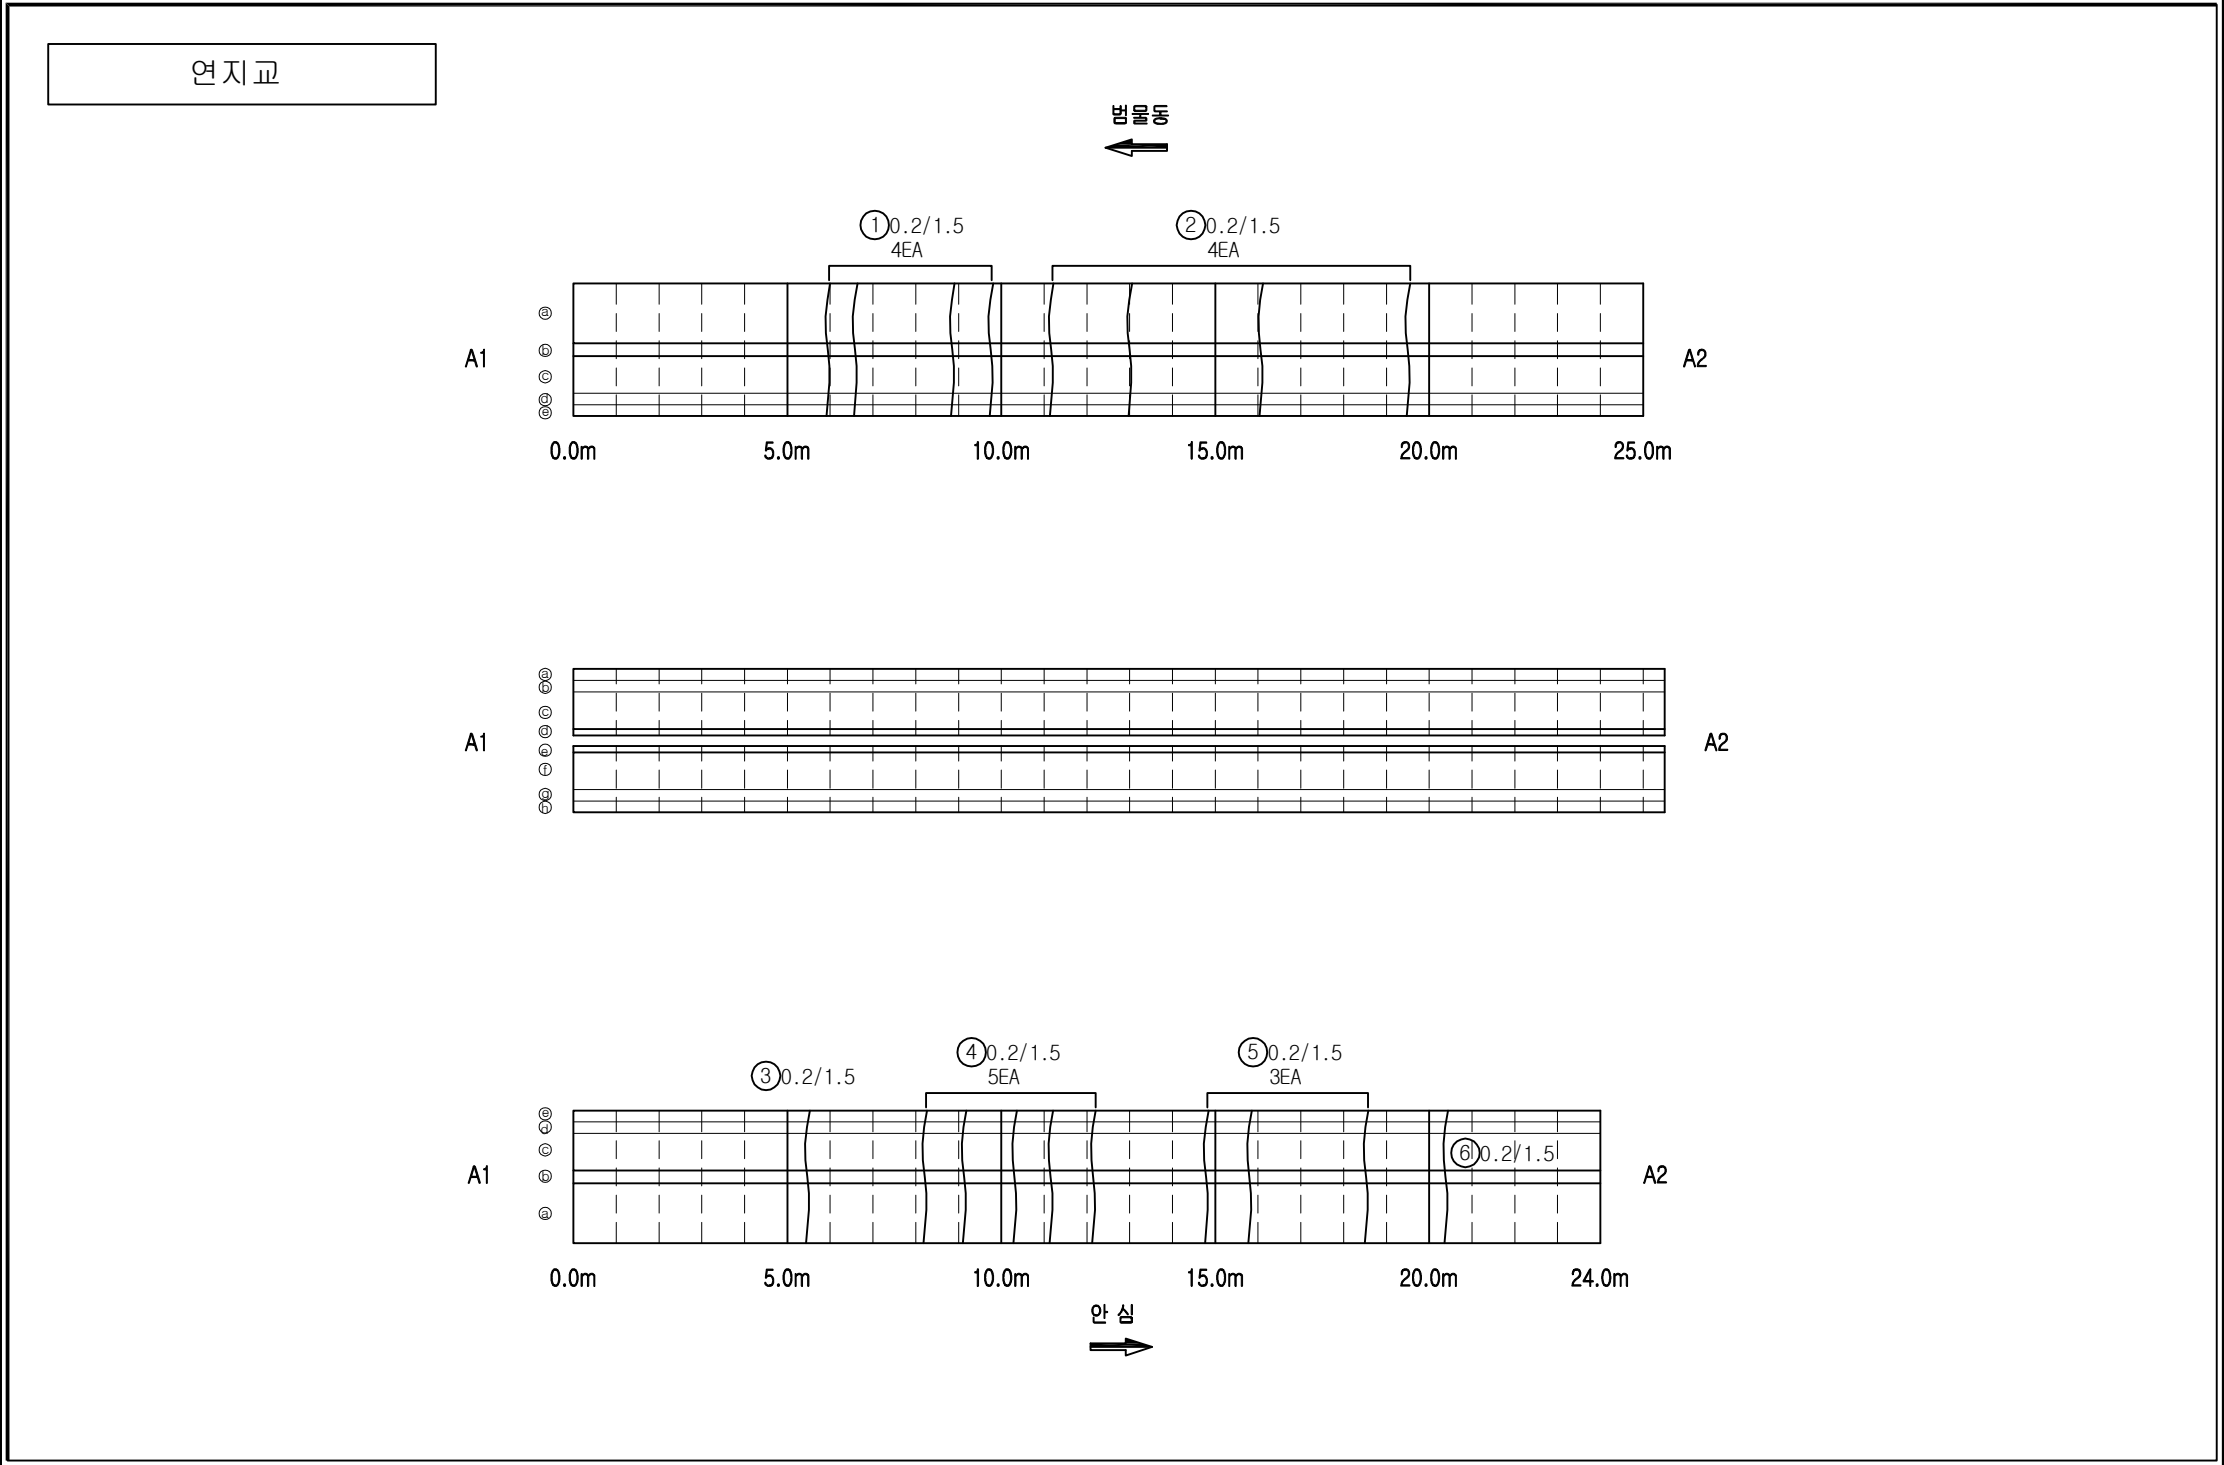
| 손상물량표 | | | | | | | | |
|---|---|---|---|---|---|---|---|---|
| 1 | 방호벽 | 균열(Cw≤0.2mm) | 0.2 | 1.50 | 4 | m | 6.00 | 주의관찰 |
| 2 | 방호벽 | 균열(Cw≤0.2mm) | 0.2 | 1.50 | 4 | m | 6.00 | 주의관찰 |
| 3 | 방호벽 | 균열(Cw≤0.2mm) | 0.2 | 1.50 | 1 | m | 1.50 | 주의관찰 |
| 4 | 방호벽 | 균열(Cw≤0.2mm) | 0.2 | 1.50 | 5 | m | 7.50 | 주의관찰 |
| 5 | 방호벽 | 균열(Cw≤0.2mm) | 0.2 | 1.50 | 3 | m | 4.50 | 주의관찰 |
| 6 | 방호벽 | 균열(Cw≤0.2mm) | 0.2 | 1.50 | 1 | m | 1.50 | 주의관찰 |

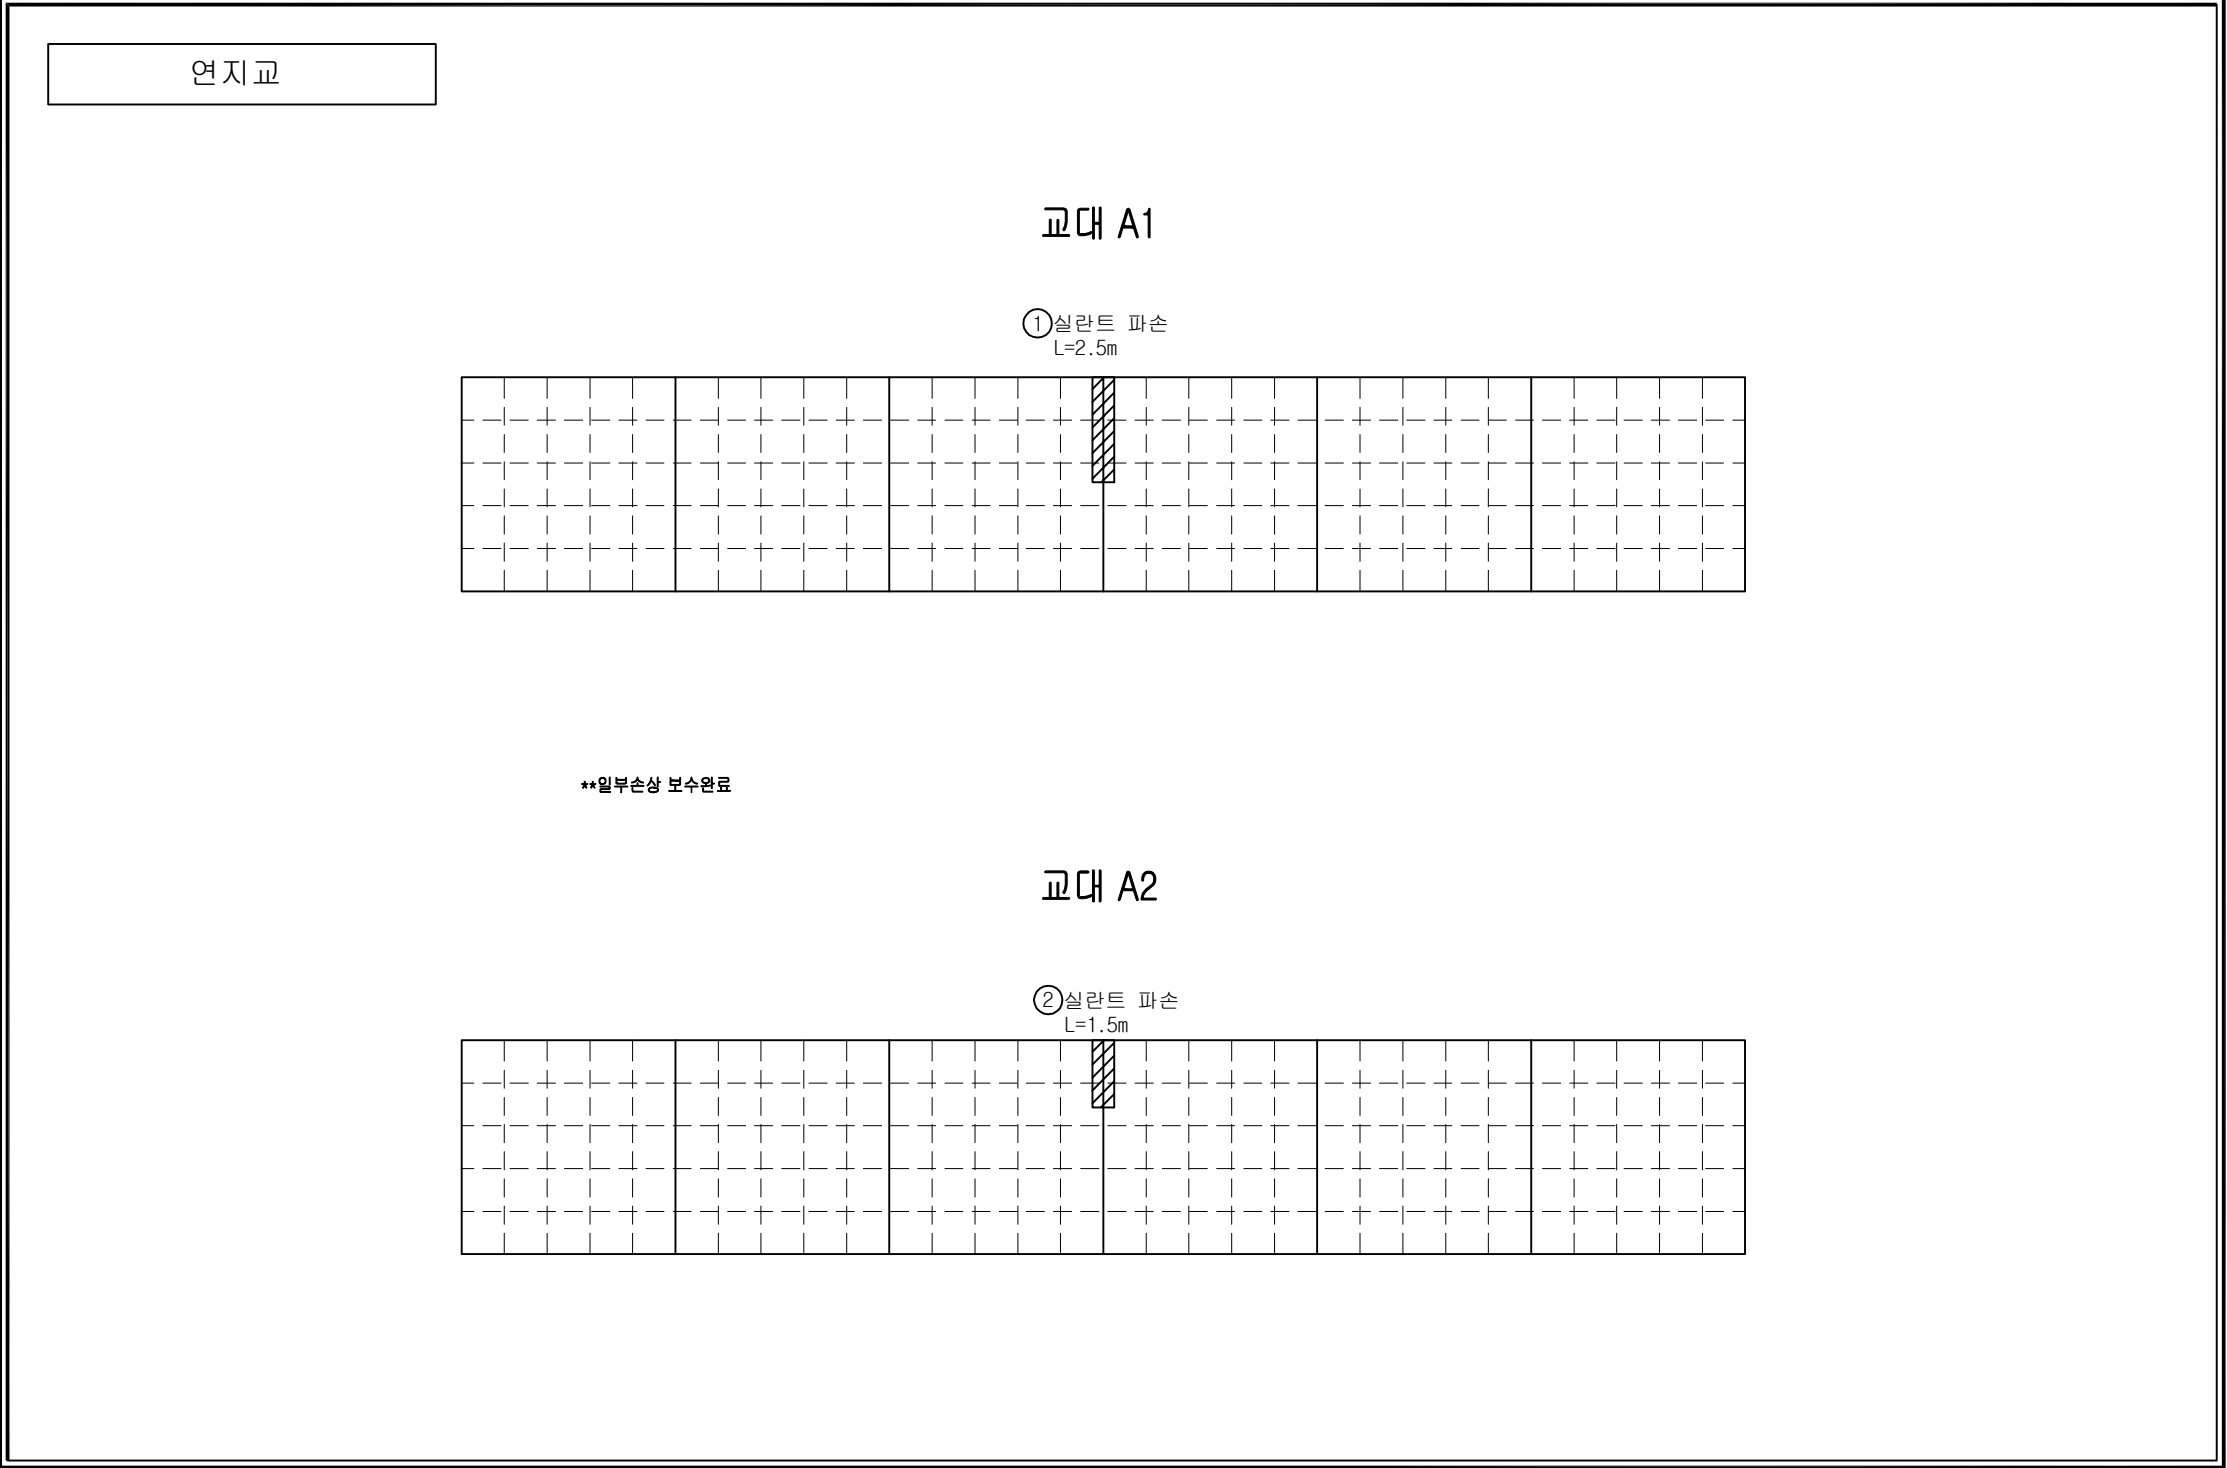
| 손상물량표 | | | | | | | | |
|---|---|---|---|---|---|---|---|---|
| 1 | 교대 | 실란트 파손 | - | 2.50 | 1 | m | 2.50 | 실란트처리 |
| 2 | 교대 | 실란트 파손 | - | 1.50 | 1 | m | 1.50 | 실란트처리 |
