## 02. 옹벽

ID :부산울산선 웅벽 29.483K(포항) STA.0.0 ~ STA.40.0

| 용역명 | | 부산울산선 11.75k(부산) 등 12개소 비탈면·옹벽 정밀안전점검 및 성능평가용역 | | | |

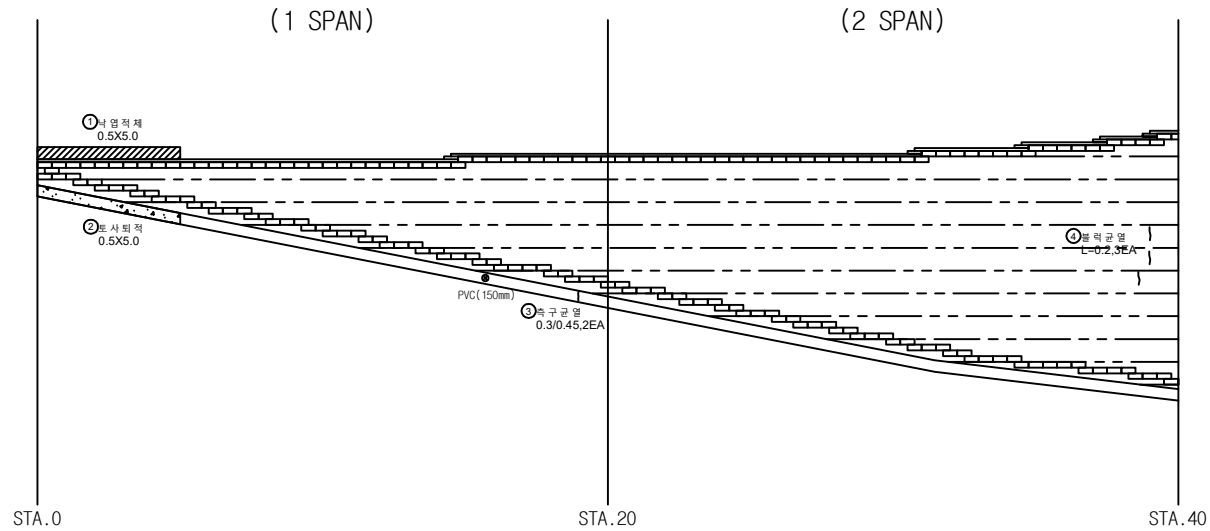
| 번호 | 손상내용 | 폭(mm) | 길이(m) | 너비(m) | 개소 | 손상물량 | | 비고 |
|---|---|---|---|---|---|---|---|---|
| 1 | 낙엽적체 | | 0.5 | 5.0 | 1 | 2.50 | m <sup>2</sup> | |
| 2 | 토사퇴적 | | 0.5 | 5.0 | 1 | 2.50 | m <sup>2</sup> | |
| 3 | 측구균열 | 0.3 | 0.45 | | 2 | 0.90 | m | |
| 4 | 평행균열 | | 0.2 | | 3 | 0.60 | m | |

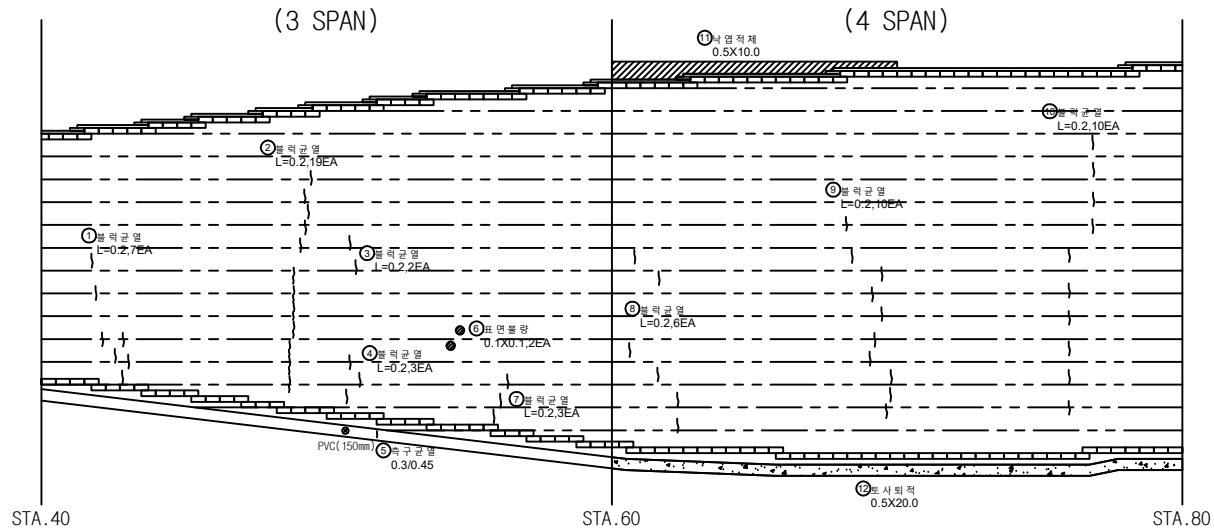
ID :부산울산선 웅벽 29.483K(포항) STA.40.0 ~ STA.80.0

| 번호 | 손상내용 | 폭(mm) | 길이(m) | 너비(m) | 개소 | 손상물량 | | 비고 |
|---|---|---|---|---|---|---|---|---|
| 1 | 불력균열 | | 0.2 | | 7 | 1.40 | m | |
| 2 | 불력균열 | | 0.2 | | 19 | 3.80 | m | |
| 3 | 불력균열 | | 0.2 | | 2 | 0.40 | m | |
| 4 | 불력균열 | | 0.2 | | 3 | 0.60 | m | |
| 5 | 측구구멍 | 0.3 | 0.45 | | 1 | 0.45 | m | |
| 6 | 표면불량 | | 0.1 | 0.1 | 2 | 0.02 | m <sup>2</sup> | |
| 7 | 불력균열 | | 0.2 | | 3 | 0.60 | m | |
| 8 | 불력균열 | | 0.2 | | 6 | 1.20 | m | |
| 9 | 불력균열 | | 0.2 | | 10 | 2.00 | m | |
| 10 | 불력균열 | | 0.2 | | 10 | 2.00 | m | |
| 11 | 낙엽적체 | | 0.5 | 10.0 | 1 | 5.00 | m <sup>2</sup> | |
| 12 | 토사퇴적 | | 0.5 | 20.0 | 1 | 10.00 | m <sup>2</sup> | |

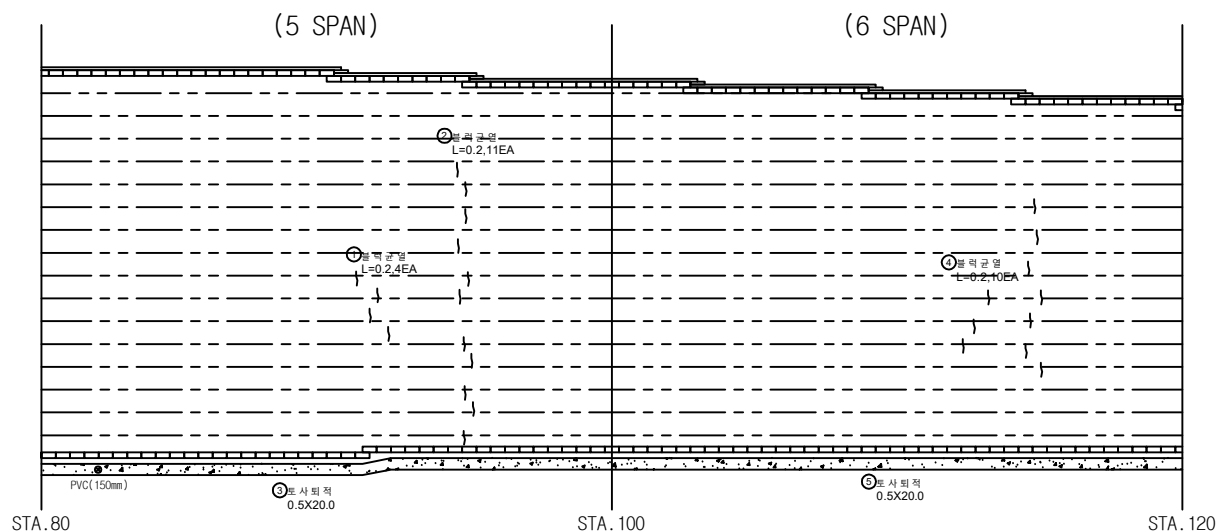
ID :부산울산선 웅벽 29.483K(포항) STA.80.0 ~ STA.120.0

| 번호 | 손상내용 | 폭(mm) | 길이(m) | 너비(m) | 개소 | 손상물량 | | 비고 |
|---|---|---|---|---|---|---|---|---|
| 1 | 블럭균열 | | 0.2 | | 4 | 0.80 | m | |
| 2 | 블럭균열 | | 0.2 | | 11 | 2.20 | m | |
| 3 | 토사퇴적 | | 0.5 | 20.0 | 1 | 10.00 | m <sup>3</sup> | |
| 4 | 블럭균열 | | 0.2 | | 10 | 2.00 | m | |
| 5 | 토사퇴적 | | 0.5 | 20.0 | 1 | 10.00 | m <sup>3</sup> | |

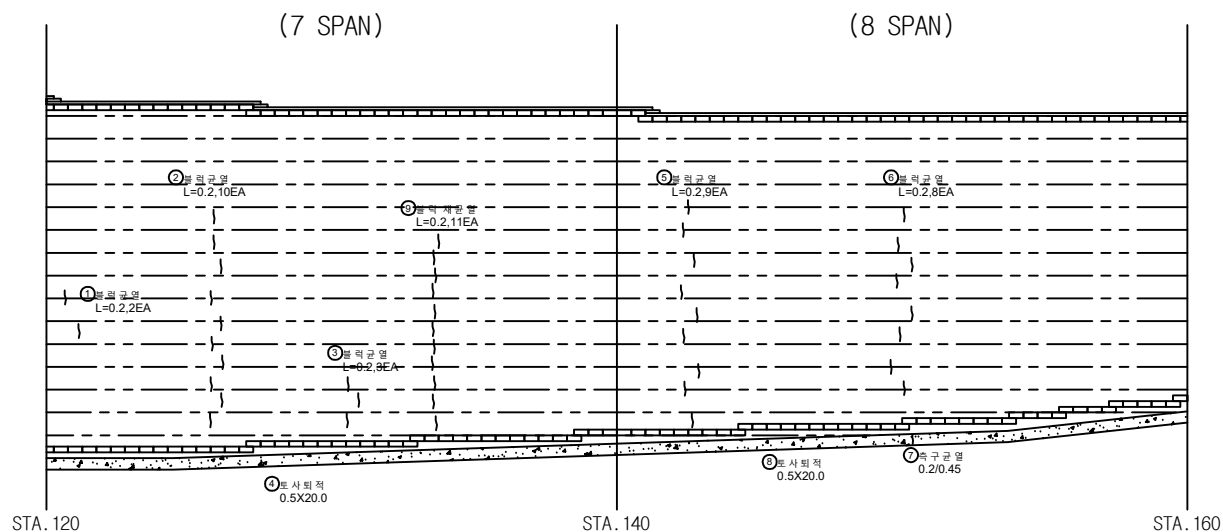
ID :부산울산선 옹벽 29.483K(포항) STA.120.0 ~ STA.160.0

| 번호 | 손상내용 | 폭(mm) | 길이(m) | 너비(m) | 개소 | 손상물량 | | 비고 |
|---|---|---|---|---|---|---|---|---|
| 1 | 블럭균열 | | 0.2 | | 2 | 0.40 | m | |
| 2 | 블럭균열 | | 0.2 | | 10 | 2.00 | m | |
| 3 | 블럭균열 | | 0.2 | | 3 | 0.60 | m | |
| 4 | 토사퇴적 | | 0.5 | 20.0 | 1 | 10.00 | m <sup>3</sup> | |
| 5 | 블럭균열 | | 0.2 | | 9 | 1.80 | m | |
| 6 | 블럭균열 | | 0.2 | | 8 | 1.60 | m | |
| 7 | 측구균열 | 0.2 | 0.45 | | 1 | 0.45 | m | |
| 8 | 토사퇴적 | | 0.5 | 20.0 | 1 | 10.00 | m <sup>3</sup> | |
| 9 | 블럭균열 | | 0.2 | | 11 | 2.20 | m | 신 |

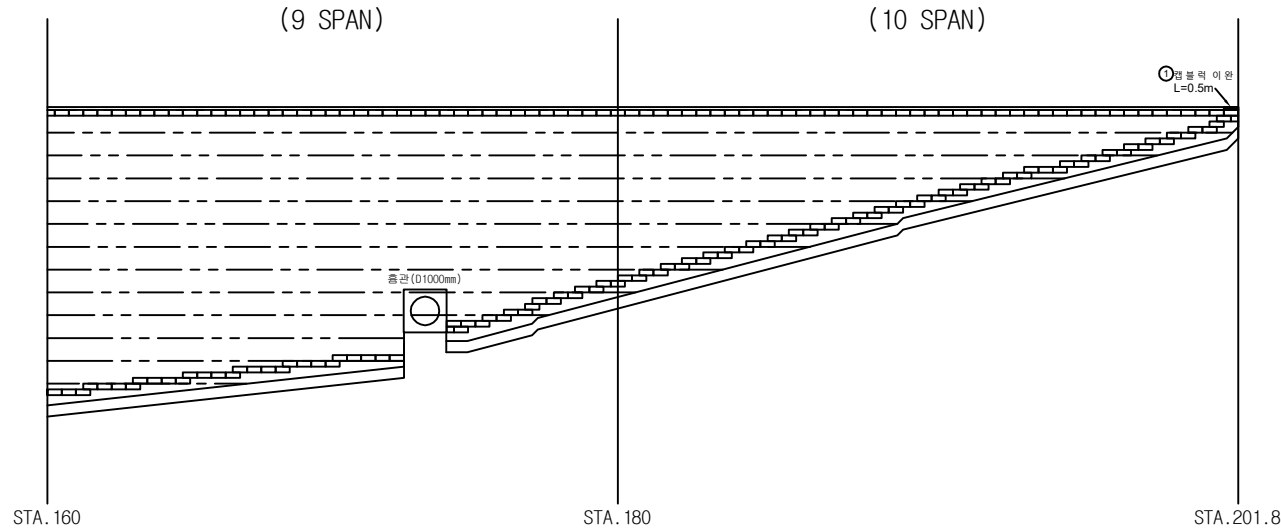
ID :부산울산선 옹벽 29.483K(포항) STA.160.0 ~ STA.201.8

| 번호 | 손상내용 | 폭(mm) | 길이(m) | 너비(m) | 개소 | 손상물량 | | 비고 |
|---|---|---|---|---|---|---|---|---|
| 1 | 캡볼력 이완 | | 0.5 | | 1 | 0.50 | m | |

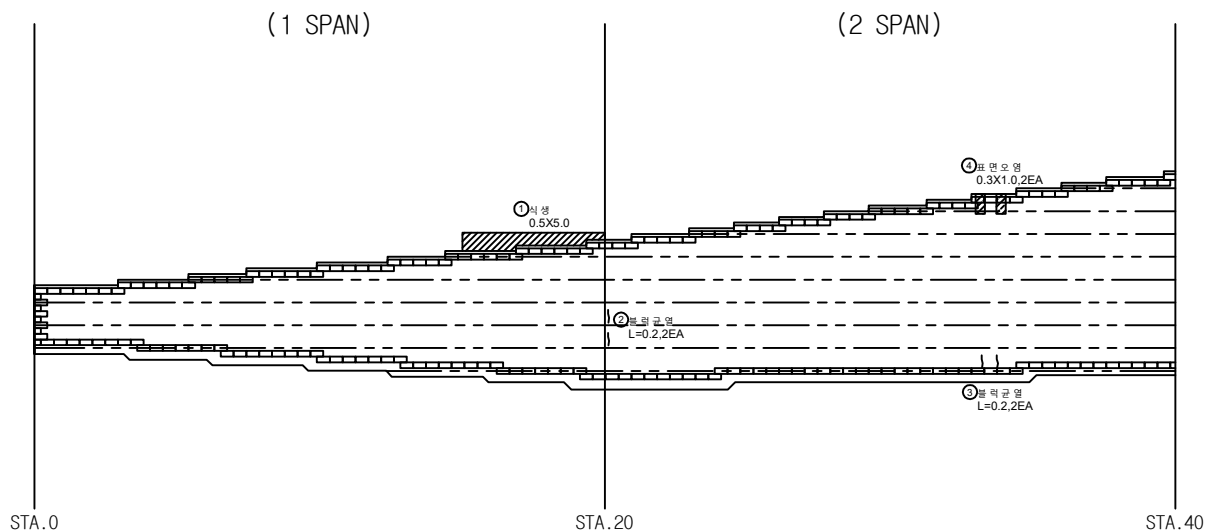
ID :부산울산선 옹벽 42.70K(포항) STA.0.0 ~ STA.40.0

| 번호 | 손상내용 | 폭(mm) | 길이(m) | 너비(m) | 개소 | 손상물량 | | 비고 |
|---|---|---|---|---|---|---|---|---|
| 1 | 식생 | | 0.5 | 5.0 | 1 | 2.50 | m <sup>2</sup> | |
| 2 | 블럭균열 | | 0.2 | | 2 | 0.40 | m | |
| 3 | 블럭균열 | | 0.2 | | 2 | 0.40 | m | |
| 4 | 표면오염 | | 0.3 | 1.0 | 2 | 0.60 | m <sup>2</sup> | |

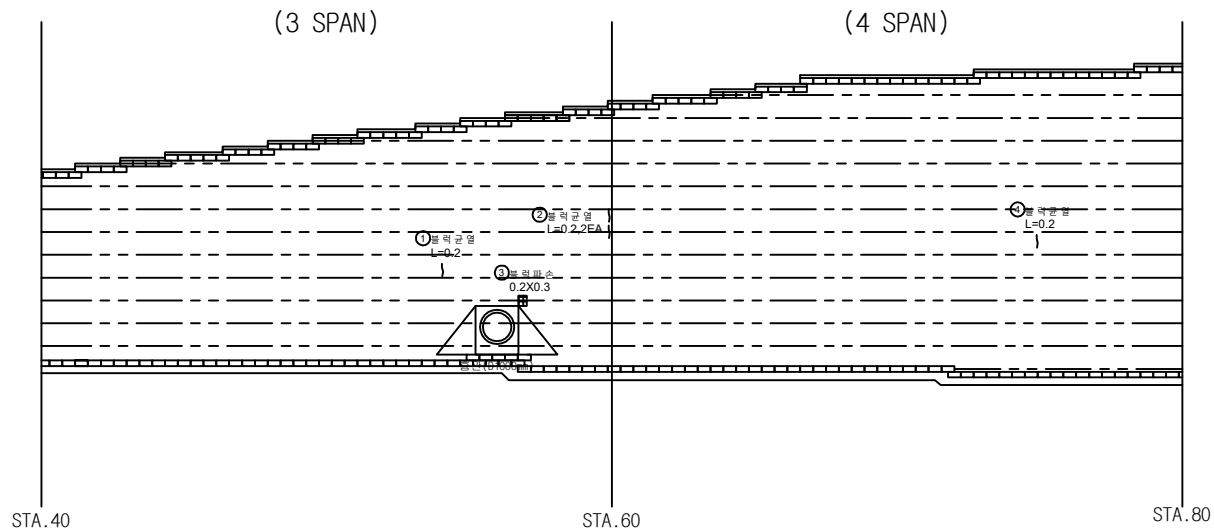
ID :부산울산선 옹벽 42.70K(포항) STA.40.0 ~ STA.80.0

| 번호 | 손상내용 | 폭(mm) | 길이(m) | 너비(m) | 개소 | 손상물량 | | 비고 |
|---|---|---|---|---|---|---|---|---|
| 1 | 블럭균열 | | 0.2 | | 1 | 0.20 | m | |
| 2 | 블럭균열 | | 0.2 | | 2 | 0.40 | m | |
| 3 | 블럭파손 | | 0.2 | 0.3 | 1 | 0.06 | m <sup>2</sup> | |
| 4 | 블럭균열 | | 0.2 | | 1 | 0.20 | m | 신 |

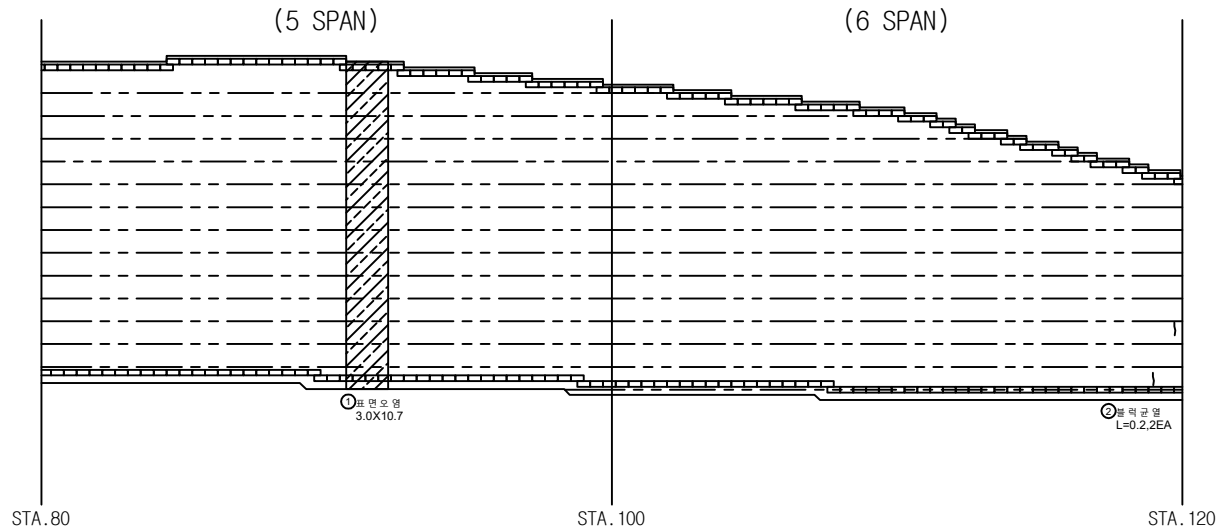
ID :부산울산선 옹벽 42.70K(포항) STA.80.0 ~ STA.120.0

| 번호 | 손상내용 | 폭(mm) | 길이(m) | 너비(m) | 개소 | 손상물량 | | 비고 |
|---|---|---|---|---|---|---|---|---|
| 1 | 표면오염 | | 3.0 | 10.7 | 1 | 32.10 | m <sup>2</sup> | |
| 2 | 표면균열 | | 0.2 | | 2 | 0.40 | m | |

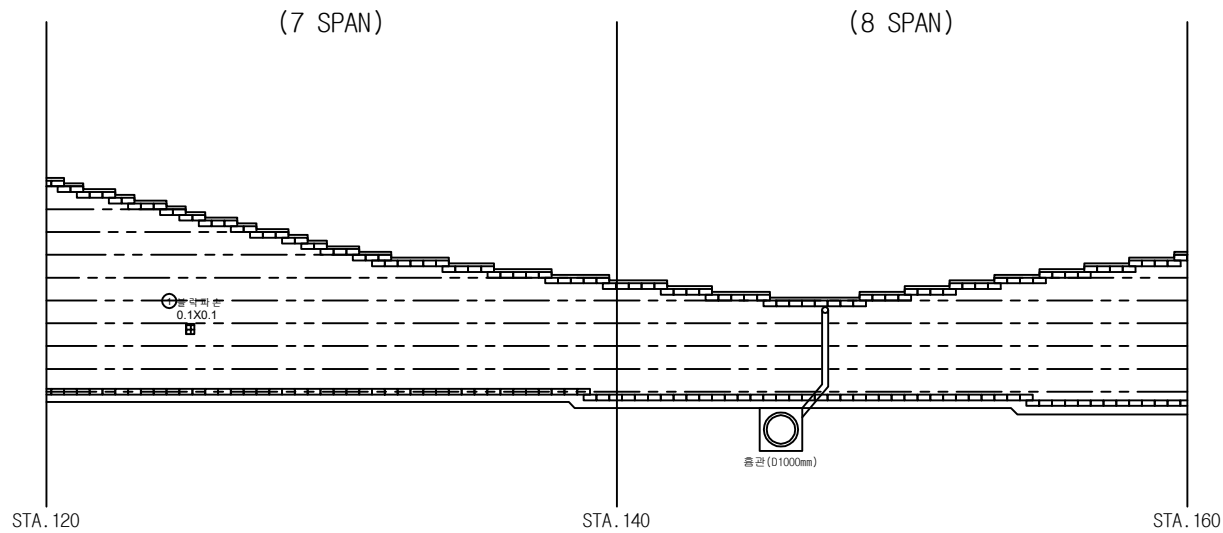
| 번호 | 손상내용 | 폭(mm) | 길이(m) | 너비(m) | 개소 | 손상물량 | | 비고 |
|---|---|---|---|---|---|---|---|---|
| 1 | 블럭파손 | | 0.1 | 0.1 | 1 | 0.01 | m <sup>2</sup> | |

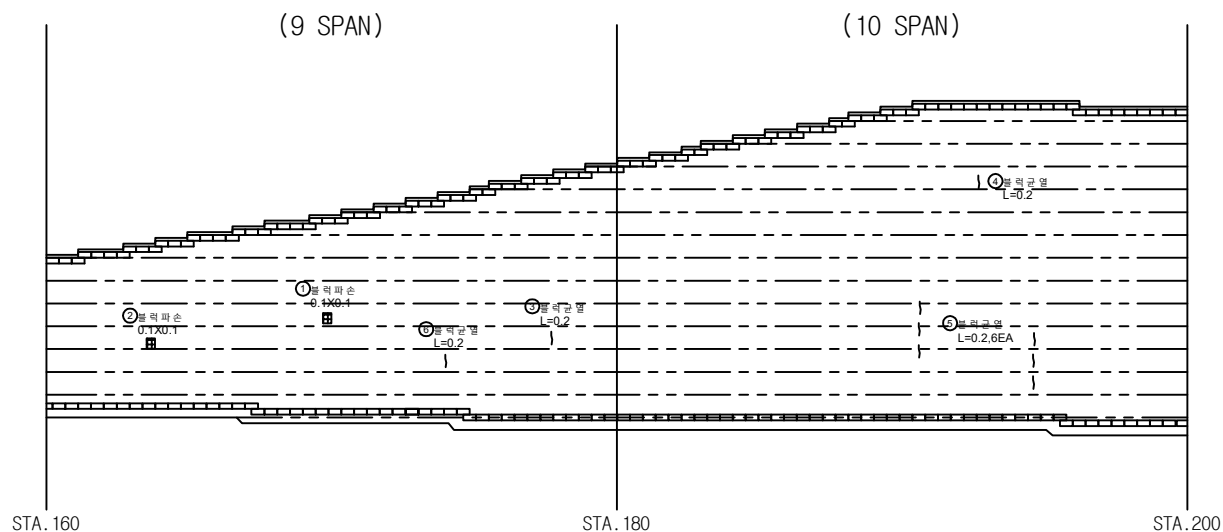
ID :부산울산선 옹벽 42.70K(포항) STA.160.0 ~ STA.200.0

| 번호 | 손상내용 | 폭(mm) | 길이(m) | 너비(m) | 개소 | 손상물량 | | 비고 |
|---|---|---|---|---|---|---|---|---|
| 1 | 블럭파손 | | 0.1 | 0.1 | 1 | 0.01 | m <sup>2</sup> | |
| 2 | 블럭파손 | | 0.1 | 0.1 | 1 | 0.01 | m <sup>2</sup> | |
| 3 | 블럭균열 | | 0.2 | | 1 | 0.20 | m | |
| 4 | 블럭균열 | | 0.2 | | 1 | 0.20 | m | |
| 5 | 블럭균열 | | 0.2 | | 6 | 1.20 | m | |
| 6 | 블럭균열 | | 0.2 | | 1 | 0.20 | m | 신 |

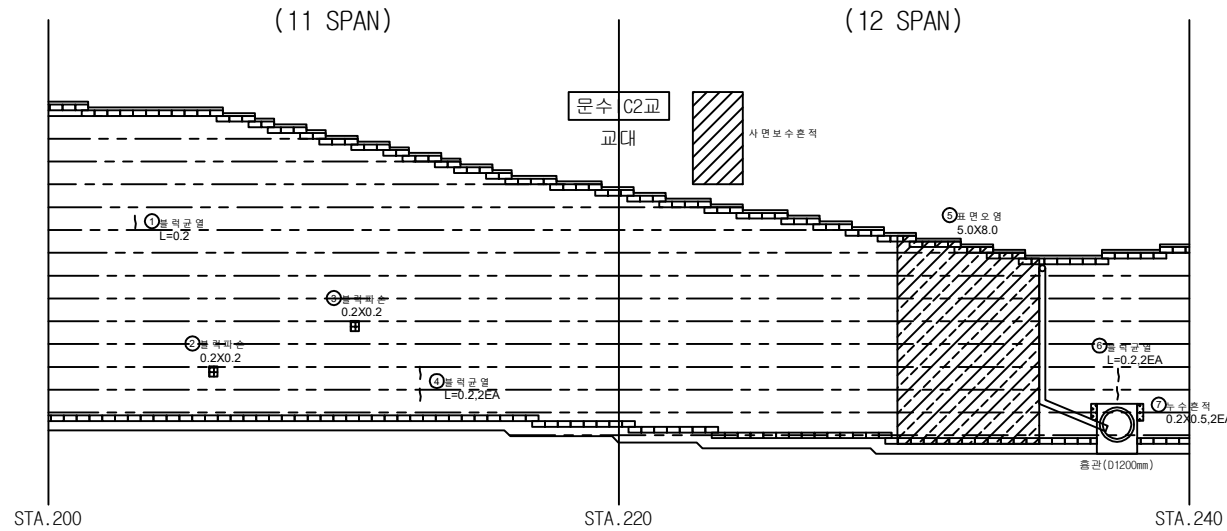
ID :부산울산선 웅벽 42.70K(포항) STA.200.0 ~ STA.240.0

| 번호 | 손상내용 | 폭(mm) | 길이(m) | 너비(m) | 개소 | 손상물량 | | 비고 |
|---|---|---|---|---|---|---|---|---|
| 1 | 불력균열 | | 0.2 | | 1 | 0.20 | m | |
| 2 | 불력파손 | | 0.2 | 0.2 | 1 | 0.04 | m² | |
| 3 | 불력파손 | | 0.2 | 0.2 | 1 | 0.04 | m² | |
| 4 | 불력균열 | | 0.2 | | 2 | 0.40 | m | |
| 5 | 표면오염 | | 5.0 | 8.0 | 1 | 40.00 | m² | |
| 6 | 불력균열 | | 0.2 | | 2 | 0.40 | m | |
| 7 | 누수흔적 | | 0.2 | 0.5 | 2 | 0.20 | m² | |

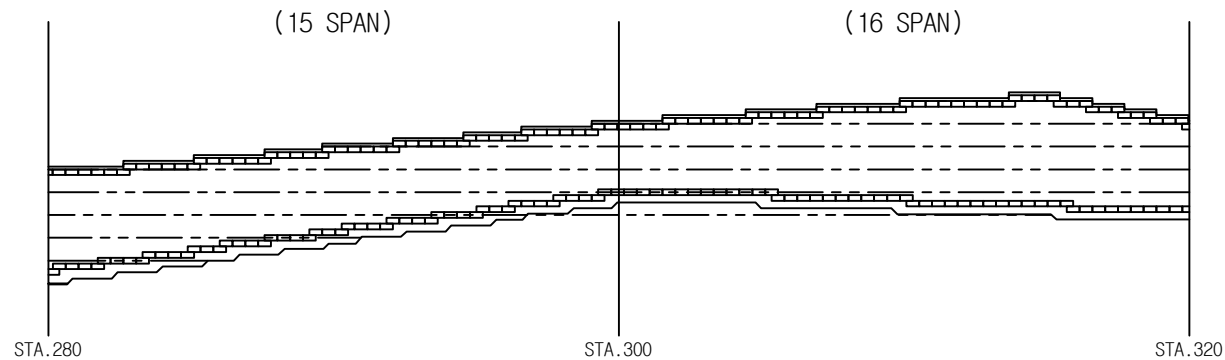
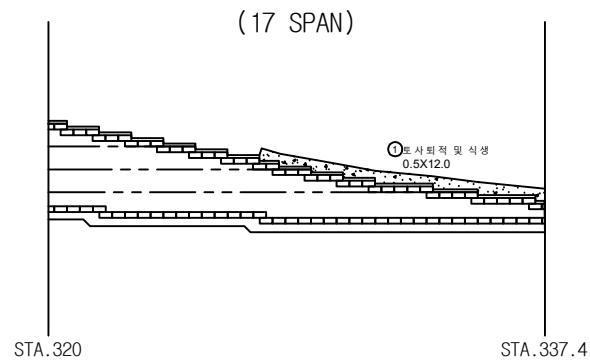
ID :부산울산선 옹벽 42.70K(포항) STA.280.0 ~ STA.337.4

| 번호 | 손상내용 | 폭(mm) | 길이(m) | 너비(m) | 개소 | 손상물량 | | 비고 |
|---|---|---|---|---|---|---|---|---|
| 1 | 토사 퇴적 | | 0.5 | 12.0 | 1 | 6.00 | m³ | |

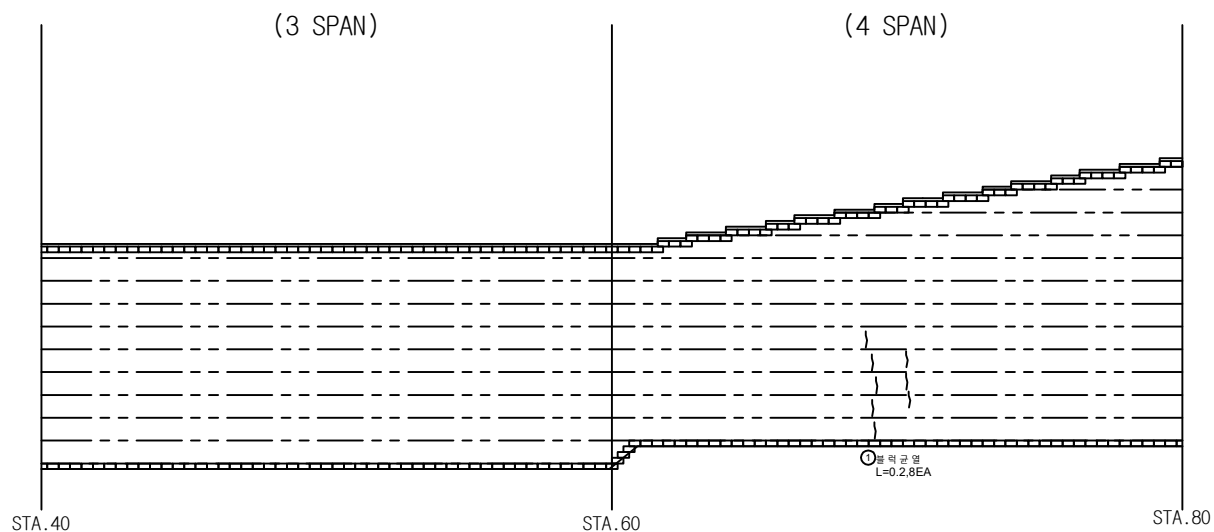
ID :부산울산선 옹벽 44.02K(부산) STA.40.0 ~ STA.80.0

| 번호 | 손상내용 | 폭(mm) | 길이(m) | 너비(m) | 개소 | 손상물량 | | 비고 |
|---|---|---|---|---|---|---|---|---|
| 1 | 블럭균열 | | 0.2 | | 8 | 1.60 | m | 추가 |

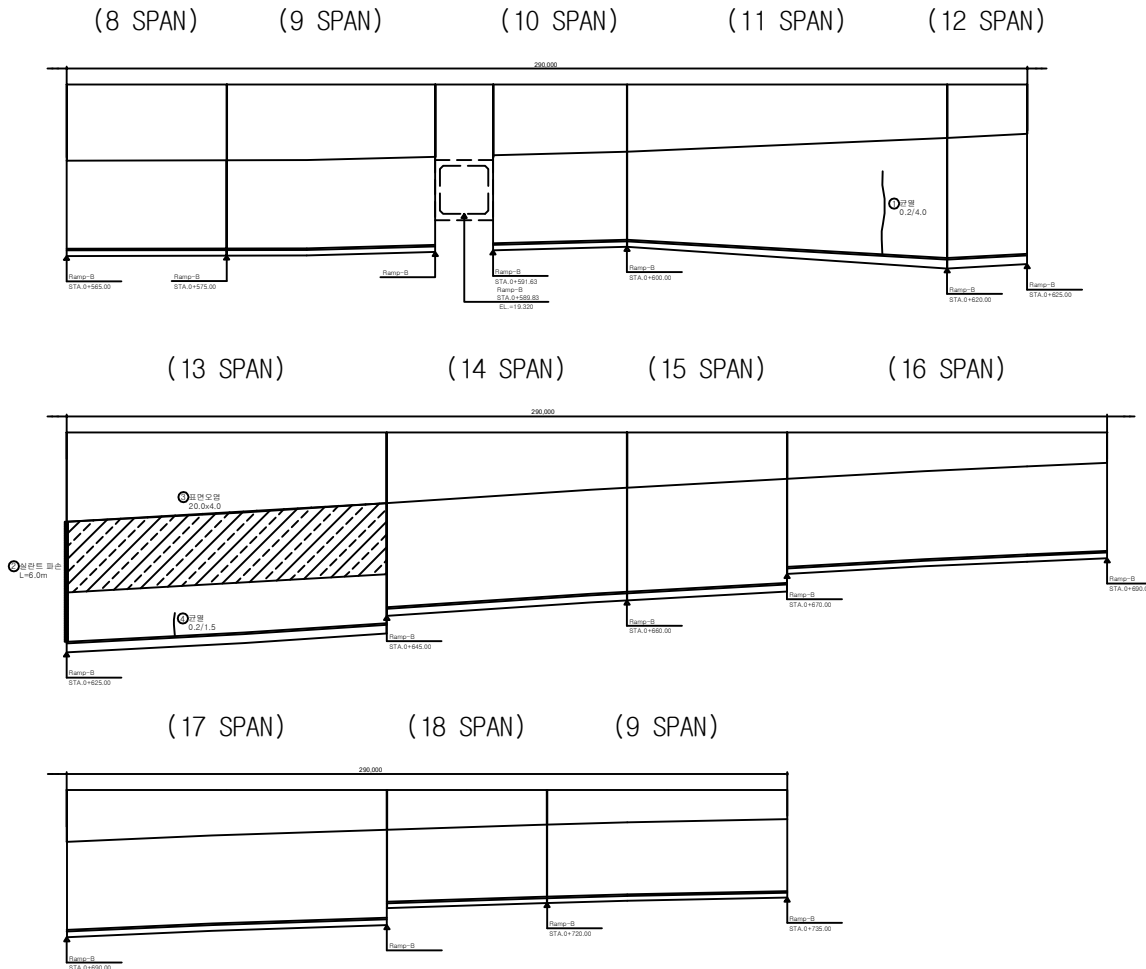
ID : 해운대송정 IC R/B 울산 STA.STA.0+445 ~0+735

| 번호 | 손상내용 | 폭(mm) | 길이(m) | 너비(m) | 개소 | 손상물량 | | 비고 |
|---|---|---|---|---|---|---|---|---|
| 1 | 균열 | 0.2 | 4.0 | | 1 | 4.00 | m | 신 |
| 4 | 균열 | 0.2 | 1.5 | | 1 | 1.50 | m | 신 |
