## 오천터널(하) 전 경 사 진

## 1. 라이닝-1

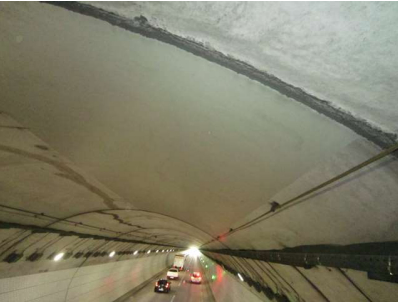
| | 13 | 천단부 균열<br>SP15 보수 | | 14 | 측벽부 이격<br>J15(L=4.0m) | | 15 | 측벽부 이격<br>J15(L=4.0m) |

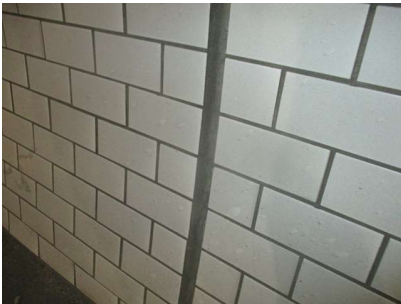
| | 16 | 측벽부 파손<br>J18(A=0.1m*1.5m) | | 17 | 천단부 균열<br>SP19 보수 | | 18 | 천단부 균열(반원)<br>SP19(CW=0.3mm/1.5m) |

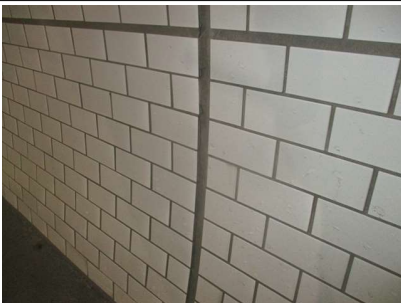
| | 19 | 측벽부 파손<br>J19(A=0.1m*1.0m) | | 20 | 타일부 타일균열<br>SP21 3EA | | 21 | 측벽부 파손<br>J21(A=0.1m*1.5m) |

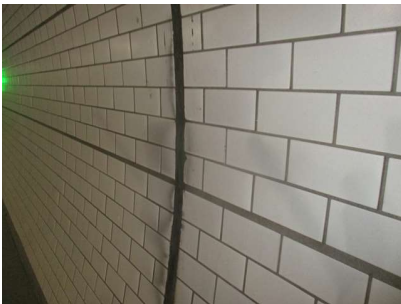
| | 22 | 측벽부 실란트들뜸<br>J22(L=4.0m) | | 23 | 측벽부 몰탈탈락<br>SP23(A=0.1m*0.7m) | | 24 | 측벽부 몰탈탈락<br>SP23(A=0.2m*0.1m*2EA) |

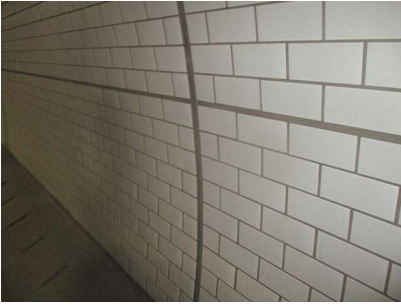
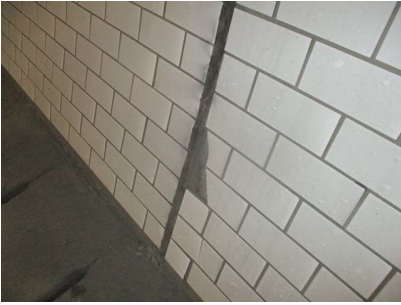
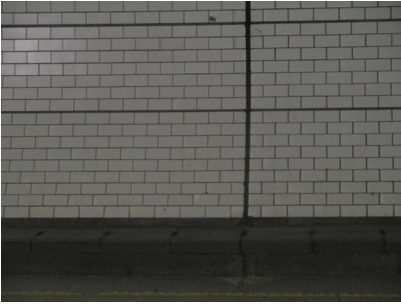
| | 25 | 측벽부 파손<br>J24(A=0.1m*1.5m) | | 26 | 타일부 타일탈락<br>SP25 2EA | | 27 | 측벽부 몰탈탈락<br>J26(A=0.1m*0.3m) |

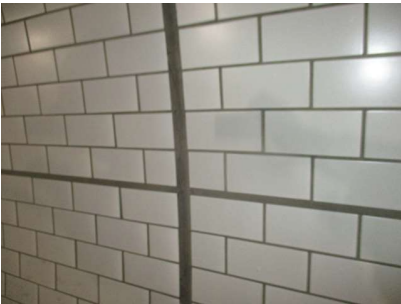
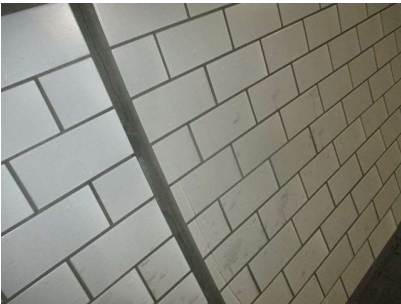
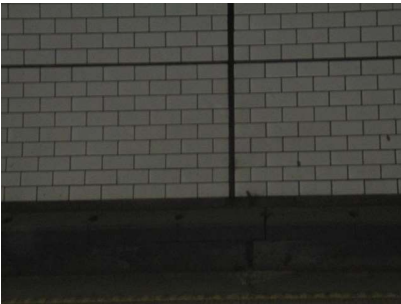
| | 28 | 측벽부 파손<br>J27(A=0.1m*2.0m) | | 29 | 타일부 타일균열<br>SP27 6EA | | 30 | 측벽부 몰탈탈락<br>SP29(A=0.1m*0.5m) |

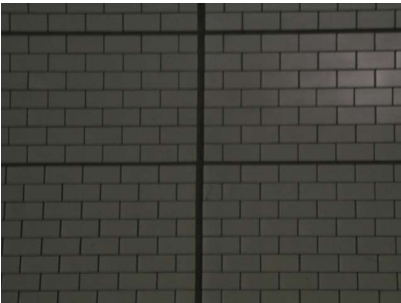
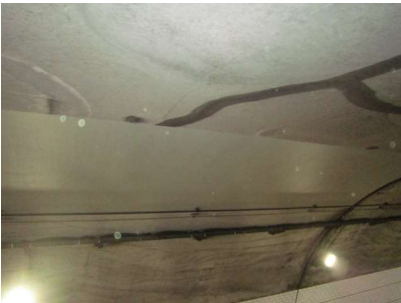
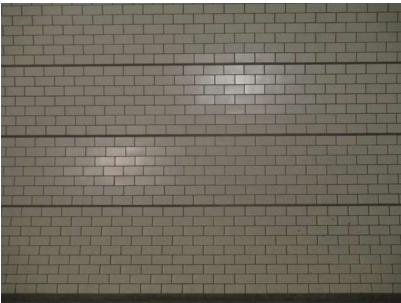
| | 31 | 타일부 타일균열<br>SP32 2EA | | 32 | 천단부 균열<br>SP33 보수 | | 33 | 타일부 타일균열<br>SP33 4EA |

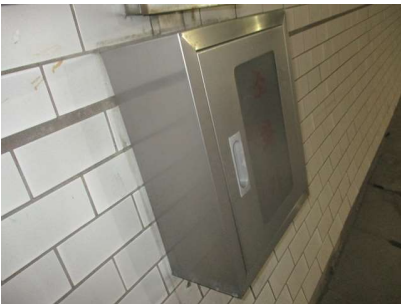
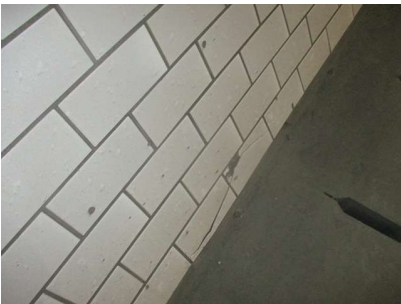
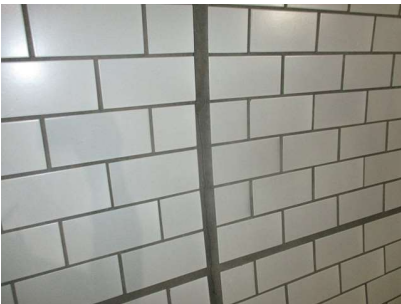
| | 34 | 타일부 소화기함파손<br>SP33 보수 | | 35 | 타일부 타일파손<br>SP34 3EA | | 36 | 측벽부 파손<br>J35(A=0.1m*1.5m) |

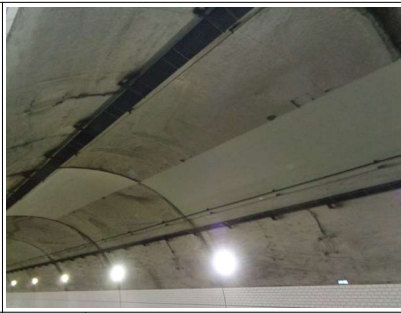
38

천단부 균열  
SP36 보수

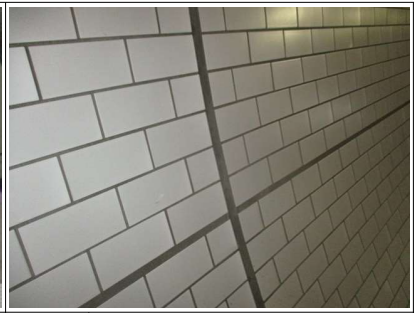
39

측벽부 파손  
J39(A=0.1m\*1.0m)

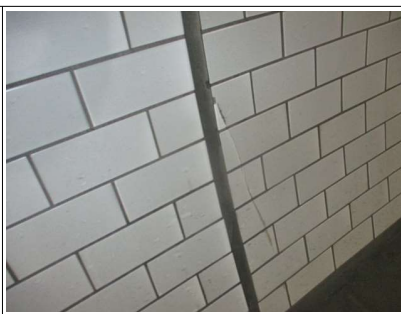
47

타일부 타일균열  
SP51 5EA

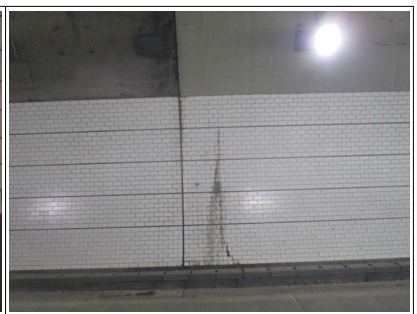
48

타일부 타일균열  
SP52 34EA

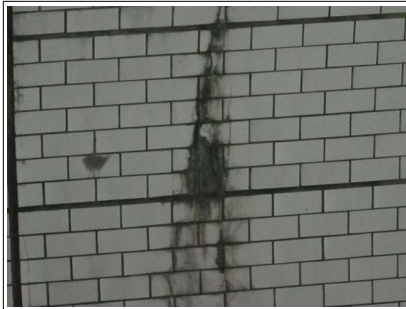
49 타일부 누수흔적  
SP52(A=0.3m\*2.5m)

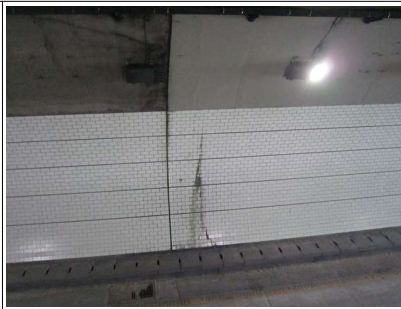
50 타일부 누수흔적  
SP52(A=0.3m\*2.5m)

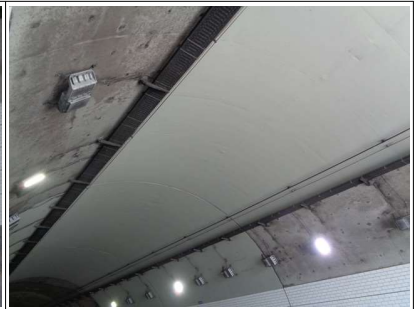
51 천단부 균열  
SP54 보수

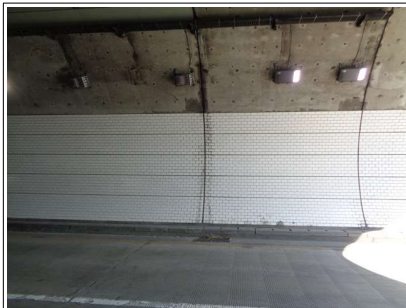
52 측벽부 누수흔적  
SP55(A=0.1m\*2.0m)

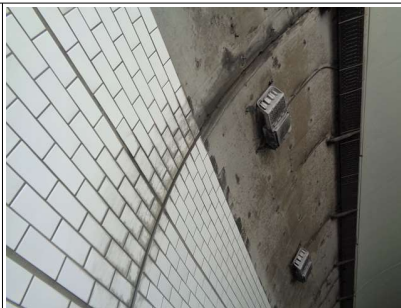
53 측벽부 누수흔적  
SP55(A=0.1m\*2.0m)

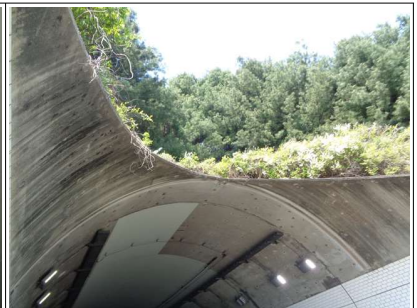
54 천단부 표면오염  
SP56(A=8.0m\*4.5m)

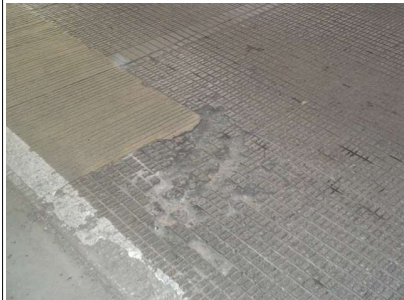
| 4 | 포장면 균열<br>SP5(L=5.0m) | 5 | 포장면 파손<br>SP8(A=0.5*0.5m*2EA) | 6 | 포장면 파손<br>SP10(A=1.0m*1.0m) |

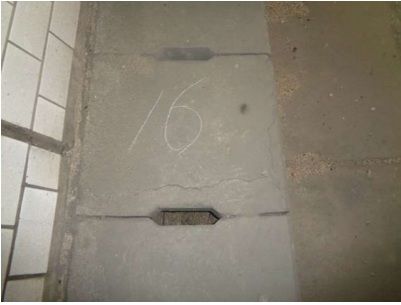
| | 13 | 공동구 덮개균열<br>SP17 1EA |

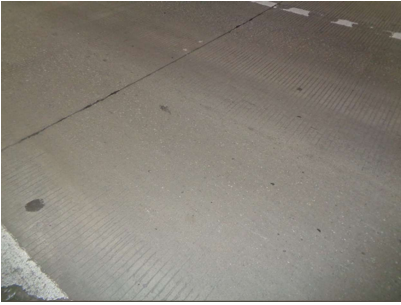
| | 14 | 포장면 망상균열<br>SP18(A=0.6m*3.0m) |

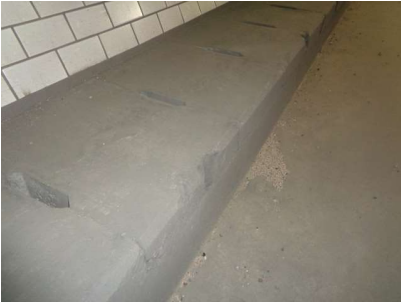
| | 15 | 공동구 덮개파손<br>SP19 6EA |

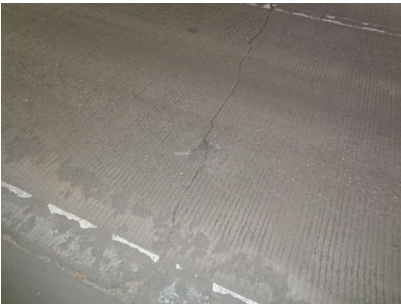
| | 16 | 포장면 파손<br>SP22(A=0.3m*0.3m) |

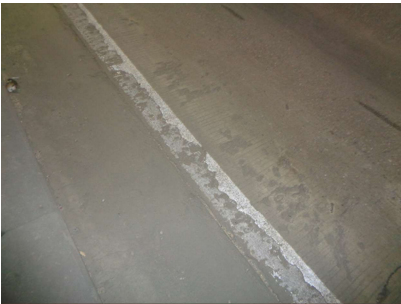
| | 17 | 포장면 박리<br>SP24(A=0.6m*2.7m) |

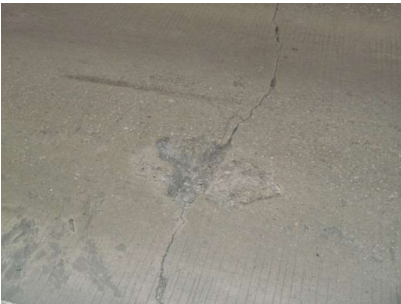
| | 18 | 포장면 파손<br>SP25(A=0.5m*0.5m) |

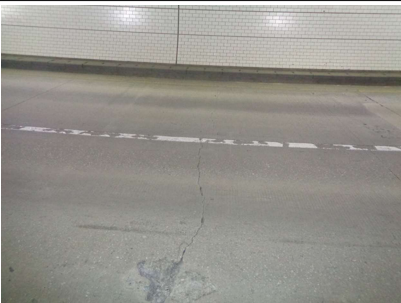
| | 19 | 포장면 균열<br>SP25(L=0.9m) |

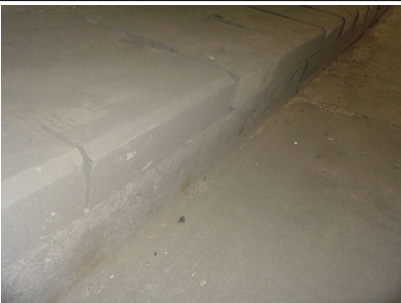
| | 20 | 공동구 박리<br>SP25(A=0.1m*0.1m*13EA) |

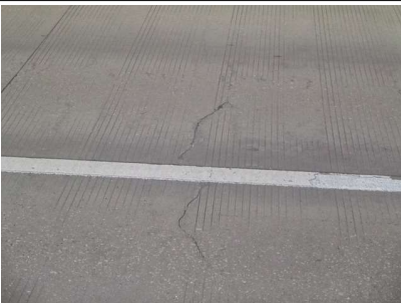
| | 21 | 포장면 균열<br>SP29(L=2.5m) |

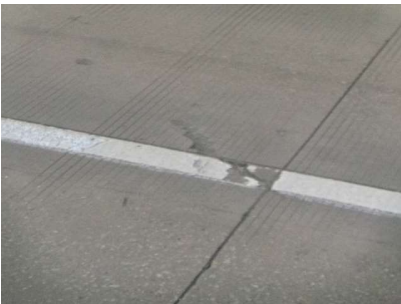
| | 22 | 포장면 긁힘<br>SP31(A=0.2m*0.8m) |

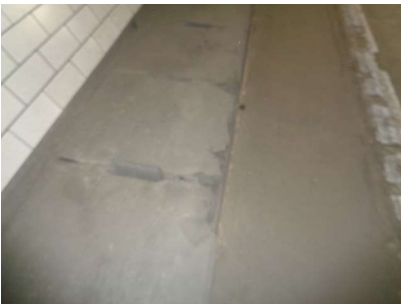
| | 23 | 공동구 덮개파손<br>SP33 3EA |

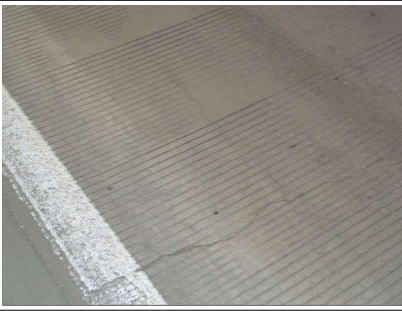
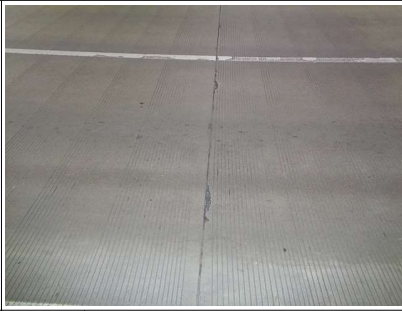
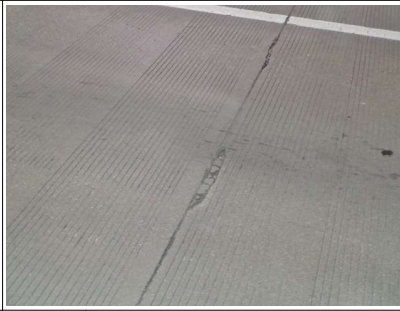
| 25 | 포장면 균열<br>SP38(L=0.5m) | 26 | 포장면 파손<br>SP40(A=0.1m*0.4m*4EA) | 27 | 포장면 파손<br>SP43(A=0.1m*0.5m*2EA) |

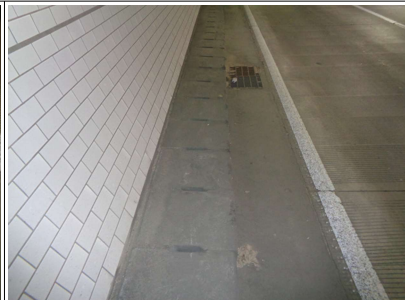
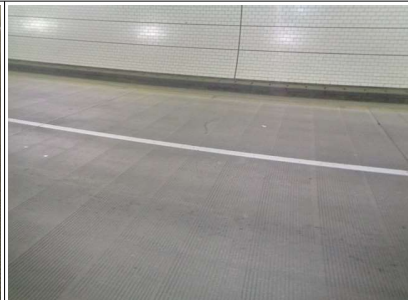
| 28 | 공동구 덮개파손<br>SP45 10EA | 29 | 공동구 덮개파손<br>SP46 8EA | 30 | 포장면 균열<br>SP49(L=3.0m) |

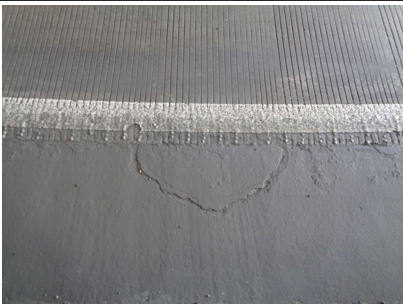
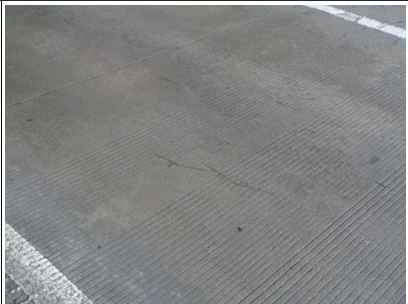
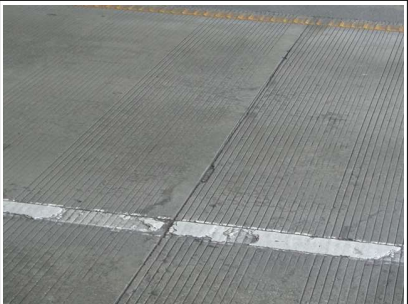
| 37 | 포장면 박리<br>SP54(A=1.0m*0.5m) | 38 | 포장면 균열<br>SP54(L=2.0m) | 39 | 포장면 파손<br>SP54(A=0.1m*0.3m) |

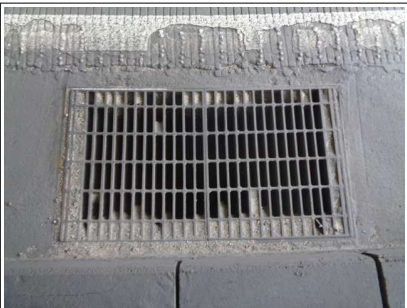
| 40 | 배수로 배수구막힘<br>SP55 보수 | |

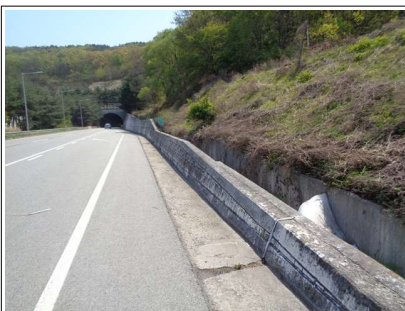
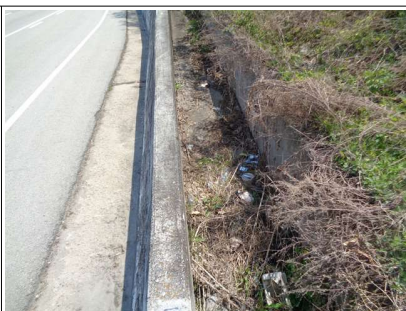
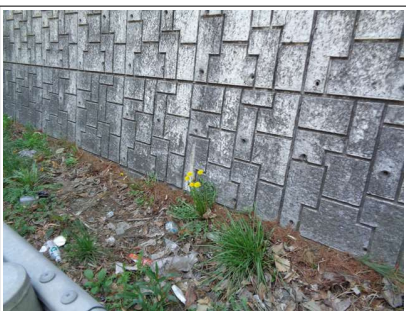
| | 4 | 진입부 옹벽 전경 | | 5 | 진입부 사면 배수로<br>토사퇴적(1.0m*20.0m) | | 6 | 진입부 옹벽 백태<br>STA.0+015(0.1m*0.6m) |

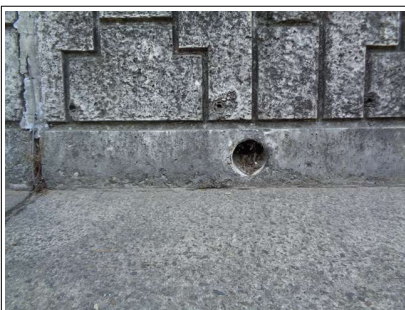
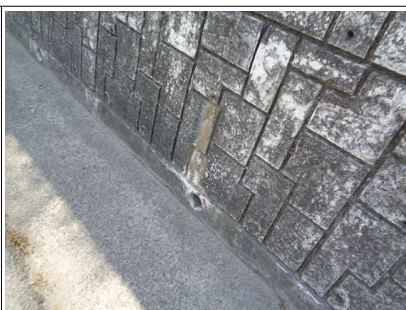
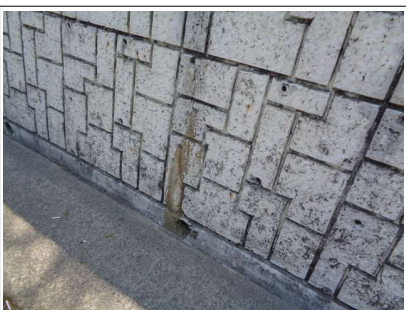
| | 7 | 진입부 옹벽 배수구막힘<br>STA.0+040 1EA | | 8 | 진입부 옹벽 백태<br>STA.0+065(0.1m*0.6m) | | 9 | 진입부 옹벽 백태<br>STA.0+075(0.1m*0.6m) |

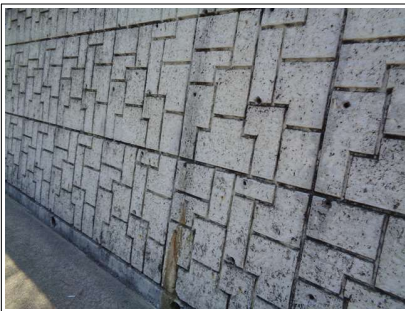
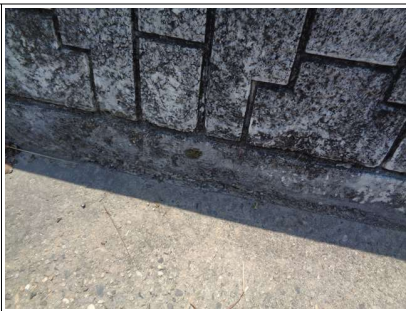
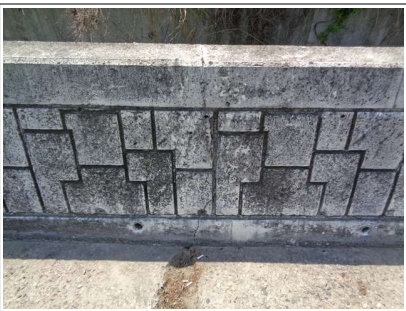
| | 10 | 진입부 옹벽 균열<br>STA.0+075(0.1mm/3.3m) | | 11 | 진입부 옹벽 배수구막힘<br>STA.0+120 1EA | | 12 | 진입부 옹벽 균열<br>STA.0+125(0.5mm/2.2m) |

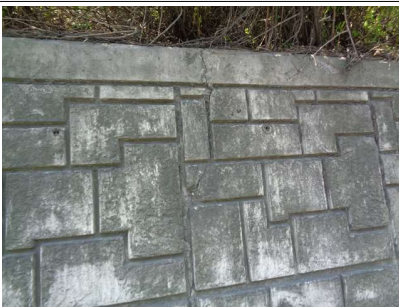
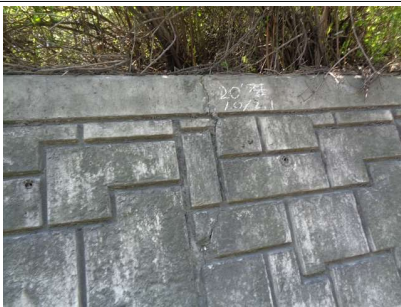
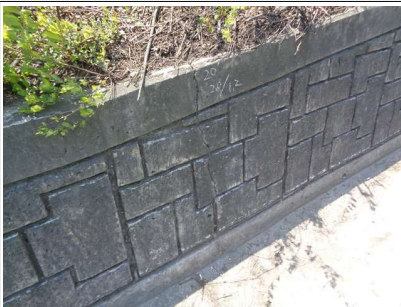
| 16 | 진입부 옹벽 균열<br>STA.0+020(1.0mm/2.1m) | 17 | 진입부 옹벽 균열<br>STA.0+020(1.0mm/2.1m) | 18 | 진입부 옹벽 균열<br>STA.0+040(2.0mm/1.2m) |

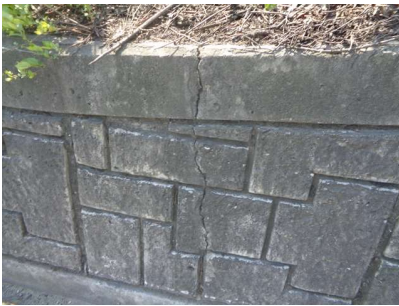
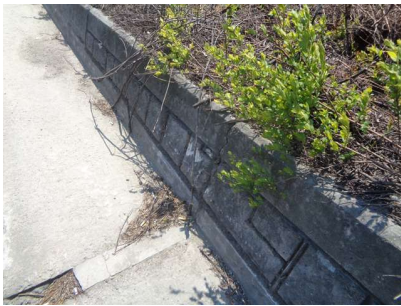
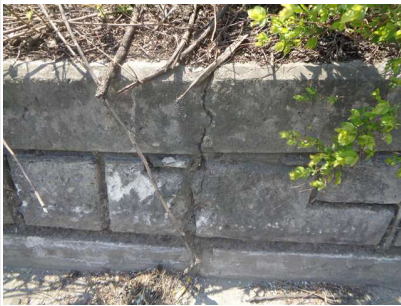
| 19<br>진입부 옹벽 균열<br>STA.0+040(2.0mm/1.2m) | 20<br>진입부 옹벽 균열<br>STA.0+055(2.0mm/0.6m) | 21<br>진입부 옹벽 균열<br>STA.0+055(2.0mm/0.6m) |
