## 오천터널(하) 전 경 사 진

## 1. 라이닝-1

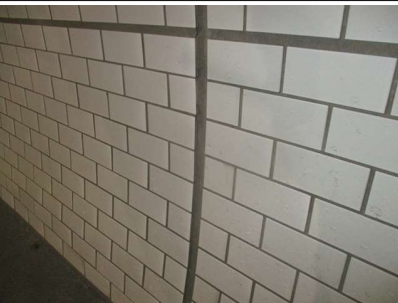
| | 19 | 측벽부 파손<br>J19(A=0.1m*1.0m) |

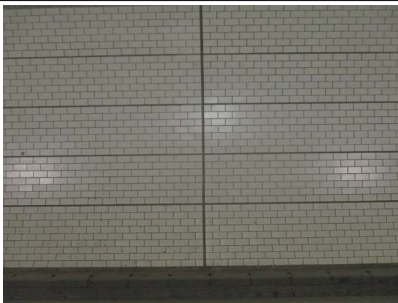
| | 20 | 타일부 타일균열<br>SP21 3EA |

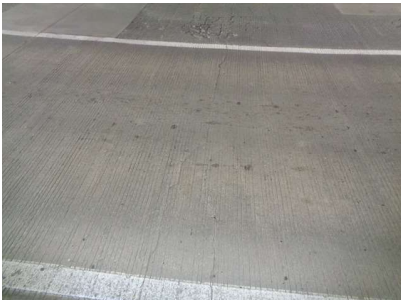
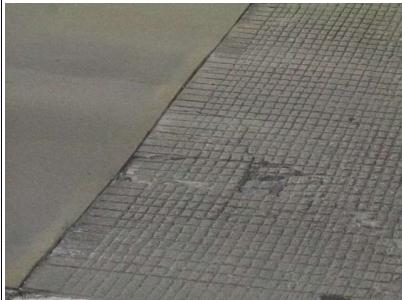
| 4 | 포장면 균열<br>SP5(L=5.0m) | 5 | 포장면 파손<br>SP8(A=0.5*0.5m*2EA) | 6 | 포장면 파손<br>SP10(A=1.0m*1.0m) |

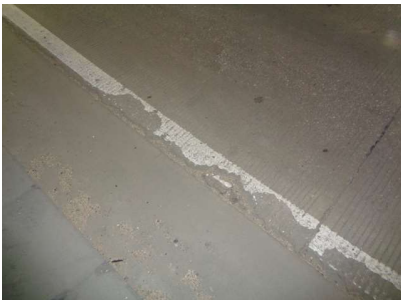
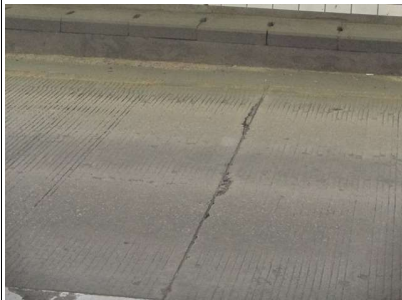
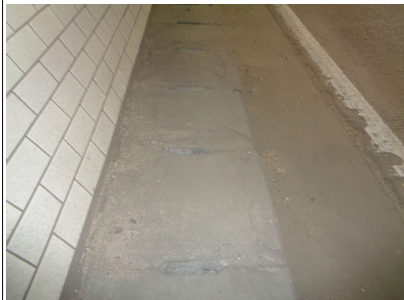
| 10 | 포장부 파손<br>SP15(A=0.1m*4.0m) | 11 | 포장부 파손<br>SP16(A=0.1m*0.5m) | 12 | 공동구 덮개파손<br>SP16 4EA |

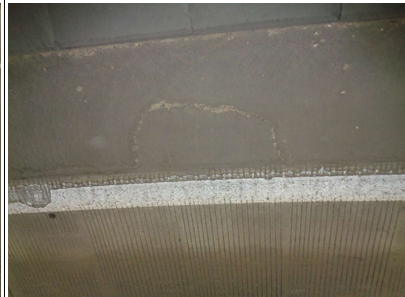
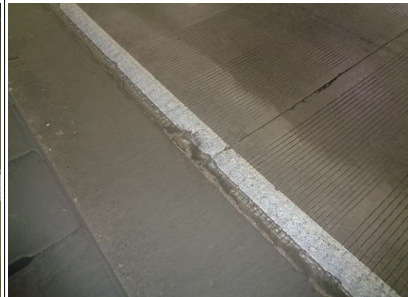
| 31 | 포장면 토사퇴적<br>SP50 보수 | 32 | 포장면 박리<br>SP50(A=0.1m*0.5m) | 33 | 포장면 파손<br>SP51(A=0.1m*1.5m) |

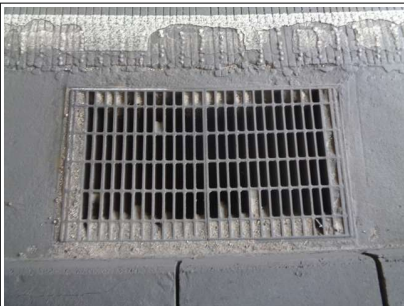
| 40 | 배수로 배수구막힘<br>SP55 보수 | |

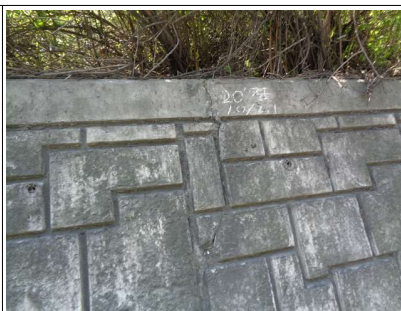
17      진입부 옹벽 균열  
STA.0+020(1.0mm/2.1m)

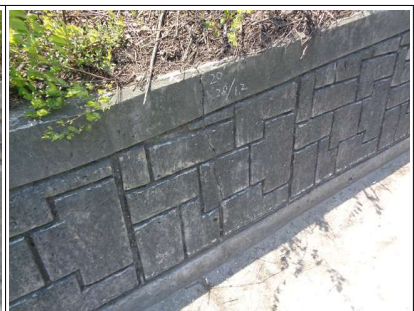
18      진입부 옹벽 균열  
STA.0+040(2.0mm/1.2m)

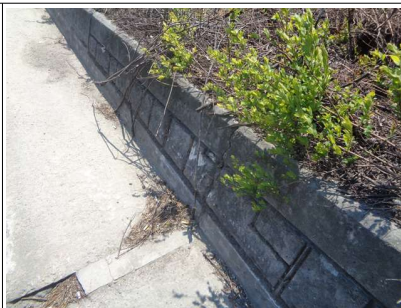
20      진입부 옹벽 균열  
STA.0+055(2.0mm/0.6m)

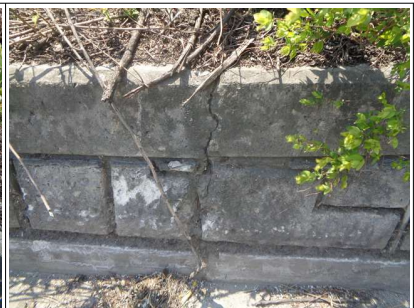
21      진입부 옹벽 균열  
STA.0+055(2.0mm/0.6m)
