## 11. 패널식 옹벽 11

## 전경 및 작업사진

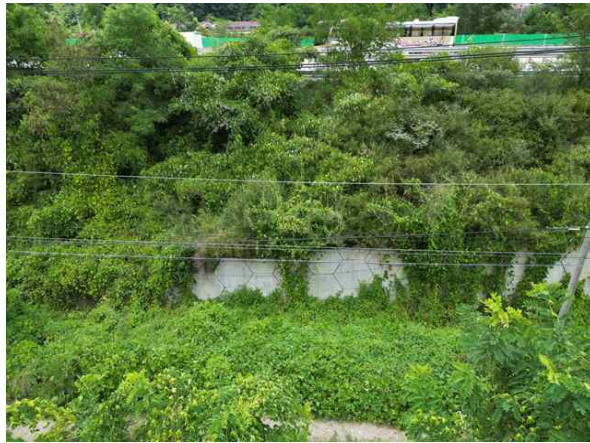
전면부 전경

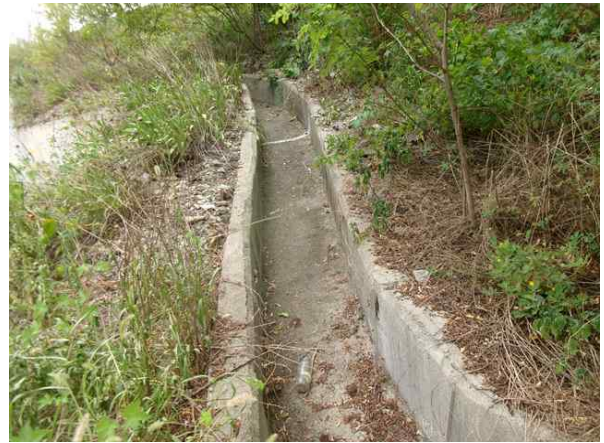
배수로 전경

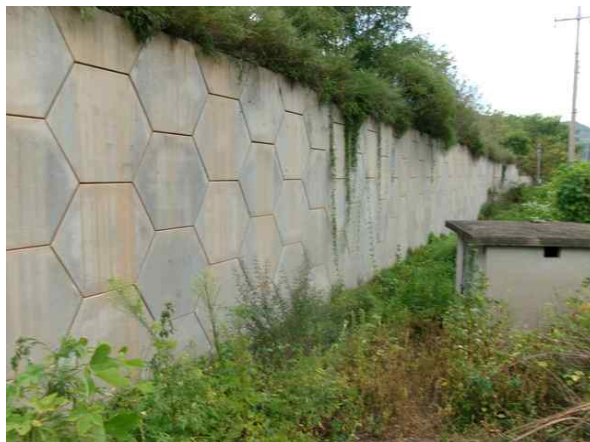
하부 전경

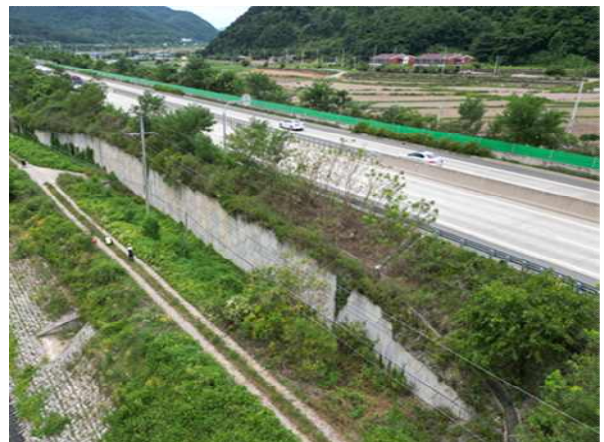
상부 전경

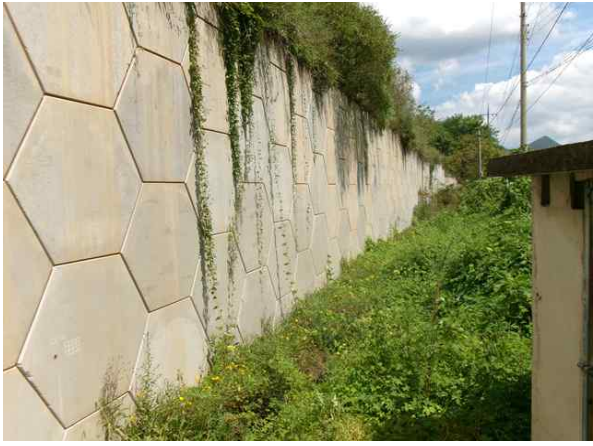
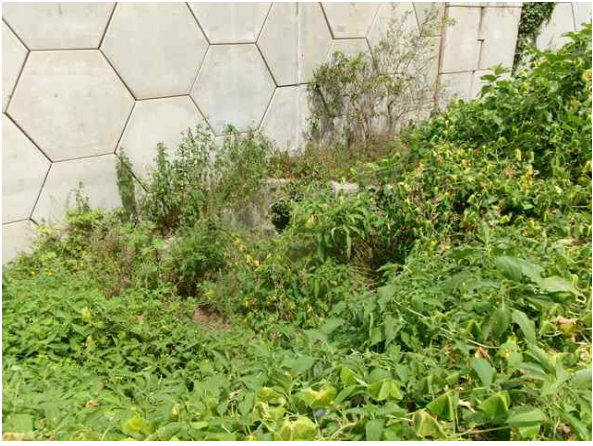
| 현황 | • 상태현황 | 현황 | • 상태현황 |

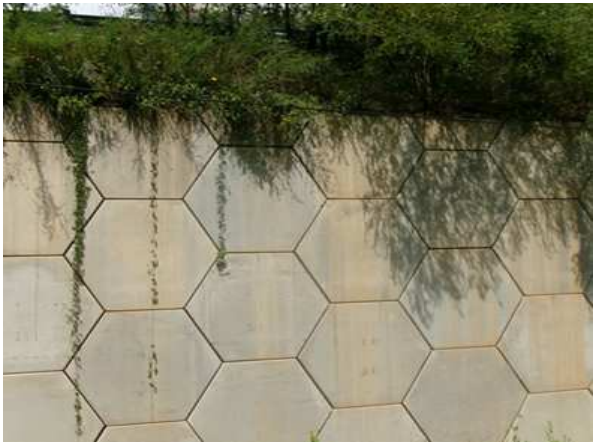
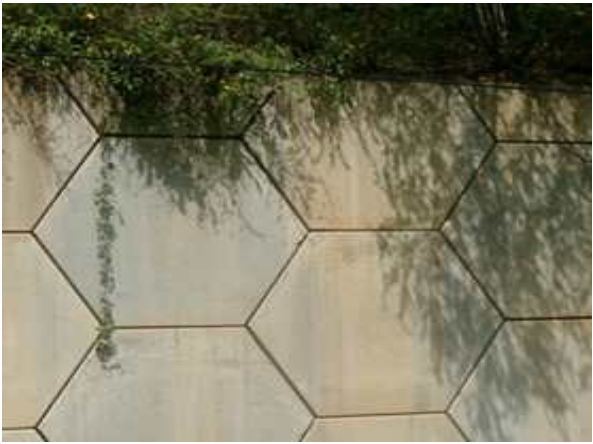
| 현황 | • S5 판넬 파손(0.2x0.1) | 현황 | • S5 판넬 파손(0.2x0.1) |
| 원인 | • 외부 충격 | 원인 | • 외부 충격 |

| 대책 | • 주의관찰 | 대책 | • 주의관찰 |

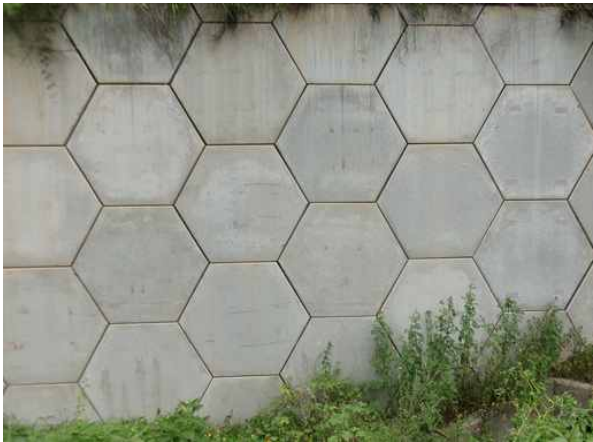
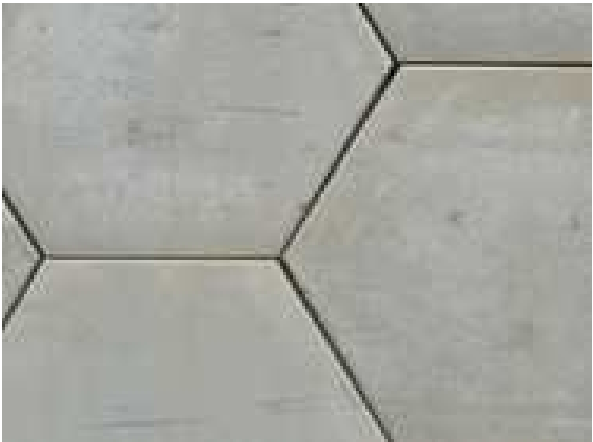
| 현황 | • S6 판넬 파손(0.1x0.1) | 현황 | • S6 판넬 파손(0.1x0.1) |
| 원인 | • 외부 충격 | 원인 | • 외부 충격 |

| 대책 | • 주의관찰 | 대책 | • 주의관찰 |

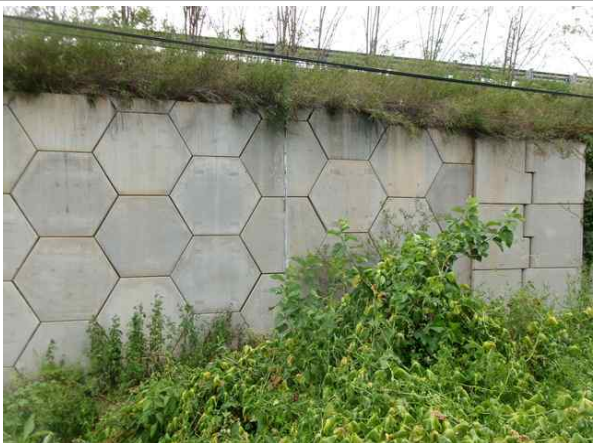
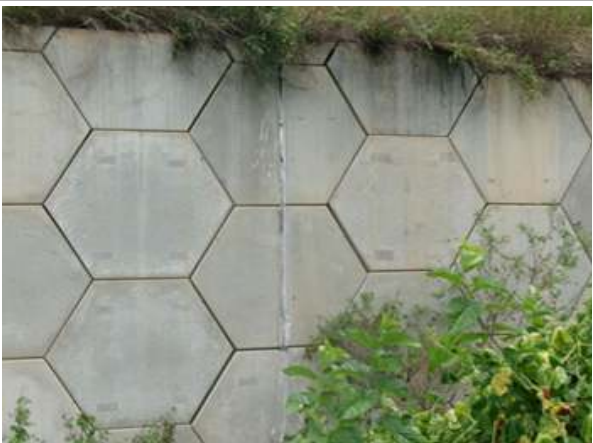
| 현황 | • S6 실란트 열화(L=4.50m) | 현황 | • S6 실란트 열화(L=4.50m) |
| 원인 | • 공용기간 증가 등 | 원인 | • 공용기간 증가 등 |

| 대책 | • 실란트 재시공 | 대책 | • 실란트 재시공 |

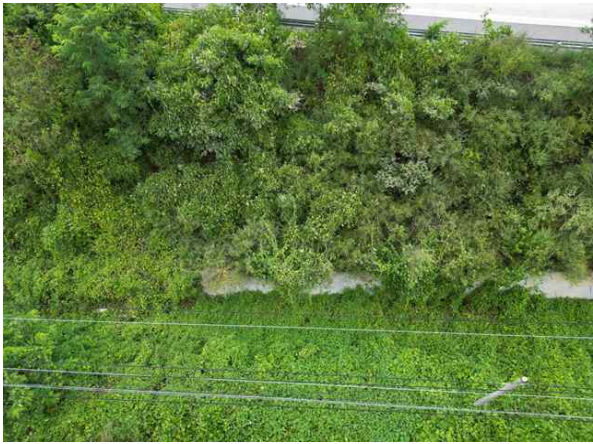
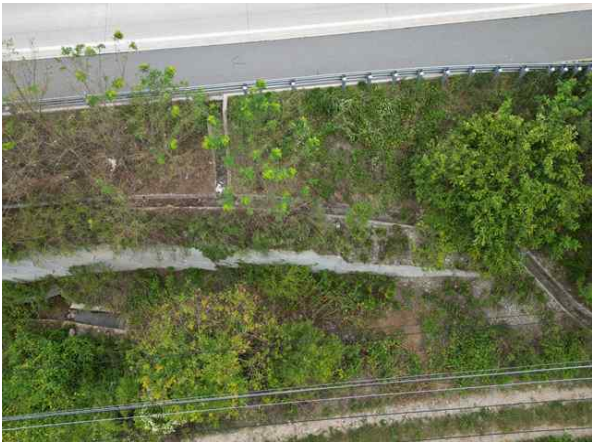
| 현황 | • 상부 성토부 상태현황 | 현황 | • 상부 성토부 상태현황 |

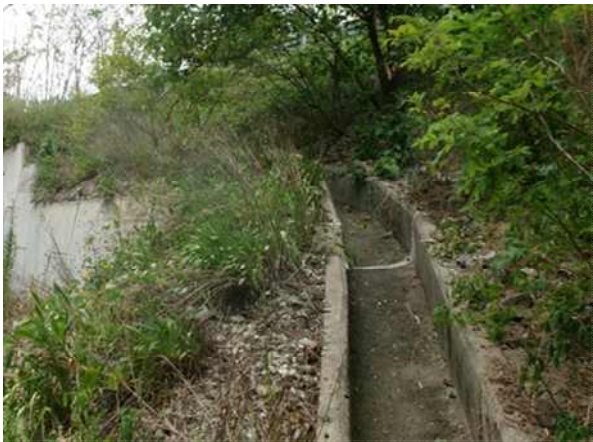
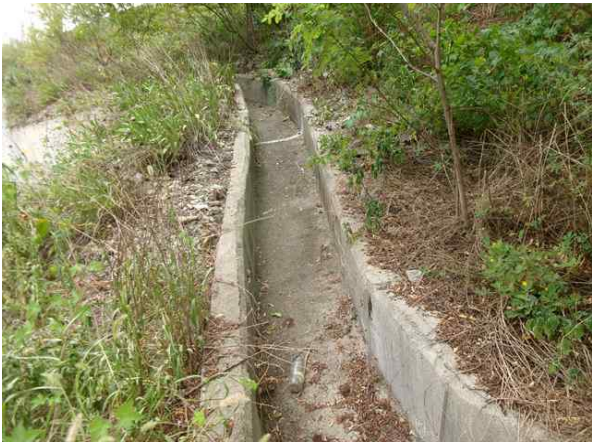
| 현황 | • 배수시설 상태현황 | 현황 | • 배수시설 상태현황 |

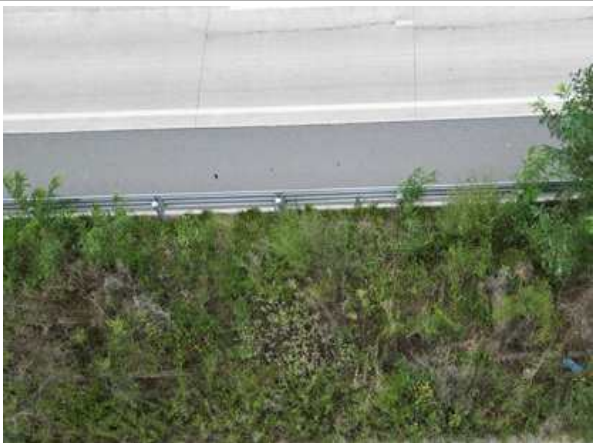
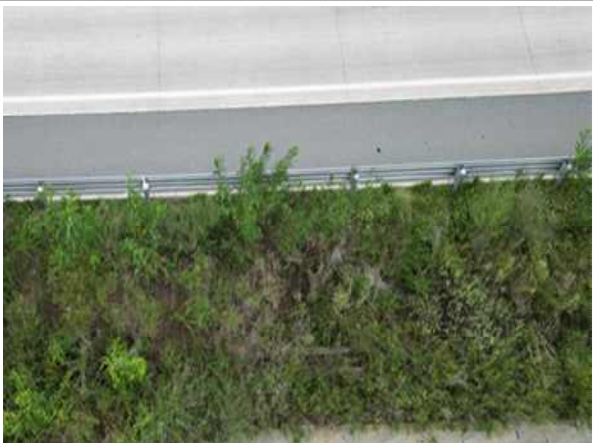
| 현황 | • 상부 도로 상태현황 | 현황 | • 상부 도로 상태현황 |
