# 01 남양5배수지(기존)

화성시 맑은물사업소

2023년 화성시 상수도시설물 안전점검용역

남양5배수지(기존) - 유출밸브실

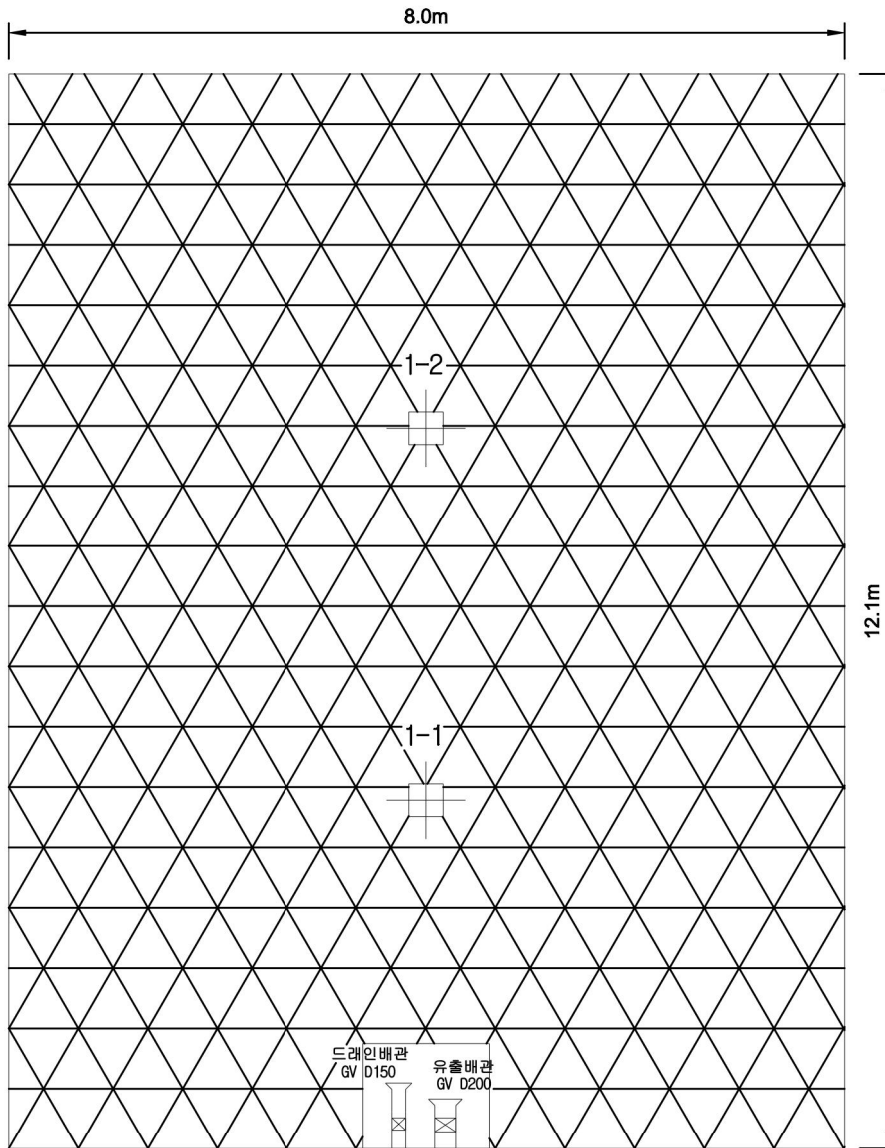
① 도장기포  
8.0X12.1

| 번호 | 내 용 | 손 상 규 모 | | | | | 비 고 |
|---|---|---|---|---|---|---|---|
| 1 | 도장기포 | 8.0 | 12.1 | 1 | 96.80 | ㎡ | 신규 |

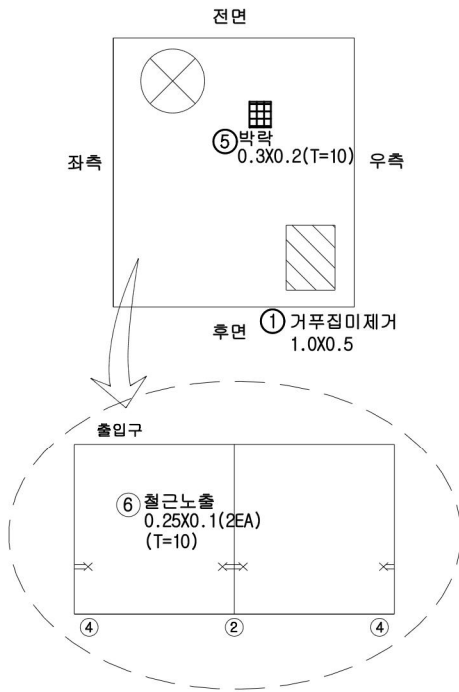
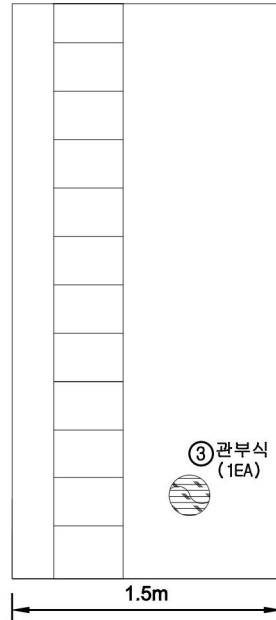
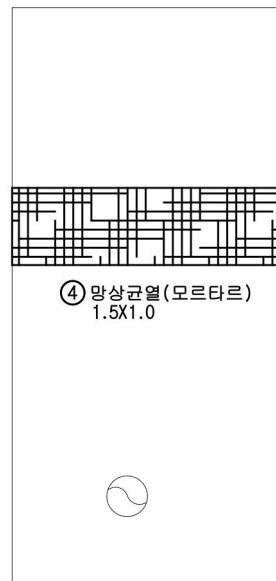
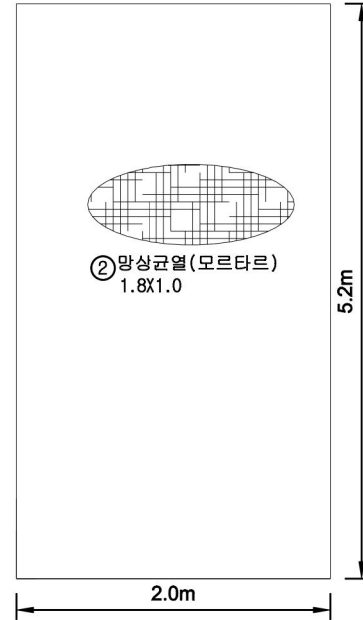
| 번호 | 내 용 | 손 상 규 모 | | | | | 비 고 |
|---|---|---|---|---|---|---|---|
| 1 | 거푸집미제거 | 1.0 | 0.5 | 1 | 0.50 | ㎡ | 기존 |
| 2 | 망상균열(모르타르) | 1.8 | 1.0 | 1 | 1.80 | ㎡ | 기존 |
| 3 | 관부식 | - | - | 1 | 1.00 | EA | 기존 |
| 4 | 망상균열(모르타르) | 1.5 | 1.0 | 1 | 1.50 | ㎡ | 기존 |
| 5 | 박락 | 0.3 | 0.2 | 1 | 0.06 | ㎡ | 기존 |
| 6 | 철근노출 | 0.25 | 0.1 | 2 | 0.05 | ㎡ | 기존 |

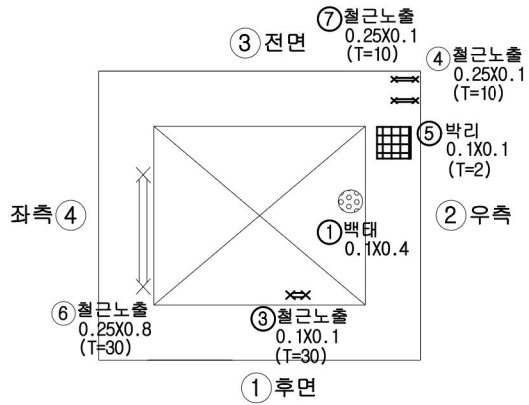
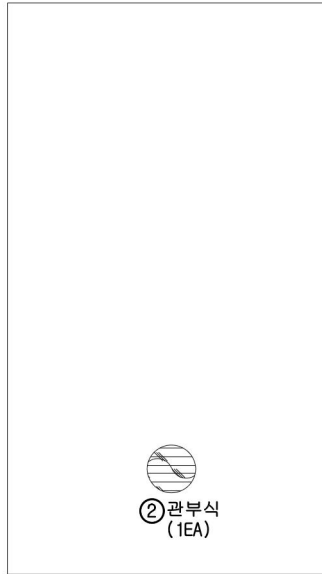
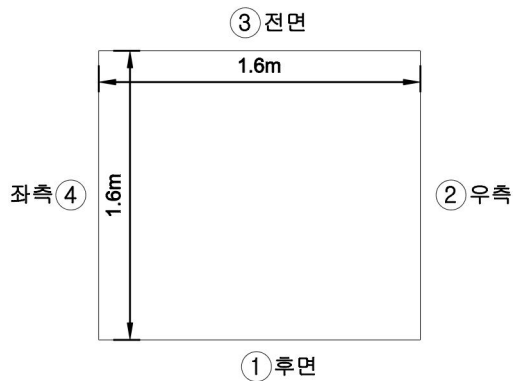
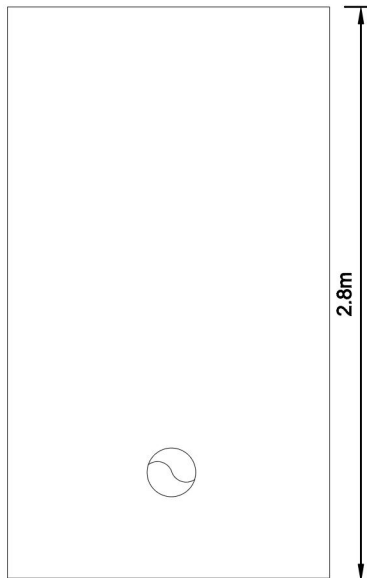
남양5배수지(기존) - 유량계설

| 번호 | 내 용 | 손 상 규 모 | | | | | 비 고 |
|---|---|---|---|---|---|---|---|
| 1 | 백태 | 0.1 | 0.4 | 1 | 0.04 | m² | 기존 |
| 2 | 관부식 | - | - | 1 | 1.00 | EA | 기존 |
| 3 | 철근노출 | 0.1 | 0.1 | 1 | 0.01 | m² | 기존 |
| 4 | 철근노출 | 0.25 | 0.1 | 1 | 0.03 | m² | 기존 |
| 5 | 박리 | 0.1 | 0.1 | 1 | 0.01 | m² | 기존 |
| 6 | 철근노출 | 0.25 | 0.8 | 1 | 0.20 | m² | 기존 |
| 7 | 철근노출 | 0.25 | 0.1 | 1 | 0.03 | m² | 기존 |
