## 32. 절토사면(STA.8+920~9+650)

| 용역명 | 서부내륙고속도로 2025년 시설물 정기안전점검 용역(하반기) |
| 시설물명 | 절토사면(STA.8+920~9+650) |
| 도면번호 | 32-01 |

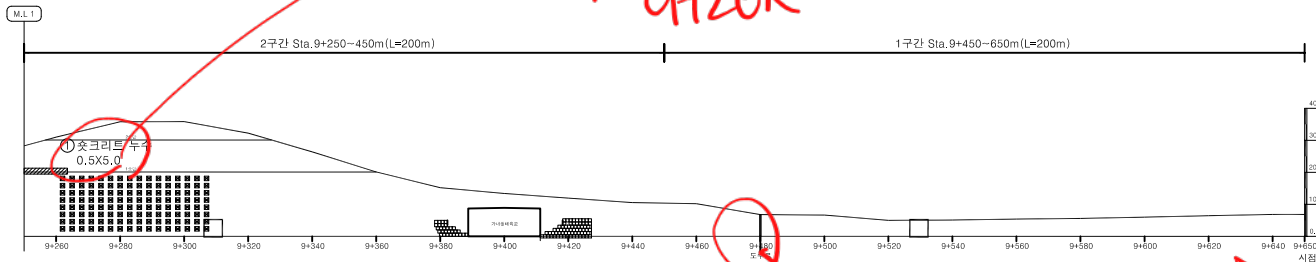
채움

| 번호 | 구분 | 결함 내용 | 손상규모 | | | | | 비고 |
|---|---|---|---|---|---|---|---|---|
| 1 | 배수로 | 측구 채우 | - | 0.5 | 5.0 | 1 | 2.50 | m³ 보수 |
