43. 보강토옹벽

(STA.2+157.750~2

+287.500(R))

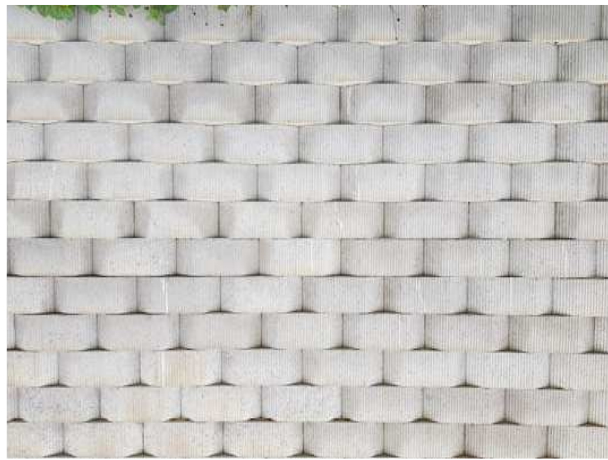
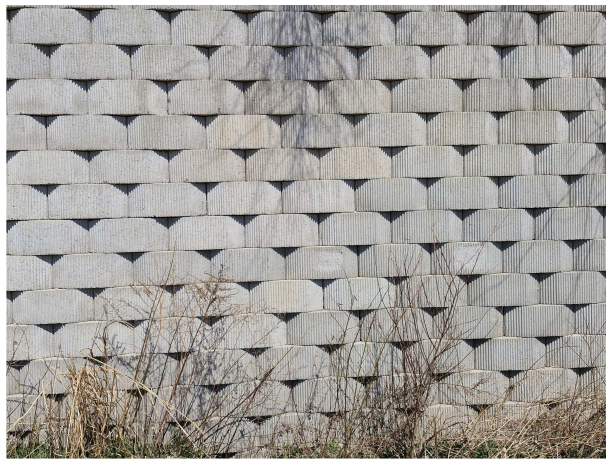
| 01<br>(25년 하반기) | 전면부 블록균열(1) | 01<br>(26년 상반기) | 전면부 블록균열(1) |

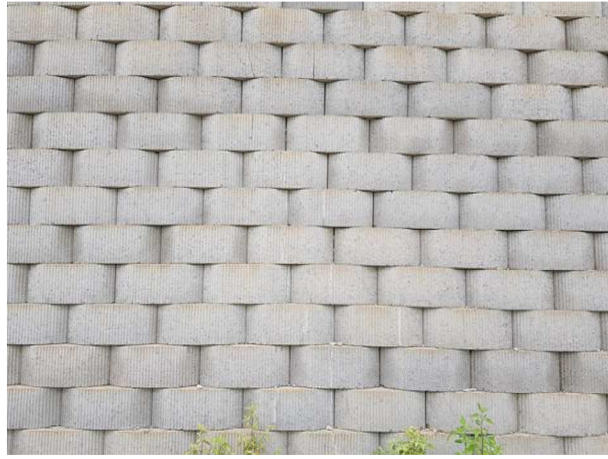
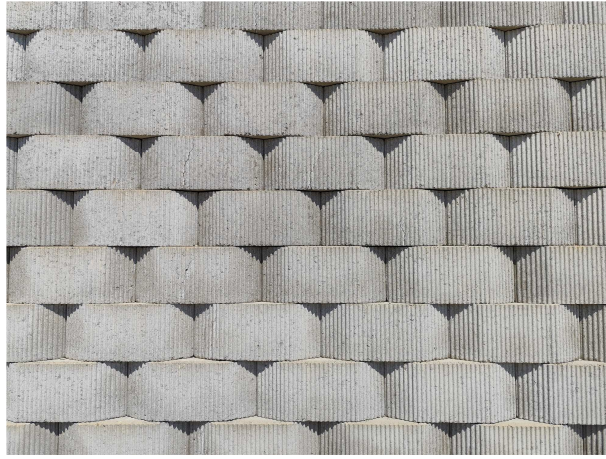
| 02<br>(25년 하반기) | 전면부 블록균열(2) | 02<br>(26년 상반기) | 전면부 블록균열(2) |

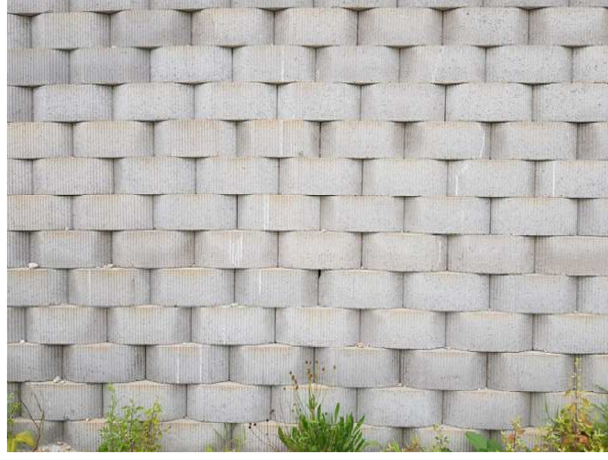
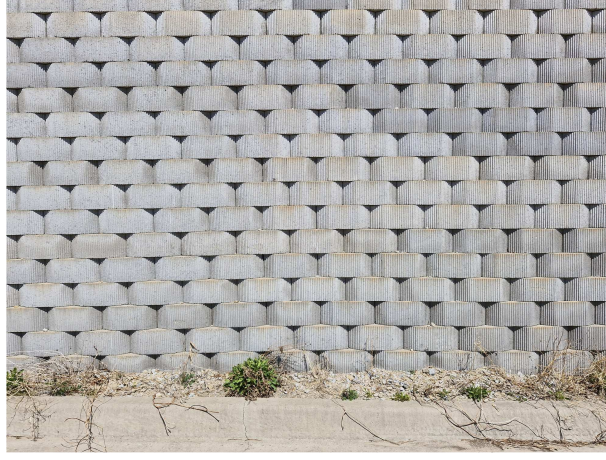
| 03<br>(25년 하반기) | 전면부 블록균열(3) | 03<br>(26년 상반기) | 전면부 블록균열(3) |

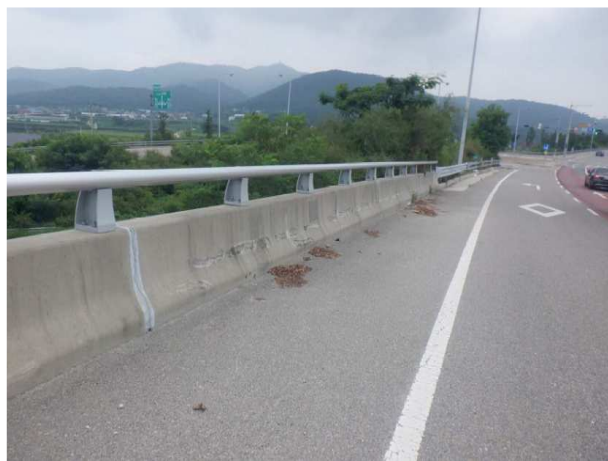
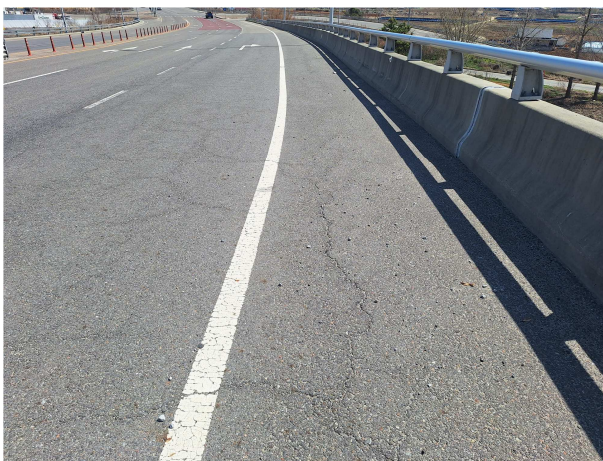
| 07<br>(25년 하반기) | 웅벽 상부 도로 포장 균열 | 07<br>(26년 상반기) | 웅벽 상부 도로 포장 균열 |

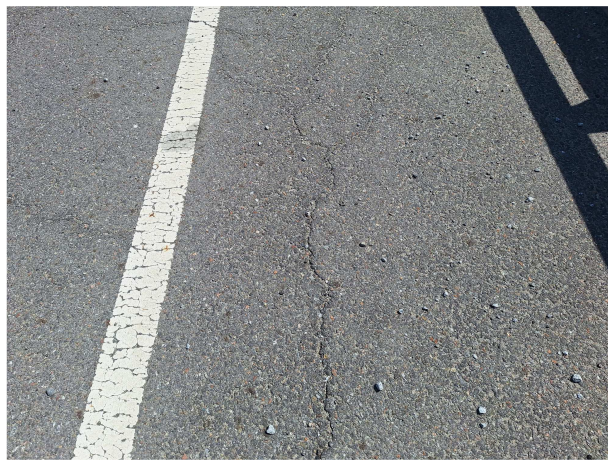
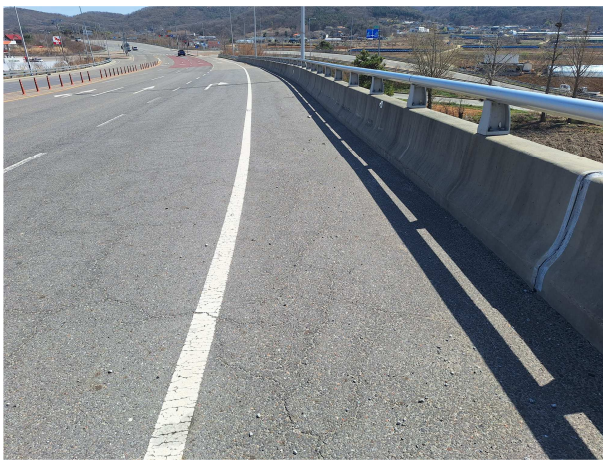
| 07<br>(26년 상반기) | 웅벽 상부 도로 포장 균열 | 07<br>(26년 상반기) | 웅벽 상부 도로 포장 균열 |

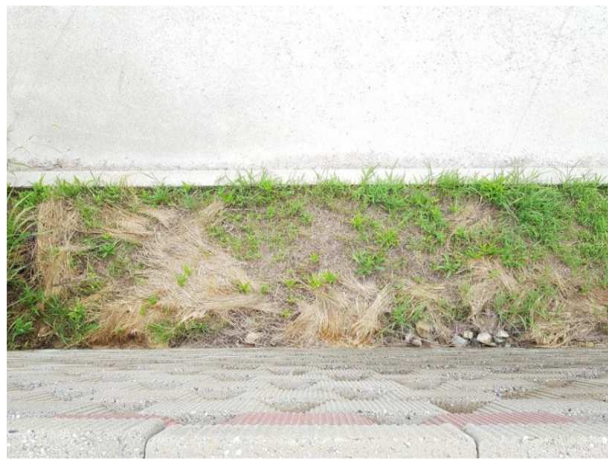
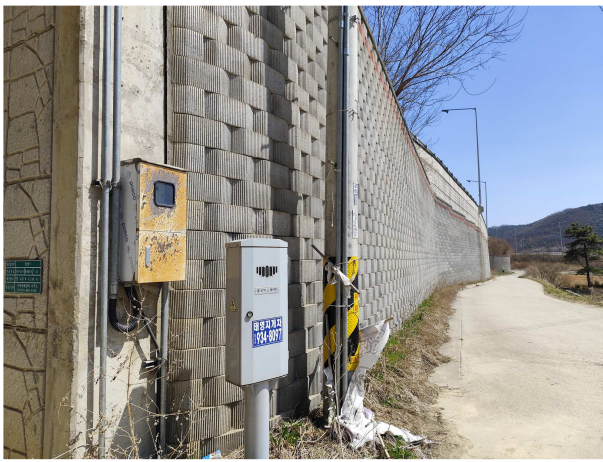
| 08<br>(25년 하반기) | 기초, 지반부 상태양호 | 08<br>(26년 상반기) | 기초, 지반부 상태양호 |
