## 26. 신봉교

## 손상현황

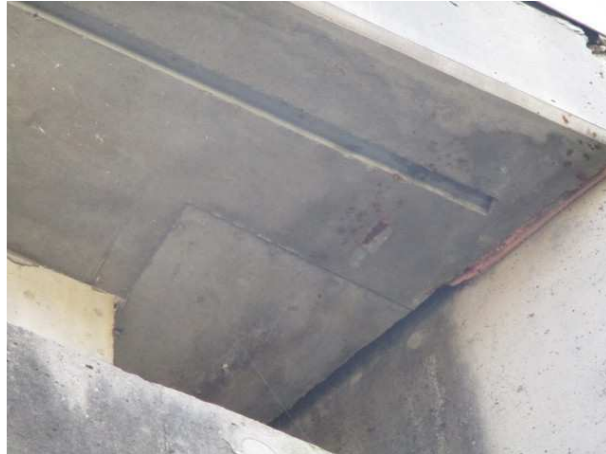
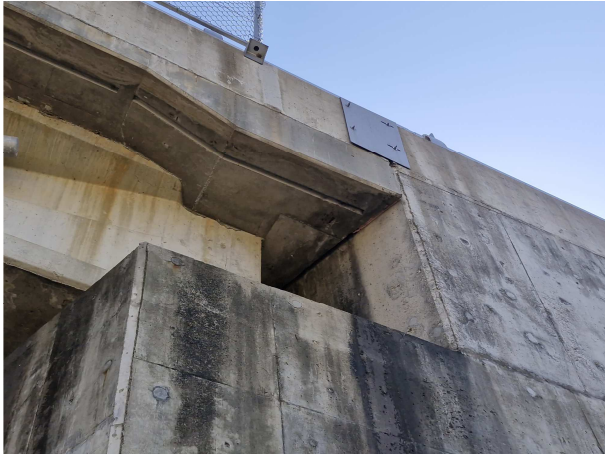
| 01<br>(25년 하반기) | 바닥판 하면<br>철근노출 | 01<br>(26년 상반기) | 바닥판 하면<br>철근노출 |

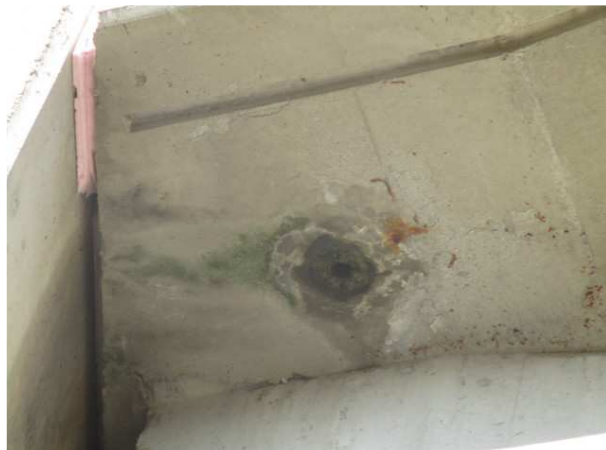
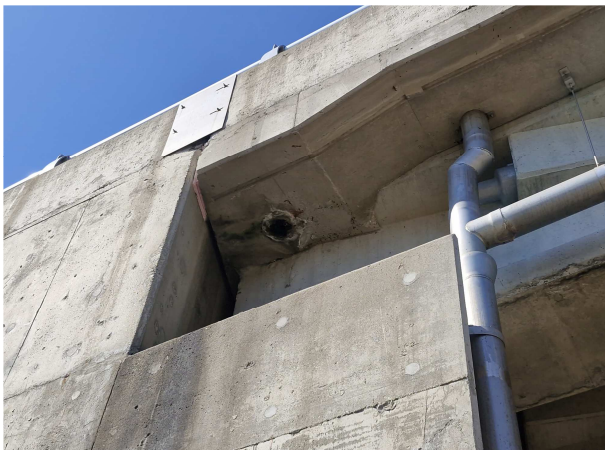
| 02<br>(25년 하반기) | 바닥판 하면<br>백태, 유공관 길이부족 | 02<br>(26년 상반기) | 바닥판 하면<br>백태, 유공관 길이부족 |

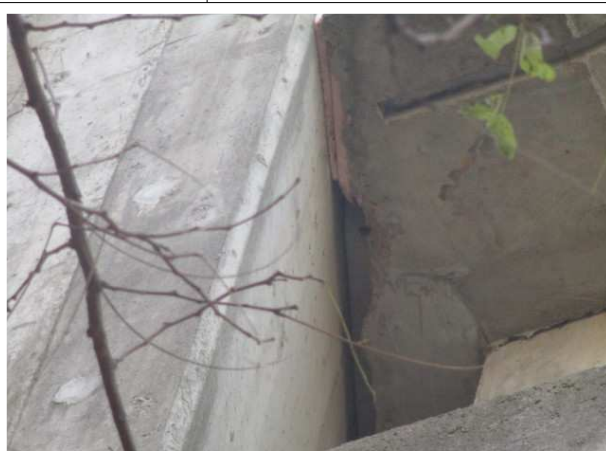
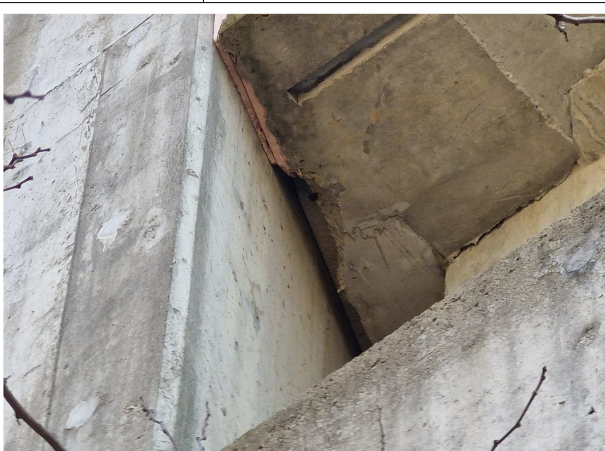
| 03<br>(25년 하반기) | 바닥판 하면<br>박락 | 03<br>(26년 상반기) | 바닥판 하면<br>박락 |

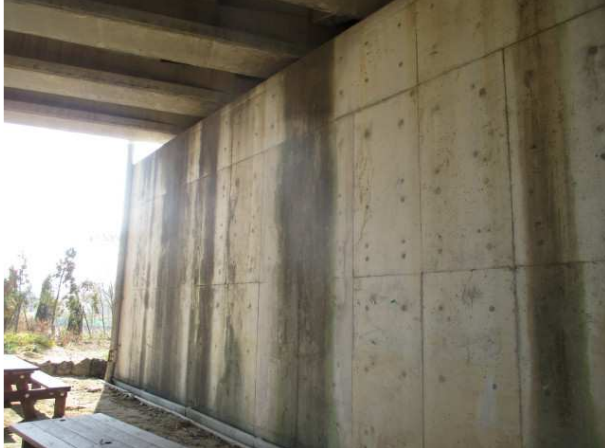
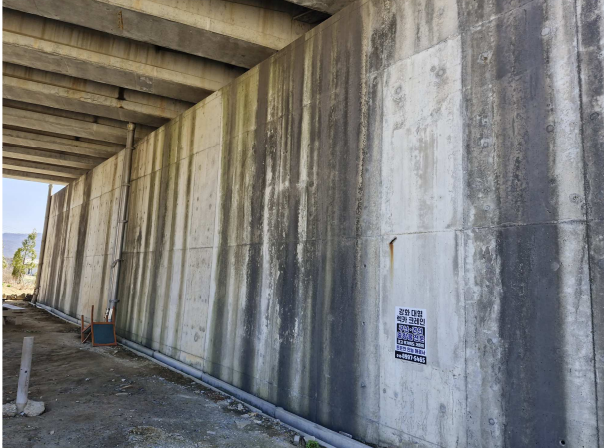
| 04<br>(25년 하반기) | 교대<br>누수오염 | 04<br>(26년 상반기) | 교대<br>누수오염 |

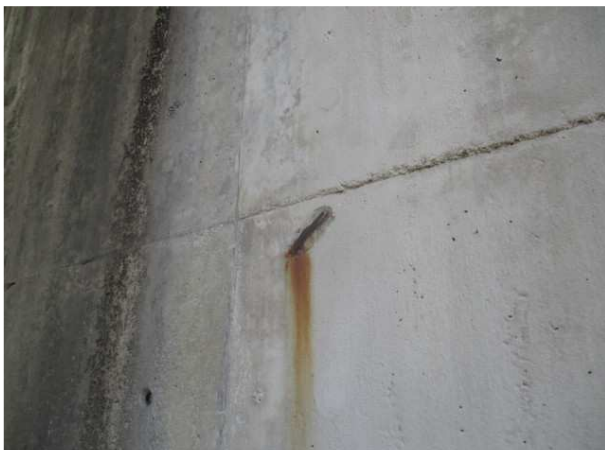
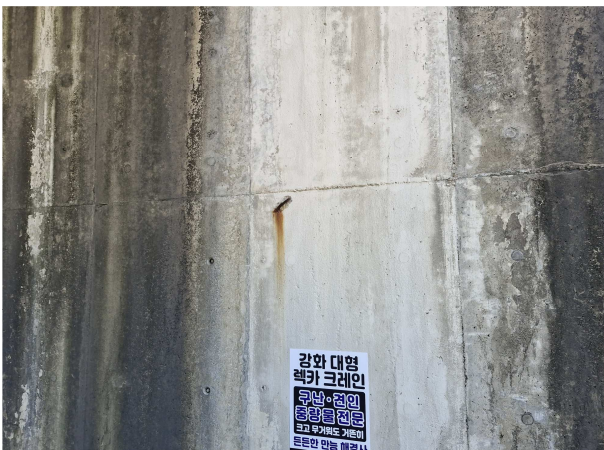
| 05<br>(25년 하반기) | 교대<br>잡철근 노출 | 05<br>(26년 상반기) | 교대<br>잡철근 노출 |

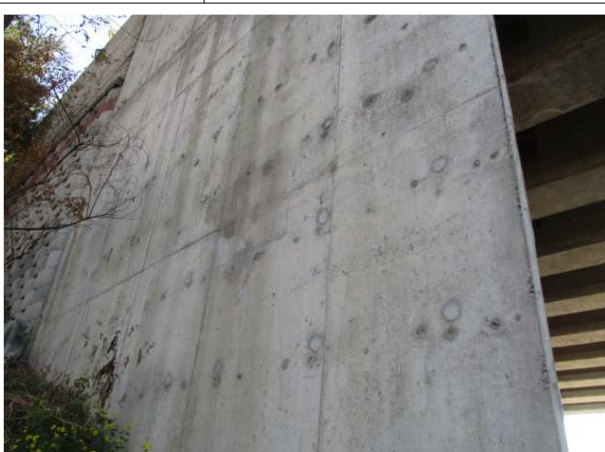
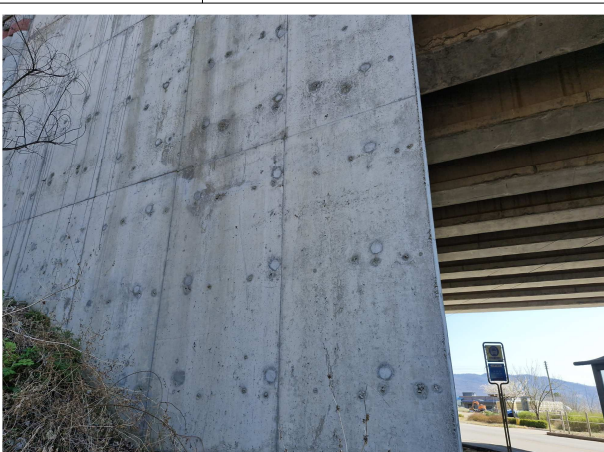
| 06<br>(25년 하반기) | 교대<br>망상균열(0.3mm미만) | 06<br>(26년 상반기) | 교대<br>망상균열(0.3mm미만) |

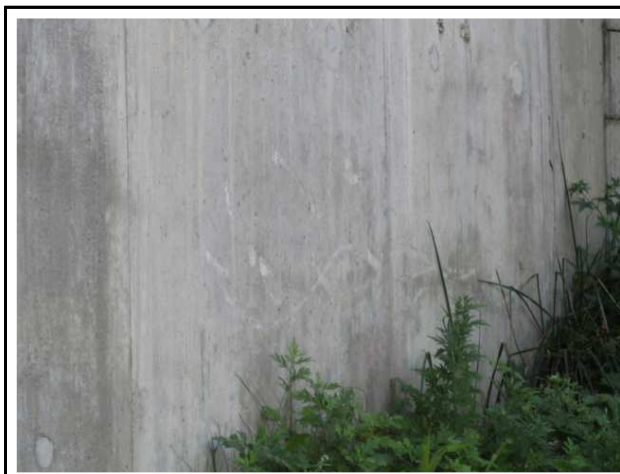
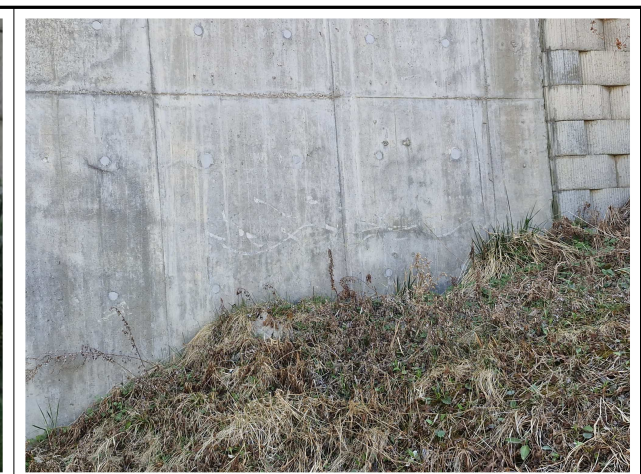
| 07<br>(25년 하반기) | 07<br>(26년 상반기) |

| 교대<br>실란트 갈라짐 | 교대<br>실란트 갈라짐 |

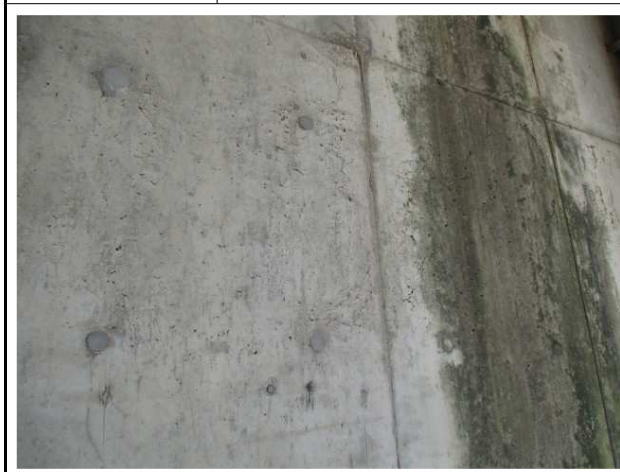
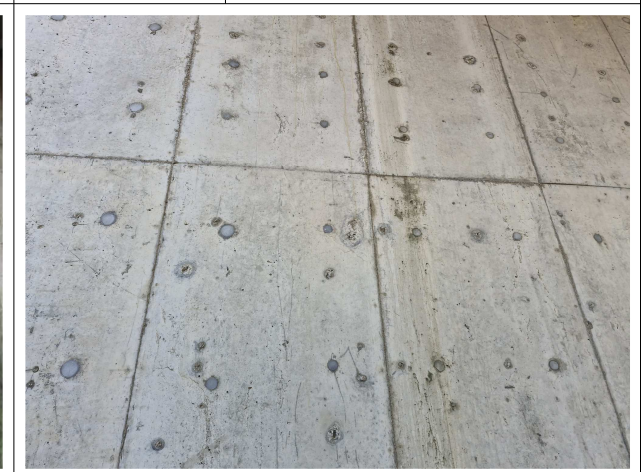
| 08<br>(25년 하반기) | 08<br>(26년 상반기) |

| 교대<br>균열 (0.3mm미만) | 교대<br>균열 (0.3mm미만) |

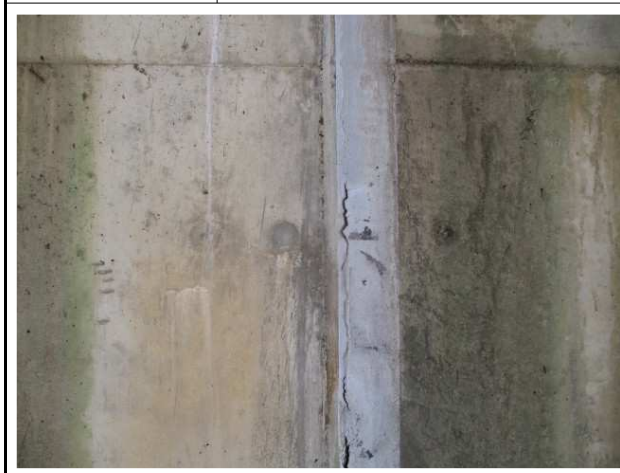
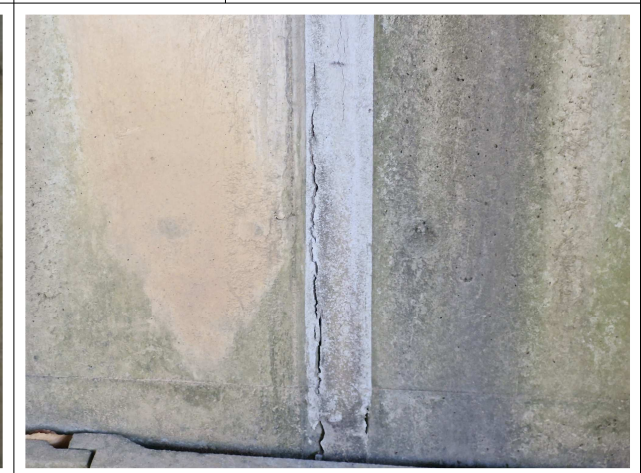
| 09<br>(25년 하반기) | 09<br>(26년 상반기) |

| 교대<br>균열 (0.3mm미만) | 교대<br>균열 (0.3mm미만) |

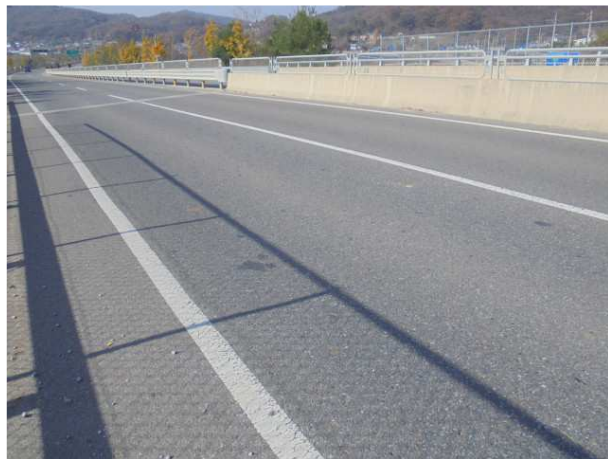
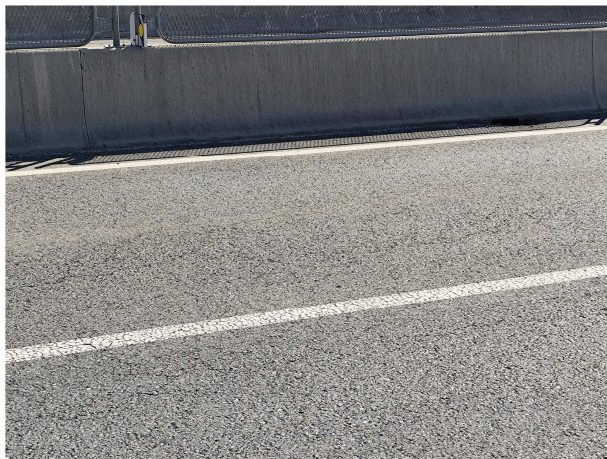
| 13<br>(25년 하반기) | 교면포장<br>아스콘 망상균열 | 13<br>(26년 상반기) | 교면포장<br>아스콘 망상균열 |

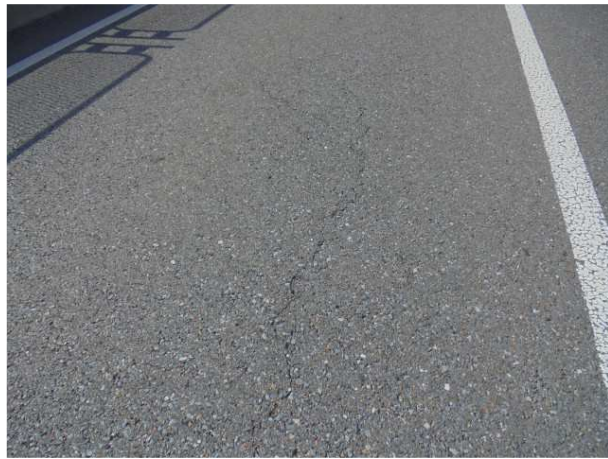
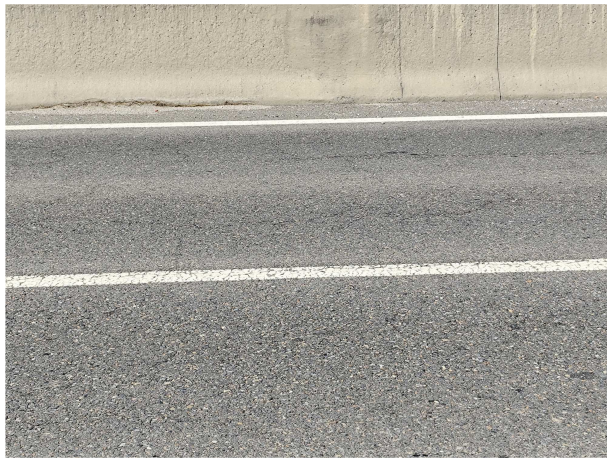
| 14<br>(25년 하반기) | 교면포장<br>아스콘 균열 | 14<br>(26년 상반기) | 교면포장<br>아스콘 균열 |

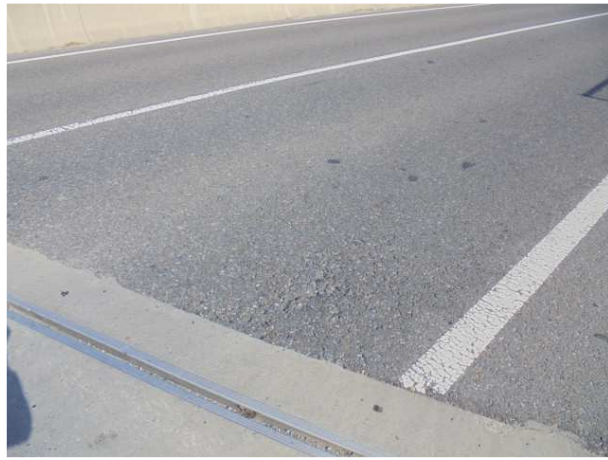
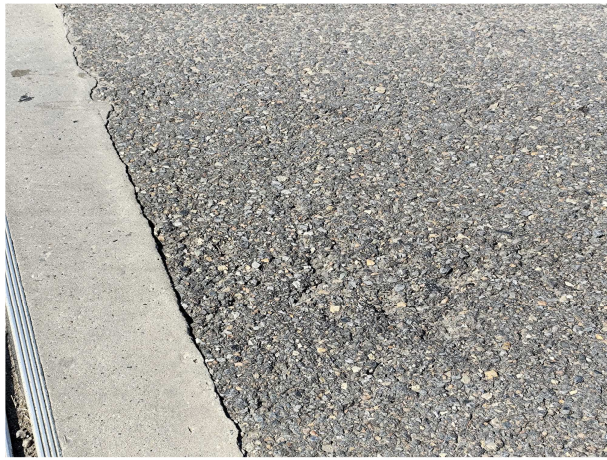
| 15<br>(25년 하반기) | 교면포장<br>아스콘 패임 | 15<br>(26년 상반기) | 교면포장<br>아스콘 패임 |

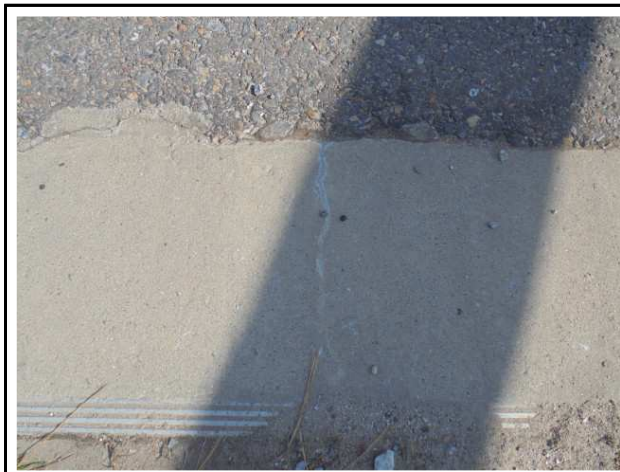
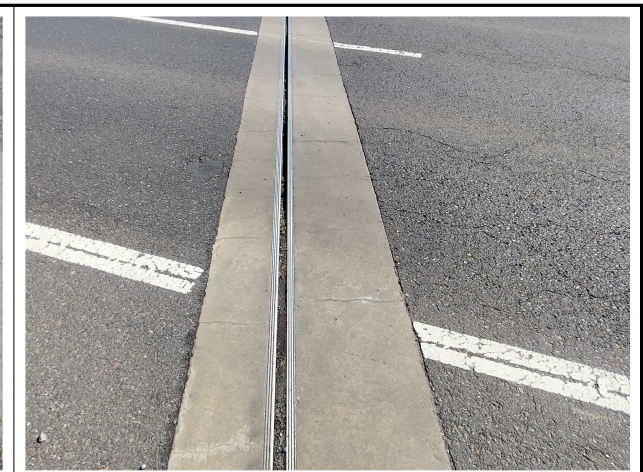
| <div>16</div> <div>(25년 하반기)</div> | <div>16</div> <div>(26년 상반기)</div> |

| <div>신축이음</div> <div>후타재 균열 (0.3mm미만)</div> | <div>신축이음</div> <div>후타재 균열 (0.3mm미만)</div> |

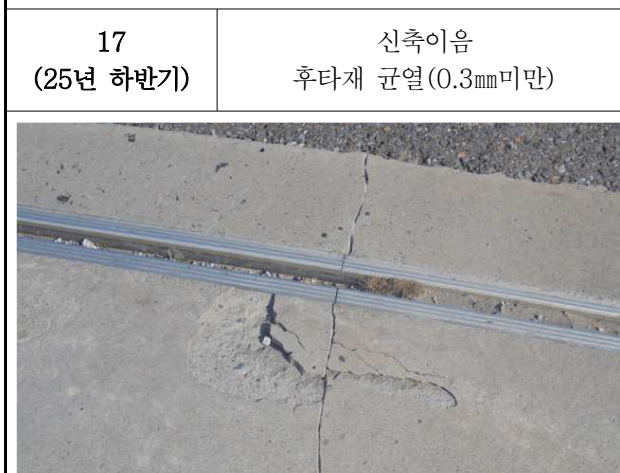
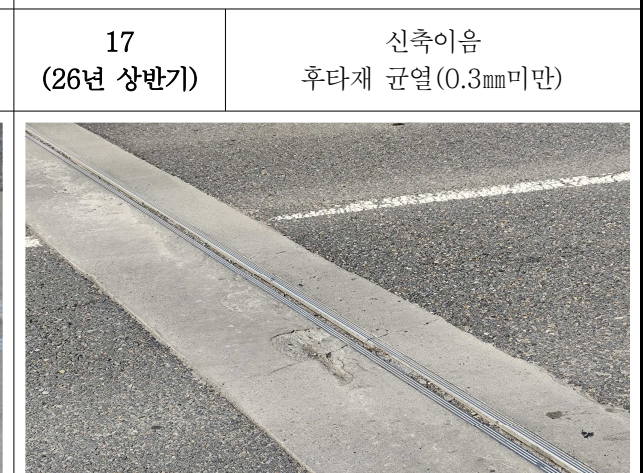
| <div>17</div> <div>(25년 하반기)</div> | <div>17</div> <div>(26년 상반기)</div> |

| <div>신축이음</div> <div>후타재 균열 (0.3mm미만)</div> | <div>신축이음</div> <div>후타재 균열 (0.3mm미만)</div> |

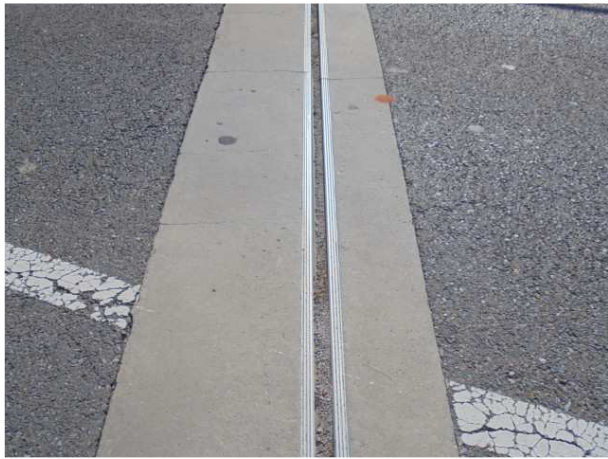
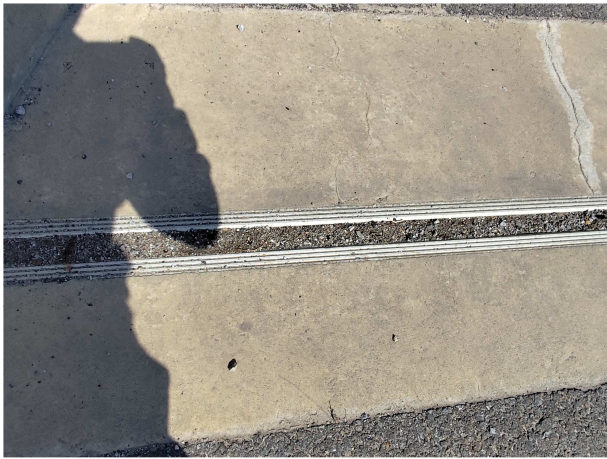
| <div>19</div> <div>(25년 하반기)</div> | <div>19</div> <div>(26년 상반기)</div> |

신축이음  
유간 토사퇴적

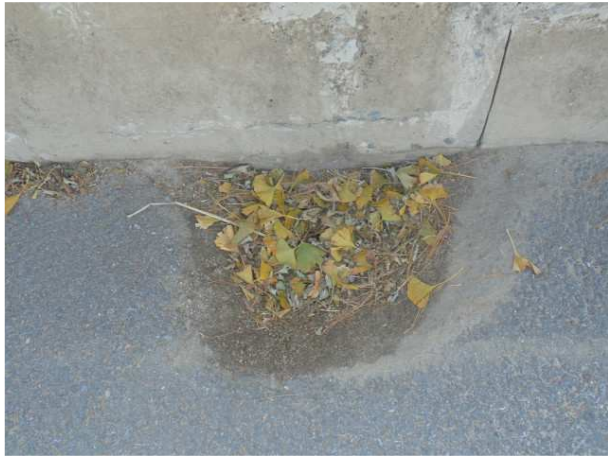
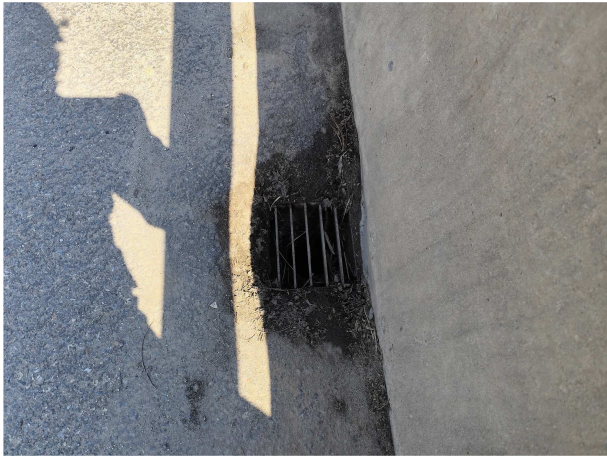
| <div>20</div> <div>(25년 하반기)</div> | <div>20</div> <div>(26년 상반기)</div> |

배수시설  
배수구 막힘

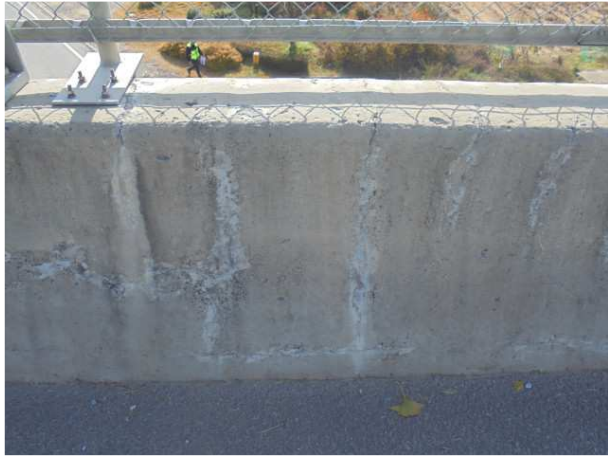
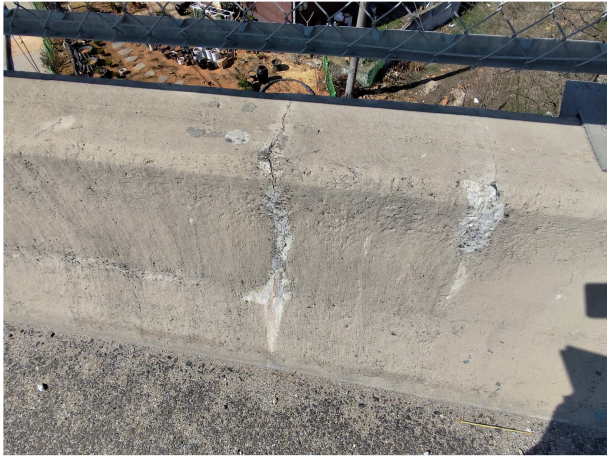
| <div>21</div> <div>(25년 하반기)</div> | <div>21</div> <div>(26년 상반기)</div> |

방호벽  
균열 (0.3mm미만)

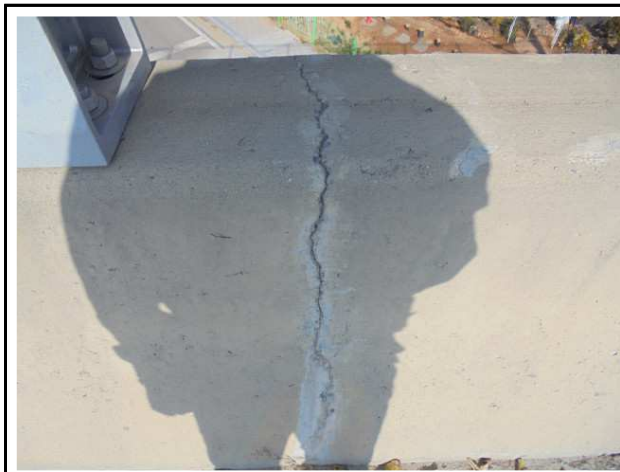
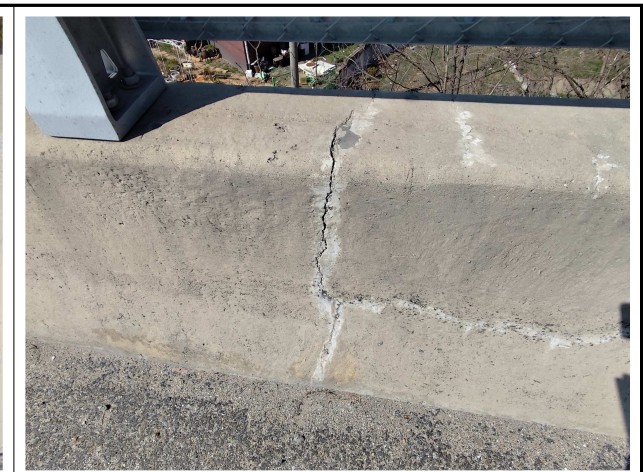
| 22<br>(25년 하반기) | 22<br>(26년 상반기) |

| 방호벽<br>균열 (0.3mm 이상) | 방호벽<br>균열 (0.3mm 이상) |
