대구 동부순환도로 (주)

2022년도 하반기 정기안전점검 기술용역

연호고가교

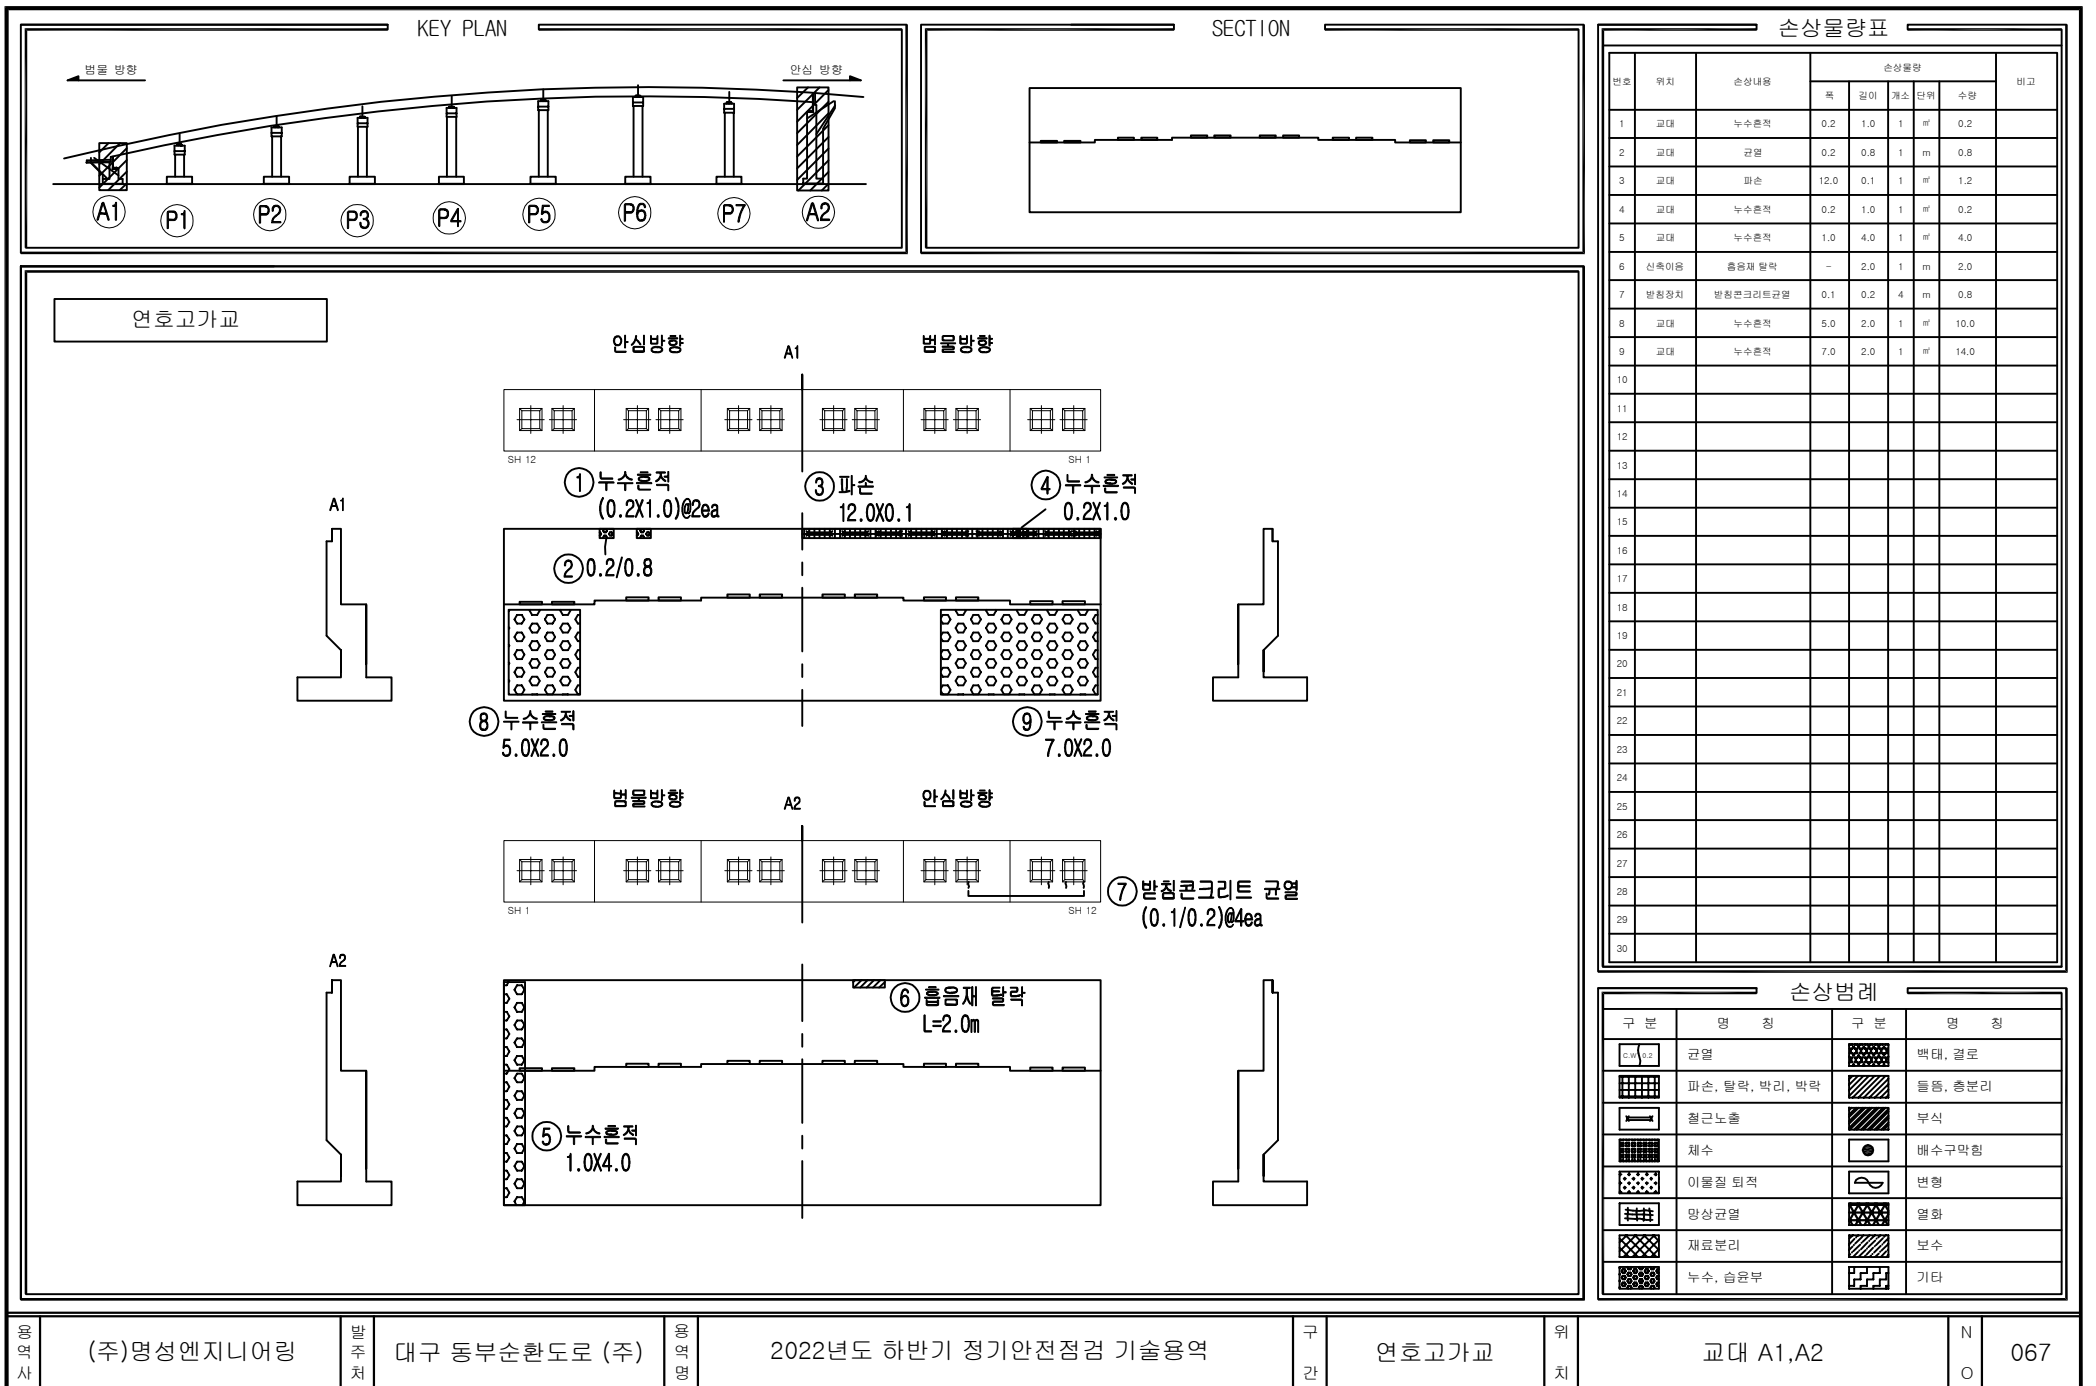
교대 A1,A2

| 번호 | 위치 | 손상내용 | 손상물량 | | | | | 비고 |
|---|---|---|---|---|---|---|---|---|
| 1 | 교대 | 누수흔적 | 0.2 | 1.0 | 1 | ㎡ | 0.2 | |
| 2 | 교대 | 균열 | 0.2 | 0.8 | 1 | m | 0.8 | |
| 3 | 교대 | 파손 | 12.0 | 0.1 | 1 | ㎡ | 1.2 | |
| 4 | 교대 | 누수흔적 | 0.2 | 1.0 | 1 | ㎡ | 0.2 | |
| 5 | 교대 | 누수흔적 | 1.0 | 4.0 | 1 | ㎡ | 4.0 | |
| 6 | 선속이음 | 흙음재 탈락 | - | 2.0 | 1 | m | 2.0 | |
| 7 | 방청장치 | 방청콘크리트균열 | 0.1 | 0.2 | 4 | m | 0.8 | |
| 8 | 교대 | 누수흔적 | 5.0 | 2.0 | 1 | ㎡ | 10.0 | |
| 9 | 교대 | 누수흔적 | 7.0 | 2.0 | 1 | ㎡ | 14.0 | |
