### 손상물량표

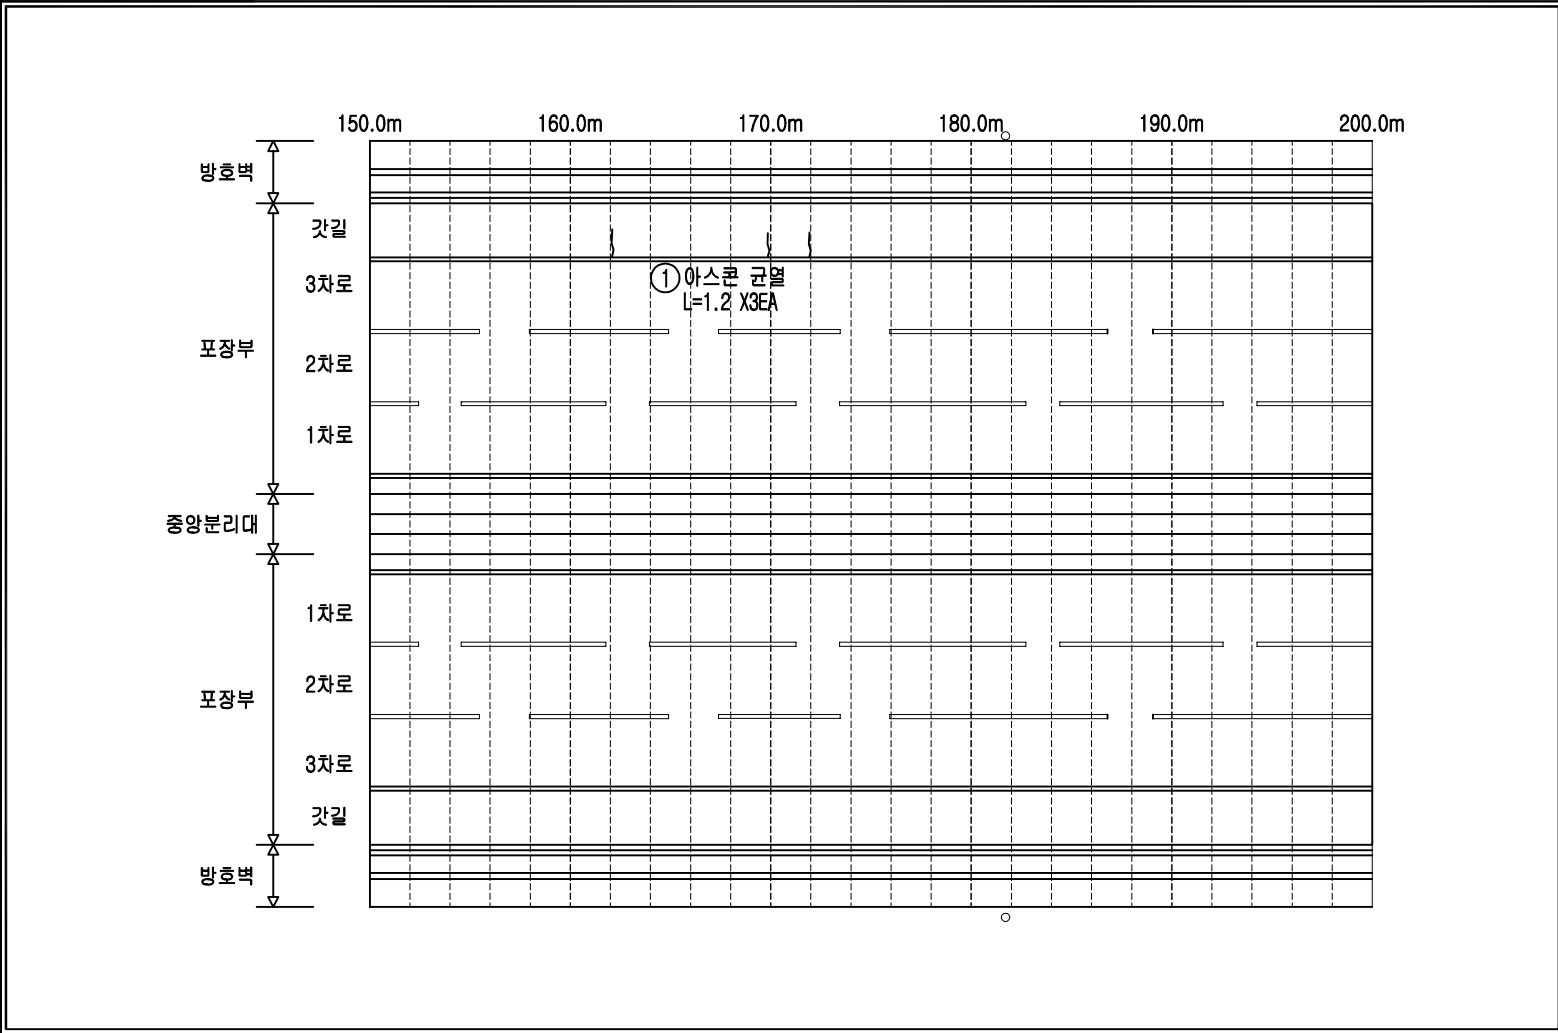
| 번 | 위치 | 손상내용 | 손상물량 | | | | | 비고 |
|---|---|---|---|---|---|---|---|---|
| 1 | 포장부 | 아스콘 균열 | - | 1.2 | 3 | m | 3.60 | |
