## **4. 보강토옹벽**

**[지선 STA.0+321~0+680]**

## 4. 보강토옹벽(지선 STA.0+321~0+680)

본 시설물은 경기도 고양시 덕양구 현천동 대덕로101번길 16에 위치한 2중 시설물로서 연장 355.0m, 지면노출높이 9.6m의 블록식 보강토옹벽이다.

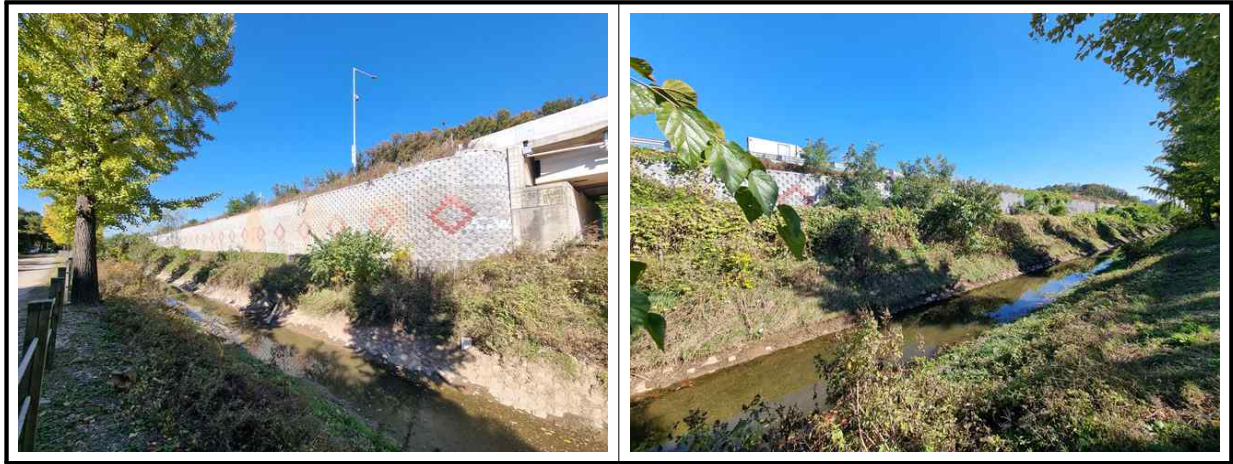
【그림 4.3.1】 지반, 기초부 전경

본 옹벽은 포장(아스콘), 비포장, 하천이 혼합된 상태로 세굴, 침하, 유실, 옹벽밀립 등에 대해 면밀한 조사를 실시하였으며, 주요 손상 및 조사결과는 다음과 같다.

- 보강토옹벽에 대한 현장조사 결과, 침하, 활동, 전도 등 구조적인 손상결함 및 세굴이 없는 양호한 상태로 조사되었다.

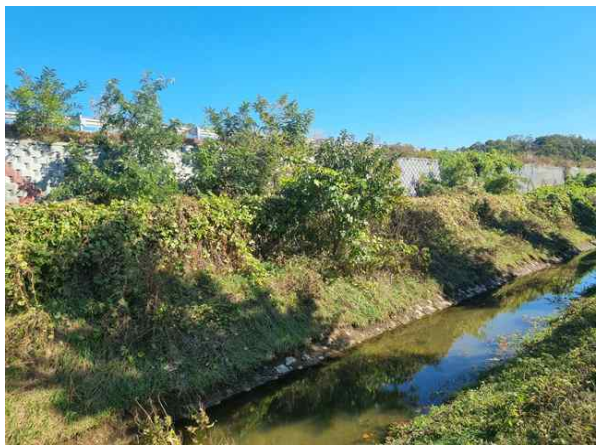
| 현 황 | • 상태양호 | 현 황 | • 상태양호 |
| 원 인 | • — | 원 인 | • — |

- 보강토옹벽의 현장조사 결과 손상이 없는 상태로 확인되었고, 침하, 활동, 전도 등 구조적인 손상결함 및 세굴이 없는 양호한 상태로 신규 손상 등은 조사되지 않았으나 주기적인 점검을 통하여 지반, 기초부의 손상발생 여부 확인 등의 유지관리가 필요할 것으로 사료된다.

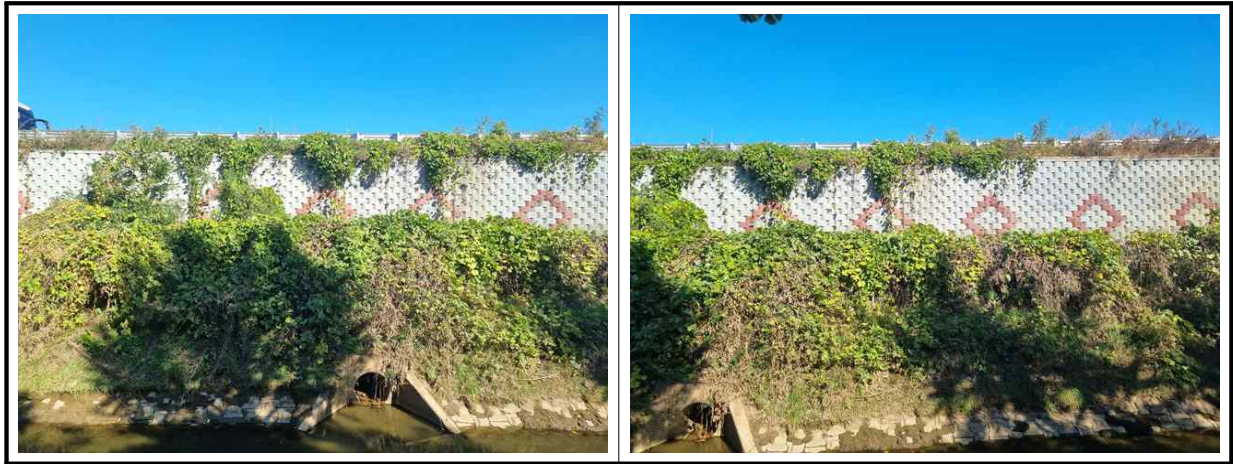
【그림 4.3.2】 전면부 전경

블럭식 보강토옹벽으로 블록의 파손 및 손상, 균열, 유실, 이격 등에 대해 면밀한 조사를 실시하였다. 보강토 옹벽은 1단으로 구성되어 있고, 시공이음부 및 이질재접합부(콘크리트)는 없는 단일 구조체로 연속화되어 시공되어 있는 상태이며, 주요 손상 및 조사결과는 다음과 같다.

- 현장조사 결과, 전면부 블록에 블록 박리, 블록 균열이 조사되었으나, 구조적인 손상결함 또한 발생하지 않은 것으로 확인되었다.

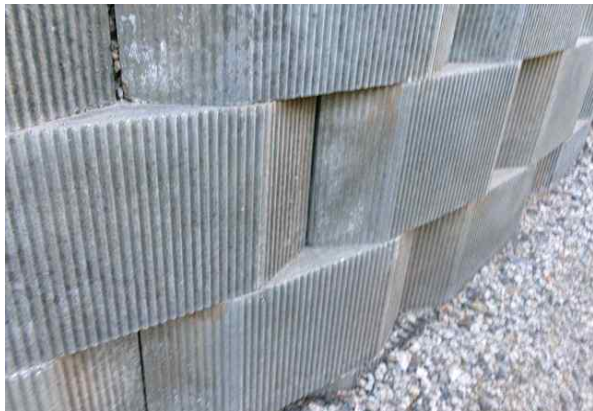
| 위 치 | 손상명 | 폭(mm) | 길이(m) | 너비(m) | 단위 | 개소 | 손상<br>물량 | 비고 |
|---|---|---|---|---|---|---|---|---|
| S17 | 블록 균열 | — | 0.3 | — | m | 3 | 0.90 | — |

| 현 황 | • S17 블록 균열 | 현 황 | • S18 블록 박리 |
| 원 인 | • 시공미흡 | 원 인 | • 시공미흡 |

| 대 책 | • 균열보수 | 대 책 | • 단면보수 |

- 보강토옹벽의 현장조사 결과 전면부 블록에 시공미흡으로 인한 블록 박리, 블록 균열 등의 손상이 확인되었고, 구조적인 손상결함 또한 발생하지 않은 것으로 확인되었으나 발생한 손상에 대하여 균열보수, 단면보수 등의 적절한 보수를 실시하고 주기적인 점검을 통하여 전면부의 신규손상 및 재손상의 발생 여부를 확인 등의 유지관리가 필요할 것으로 사료된다.

| 구 분 | 중점유지관리 사항 | 현황 사진 |
|---|---|---|
| 전<br>면<br>부 | <ul style="list-style-type: none"> <li>발생한 블록 균열의 경우 시공미흡에 의한 손상으로 판단되며, 본 손상에 대하여 균열보수 등의 적절한 보수를 실시하고 재손상 발생여부를 확인하는 유지관리가 필요</li> </ul> | |

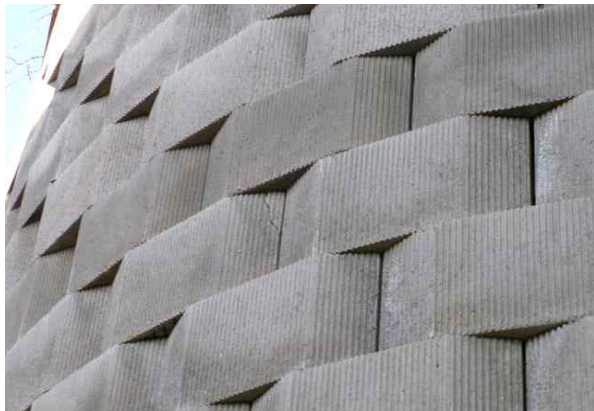
| 위 치 | 손상명 | 폭(mm) | 길이(m) | 너비(m) | 단위 | 개소 | 손상<br>물량 | 비고 |
|---|---|---|---|---|---|---|---|---|
| S18 | 블록 박리 | — | 0.3 | 0.2 | m <sup>2</sup> | 1 | 0.06 | — |

| 구 분 | 중점유지관리 사항 | 현황 사진 |
|---|---|---|
| | <ul style="list-style-type: none"> <li>발생한 블록 박리의 경우 시공미흡에 의한 손상으로 판단되며, 본 손상에 대하여 단면보수 등의 적절한 보수를 실시하고 재손상 발생여부를 확인하는 유지관리가 필요</li> </ul> | |

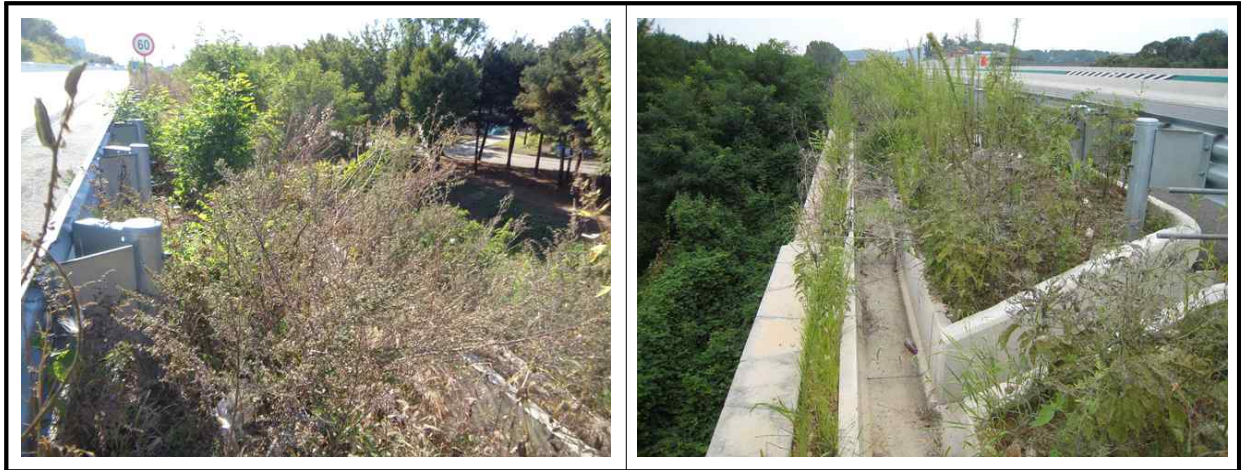
【그림 4.3.3】 주변영향인자 전경

보강토 옹벽 내의 배수시설을 확인한 결과, 옹벽 상단부에는 배수로(측구)가 설치되어 있으며, 상단의 토공 경사면에서 배출되는 지표수 등을 원활하게 배수토록 설치되어 있는 상태이다. 상단의 배수로는 옹벽의 시점 및 종점부의 측구로 시공되어 있는 상태이다.

- 보강토옹벽에 대한 현장조사 결과, 옹벽 상부 배수로, 전면부 배수관에 별도의 손상은 조사되지 않았으며, 상부성토부에도 성토부 내의 침식, 유실 등의 손상이 없는 상태이나 옹벽 내부 충전물 유실이 확인되었다.

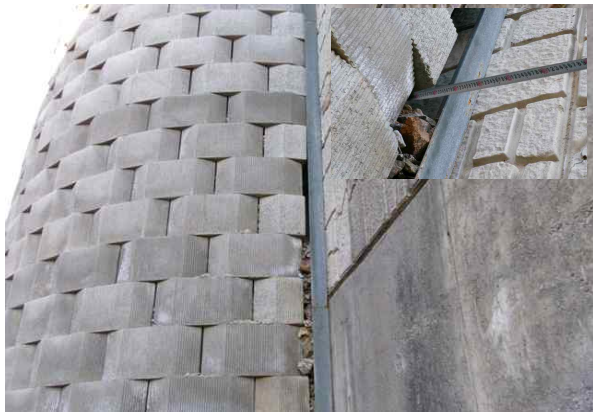
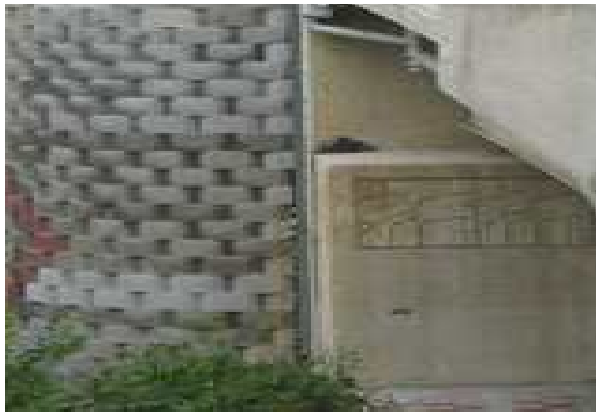
| 위 치 | 손상명 | 폭(㎜) | 길이(m) | 너비(m) | 단위 | 개소 | 손상<br>물량 | 비고 |
|---|---|---|---|---|---|---|---|---|
| S18 | 옹벽 내부<br>충진물 유실 | — | 2.00 | — | m | 1 | 2.00 | T=110.0cm |

| 현 황 | • S18 옹벽 내부 충진물 유실(22년) | 현 황 | • S18 옹벽 내부 충진물 유실(21년) |
| 원 인 | • 시공미흡 | 원 인 | • 시공미흡 |

- 보강토옹벽의 현장조사 결과, 옹벽 상부 배수로(측구)에 별도의 손상은 조사되지 않았으며, 상부성토부에도 성토부 내의 침식, 유실 등의 손상이 없는 상태로 전반적으로 양호한 상태를 유지하고 있는 것으로 조사되었으나 옹벽 종점 교량 접속부측에 옹벽 내부 충전물이 일부 유실된 것으로 확인되었다. 충전물 유실의 경우 옹벽 전면부에 구조적인 균열 및 손상이 발생하지 않은 것으로 보아 시공초기에 교량과 옹벽 사이 마감조치 미흡으로 인한 손상으로 판단되며, 본 손상에 대하여 우수유입 등에 의한 추가적인 충전물 유실 방지를 위하여 뒷채움을 실시하고 적절한 마감조치를 시행후 주기적인 점검을 통한 추가 유실 및 전면부 블록의 유동성 여부를 확인하는 측량 및 육안점검을 실시하는 것이 바람직할 것으로 사료하다.

| 대 책 | • 되메우기 및 마감조치 | 대 책 | • 되메우기 및 마감조치 |

| 구 분 | 중점유지관리 사항 | 현황 사진 |
|---|---|---|
| 성<br>토<br>부 | <ul style="list-style-type: none"> <li>발생한 옹벽 내부 충전물 유실의 경우 옹벽 전면부에 구조적인 균열 및 손상이 발생하지 않은 것으로 보아 시공초기에 교량과 옹벽 사이 마감조치 미흡으로 인한 손상으로 판단되며, 본 손상에 대하여 우수유입 등에 의한 추가적인 충전물 유실 방지를 위하여 뒷채움을 실시하고 적절한 마감조치를 시행후 주기적인 점검을 통한 추가 유실 및 전면부 블록의 유동성 여부를 확인하는 측량 및 육안점검을 실시하는 것이 필요</li> </ul> | |

- 성토부의 옹벽 내부 충전물 유실의 경우 옹벽 전면부에 구조적인 균열 및 손상이 발생하지 않은 것으로 보아 시공초기에 교량과 옹벽 사이 마감조치 미흡으로 인한 손상으로 유추된다. 본 손상부에 우수유입 등 외부 요인에 의한 추가 유실 발생 등의 손상진전을 방지하기 위하여 되메우기를 실시 후 재손상 방지를 위한 적절한 마감조치 대책을 수립하고 주기적인 점검을 통한 추가 유실 및 전면부 블록의 유동성 여부를 확인하는 측량 및 육안점검을 실시하는 것이 바람직할 것으로 사료된다.
- 전면부에 발생한 블록 균열, 블록 박리의 경우 시공미흡에 의한 손상으로 판단되며, 본 손상에 대하여 균열보수, 단면보수 등의 적절한 보수를 실시하고 재손상 발생여부를 확인하는 유지관리가 필요

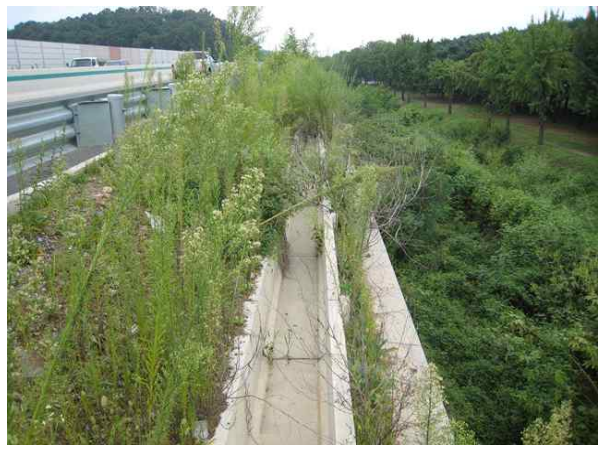
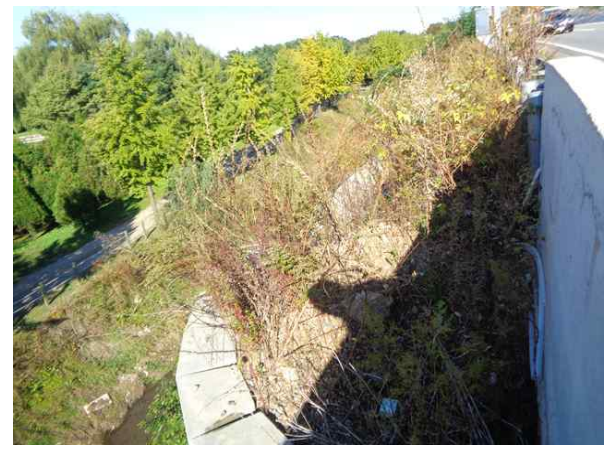
| 현 황 | • 상태양호 | 현 황 | • 상태양호 |
| 원 인 | • - | 원 인 | • - |

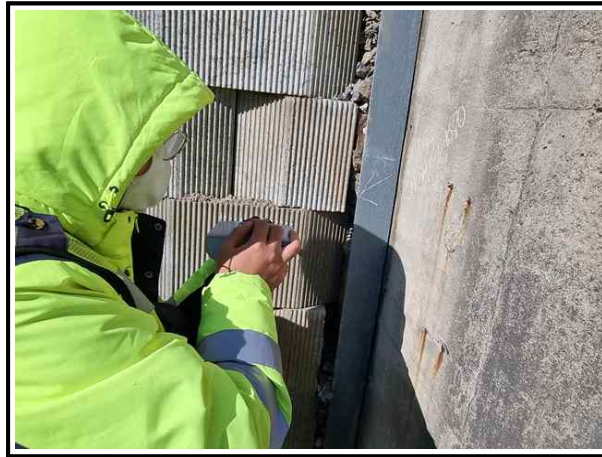
【그림 4.3.6】 슈미트해머를 이용한 반발경도시험 전경

본 용역에서는 대상 구조물의 재료시험은 콘크리트부재(블록)에 대해 콘크리트 압축강도를 파악하기 위하여 반발경도시험으로 시행하였으며, 콘크리트의 품질 및 내구성을 평가하였다.

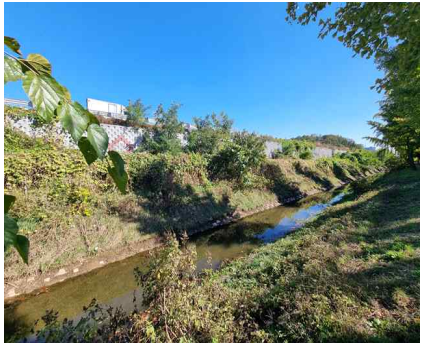
| 구 분 | 중점유지관리 사항 | 현황 사진 |
|---|---|---|
| 기<br>초<br>부 | <ul style="list-style-type: none"> <li>우수에 의한 기초부 침식, 세굴 등의 손상 발생여부를 주기적인 관찰을 통한 확인필요</li> </ul> | |
