## **8. PRN옹벽**

### **[STA.27+049~27+240]**

## 8. PRN옹벽 (STA.27+049~27+240)

본 시설물은 경기도 파주시 월롱면 덕은리 68-9에 위치한 2중 시설물로서 연장 290.0m, 지면 노출높이 9.0m의 블록식 보강토옹벽이다.

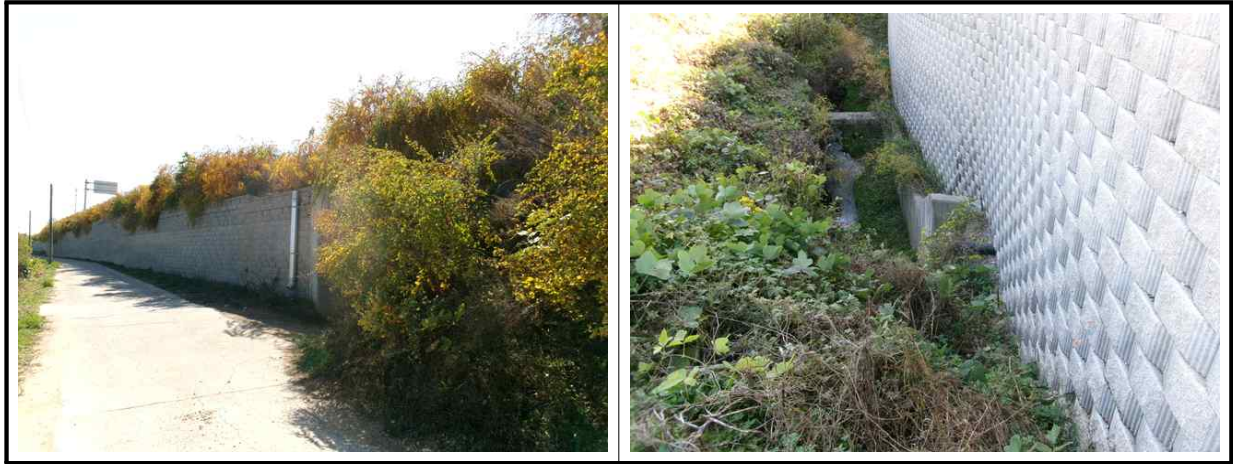
【그림 8.3.1】 지반, 기초부 전경

본 옹벽은 포장(콘크리트), 비포장, 하천이 혼합된 상태로 세굴, 침하, 유실, 옹벽밀림 등에 대해 면밀한 조사를 실시하였으며, 주요 손상 및 조사결과는 다음과 같다.

- 보강토옹벽에 대한 현장조사 결과, 침하, 활동, 전도 등 구조적인 손상결함 및 세굴이 없는 양호한 상태로 조사되었다.

- 보강토옹벽의 현장조사 결과 손상이 없는 상태로 확인되었고, 침하, 활동, 전도 등 구조적인 손상결함 및 세굴이 없는 양호한 상태로 신규 손상 등은 조사되지 않았으나 주기적인 점검을 통하여 지반, 기초부의 손상발생 여부 확인 등의 유지관리가 필요할 것으로 사료된다.

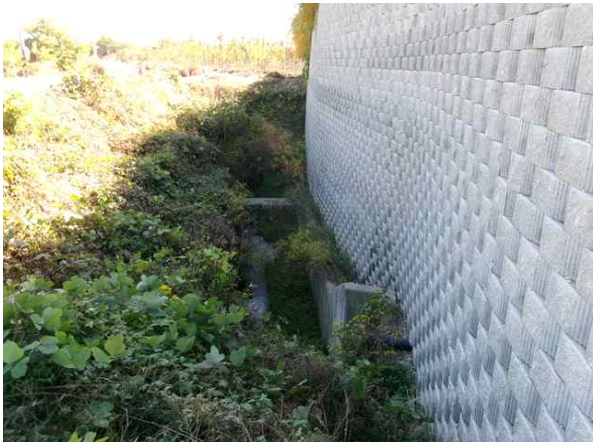
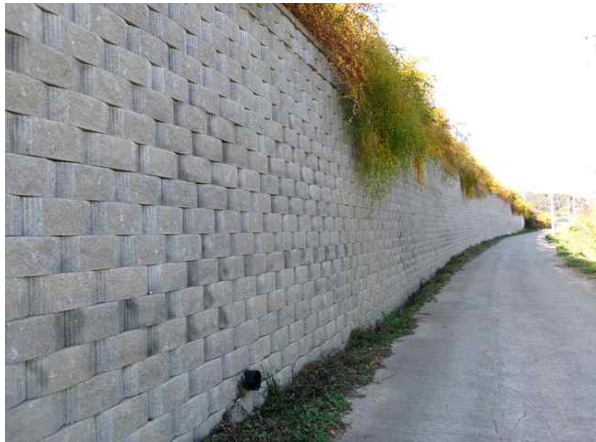
| 현 황 | • 상태양호 | 현 황 | • 상태양호 |
| 원 인 | • — | 원 인 | • — |

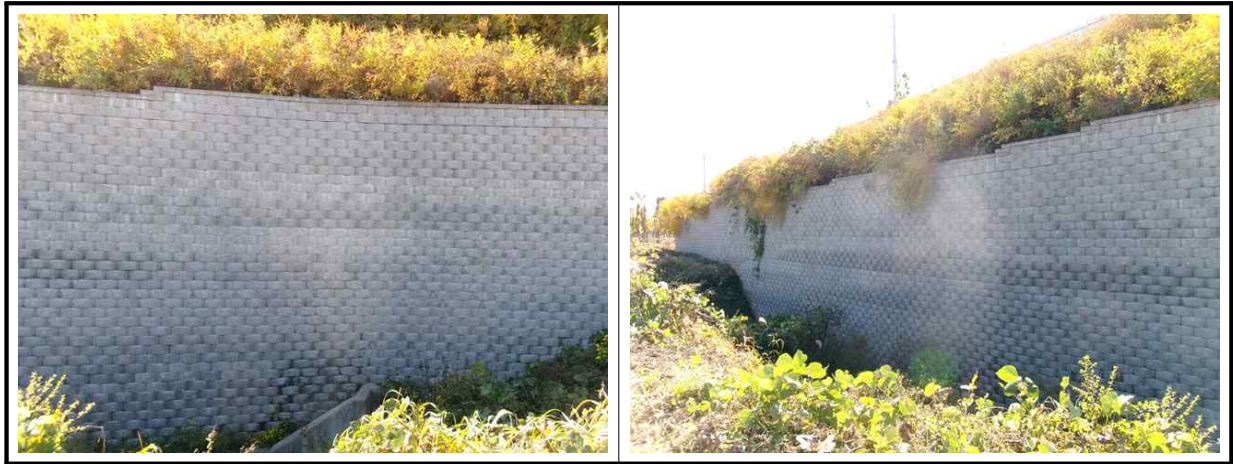
【그림 8.3.2】 전면부 전경

블럭식 보강토옹벽으로 블록의 파손 및 손상, 균열, 유실, 이격 등에 대해 면밀한 조사를 실시하였다. 보강토 옹벽은 1단으로 구성되어 있고, 시공이음부 및 이질재접합부(콘크리트)는 없는 단일 구조체로 연속화되어 시공되어 있는 상태이며, 주요 손상 및 조사결과는 다음과 같다.

- 현장조사 결과, 전면부 블록은 손상이 없는 양호한 상태로 조사되었으며, 구조적인 손상결함 또한 발생하지 않은 것으로 확인되었다.

- 보강토옹벽의 현장조사 결과 전면부 블록은 손상이 없는 상태로 확인되었고, 구조적인 손상결함 또한 발생하지 않은 것으로 확인되었으나 주기적인 점검을 통하여 전면부의 손상발생 여부 확인 등의 유지관리가 필요할 것으로 사료된다.

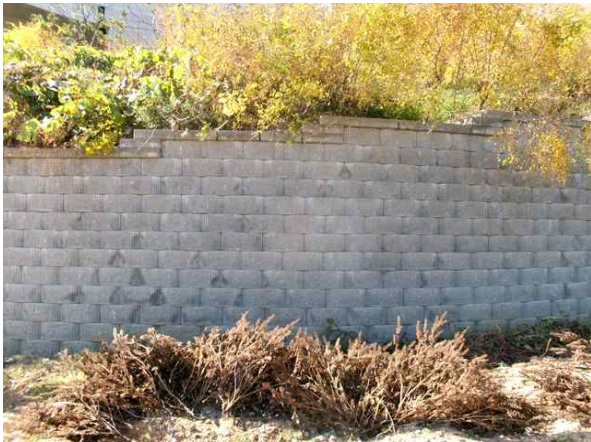
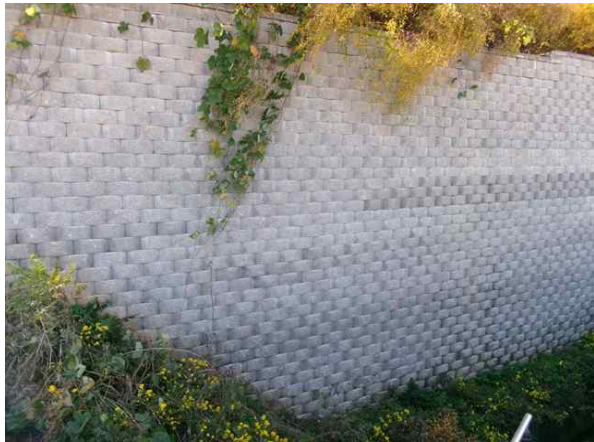
| 현 황 | • 상태양호 | 현 황 | • 상태양호 |
| 원 인 | • — | 원 인 | • — |

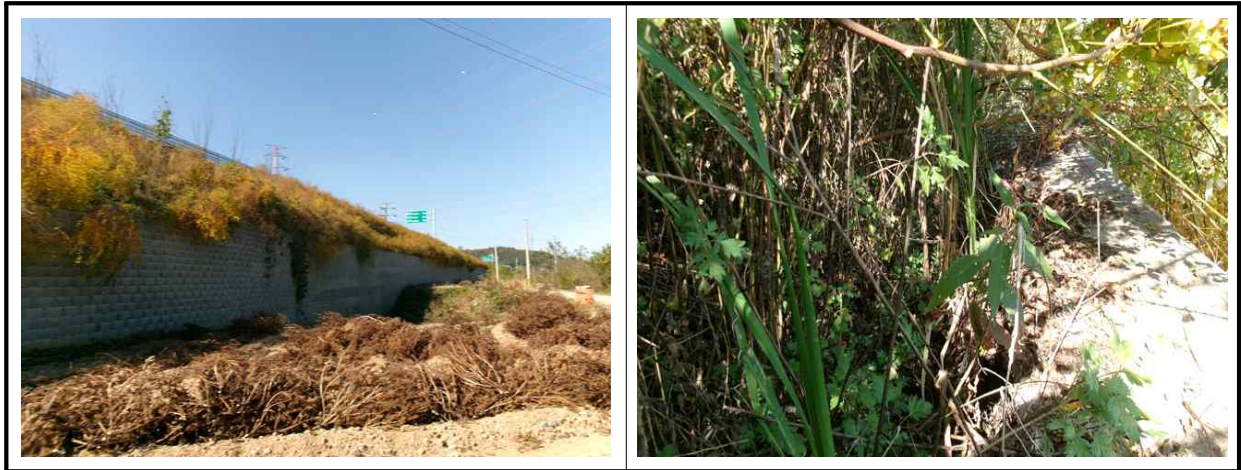
【그림 8.3.3】 주변영향인자 전경

보강토 옹벽 내의 배수시설을 확인한 결과, 옹벽 상단부에는 배수로(측구)가 설치되어 있으며, 상단의 토공 경사면에서 배출되는 지표수 등을 원활하게 배수토록 설치되어 있는 상태이다. 상단의 배수로는 옹벽의 시점 및 종점부의 측구로 시공되어 있는 상태이다.

- 보강토옹벽에 대한 현장조사 결과, 옹벽 상부 배수로, 전면부 배수관에 별도의 손상은 조사되지 않았으며, 상부성토부에도 성토부 내의 침식, 유실 등의 손상이 없는 상태로 전반적으로 양호한 상태를 유지하고 있는 것으로 조사되었다.

- 보강토옹벽의 현장조사 결과, 옹벽 상부 배수로(측구)에 별도의 손상은 조사되지 않았으며, 상부성토부에도 성토부 내의 침식, 유실 등의 손상이 없는 상태로 전반적으로 양호한 상태를 유지하고 있는 것으로 조사되었으나 원활한 유지관리를 위하여 배수로 인근 정비를 실시하고, 주기적인 점검을 통하여 전면부의 손상발생 여부 확인 등의 유지관리가 필요할 것으로 사료 된다.

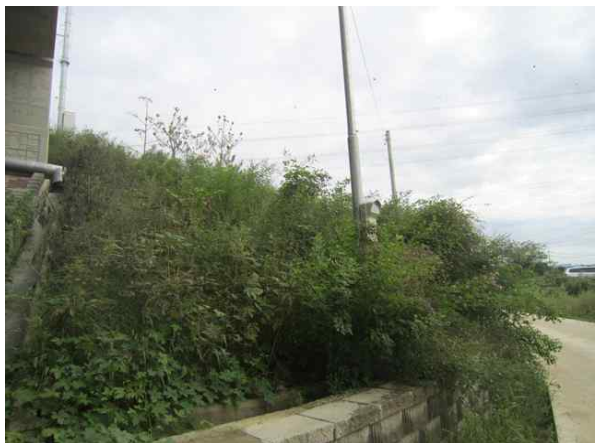
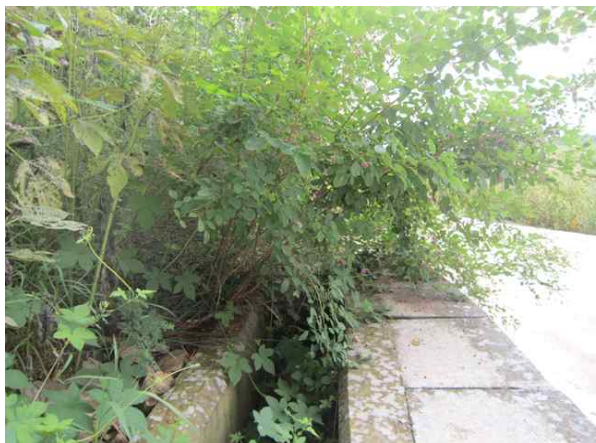
| 현 황 | • 상태양호 | 현 황 | • 상태양호 |
| 원 인 | • — | 원 인 | • — |

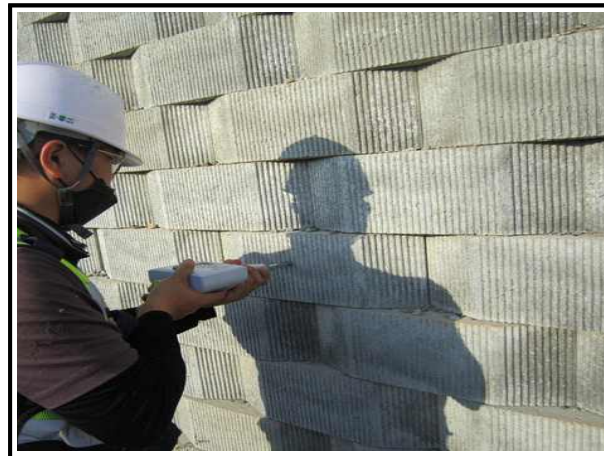
【그림 8.3.7】 슈미트해머를 이용한 반발경도시험 전경

본 용역에서는 대상 구조물의 재료시험은 콘크리트부재(블록)에 대해 콘크리트 압축강도를 파악하기 위하여 반발경도시험으로 시행하였으며, 콘크리트의 품질 및 내구성을 평가하였다.

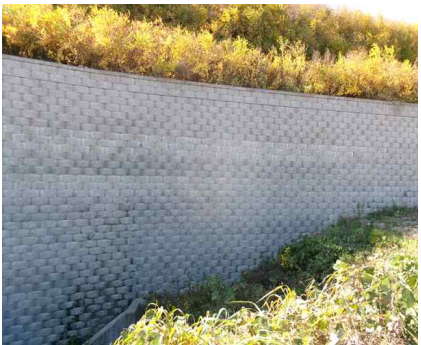
| 구 분 | 중점유지관리 사항 | 현황 사진 |
|---|---|---|
| 전<br>면<br>부 | <ul style="list-style-type: none"> <li>균열 및 파손, 배부름 발생에 대한 주기적인 점검을 통해 발생규모 및 현황관리를 실시하고, 일정규모 이상 발생할 경우 보수를 통한 관리 필요</li> </ul> | |

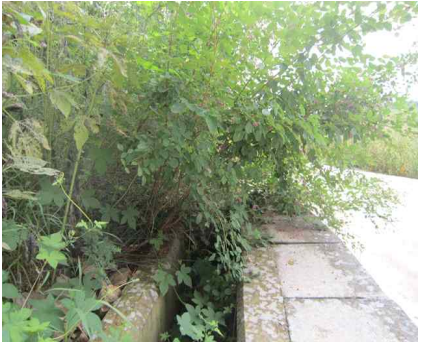
| 구 분 | 중점유지관리 사항 | 현황 사진 |
|---|---|---|
| 배<br>수<br>시<br>설 | <ul style="list-style-type: none"> <li>배수로에 발생하는 토사퇴적의 경우 장기공용, 우수 등에 의한 손상으로 원활한 배수를 위해 주기적인 정비를 통한 관리 필요</li> </ul> | |

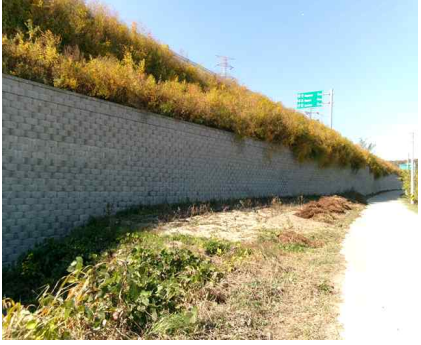
| 구 분 | 중점유지관리 사항 | 현황 사진 |
|---|---|---|
| 성<br>토<br>부 | <ul style="list-style-type: none"> <li>우수 및 동결융해에 의한 지하수 침투, 식생유실 발생여부를 주기적인 관찰을 통한 확인필요</li> </ul> | |

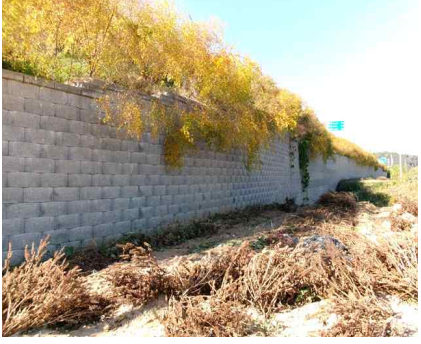
| 구 분 | 중점유지관리 사항 | 현황 사진 |
|---|---|---|
| 기<br>초<br>부 | <ul style="list-style-type: none"> <li>우수에 의한 기초부 침식, 세굴 등의 손상 발생여부를 주기적인 관찰을 통한 확인필요</li> </ul> | |
