| CW/0.2 | 균열 | | | 용역명 | 2024년 국도3호선 기타시설물<br>진압2교 등 31개소 정기안전점검 용역 |
| | 파손, 탈락 | | | 구조물명 | 백록육교 |

ID : 바닥판 하면 (S1) 외관조사망도

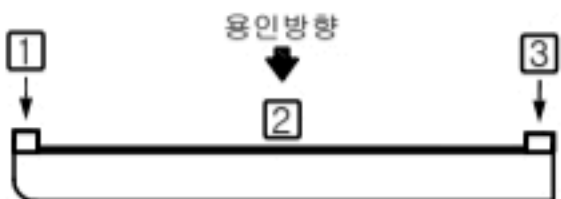
② 연석 균열  
0.3/0.75, 8EA

① 토사회적  
10.0X0.5

③ 중분대 균열  
0.2/1.0

검측  
포장균열  
L=8.0m  
상  
033.34

| No. | 손상내용 | 2024년 정기점검 | | | | | | | 비고 |
|---|---|---|---|---|---|---|---|---|---|
| 1 | 토사퇴적 | - | - | 10.0 | 0.5 | 1 | 5.00 | m² | |
| 2 | 연석 균열 | - | 0.3 | 0.75 | - | 8 | 6.00 | m | |
| 3 | 중분대 균열 | - | 0.2 | 1.0 | - | 1 | 1.00 | m | |

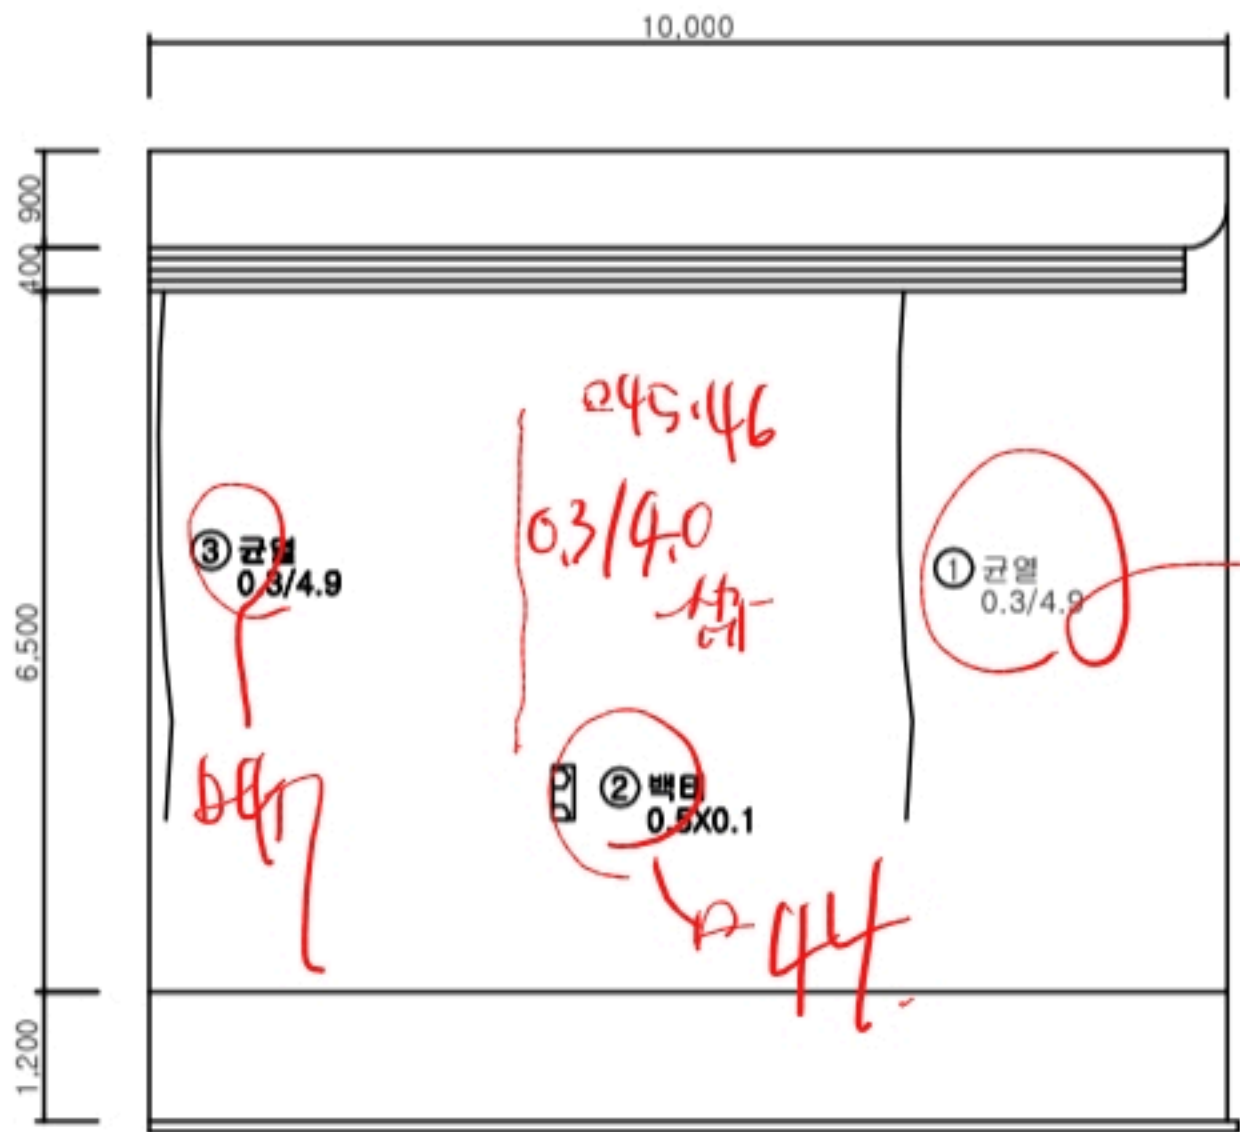
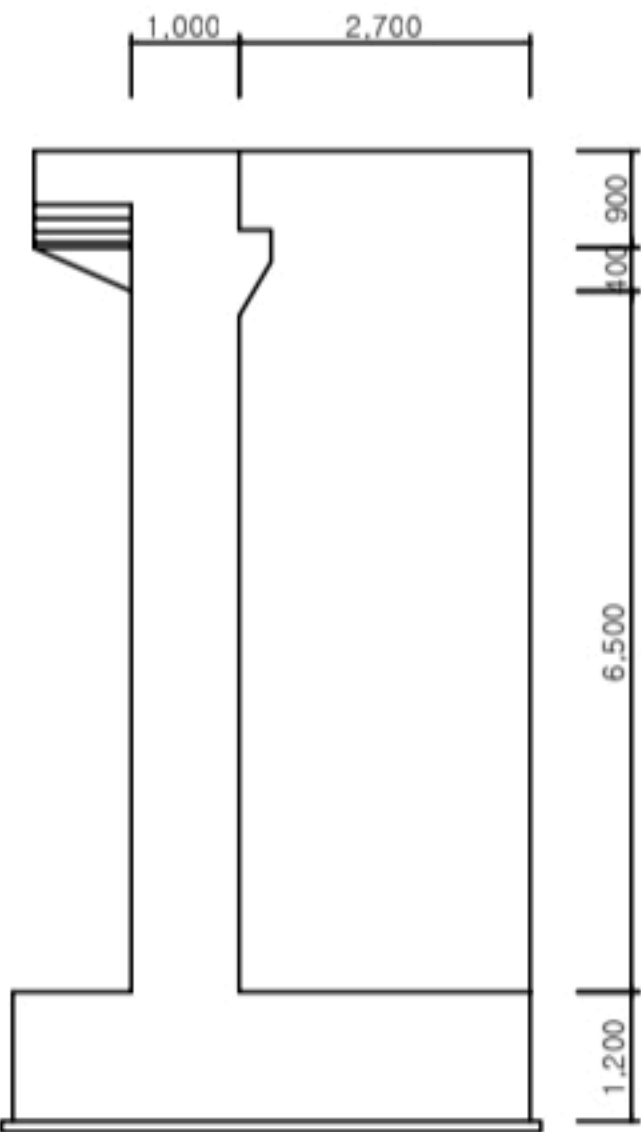
ID : 교대 (A1) 외관조사망도

| No. | 손상내용 | 2024년 정기점검 | | | | | | | 비고 |
|---|---|---|---|---|---|---|---|---|---|
| 1 | 균열 | - | 0.3 | 4.9 | - | 1 | 4.90 | m | |
| 2 | 백태 | - | - | 0.5 | 0.1 | 1 | 0.05 | m² | |
| 3 | 균열 | - | 0.3 | 4.9 | - | 1 | 4.90 | m | |

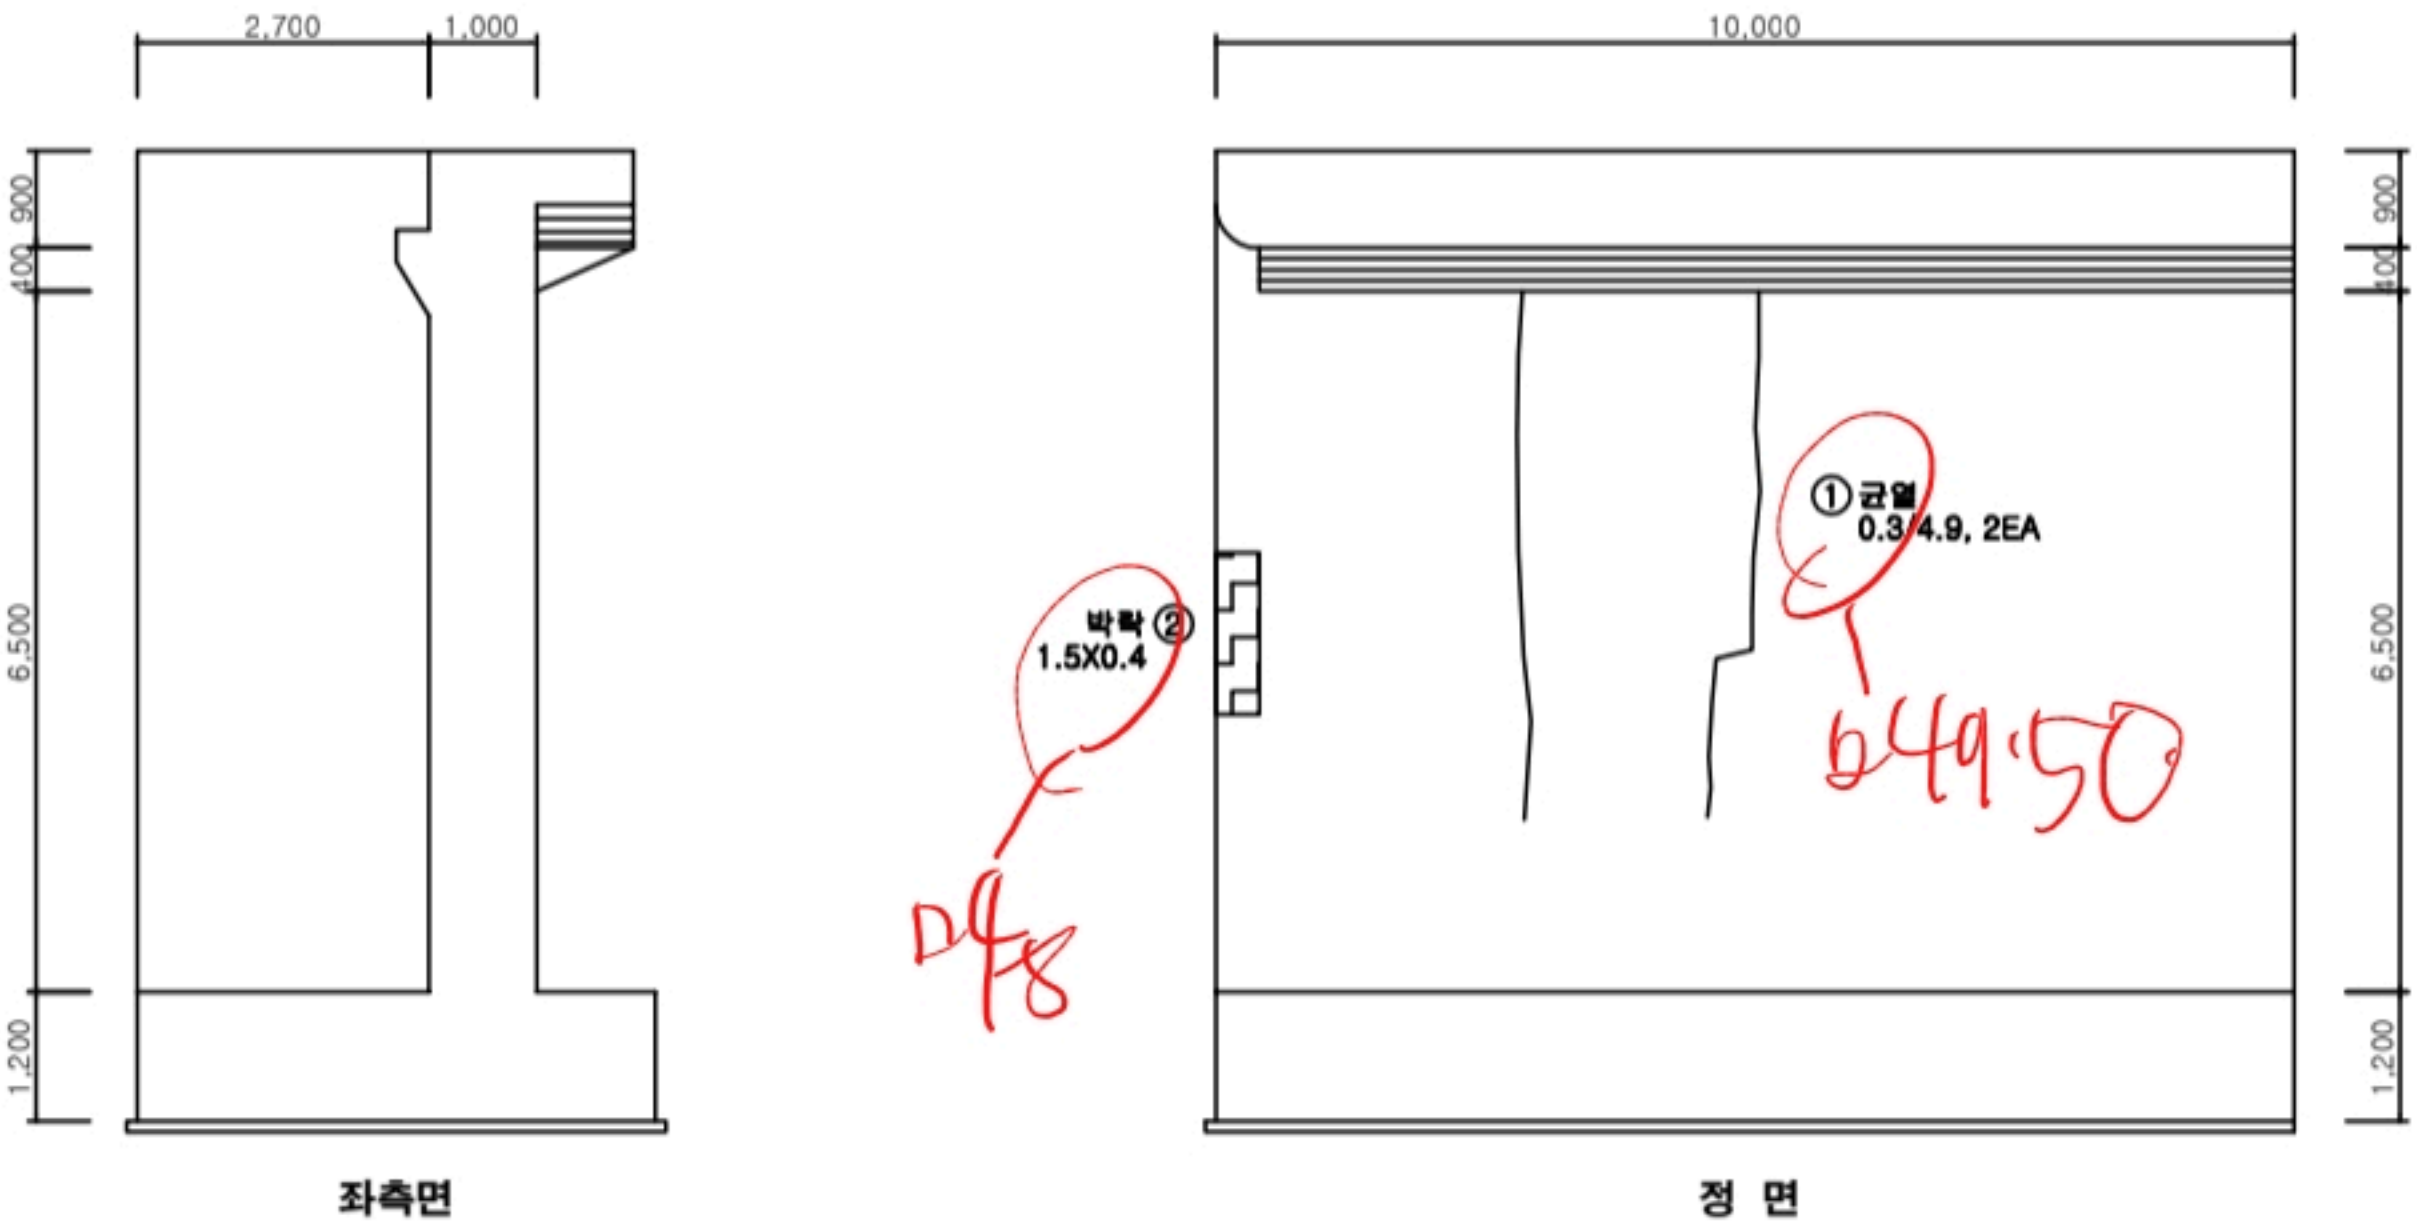
ID : 교대 (A2) 외관조사망도

| No. | 손상내용 | 2024년 정기점검 | | | | | | | 비고 |
|---|---|---|---|---|---|---|---|---|---|
| 1 | 균열 | - | 0.3 | 4.9 | - | 2 | 1.00 | m | |
| 2 | 박락 | - | - | 1.5 | 0.4 | 1 | 1.00 | m² | |

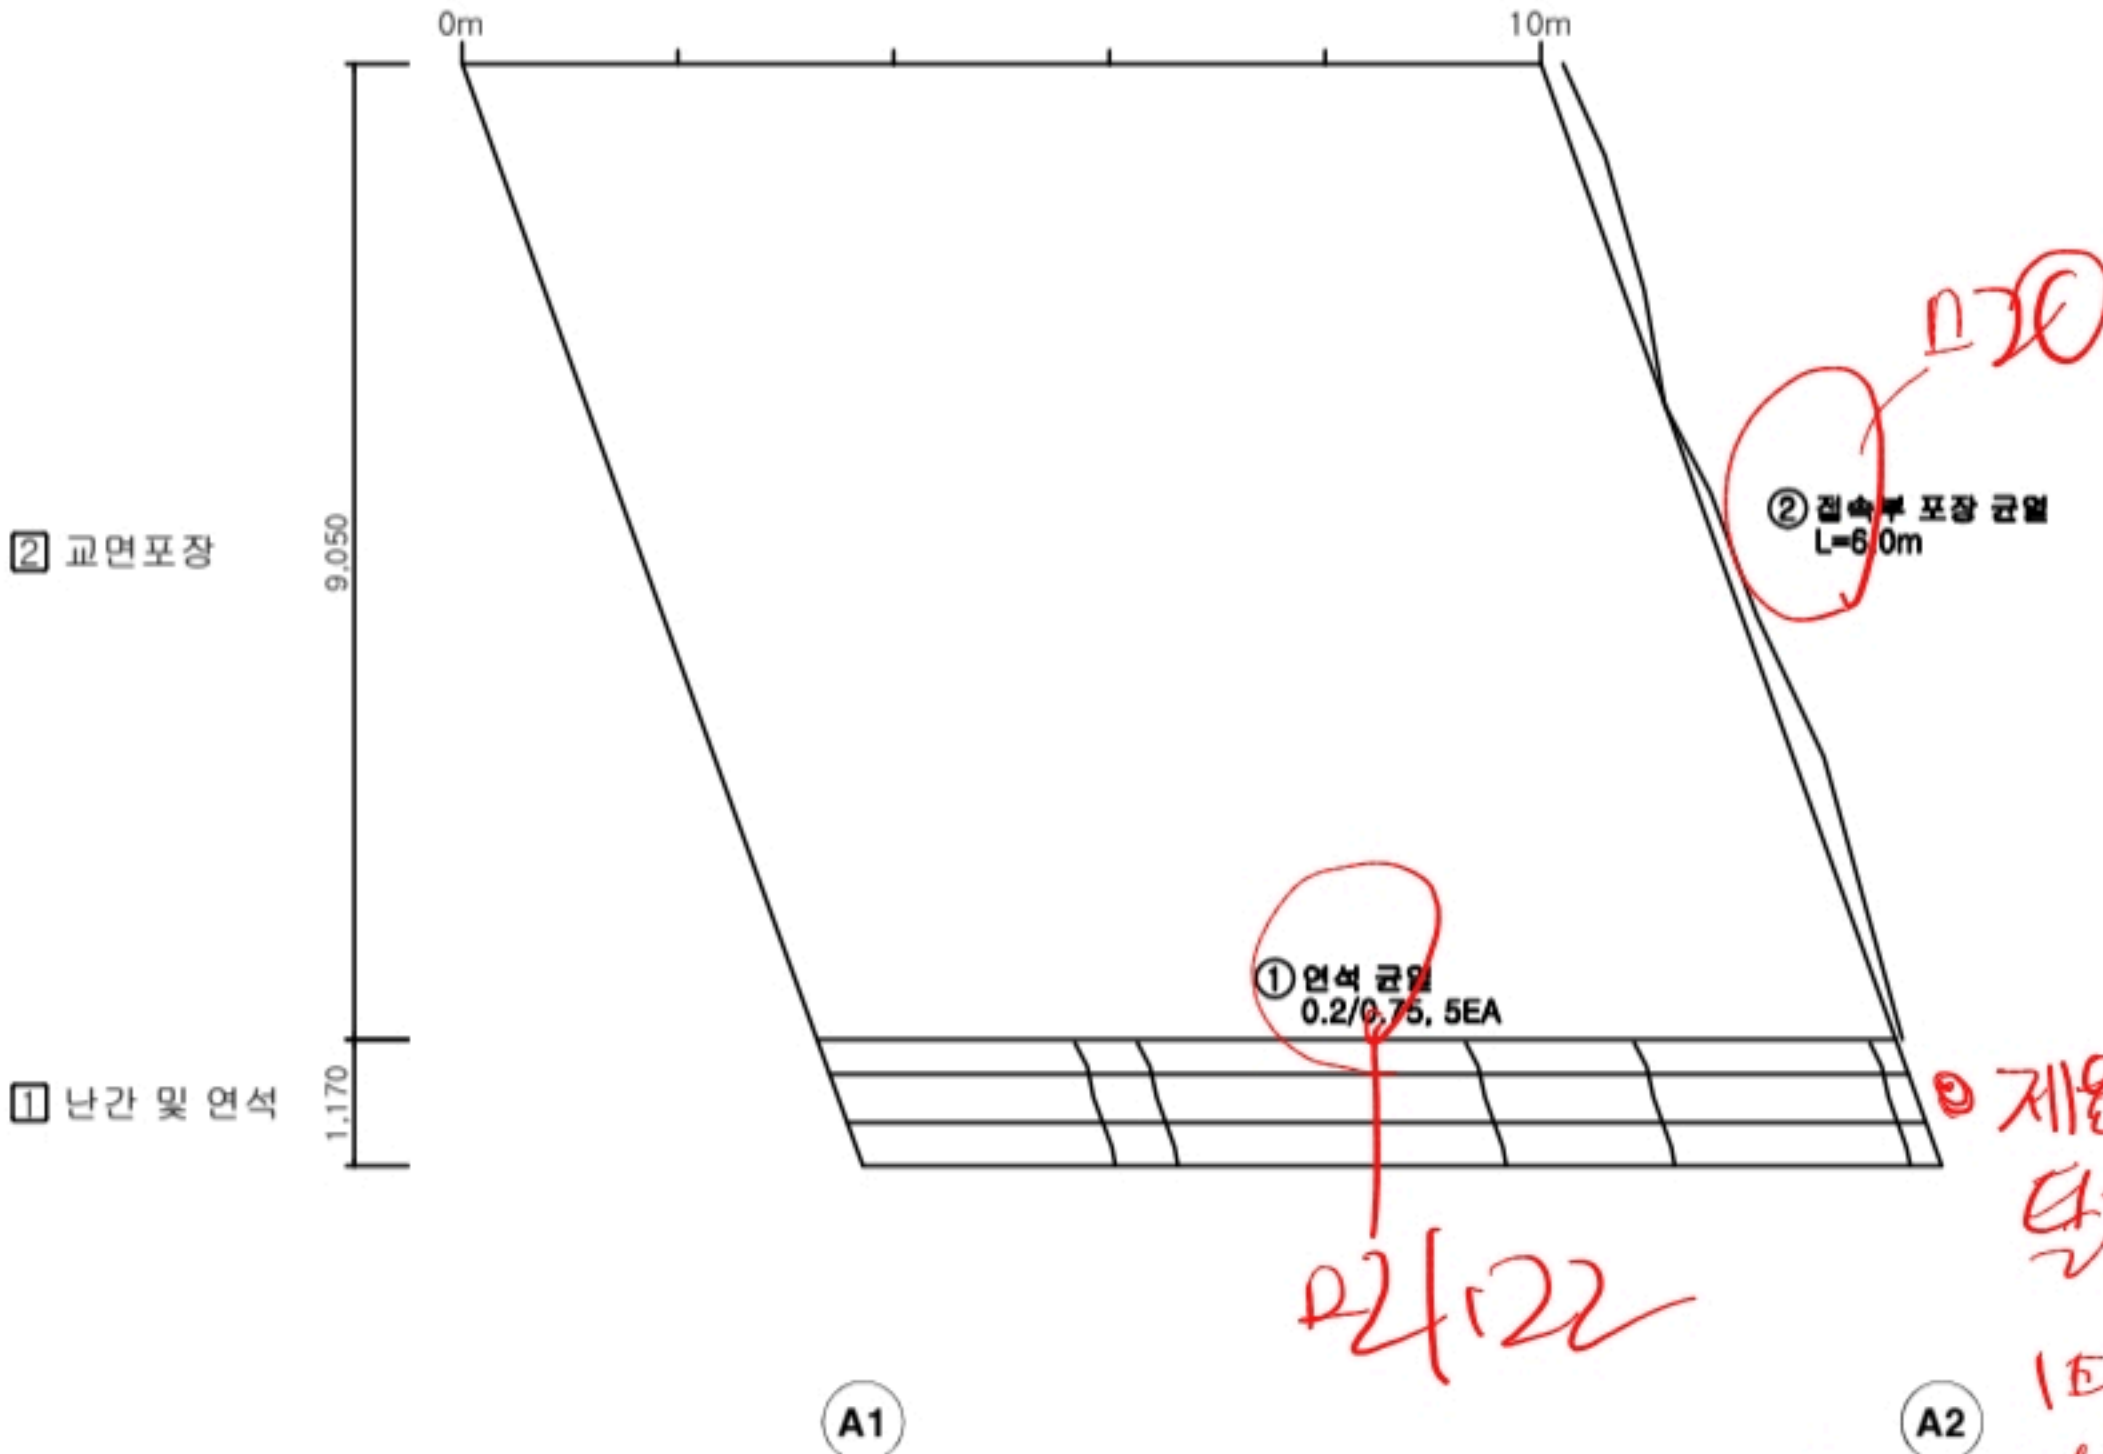
| No. | 손상내용 | 2024년 정기점검 | | | | | | | 비고 |
|---|---|---|---|---|---|---|---|---|---|
| 1 | 연석 균열 | - | 0.2 | 0.75 | - | 5 | 3.75 | m | |
| 2 | 접속부 포장 균열 | - | - | 6.0 | - | 1 | 6.00 | m | |

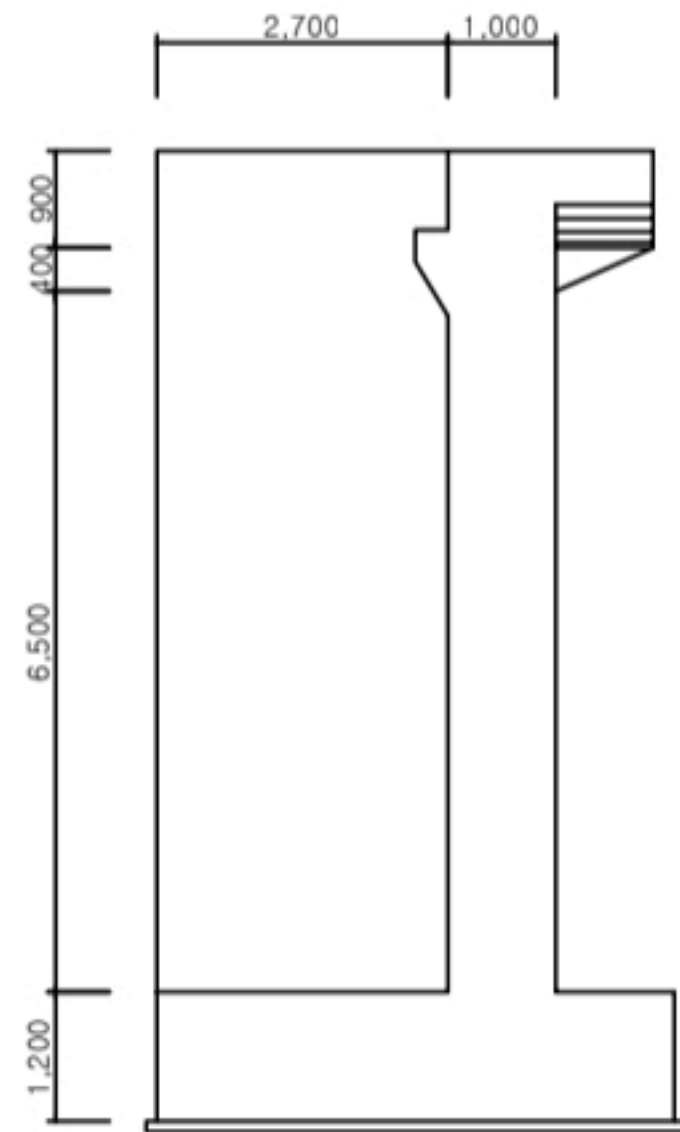
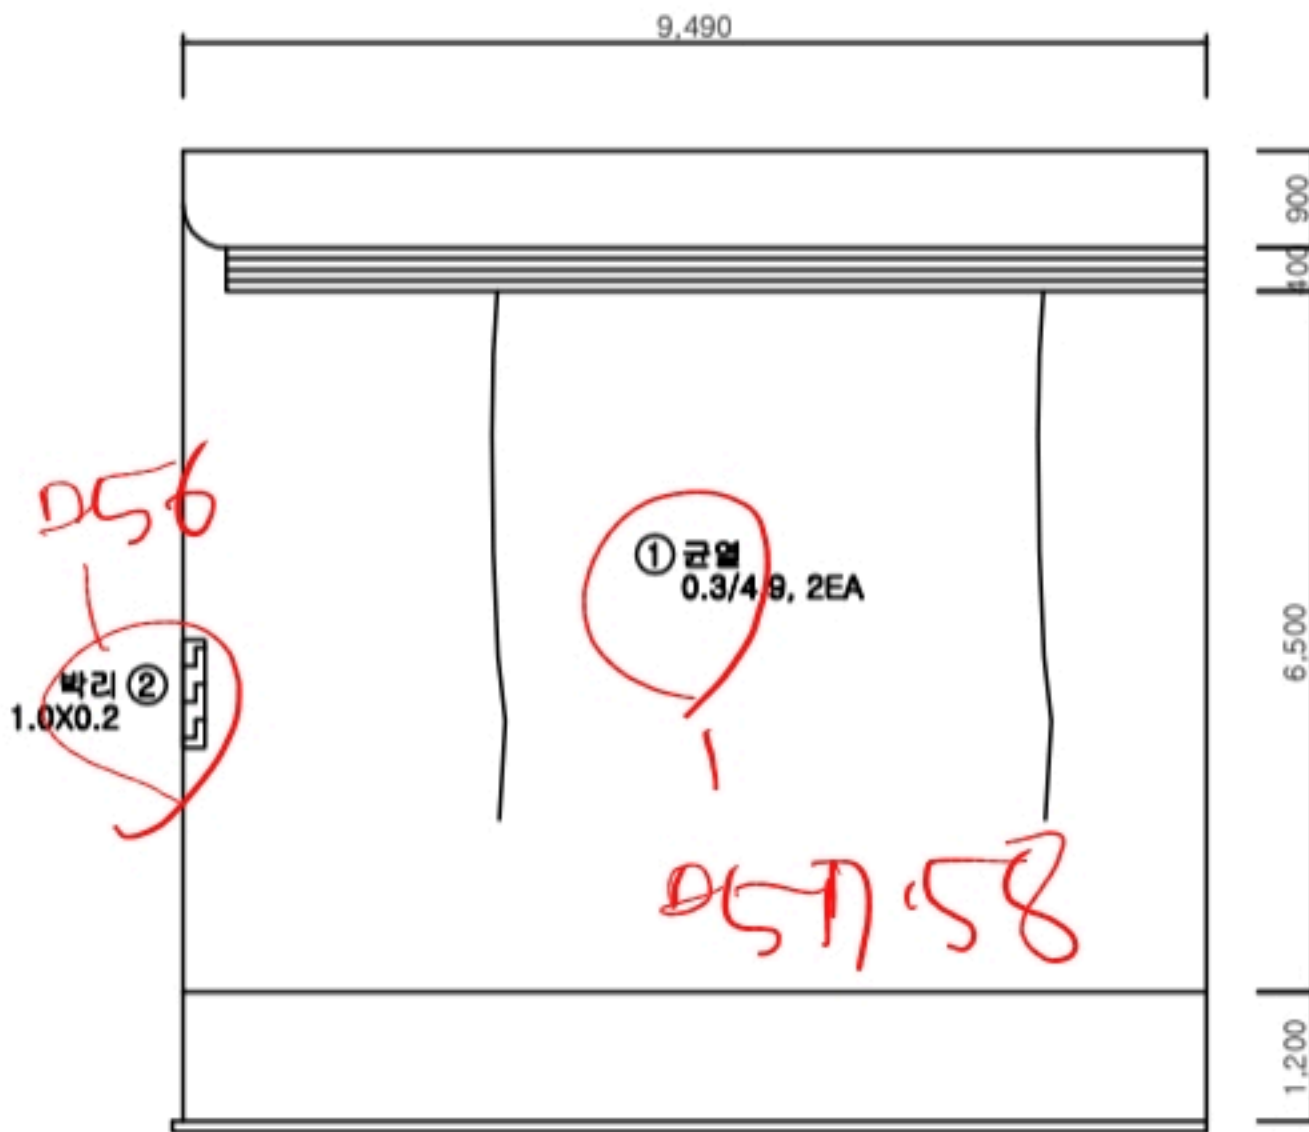
ID : 교대 (A1) 외관조사망도

| No. | 손상내용 | 2024년 정기점검 | | | | | | | 비고 |
|---|---|---|---|---|---|---|---|---|---|
| 1 | 균열 | - | 0.3 | 4.9 | - | 2 | 9.80 | m | |
| 2 | 박리 | - | - | 1.0 | 0.2 | 1 | 0.20 | m² | |

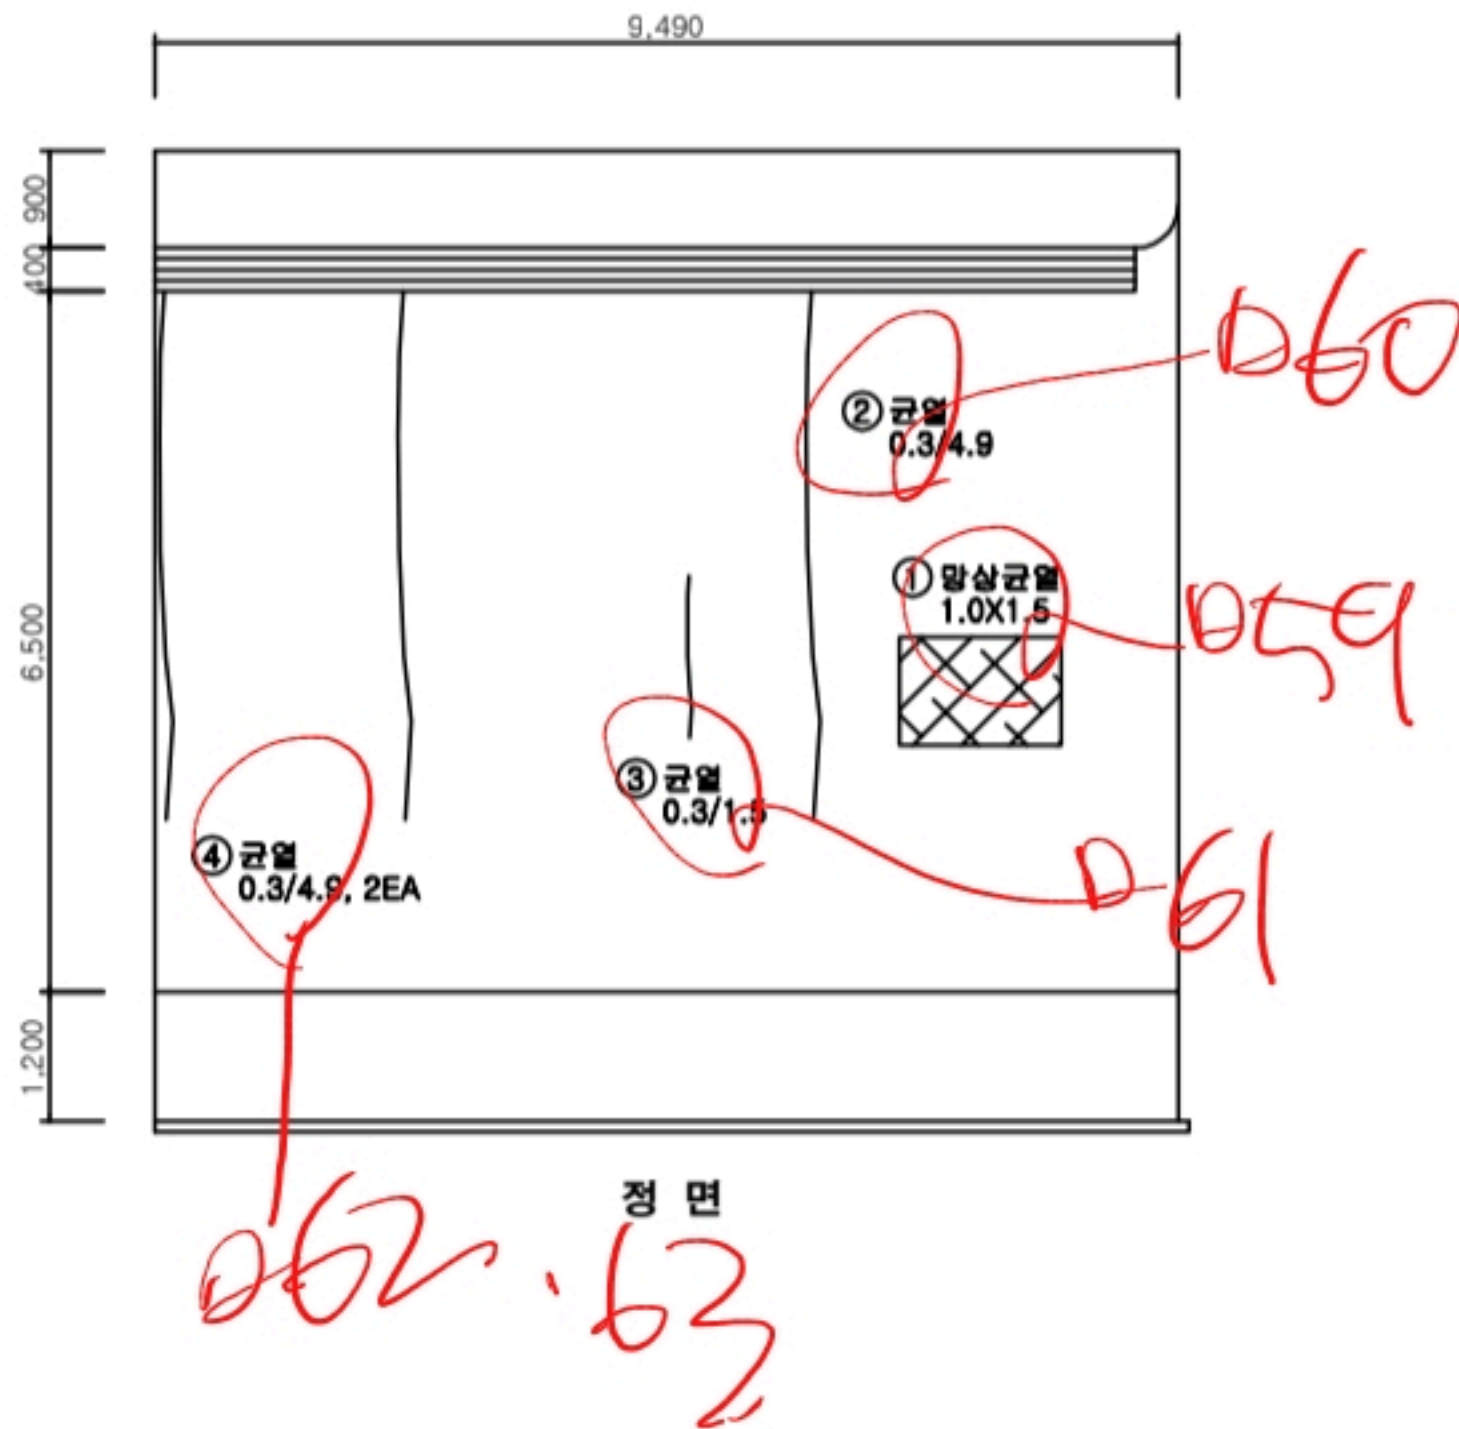
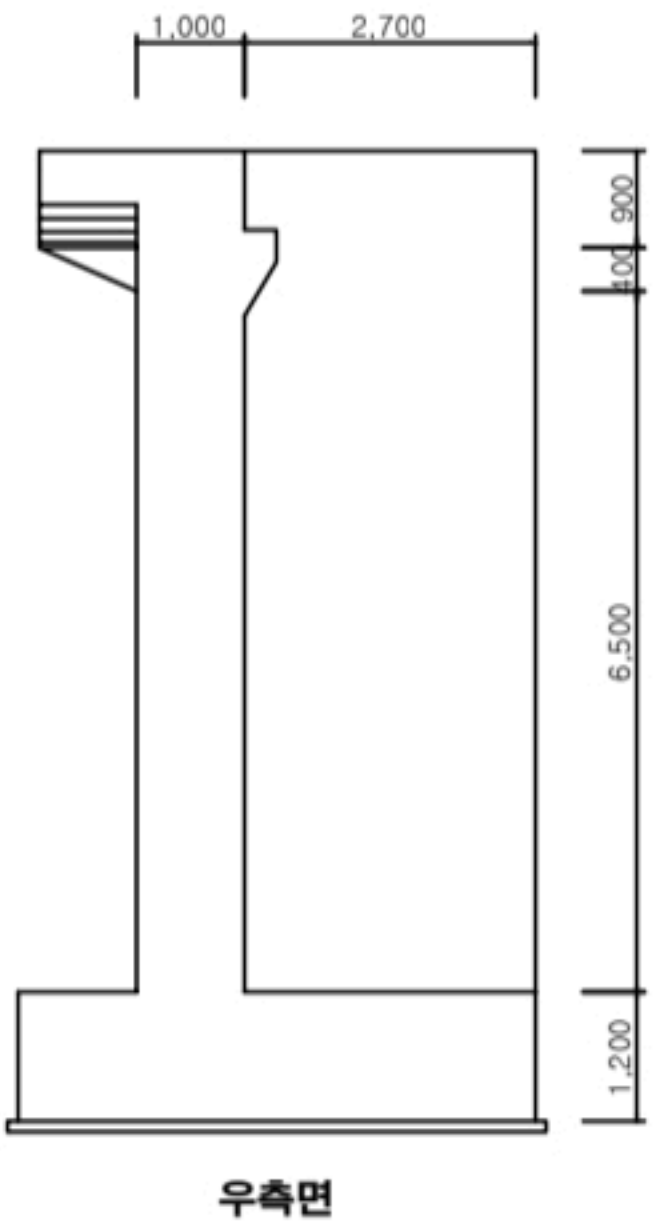
ID : 교대 (A2) 외관조사망도

| No. | 손상내용 | 2024년 정기점검 | | | | | | | 비고 |
|---|---|---|---|---|---|---|---|---|---|
| 1 | 망상균열 | - | - | 1.0 | 1.5 | 1 | 1.50 | m² | |
| 2 | 균열 | - | 0.3 | 4.9 | - | 1 | 4.90 | m | |
| 3 | 균열 | - | 0.3 | 1.5 | - | 1 | 1.50 | m | |
| 4 | 균열 | - | 0.3 | 4.9 | - | 2 | 9.80 | m | |
