## 불광천포장부 J50(1K 373) ~ J53(1K 445)

### 손상물량표

불광천1복개 정밀안전진단 및 녹번천복개 정밀점검 용역

불광천포장부 J50(1K 373) ~ J53(1K 445)

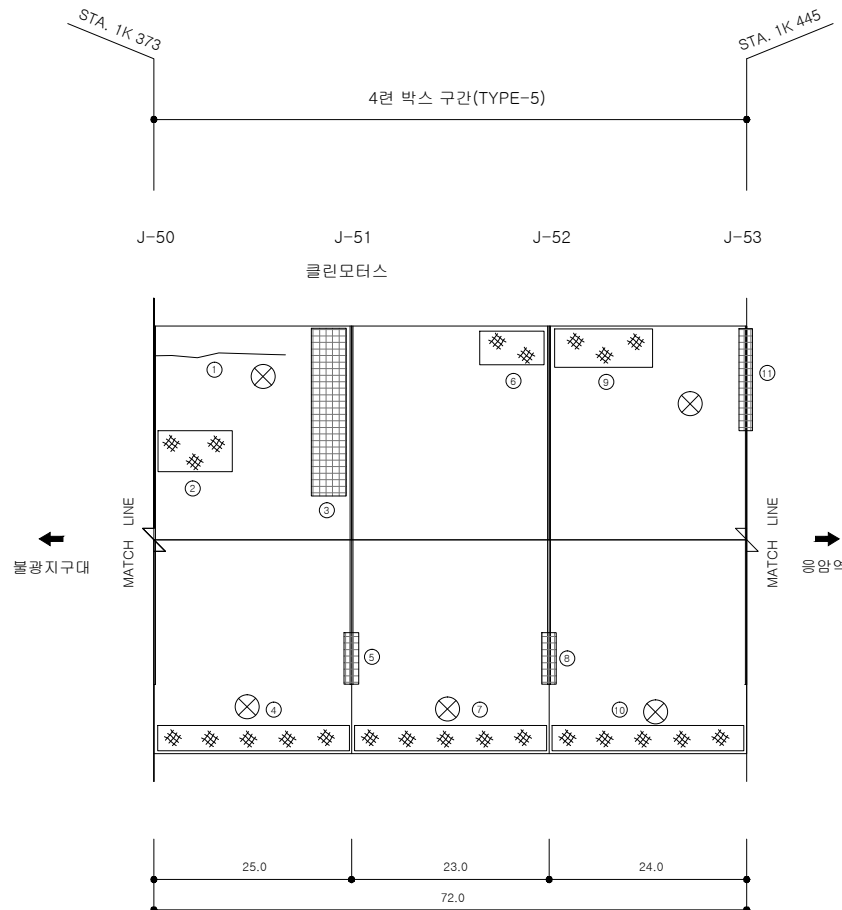
| 범례 | | ① ~ 2013 신규 | | 기① - 기존손상 | | | | ① 보수원료 | | | |
|---|---|---|---|---|---|---|---|---|---|---|---|
| 1 | 50-51 | S | 2013 | 균열 | 0.5 | 8.0 | | 8.00 | m | 1 | 신규 |
| 2 | 50-51 | S | 2013 | 망상균열 | 2.0 | 15.0 | | 30.00 | m <sup>2</sup> | 1 | 신규 |
| 3 | 50-51 | S | 2013 | 아스콘파손 | 2.0 | 11.0 | | 22.00 | m <sup>2</sup> | 1 | 신규 |
| 4 | 50-51 | S | 2013 | 망상균열 | 25.0 | 2.0 | | 50.00 | m <sup>2</sup> | 1 | 신규 |
| 5 | 51 | S | 2013 | 탄성조인트파손 | 0.8 | 4.0 | | 3.20 | m <sup>2</sup> | 1 | 신규 |
| 6 | 51-52 | S | 2013 | 망상균열 | 5.0 | 3.0 | | 15.00 | m <sup>2</sup> | 1 | 신규 |
| 7 | 51-52 | S | 2013 | 망상균열 | 23.0 | 2.0 | | 46.00 | m <sup>2</sup> | 1 | 신규 |
| 8 | 52 | S | 2013 | 탄성조인트파손 | 0.8 | 2.3 | | 1.84 | m <sup>2</sup> | 1 | 신규 |
| 9 | 52-53 | S | 2013 | 망상균열 | 19.0 | 3.5 | | 66.50 | m <sup>2</sup> | 1 | 신규 |
| 10 | 52-53 | S | 2013 | 망상균열 | 24.0 | 2.0 | | 48.00 | m <sup>2</sup> | 1 | 신규 |
| 11 | 53 | S | 2013 | 탄성조인트파손 | 0.8 | 4.7 | | 3.76 | m <sup>2</sup> | 1 | 신규 |

-1순위 : Type-7~9 (예일여고~역말사거리)  
 -2순위 : Type-9~11 (역말사거리~신사오거리) 및 조인트 손상  
 -3순위 : Type-1~7 (시점~예일여고) 및 포장균열
