### 손상물량표

불광천1복개 정밀안전진단 및 녹번천복개 정밀점검 용역

불광천포장부 J53(1K 445) ~ J55(1K 490)

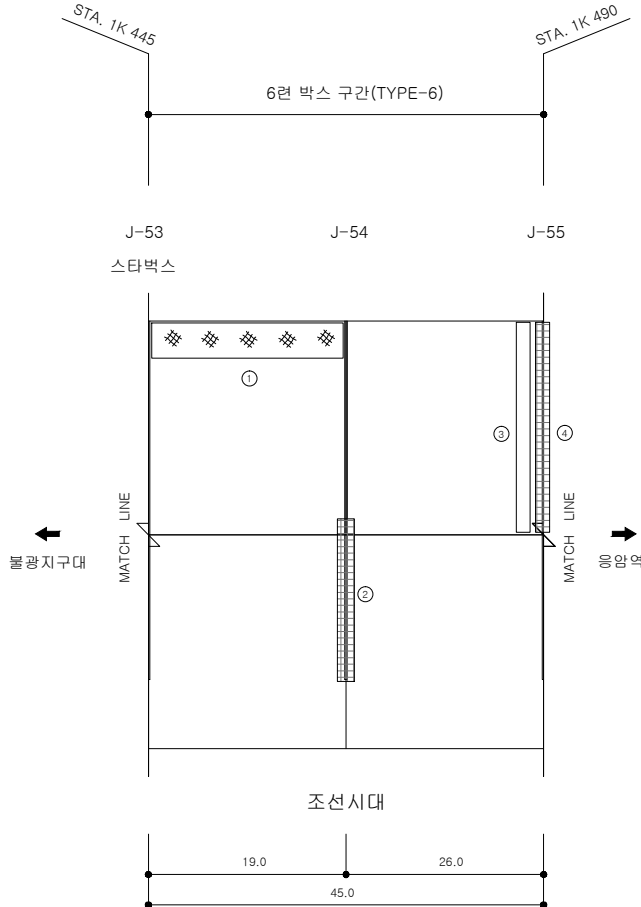
0-13

| 번 | 레 | 손상 위치 | 적출년도 | 결함규모 | | | | | | 단위 | 개소 | 비고 |
|---|---|---|---|---|---|---|---|---|---|---|---|---|
| 1 | | 53-54 | S | 2013 | 망상균열 | 3.5 | 19.0 | | 66.50 | m | 1 | 신규 |
| 2 | | 54 | S | 2013 | 탄성조인트파손 | 0.8 | 10.0 | | 10.00 | m | 1 | 신규 |
| 3 | | 54-55 | S | 2013 | 포장파손 | 2.5 | 10.0 | | 25.0 | m | 1 | 신규 |
| 4 | | 55 | S | 2013 | 탄성조인트파손 | 0.8 | 10.0 | | 10.00 | m | 1 | 신규 |

-1순위 : Type-7~9 (예일여고~역말사거리)  
-2순위 : Type-9~11 (역말사거리~신사오거리) 및 조인트 손상  
-3순위 : Type-1~7 (시점~예일여고) 및 포장균열
