### 손 상 물 량 표

불광천1복개 정밀안전진단 및 북변천복개 정밀점검 용역

불 광 천 포 장 부  
J60(1K 624) ~ J65(1K 752)

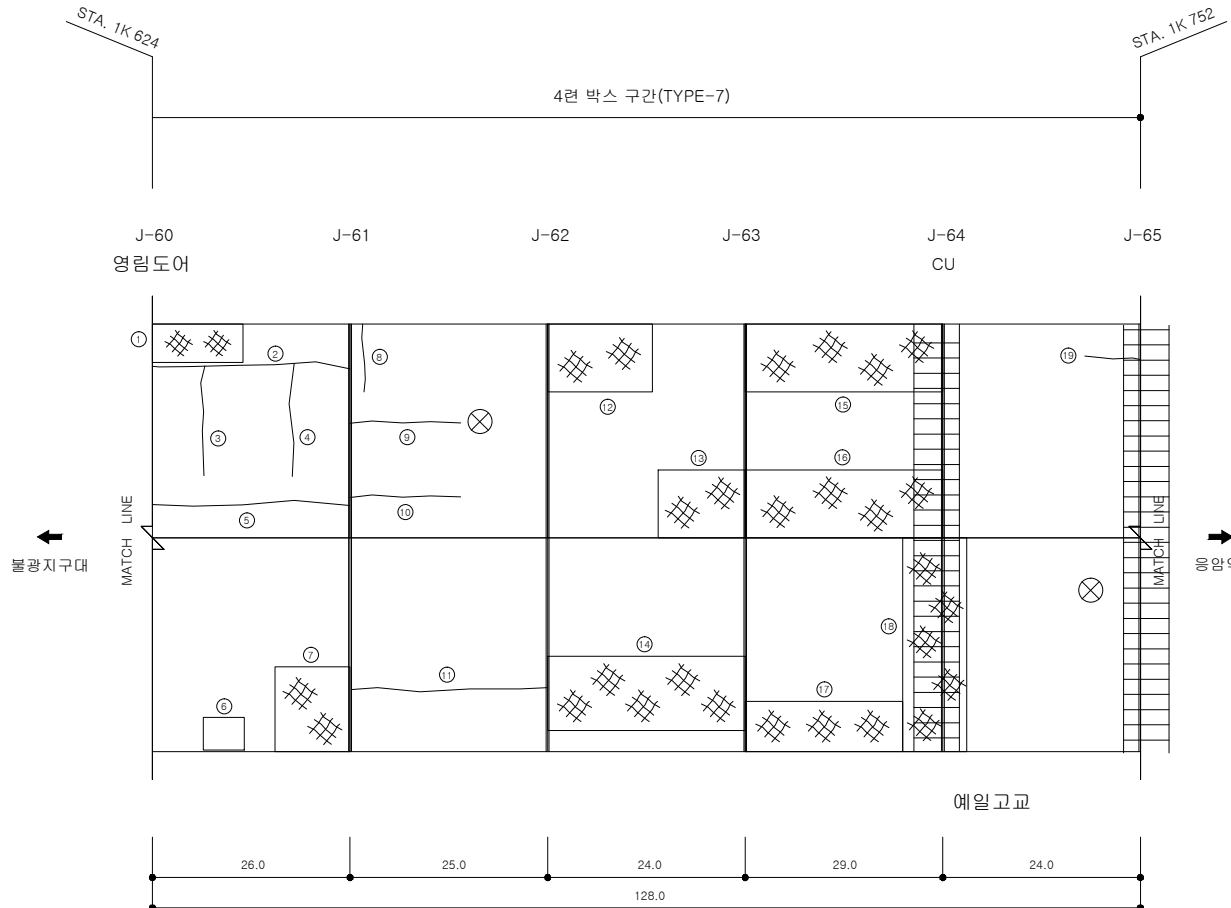
| 범 례 | | | ㉠ - 2013 신규 | | 기① - 기존순성 | | ㉡ 보수완료 | | | | |
|---|---|---|---|---|---|---|---|---|---|---|---|
| 1 | 60-61 | S | 2013 | 망상균열 | 3.5 | 10.0 | | 35.0 | m | 1 | 신규 |
| 2 | 60-61 | S | 2013 | 균열 | | 26.0 | | 26.0 | m | 1 | 신규 |
| 3 | 60-61 | S | 2013 | 균열 | | 8.0 | | 8.00 | m | 1 | 신규 |
| 4 | 60-61 | S | 2013 | 균열 | | 8.0 | | 8.00 | m | 1 | 신규 |
| 5 | 60-61 | S | 2013 | 균열 | | 26.0 | | 26.0 | m | 1 | 신규 |
| 6 | 60-61 | S | 2013 | 소성변형 | 2.0 | 3.0 | | 6.00 | m | 1 | 신규 |
| 7 | 60-61 | S | 2013 | 망상균열 | 4.0 | 8.0 | | 32.0 | m | 1 | 신규 |
| 8 | 61-62 | S | 2013 | 균열 | | 3.0 | | 3.00 | m | 1 | 신규 |
| 9 | 61-62 | S | 2013 | 균열 | | 15.0 | | 15.0 | m | 1 | 신규 |
| 10 | 61-62 | S | 2013 | 균열 | | 15.0 | | 15.0 | m | 1 | 신규 |
| 11 | 61-62 | S | 2013 | 균열 | | 25.0 | | 25.0 | m | 1 | 신규 |
| 12 | 62-63 | S | 2013 | 망상균열 | 3.5 | 12.5 | | 43.75 | m | 1 | 신규 |
| 13 | 62-63 | S | 2013 | 망상균열 | 3.5 | 10.0 | | 35.0 | m | 1 | 신규 |
| 14 | 62-63 | S | 2013 | 망상균열 | 4.0 | 24.0 | | 96.0 | m | 1 | 신규 |
| 15 | 63-64 | S | 2013 | 망상균열 | 3.5 | 29.0 | | 101.5 | m | 1 | 신규 |
| 16 | 63-64 | S | 2013 | 망상균열 | 3.5 | 29.0 | | 101.5 | m | 1 | 신규 |
| 17 | 63-64 | S | 2013 | 망상균열 | 2.0 | 19.0 | | 38.0 | m | 1 | 신규 |
| 18 | 63-64 | S | 2013 | 망상균열 | 8.0 | 10.0 | | 80.0 | m | 1 | 신규 |
| 19 | 64-65 | S | 2013 | 균열 | 1.5 | 5.0 | | 5.00 | m | 1 | 신규 |

-1순위 : Type-7~9 (예일여고~역말사거리)  
-2순위 : Type-9~11 (역말사거리~신사오거리) 및 조인트 손상  
-3순위 : Type-1~7 (시점~예일여고) 및 포장균열
