손 상 물 량 표

불광천1복개 정밀안전진단 및 북변천복개 정밀점검 용역

불 광 천 포 장 부  
J65(1K 752) ~ J70(1K 880)

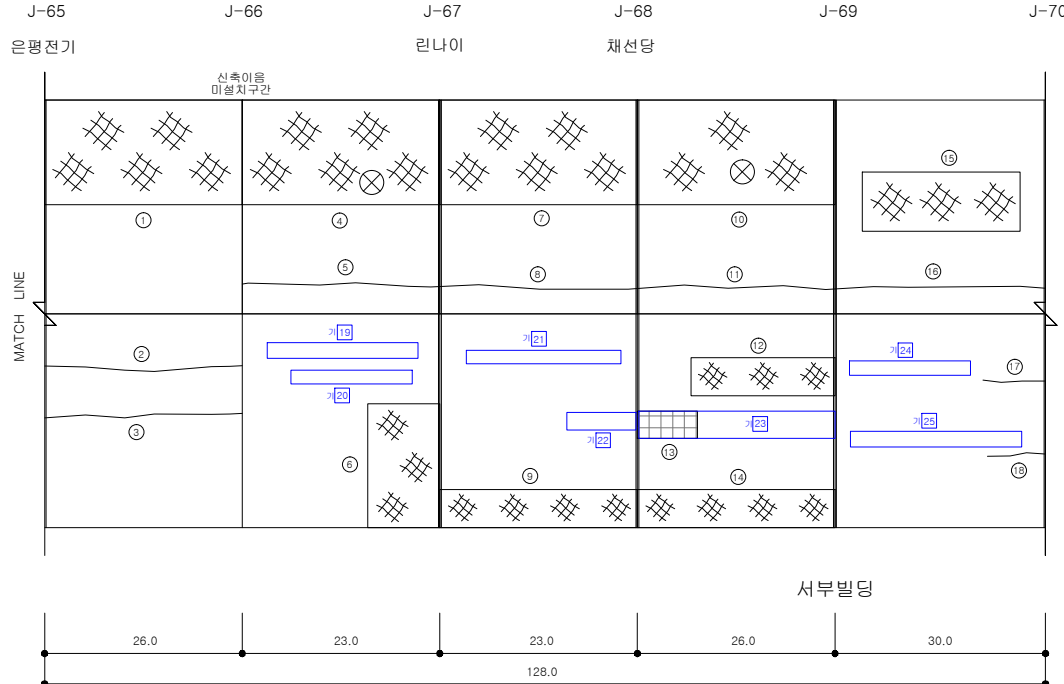
| 범 례 | | | ㉠ - 2013 신규 | | | | 기㉡ - 기존순성 | | | | T 보수완료 | | | |
|---|---|---|---|---|---|---|---|---|---|---|---|--|--|--|
| 1 | 65-66 | S | 2013 | 망상균열 | 5.0 | 26.0 | | 130.0 | m | 1 | 신규 | | | |
| 4 | 66-67 | S | 2013 | 망상균열 | 5.0 | 23.0 | | 115.0 | m | 1 | 신규 | | | |
| 7 | 67-68 | S | 2013 | 망상균열 | 5.0 | 23.0 | | 115.0 | m | 1 | 신규 | | | |
| 10 | 68-69 | S | 2013 | 망상균열 | 5.0 | 26.0 | | 130.0 | m | 1 | 신규 | | | |
| 13 | 68-69 | S | 2013 | 보수부 파손 | 1.0 | 5.0 | | 5.00 | m | 1 | 신규 | | | |
| 15 | 69-70 | S | 2013 | 망상균열 | 3.5 | 20.0 | | 70.0 | m | 1 | 신규 | | | |
