불 광 천 포 장 부 J80(2K 122) ~ J85(2K 245)

손 상 물 량 표

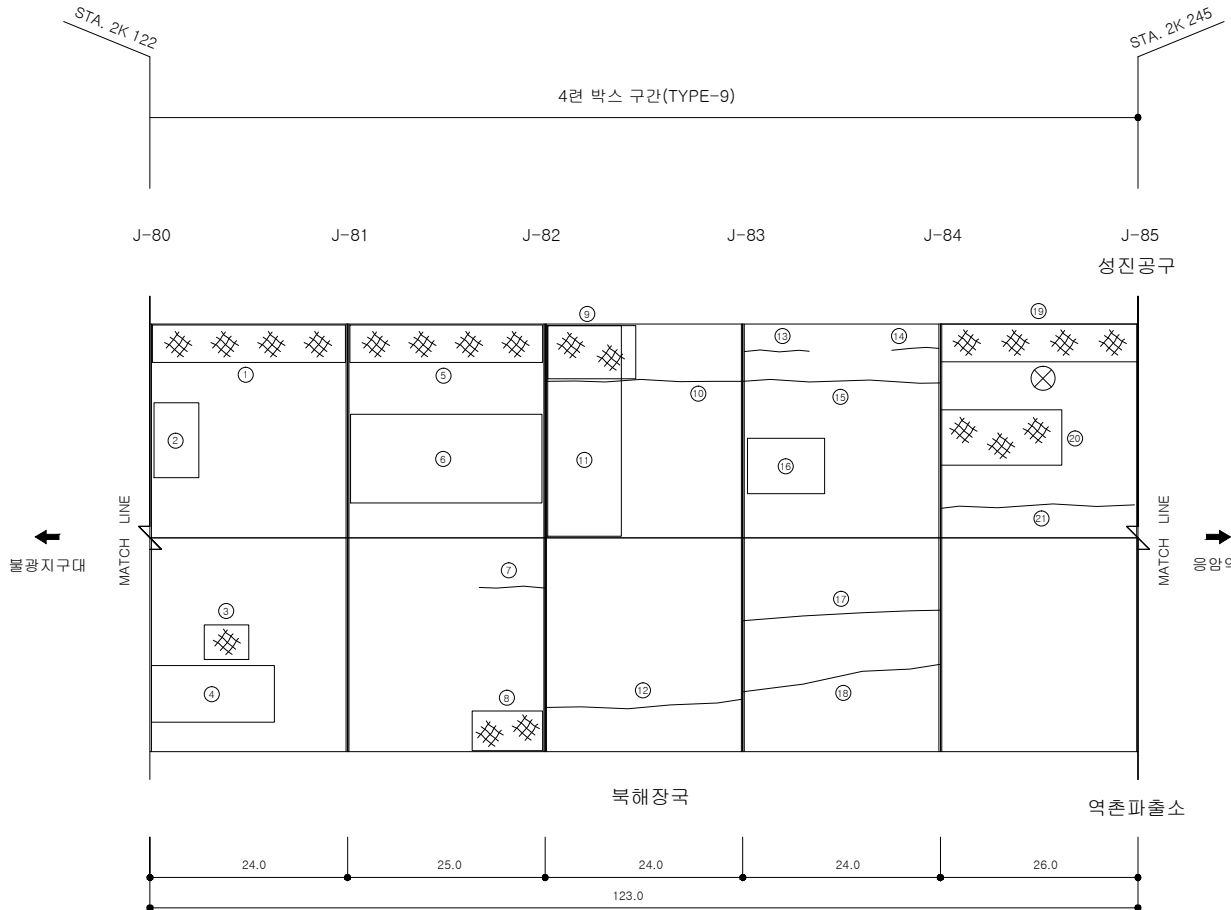
| 범 례 | | | ㉠ - 2013 신규 | | 기㉡ - 기존순성 | | I 보수완료 | | | | | |
|---|---|---|---|---|---|---|---|---|---|---|---|---|
| 1 | 80-81 | S | 2013 | 망상균열 | 2.0 | 24.0 | | | 48.0 | m | 1 | 신규 |
| 2 | 80-81 | S | 2013 | 소성변형 | 5.0 | 5.0 | | | 25.0 | m | 1 | 신규 |
| 5 | 81-82 | S | 2013 | 망상균열 | 2.0 | 23.5 | | | 94.0 | m | 1 | 신규 |
| 6 | 81-82 | S | 2013 | 소성변형 | 5.0 | 25.0 | | | 125.0 | m | 1 | 신규 |
| 11 | 82-83 | S | 2013 | 소성변형 | 8.0 | 10.0 | | | 80.0 | m | 1 | 신규 |
| 16 | 83-84 | S | 2013 | 소성변형 | 4.0 | 7.0 | | | 28.0 | m | 1 | 신규 |

-1순위 : Type-7~9 (예일여고~역말사거리)  
 -2순위 : Type-9~11 (역말사거리~신사오거리) 및 조인트 손상  
 -3순위 : Type-1~7 (시점~예일여고) 및 포장균열
