## 불 광 천 포 장 부 J90(2K 368) ~ J95(2K 489)

### 손 상 물 량 표

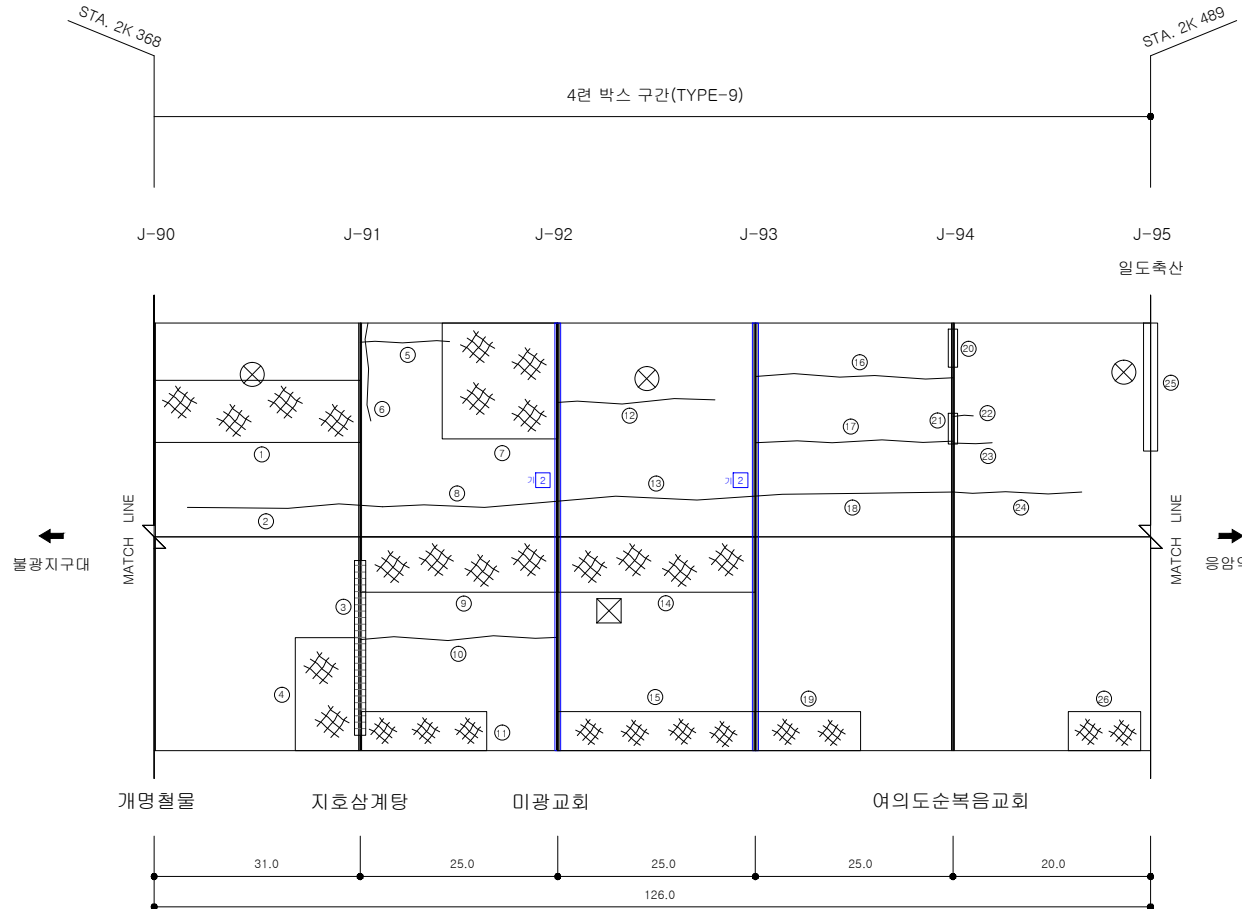
| 법 레 | | | ㉠ 2013 신규 | | | 기㉡ - 기존손상 | | | ㉢ 보수완료 | | |
|---|---|---|---|---|---|---|---|---|---|---|---|
| 1 | 90-91 | S | 2013 | 망상균열 | 4.5 | 31.0 | | 139.5 | m | 1 | 신규 |
| 2 | 90-91 | S | 2013 | 균열 | | 27.0 | | 27.0 | m | 1 | 신규 |
| 3 | 91 | S | 2013 | 후타재파손 | 0.8 | 8.0 | | 6.40 | m | 1 | 신규 |
| 4 | 90-91 | S | 2013 | 망상균열 | 8.0 | 9.0 | | 72.0 | m | 1 | 신규 |
| 5 | 91-92 | S | 2013 | 균열 | 1.5 | 10.0 | | 15.0 | m | 1 | 신규 |
| 6 | 91-92 | S | 2013 | 균열 | 1.5 | 5.0 | | 7.50 | m | 1 | 신규 |
| 7 | 91-92 | S | 2013 | 망상균열 | 6.5 | 11.5 | | 74.75 | m | 1 | 신규 |
| 8 | 91-92 | S | 2013 | 균열 | | 25.0 | | 25.0 | m | 1 | 신규 |
| 9 | 91-92 | S | 2013 | 망상균열 | 3.0 | 25.0 | | 75.0 | m | 1 | 신규 |
| 10 | 91-92 | S | 2013 | 균열 | 1.0 | 25.0 | | 25.0 | m | 1 | 신규 |
| 11 | 91-92 | S | 2013 | 망상균열 | 2.0 | 10.0 | | 20.0 | m | 1 | 신규 |
| 12 | 92-93 | S | 2013 | 균열 | 1.0 | 20.0 | | 20.0 | m | 1 | 신규 |
| 13 | 92-93 | S | 2013 | 균열 | | 25.0 | | 25.0 | m | 1 | 신규 |
| 14 | 92-93 | S | 2013 | 망상균열 | 3.0 | 25.0 | | 75.0 | m | 1 | 신규 |
| 15 | 92-93 | S | 2013 | 망상균열 | 2.0 | 25.0 | | 50.0 | m | 1 | 신규 |
| 16 | 93-94 | S | 2013 | 균열 | | 25.0 | | 25.0 | m | 1 | 신규 |
| 17 | 93-94 | S | 2013 | 균열 | 1.0 | 25.0 | | 25.0 | m | 1 | 신규 |
| 18 | 93-94 | S | 2013 | 균열 | | 25.0 | | 25.0 | m | 1 | 신규 |
| 19 | 93-94 | S | 2013 | 망상균열 | 2.0 | 10.0 | | 20.0 | m | 1 | 신규 |
| 20 | 94 | S | 2013 | 후타재마모 | 0.7 | 3.0 | | 2.10 | m | 1 | 신규 |
| 21 | 94 | S | 2013 | 후타재마모 | 0.7 | 2.5 | | 1.54 | m | 1 | 신규 |
| 22 | 94-95 | S | 2013 | 균열 | | 1.0 | | 1.00 | m | 1 | 신규 |
| 23 | 94-95 | S | 2013 | 균열 | | 2.0 | | 2.00 | m | 1 | 신규 |
| 24 | 94-95 | S | 2013 | 균열 | | 14.0 | | 14.00 | m | 1 | 신규 |
| 25 | 95 | S | 2013 | 후타재마모 | 0.7 | 7.8 | | 5.46 | m | 1 | 신규 |
| 26 | 94-95 | S | 2013 | 망상균열 | 2.0 | 8.0 | | 16.0 | m | 1 | 신규 |

-1순위 : Type-7~9 (예일여고~역말사거리)  
 -2순위 : Type-9~11 (역말사거리~신사오거리) 및 조인트 손상  
 -3순위 : Type-1~7 (시점~예일여고) 및 포장균열
