### 손상물량표

불광천1복개 정밀안전진단 및 녹번천복개 정밀점검 용역

불광천포장부  
J95(2K 489) ~ J96(2K 498)

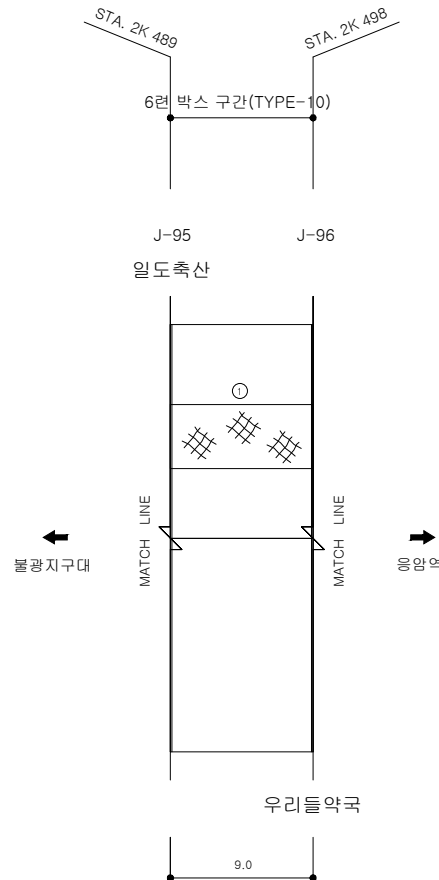
| 범례 | | ① ~ 2013 신규 | | 기① - 기존손상 | | ① 보수완료 | | | | | |
|---|---|---|---|---|---|---|---|---|---|---|---|
| 1 | 95-96 | S | 2013 | 망상균열 | 3.5 | 9.0 | | 31.50 | m | 1 | 신규 |
