불 광 천 포 장 부 J35(0K 999) ~ J40(1K 128)

손 상 물 량 표

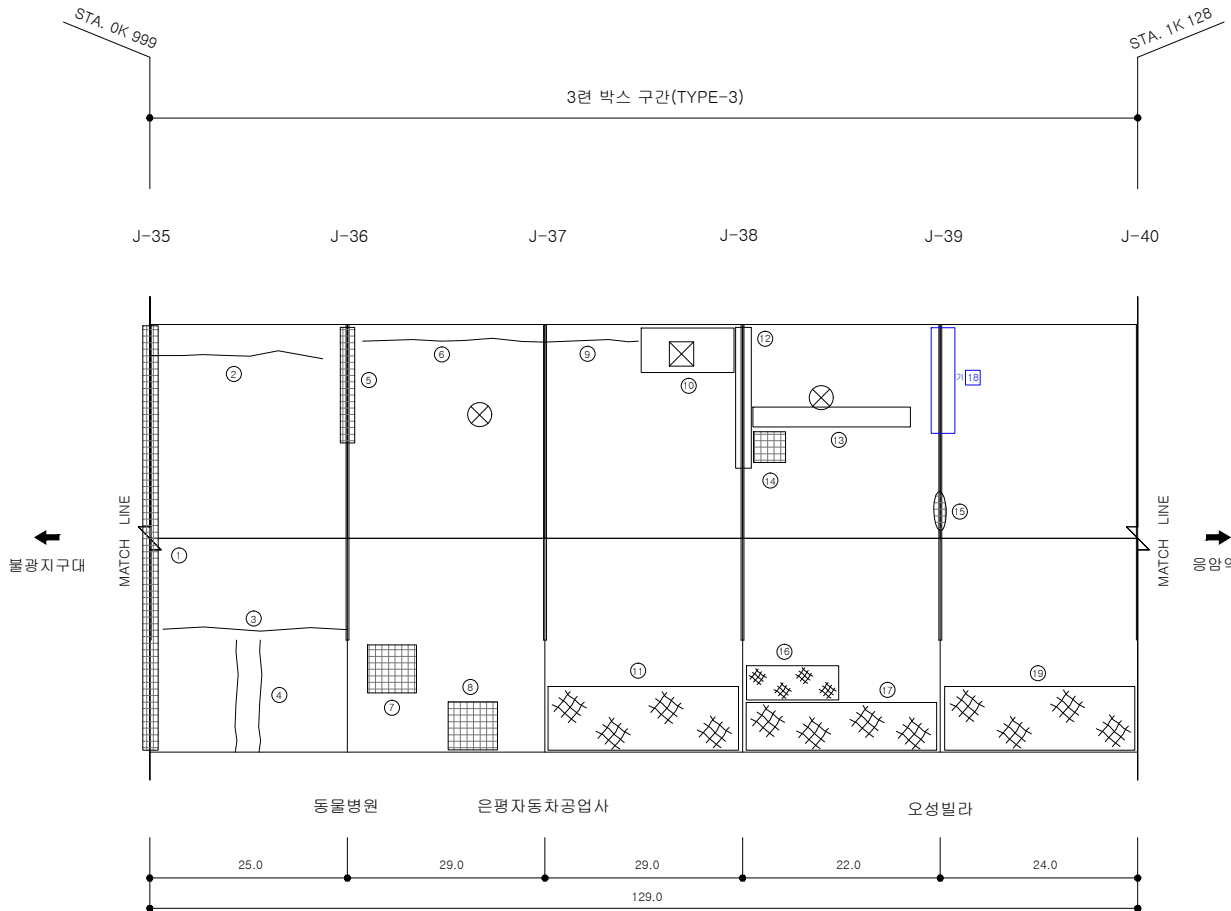
| 번 호 | 손 상 위 치 | 적출년도 | 결함규모 | | | | | 단 위 | 개 소 | 비 고 |
|---|---|---|---|---|---|---|---|---|---|---|
| 1 | 35 | S | 2013 | 후타재파손 | 0.8 | 22.0 | | m | 1 | 신규 |
| 2 | 35-36 | S | 2013 | 균열 | | 25.0 | | m | 1 | 신규 |
| 3 | 35-36 | S | 2013 | 균열 | | 25.0 | | m | 1 | 신규 |
| 4 | 35-36 | S | 2013 | 균열 | 0.5 | 5.0 | | m | 2 | 신규 |
| 5 | 36 | S | 2013 | 후타재파손 | 0.7 | 8.0 | | m | 1 | 신규 |
| 6 | 36-37 | S | 2013 | 균열 | | 29.0 | | m | 1 | 신규 |
| 7 | 36-37 | S | 2013 | 파손 | 4.0 | 4.0 | | m | 1 | 신규 |
| 8 | 36-37 | S | 2013 | 파손 | 4.0 | 4.0 | | m | 1 | 신규 |
| 9 | 37-38 | S | 2013 | 균열 | | 10.0 | | m | 1 | 신규 |
| 10 | 37-38 | S | 2013 | 포장마모 | 10.0 | 4.0 | | m | 1 | 신규 |
| 11 | 37-38 | S | 2013 | 망상균열 | 29.0 | 6.0 | | m | 1 | 신규 |
| 12 | 38 | S | 2013 | 후타재마모 | 0.8 | 7.5 | | m | 1 | 신규 |
| 13 | 38-39 | S | 2013 | 포장마모 | 23.0 | 4.0 | | m | 1 | 신규 |
| 14 | 38-39 | S | 2013 | 포장파손 | 2.5 | 3.0 | | m | 1 | 신규 |
| 15 | 38-39 | S | 2013 | 탄성조인트파손 | 0.2 | 0.3 | | m | 1 | 신규 |
| 16 | 38-39 | S | 2013 | 망상균열 | 7.0 | 3.0 | | m | 1 | 신규 |
| 17 | 38-39 | S | 2013 | 망상균열 | 22.0 | 3.0 | | m | 1 | 신규 |
| 18 | 39 | S | 2013 | 보수완료 | 2.0 | 5.0 | | m | 1 | 기존보수 |
| 19 | 39-40 | S | 2013 | 망상균열 | 24.0 | 3.0 | | m | 1 | 신규 |

-1순위 : Type-7~9 (예일여고~역말사거리)  
 -2순위 : Type-9~11 (역말사거리~신사오거리) 및 조인트 손상  
 -3순위 : Type-1~7 (시점~예일여고) 및 포장균열
