(구)남한강교 외관조사망도 바닥판 주형 S6

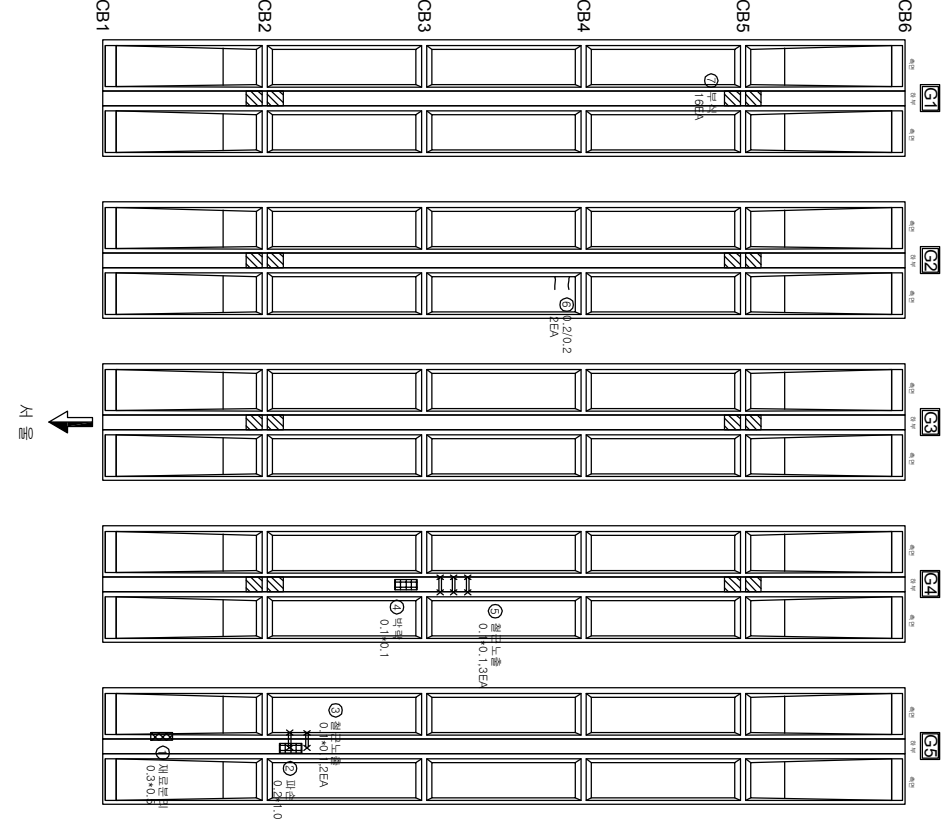
| 번호 | 손상 내용 | 손상 규모 | | | 단위 | 비고 |
|---|---|---|---|---|---|---|
| 1 | 재문판리 | 0.3 | 0.5 | 1 | 0.15 | m <sup>2</sup> |
| 2 | 파손 | 0.2 | 1.0 | 1 | 0.20 | m <sup>2</sup> |
| 3 | 철근노출 | 0.1 | 0.1 | 2 | 0.02 | m <sup>2</sup> |
| 4 | 박락 | 0.1 | 0.1 | 1 | 0.01 | m <sup>2</sup> |
| 5 | 철근노출 | 0.1 | 0.1 | 3 | 0.03 | m <sup>2</sup> |
| 6 | 균열(Cw=0.3mm 이하) | | 0.2 | 2 | 0.40 | m |
| 7 | 철근부식 | | | 16 | 16.00 | ea |
