(구)남한강교 외관조사망도 교각 P17

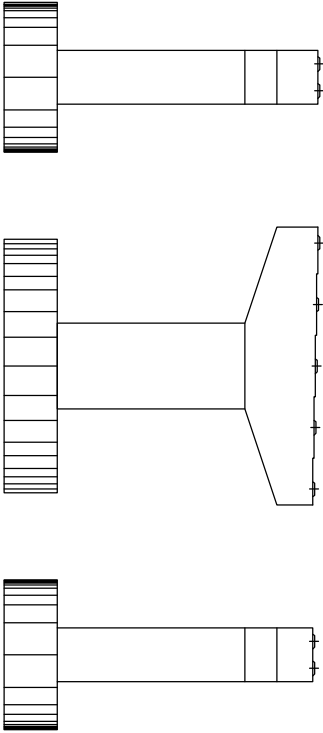
< 서울 방향 >

| 번호 | 손상 내용 | 손상 규모 | | | 단위 | 비고 |
|---|---|---|---|---|---|---|
| 1 | 벽면 | 0.2 | 0.3 | 1 | 0.06 | m <sup>2</sup> |
| 2 | 철근노출 | 0.2 | 2.0 | 1 | 0.40 | m <sup>2</sup> |
| 3 | 균열(Cw=0.3mm/0.1mm) | 0.5 | 0.5 | 2 | 1.00 | m |
| 4 | 균열(Cw=0.3mm/0.6) | 0.5 | 0.5 | 1 | 0.50 | m |
| 5 | 벽면 | 0.3 | 0.8 | 1 | 0.24 | m <sup>2</sup> |
| 6 | 균열(Cw=0.3mm/0.1mm) | 0.8 | 1 | 1 | 0.80 | m |
| 7 | 균열(Cw=0.3mm/0.1mm) | 0.5 | 1 | 1 | 0.50 | m |
