## 02. 오송1교(T1)

## 2.현황사진

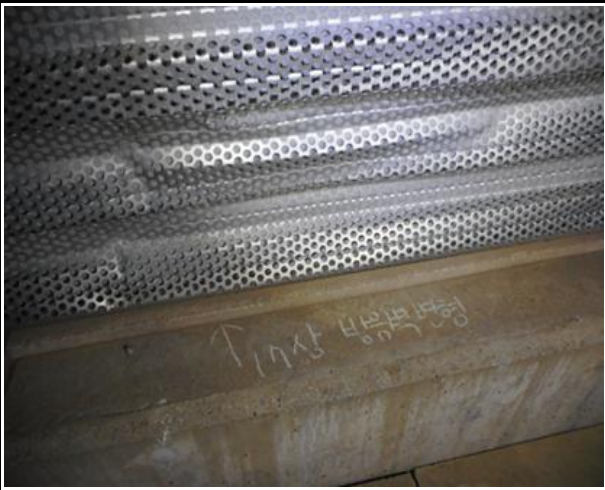
| | 위치 | S1 | 방음벽 | 도면번호 | | HK-오송1교(T1)-1 | 위치 | S1 | 보도부 | 도면번호 | HK-오송1교(T1)-3 |
| | 내용 | 변형 | 0.1m, 0.3m, 1EA | 연번 | HK-오송1교(T1)-1-1 | | 내용 | 덮개설치불량 | --, --, 1EA | 연번 | HK-오송1교(T1)-3-1 |

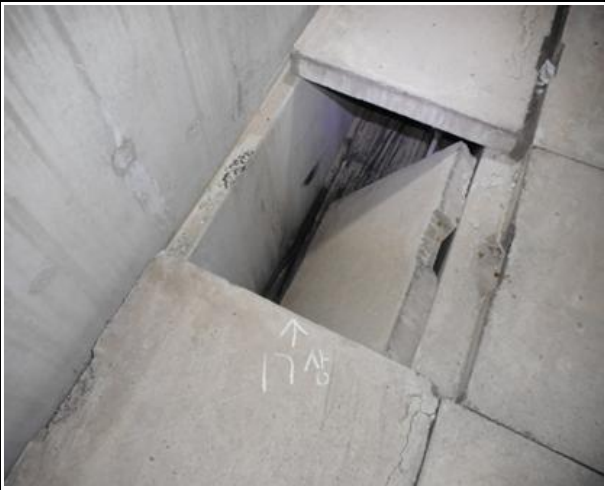
| | 위치 | S2 | 보도부 | 도면번호 | | HK-오송1교(T1)-4 | 위치 | S2 | 보도부 | 도면번호 | HK-오송1교(T1)-5 |
| | 내용 | 덮개파손 | --, --, 1EA | 연번 | HK-오송1교(T1)-4-1 | | 내용 | 덮개파손 | --, --, 1EA | 연번 | HK-오송1교(T1)-5-1 |

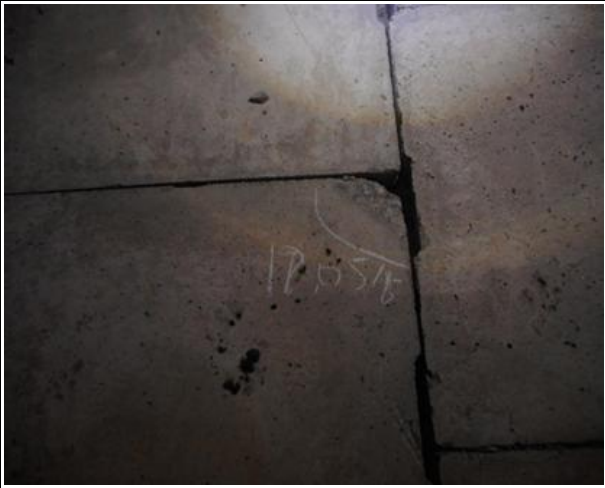
| | 위치 | S2 | 보도부 | 도면번호 | | HK-오송1교(T1)-6 | 위치 | S3 | 방음벽 | 도면번호 | HK-오송1교(T1)-7 |
| | 내용 | 덮개파손 | --, --, 1EA | 연번 | HK-오송1교(T1)-6-1 | | 내용 | 변형 | 1m, 0.5m, 1EA | 연번 | HK-오송1교(T1)-7-1 |

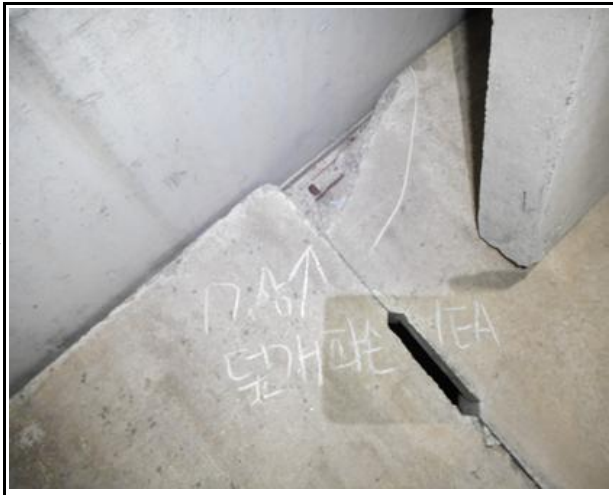
| | 위치 | S3 | 보도부 | 도면번호 | | HK-오송1교(T1)-7 | 위치 | S3 | 보도부 | 도면번호 | HK-오송1교(T1)-7 |
| | 내용 | 덮개파손 | --, --, 1EA | 연번 | HK-오송1교(T1)-7-2 | | 내용 | 덮개설치불량 | --, --, 1EA | 연번 | HK-오송1교(T1)-7-3 |

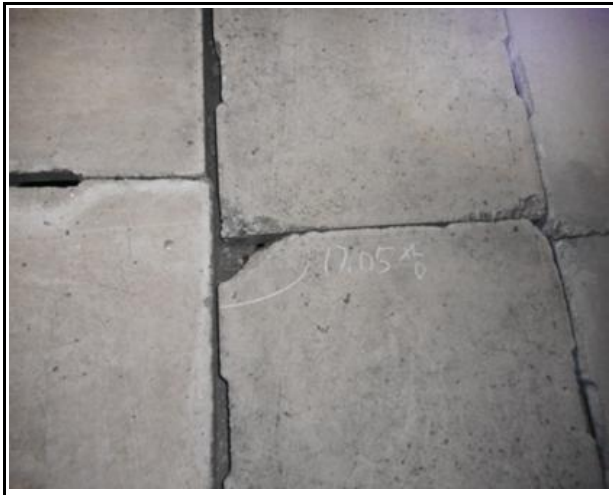
| | 위치 | S3 | 보도부 | 도면번호 | | HK-오송1교(T1)-7 | 위치 | S3 | 보도부 | 도면번호 | HK-오송1교(T1)-8 |
| | 내용 | 덮개파손 | --, --, 1EA | 연번 | HK-오송1교(T1)-7-4 | | 내용 | 덮개설치불량 | --, --, 1EA | 연번 | HK-오송1교(T1)-8-1 |

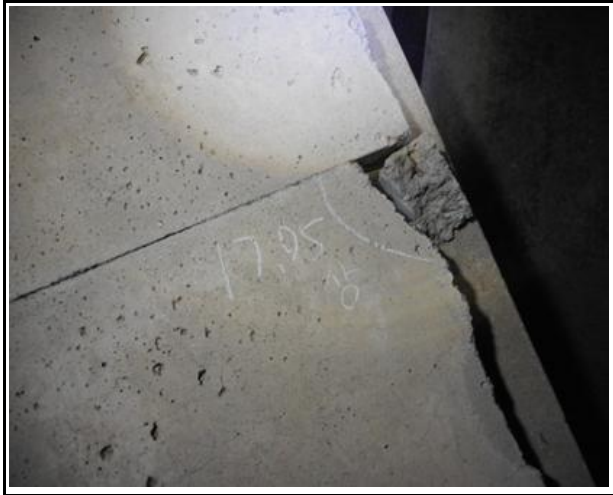
| | 위치 | S4 | 보도부 | 도면번호 | | HK-오송1교(T1)-10 | 위치 | S4 | 보도부 | 도면번호 | HK-오송1교(T1)-10 |
| | 내용 | 덮개파손 | --, --, 1EA | 연번 | HK-오송1교(T1)-10-1 | | 내용 | 덮개파손 | --, --, 1EA | 연번 | HK-오송1교(T1)-10-2 |

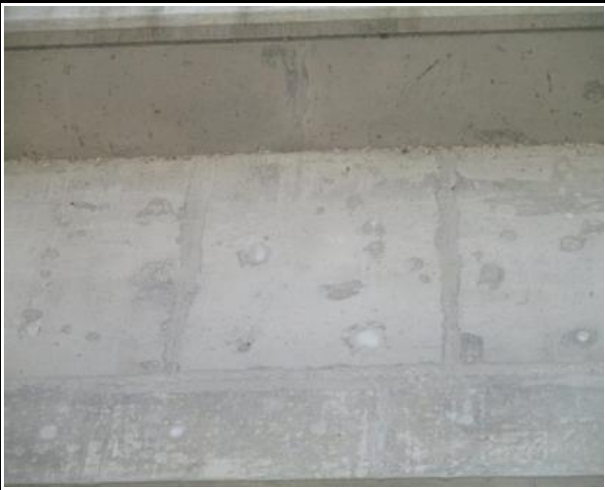
| | 위치 | S1 | 좌벽체 | 도면번호 | | HK-오송1교(T1)-12 | 위치 | S1 | 켄틸레버하면 | 도면번호 | HK-오송1교(T1)-12 |
| 내용 | | 균열(0.3mm미만) 0.2mm, 1.5m, 1EA | | 연번 | HK-오송1교(T1)-12-6 | 내용 | | 콘크리트파손 0.2m, 0.4m, 1EA | | 연번 | HK-오송1교(T1)-12-7 |

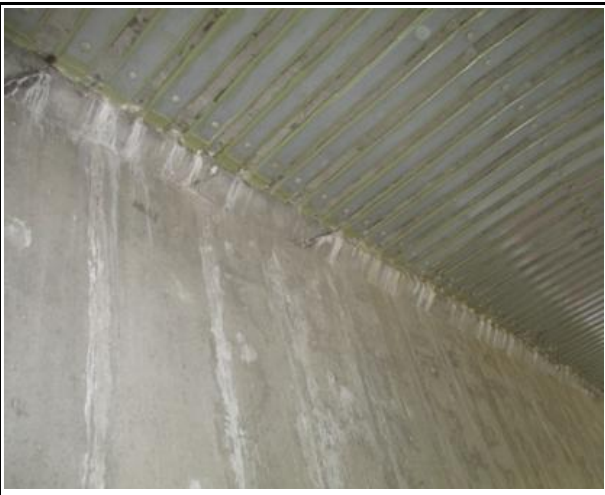
| | 위치 | S1 | 켄틸레버하면 | 도면번호 | | HK-오송1교(T1)-12 | 위치 | S1 | 좌벽체 | 도면번호 | HK-오송1교(T1)-12 |
| 내용 | | 백태 0.2m, 15m, 1EA | | 연번 | HK-오송1교(T1)-12-8 | 내용 | | 균열(0.3mm미만) 0.2mm, 0.5m, 1EA | | 연번 | HK-오송1교(T1)-12-9 |

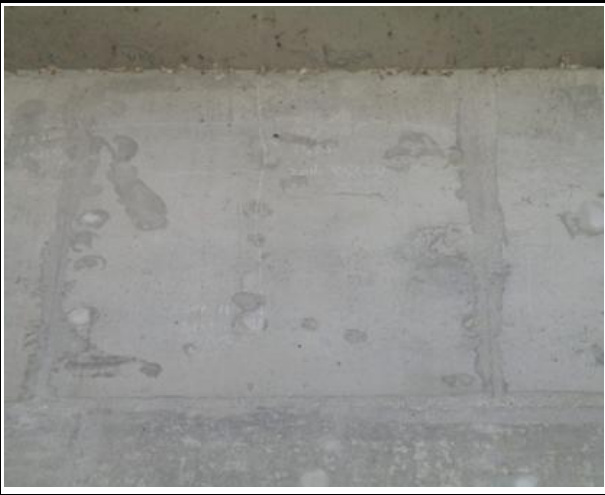
| | 위치 | S1 | 좌측켄틸레버 | 도면번호 | | HK-오송1교(T1)-13 | 위치 | S1 | 좌벽체 | 도면번호 | HK-오송1교(T1)-13 |
| 내용 | | 균열(0.3mm미만) 0.2mm, 5m, 1EA | | 연번 | HK-오송1교(T1)-13-1 | 내용 | | 균열(0.3mm미만) 0.2mm, 2.5m, 1EA | | 연번 | HK-오송1교(T1)-13-2 |

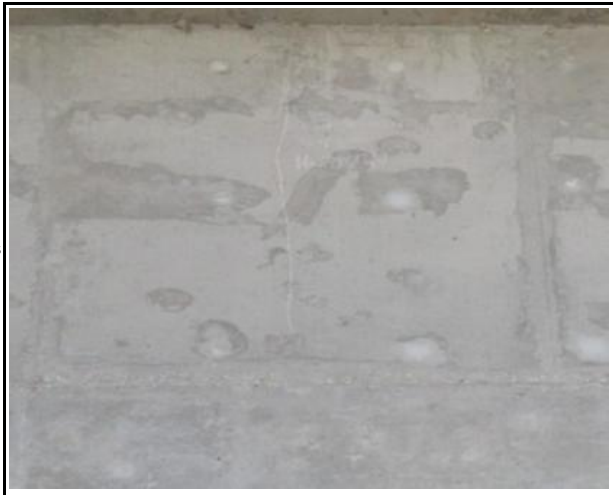
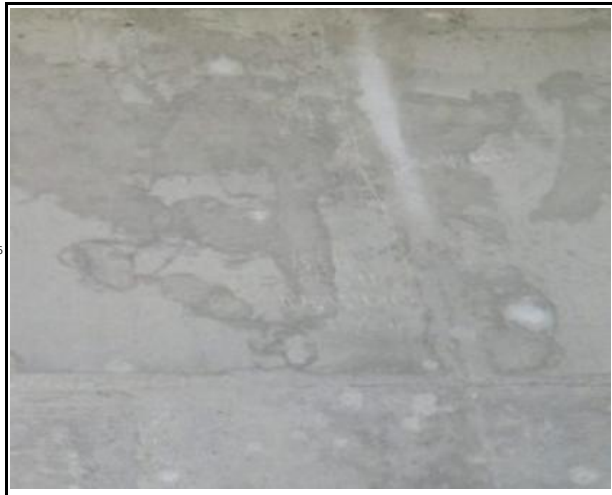
| 25 | | | | | 26 | | | | | |

| | 위치 | S1 | 좌벽체 | 도면번호 | | HK-오송1교(T1)-13 | 위치 | S1 | 좌벽체 | 도면번호 |
| | 내용 | 균열(0.3mm이상) 0.3mm, 2m, 1EA | | 연번 | HK-오송1교(T1)-13-3 | 내용 | 균열(0.3mm미만) 0.2mm, 2m, 1EA | | 연번 | HK-오송1교(T1)-13-4 |

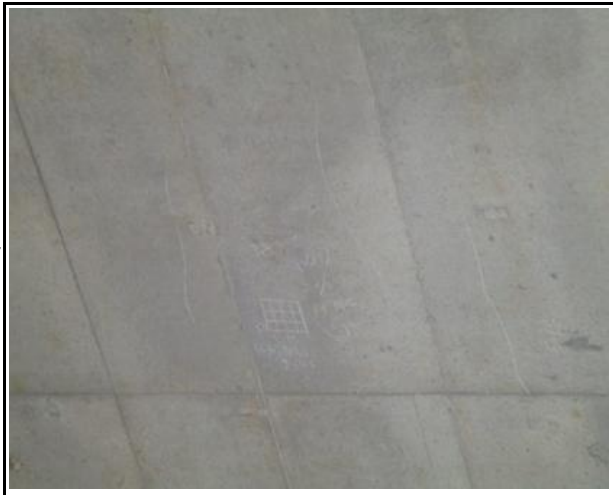
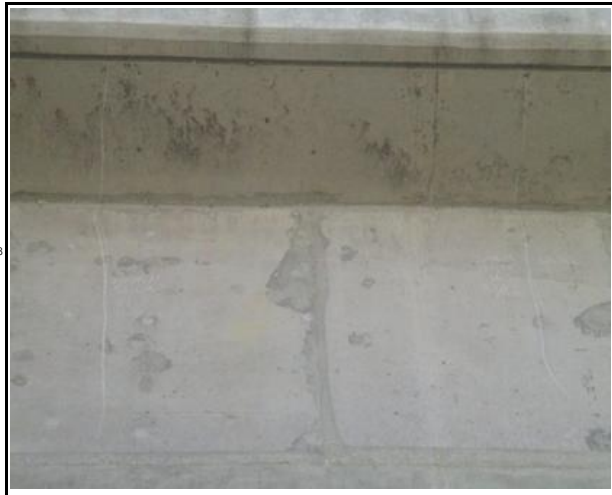
| 27 | | | | | 28 | | | | | |

| | 위치 | S1 | 바닥판하면 | 도면번호 | | HK-오송1교(T1)-14 | 위치 | S1 | 좌벽체 | 도면번호 |
| | 내용 | 균열(0.3mm미만) 0.2mm, 0.5m, 3EA | | 연번 | HK-오송1교(T1)-14-1 | 내용 | 균열(0.3mm미만) 0.2mm, 2m, 2EA | | 연번 | HK-오송1교(T1)-14-2 |

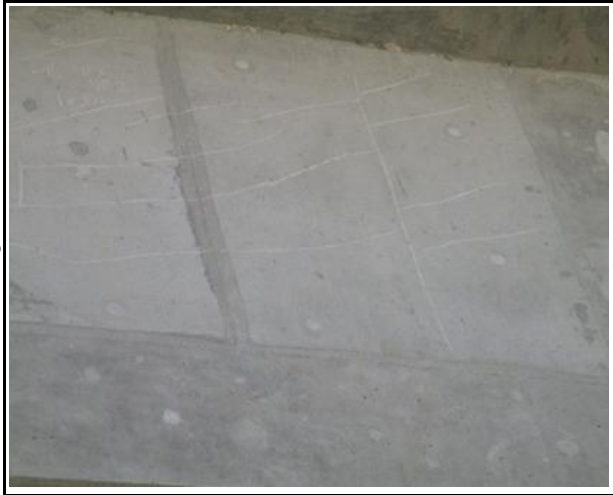
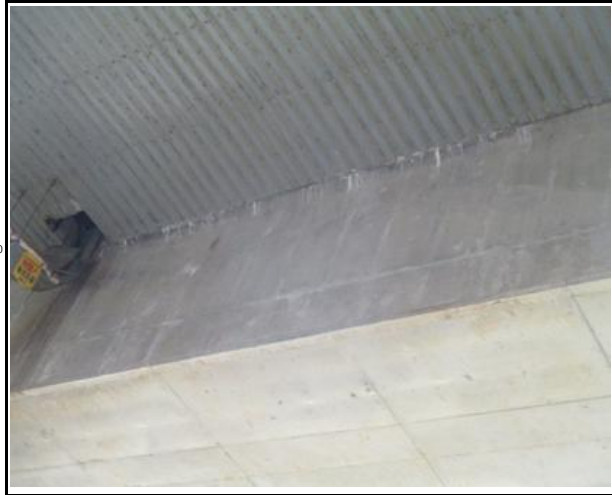
| 29 | | | | | 30 | | | | | |

| | 위치 | S1 | 좌벽체 | 도면번호 | | HK-오송1교(T1)-14 | 위치 | S1 | 우벽체 | 도면번호 |
| | 내용 | 망상균열 1m, 3m, 1EA | | 연번 | HK-오송1교(T1)-14-3 | 내용 | 백태 0.2m, 7m, 1EA | | 연번 | HK-오송1교(T1)-14-4 |

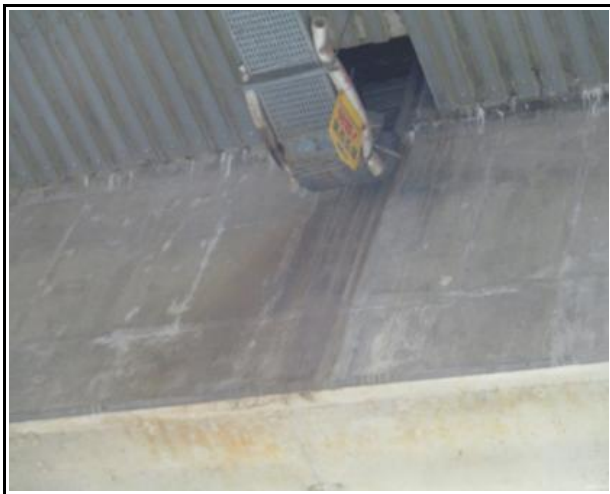
31

| 위치 | S1 | 우벽체 | 도면번호 | HK-오송1교(T1)-14 |
| 내용 | 누수흔적 | 0.6m, 2m, 1EA | 연번 | HK-오송1교(T1)-14-5 |

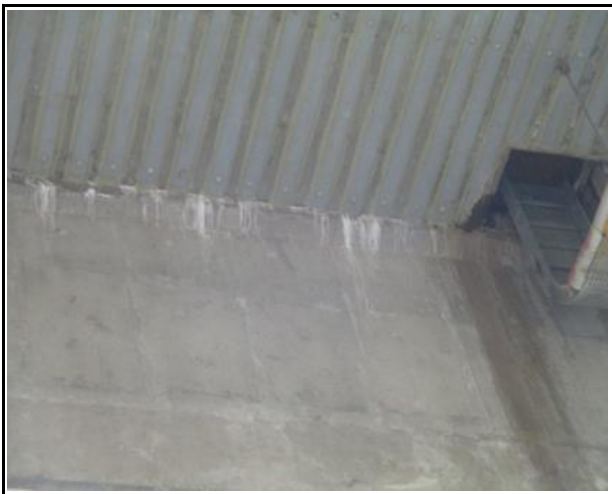
32

| 위치 | S1 | 우벽체 | 도면번호 | HK-오송1교(T1)-14 |
| 내용 | 백태 | 0.2m, 3m, 1EA | 연번 | HK-오송1교(T1)-14-6 |

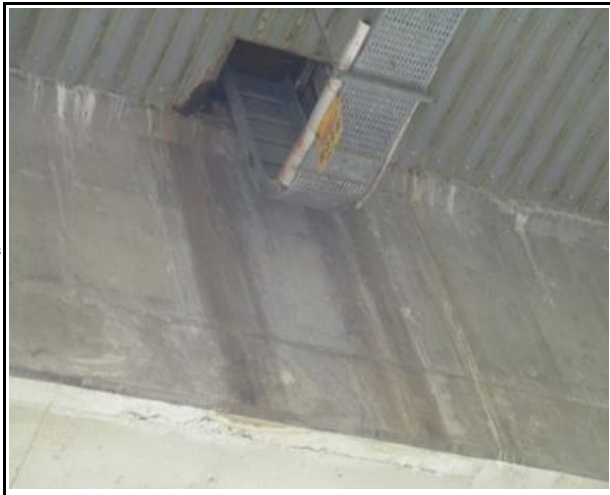
33

| 위치 | S1 | 우벽체 | 도면번호 | HK-오송1교(T1)-14 |
| 내용 | 누수흔적 | 1.5m, 2m, 1EA | 연번 | HK-오송1교(T1)-14-7 |

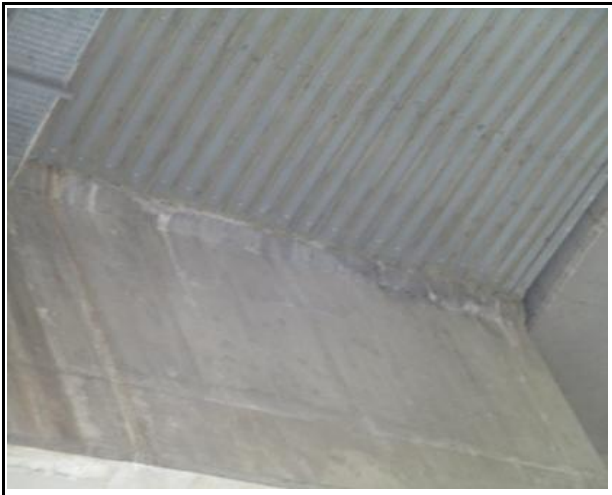
34

| 위치 | S1 | 우벽체 | 도면번호 | HK-오송1교(T1)-14 |
| 내용 | 백태 | 0.2m, 4m, 1EA | 연번 | HK-오송1교(T1)-14-8 |

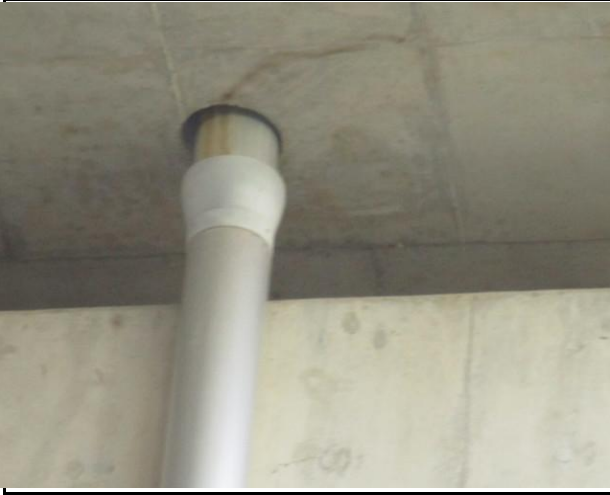
35

| 위치 | S3 | 바닥판하면 | 도면번호 | HK-오송1교(T1)-19 |
| 내용 | 기타 | 0.5m, 0.5m, 1EA | 연번 | HK-오송1교(T1)-19-1 |

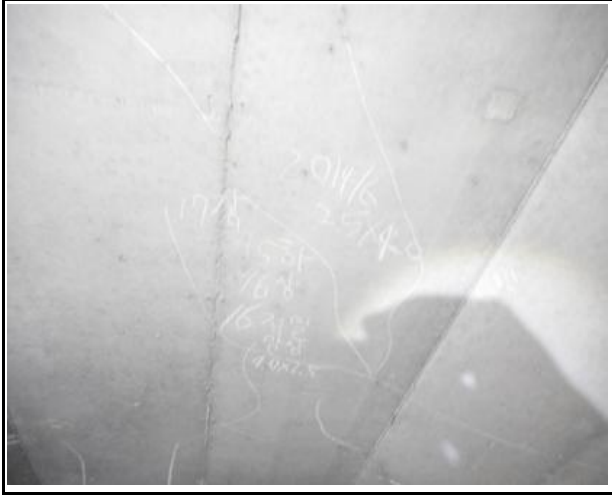
36

| 위치 | S1 | 상부슬래브 | 도면번호 | HK-오송1교(T1)-23 |
| 내용 | 망상균열 | 4m, 2.5m, 1EA | 연번 | HK-오송1교(T1)-23-1 |

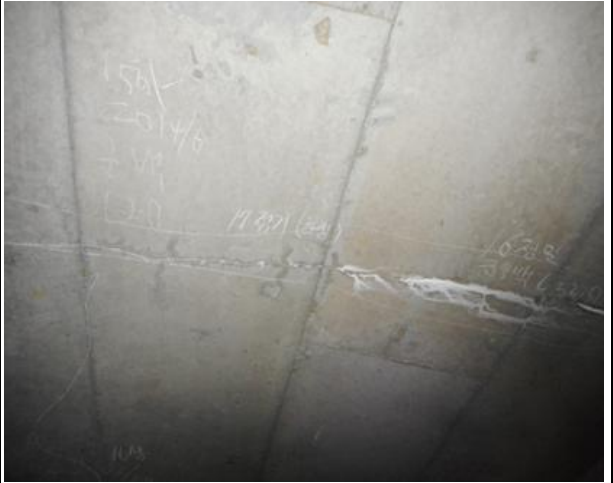
| <div data-bbox="140 678 204 723">위치</div> <div data-bbox="212 678 507 723">S1 상부슬래브</div> <div data-bbox="515 678 627 723">도면번호</div> <div data-bbox="635 678 794 723">HK-오송1교(T1)-23</div> | <div data-bbox="801 678 865 723">위치</div> <div data-bbox="873 678 1160 723">S1 상부슬래브</div> <div data-bbox="1168 678 1279 723">도면번호</div> <div data-bbox="1287 678 1449 723">HK-오송1교(T1)-23</div> |
| <div data-bbox="140 734 204 790">내용</div> <div data-bbox="212 734 507 790">백태 0.2m, 2.5m, 1EA</div> <div data-bbox="515 734 627 790">연번</div> <div data-bbox="635 734 794 790">HK-오송1교(T1)-23-8</div> | <div data-bbox="801 734 865 790">내용</div> <div data-bbox="873 734 1160 790">균열(0.3mm미만) 0.2mm, 2m, 1EA</div> <div data-bbox="1168 734 1279 790">연번</div> <div data-bbox="1287 734 1449 790">HK-오송1교(T1)-23-9</div> |

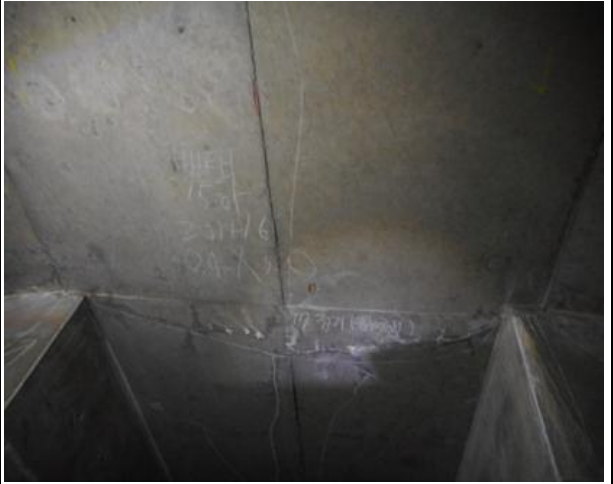
| <div data-bbox="140 1328 204 1373">위치</div> <div data-bbox="212 1328 507 1373">S1 상부슬래브</div> <div data-bbox="515 1328 627 1373">도면번호</div> <div data-bbox="635 1328 794 1373">HK-오송1교(T1)-23</div> | <div data-bbox="801 1328 865 1373">위치</div> <div data-bbox="873 1328 1160 1373">S1 상부슬래브</div> <div data-bbox="1168 1328 1279 1373">도면번호</div> <div data-bbox="1287 1328 1449 1373">HK-오송1교(T1)-23</div> |
| <div data-bbox="140 1384 204 1440">내용</div> <div data-bbox="212 1384 507 1440">백태 0.4m, 3m, 1EA</div> <div data-bbox="515 1384 627 1440">연번</div> <div data-bbox="635 1384 794 1440">HK-오송1교(T1)-23-10</div> | <div data-bbox="801 1384 865 1440">내용</div> <div data-bbox="873 1384 1160 1440">망상균열 0.8m, 3m, 1EA</div> <div data-bbox="1168 1384 1279 1440">연번</div> <div data-bbox="1287 1384 1449 1440">HK-오송1교(T1)-23-11</div> |

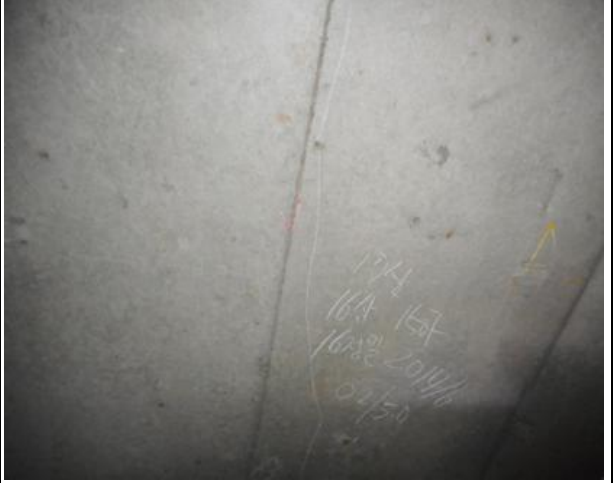
| <div data-bbox="140 1977 204 2022">위치</div> <div data-bbox="212 1977 507 2022">S1 상부슬래브</div> <div data-bbox="515 1977 627 2022">도면번호</div> <div data-bbox="635 1977 794 2022">HK-오송1교(T1)-23</div> | <div data-bbox="801 1977 865 2022">위치</div> <div data-bbox="873 1977 1160 2022">S1 좌벽체</div> <div data-bbox="1168 1977 1279 2022">도면번호</div> <div data-bbox="1287 1977 1449 2022">HK-오송1교(T1)-23</div> |
| <div data-bbox="140 2033 204 2089">내용</div> <div data-bbox="212 2033 507 2089">균열(0.3mm미만) 0.2mm, 1m, 1EA</div> <div data-bbox="515 2033 627 2089">연번</div> <div data-bbox="635 2033 794 2089">HK-오송1교(T1)-23-12</div> | <div data-bbox="801 2033 865 2089">내용</div> <div data-bbox="873 2033 1160 2089">백태 0.2m, 0.4m, 1EA</div> <div data-bbox="1168 2033 1279 2089">연번</div> <div data-bbox="1287 2033 1449 2089">HK-오송1교(T1)-23-13</div> |

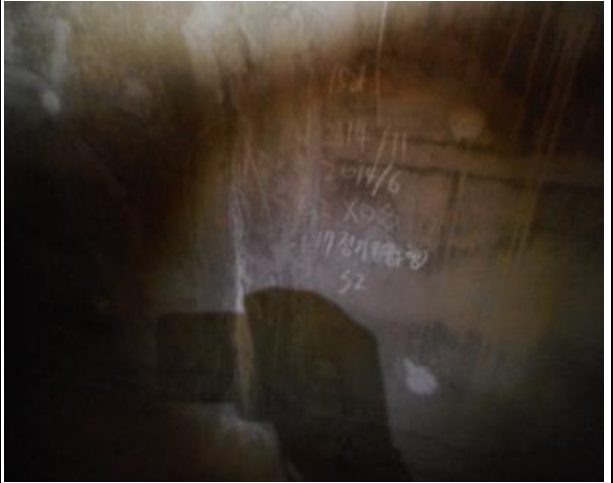
| <div data-bbox="140 678 791 723"> <div>위치</div><div>S1</div><div>좌벽체</div><div>도면번호</div><div>HK-오송1교(T1)-23</div> </div> <div data-bbox="140 734 791 790"> <div>내용</div><div>백태</div><div>0.2m, 0.8m, 1EA</div><div>연번</div><div>HK-오송1교(T1)-23-14</div> </div> | <div data-bbox="804 678 1445 723"> <div>위치</div><div>S1</div><div>좌벽체</div><div>도면번호</div><div>HK-오송1교(T1)-23</div> </div> <div data-bbox="804 734 1445 790"> <div>내용</div><div>백태</div><div>0.1m, 0.8m, 1EA</div><div>연번</div><div>HK-오송1교(T1)-23-15</div> </div> |

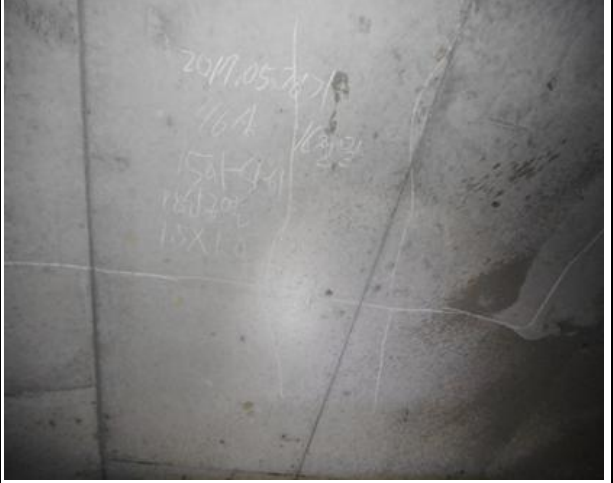
| <div data-bbox="140 1977 791 2022"> <div>위치</div><div>S1</div><div>상부슬래브</div><div>도면번호</div><div>HK-오송1교(T1)-23</div> </div> <div data-bbox="140 2033 791 2089"> <div>내용</div><div>망상균열</div><div>1m, 1.5m, 1EA</div><div>연번</div><div>HK-오송1교(T1)-23-18</div> </div> | <div data-bbox="804 1977 1445 2022"> <div>위치</div><div>S1</div><div>상부슬래브</div><div>도면번호</div><div>HK-오송1교(T1)-23</div> </div> <div data-bbox="804 2033 1445 2089"> <div>내용</div><div>균열(0.3mm미만)</div><div>0.2mm, 0.7m, 1EA</div><div>연번</div><div>HK-오송1교(T1)-23-19</div> </div> |

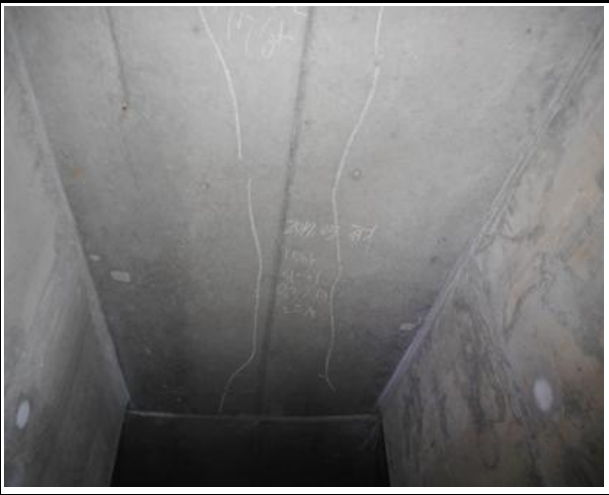
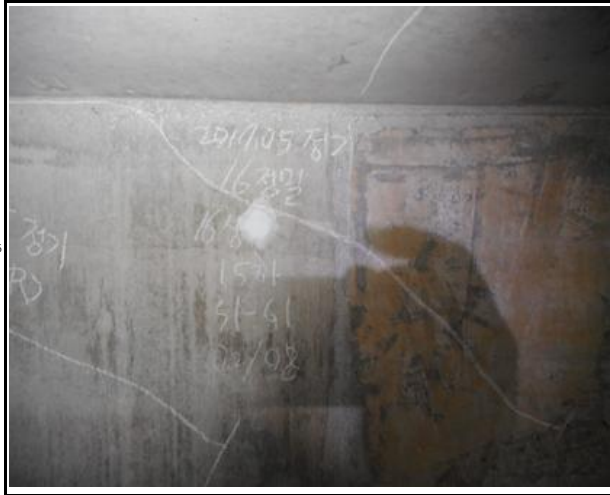
| 55 | | | | | 56 | | | | |

| | 위치 | S1 상부슬래브 | 도면번호 | HK-오송1교(T1)-23 | | 위치 | S1 우벽체 | 도면번호 | HK-오송1교(T1)-23 |
| | 내용 | 균열(0.3mm미만) 0.2mm, 2m, 2EA | 연번 | HK-오송1교(T1)-23-20 | | 내용 | 균열(0.3mm미만) 0.2mm, 0.8m, 1EA | 연번 | HK-오송1교(T1)-23-21 |

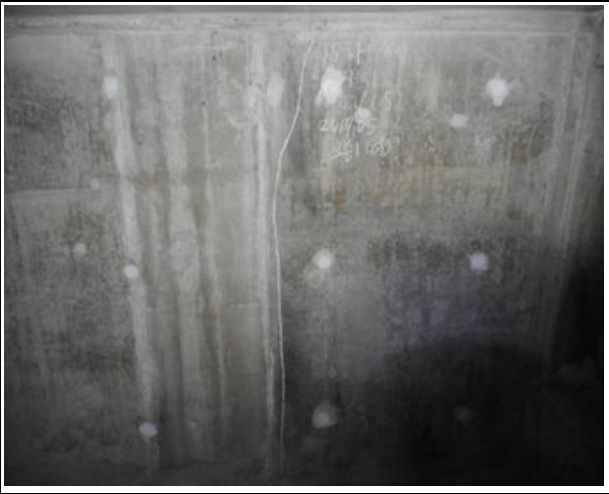
| | 위치 | S1 우벽체 | 도면번호 | HK-오송1교(T1)-23 | | 위치 | S1 우벽체 | 도면번호 | HK-오송1교(T1)-23 |
| | 내용 | 균열(0.3mm미만) 0.2mm, 1.5m, 1EA | 연번 | HK-오송1교(T1)-23-22 | | 내용 | 균열(0.3mm미만) 0.2mm, 1.5m, 1EA | 연번 | HK-오송1교(T1)-23-23 |

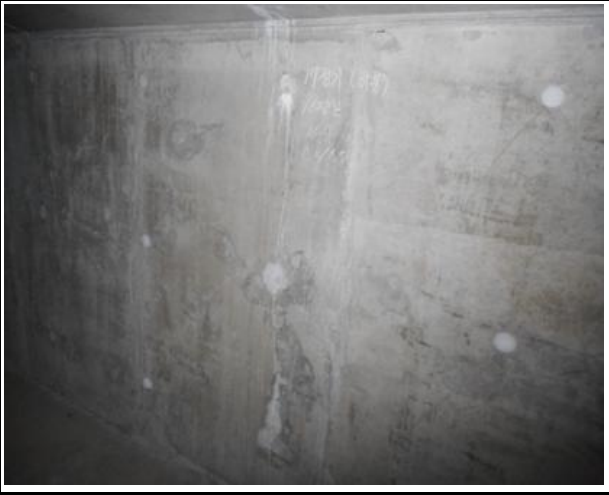
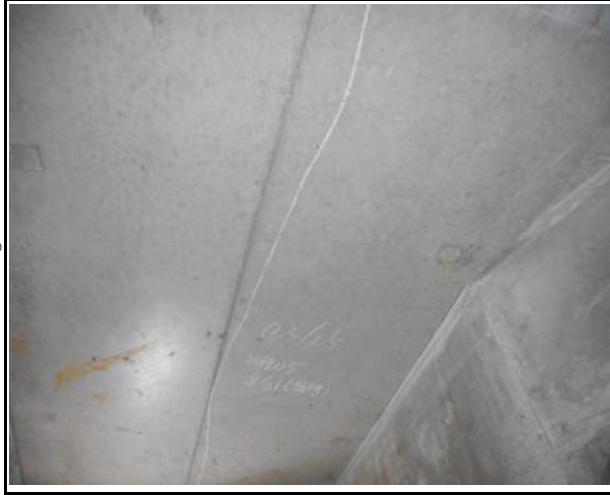
| 59 | | | | | 60 | | | | |

| | 위치 | S1 우벽체 | 도면번호 | HK-오송1교(T1)-23 | | 위치 | S1 상부슬래브 | 도면번호 | HK-오송1교(T1)-23 |
| | 내용 | 균열(0.3mm미만) 0.2mm, 1.5m, 1EA | 연번 | HK-오송1교(T1)-23-24 | | 내용 | 균열(0.3mm미만) 0.2mm, 2.5m, 1EA | 연번 | HK-오송1교(T1)-23-25 |

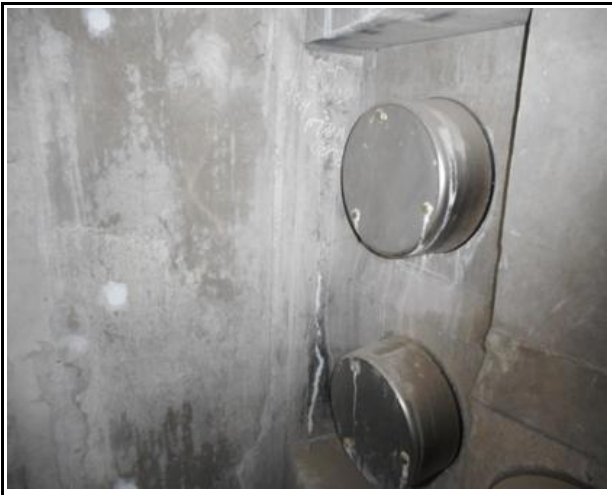
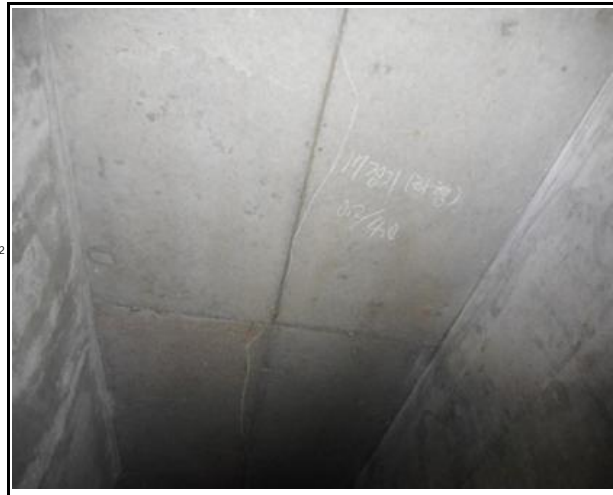
| 61 | | | | | 62 | | | | |

| 위치 | S1 | 상부슬래브 | 도면번호 | HK-오송1교(T1)-23 | 위치 | S1 | 상부슬래브 | 도면번호 | HK-오송1교(T1)-23 |
| 내용 | 백태 | 0.1m, 1m, 1EA | 연번 | HK-오송1교(T1)-23-26 | 내용 | 균열(0.3mm미만) | 0.2mm, 4m, 1EA | 연번 | HK-오송1교(T1)-23-27 |

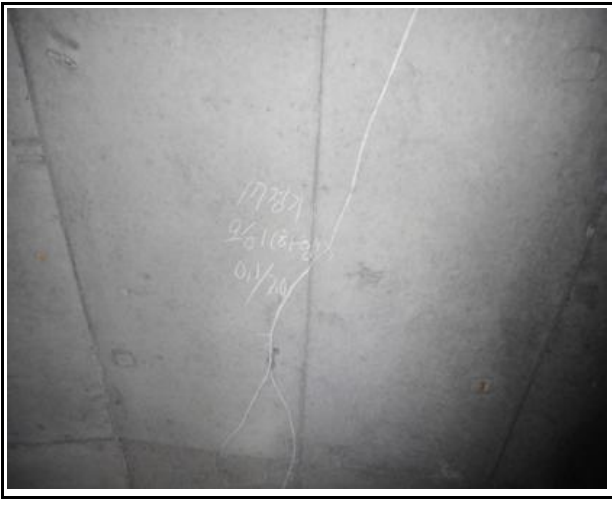
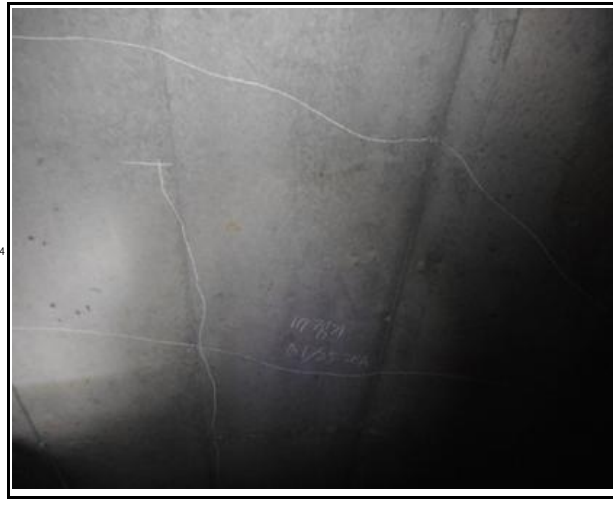
| 63 | | | | | 64 | | | | |

| 위치 | S1 | 상부슬래브 | 도면번호 | HK-오송1교(T1)-23 | 위치 | S1 | 상부슬래브 | 도면번호 | HK-오송1교(T1)-23 |
| 내용 | 균열(0.3mm미만) | 0.1mm, 2m, 1EA | 연번 | HK-오송1교(T1)-23-28 | 내용 | 균열(0.3mm미만) | 0.1mm, 2.5m, 2EA | 연번 | HK-오송1교(T1)-23-29 |

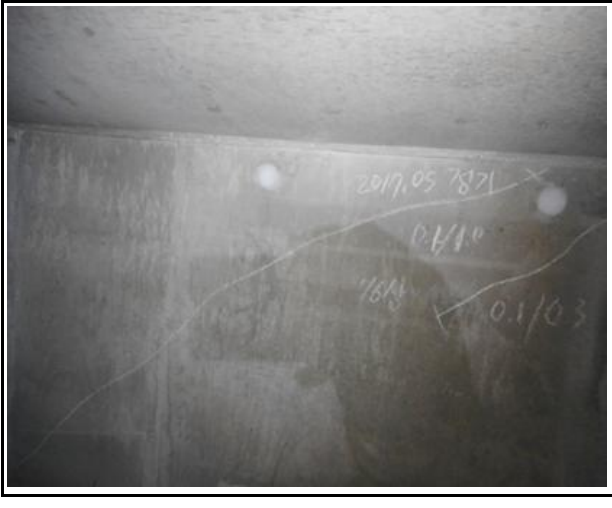
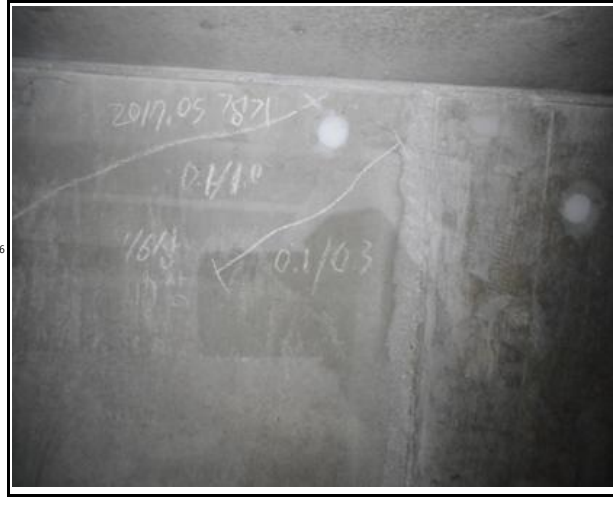
| 65 | | | | | 66 | | | | |

| 위치 | S1 | 좌벽체 | 도면번호 | HK-오송1교(T1)-23 | 위치 | S1 | 좌벽체 | 도면번호 | HK-오송1교(T1)-23 |
| 내용 | 균열(0.3mm미만) | 0.1mm, 1m, 1EA | 연번 | HK-오송1교(T1)-23-30 | 내용 | 균열(0.3mm미만) | 0.1mm, 0.3m, 1EA | 연번 | HK-오송1교(T1)-23-31 |

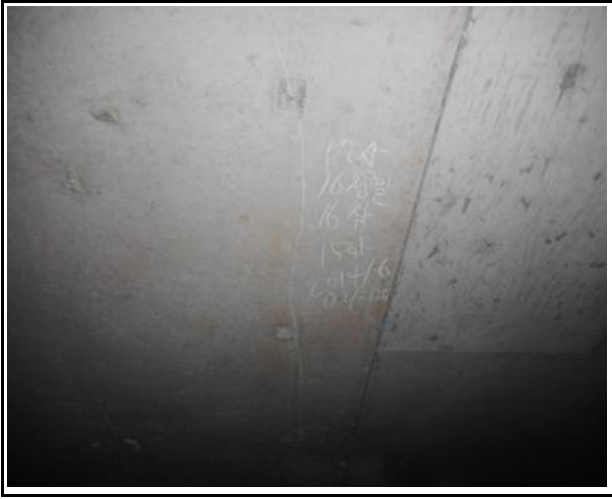
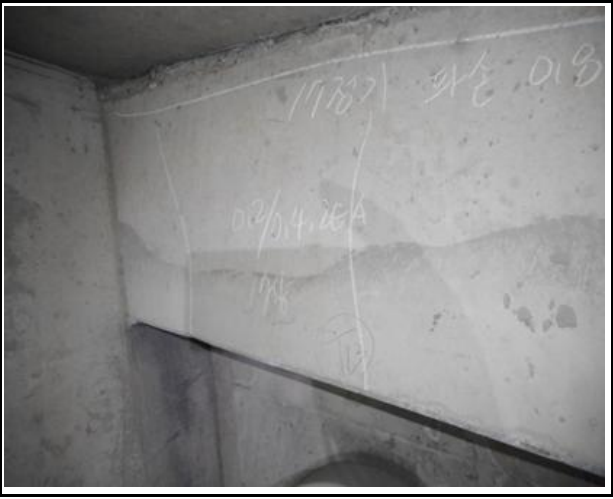
| <div data-bbox="130 678 790 723"> <div>위치</div><div>S2</div><div>상부슬래브</div><div>도면번호</div><div>HK-오송1교(T1)-24</div> </div> <div data-bbox="130 723 790 790"> <div>내용</div><div>균열(0.3mm미만) 0.2mm, 20m, 1EA</div><div>연번</div><div>HK-오송1교(T1)-24-3</div> </div> | <div data-bbox="790 678 1453 723"> <div>위치</div><div>S2</div><div>상부슬래브</div><div>도면번호</div><div>HK-오송1교(T1)-24</div> </div> <div data-bbox="790 723 1453 790"> <div>내용</div><div>균열(0.3mm미만) 0.2mm, 0.4m, 2EA</div><div>연번</div><div>HK-오송1교(T1)-24-4</div> </div> |

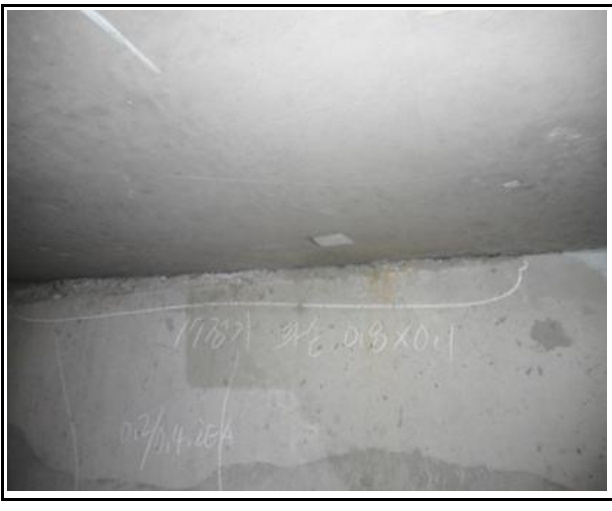
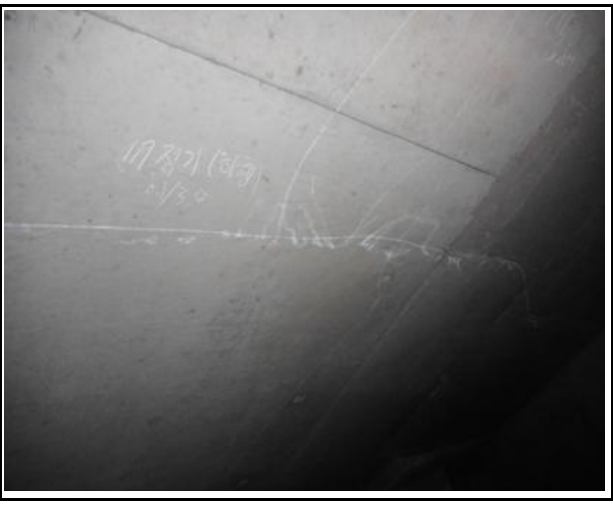
| <div data-bbox="130 1328 790 1373"> <div>위치</div><div>S2</div><div>상부슬래브</div><div>도면번호</div><div>HK-오송1교(T1)-24</div> </div> <div data-bbox="130 1373 790 1440"> <div>내용</div><div>파손 0.1m, 0.8m, 1EA</div><div>연번</div><div>HK-오송1교(T1)-24-5</div> </div> | <div data-bbox="790 1328 1453 1373"> <div>위치</div><div>S2</div><div>상부슬래브</div><div>도면번호</div><div>HK-오송1교(T1)-24</div> </div> <div data-bbox="790 1373 1453 1440"> <div>내용</div><div>균열(0.3mm미만) 0.1mm, 3m, 1EA</div><div>연번</div><div>HK-오송1교(T1)-24-6</div> </div> |

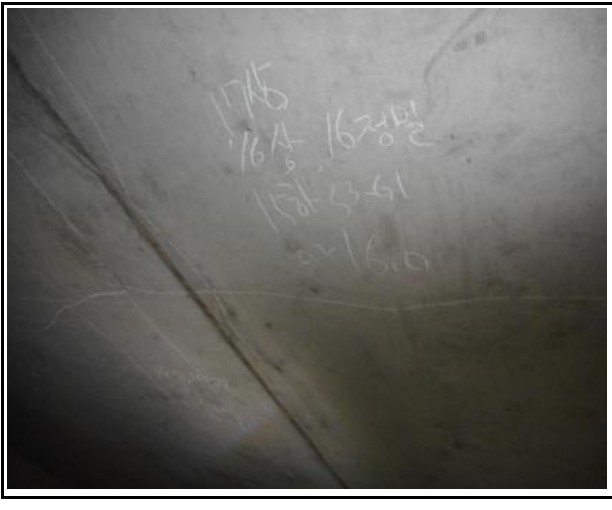
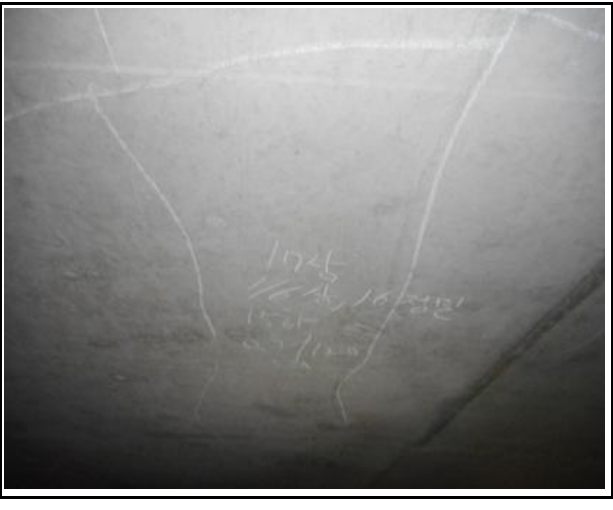
| <div data-bbox="130 1977 790 2022"> <div>위치</div><div>S3</div><div>상부슬래브</div><div>도면번호</div><div>HK-오송1교(T1)-25</div> </div> <div data-bbox="130 2022 790 2085"> <div>내용</div><div>균열(0.3mm미만) 0.2mm, 6m, 1EA</div><div>연번</div><div>HK-오송1교(T1)-25-1</div> </div> | <div data-bbox="790 1977 1453 2022"> <div>위치</div><div>S3</div><div>상부슬래브</div><div>도면번호</div><div>HK-오송1교(T1)-25</div> </div> <div data-bbox="790 2022 1453 2085"> <div>내용</div><div>균열(0.3mm미만) 0.2mm, 12m, 3EA</div><div>연번</div><div>HK-오송1교(T1)-25-2</div> </div> |

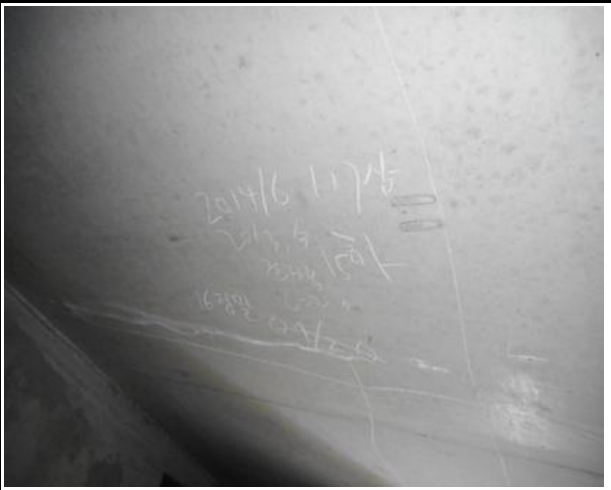
| <div data-bbox="130 678 791 719" data-label="Text"> <div>위치</div><div>S3</div><div>상부슬래브</div><div>도면번호</div><div>HK-오송1교(T1)-25</div> </div> <div data-bbox="130 719 791 790" data-label="Text"> <div>내용</div><div>백태</div><div>0.2m, 2m, 1EA</div><div>연번</div><div>HK-오송1교(T1)-25-3</div> </div> | <div data-bbox="791 678 1453 719" data-label="Text"> <div>위치</div><div>S3</div><div>상부슬래브</div><div>도면번호</div><div>HK-오송1교(T1)-25</div> </div> <div data-bbox="791 719 1453 790" data-label="Text"> <div>내용</div><div>백태</div><div>0.2m, 5m, 1EA</div><div>연번</div><div>HK-오송1교(T1)-25-4</div> </div> |

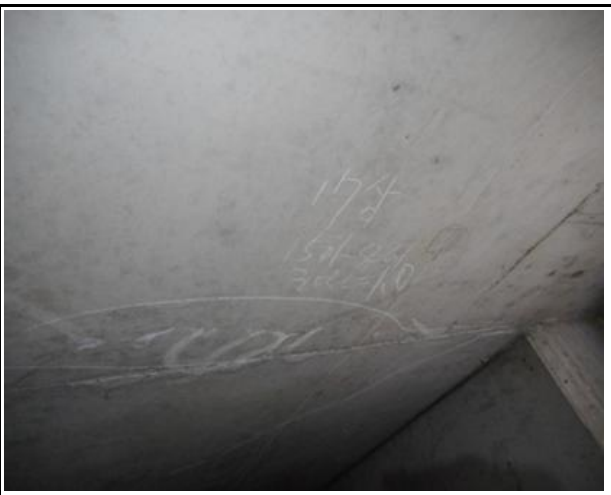
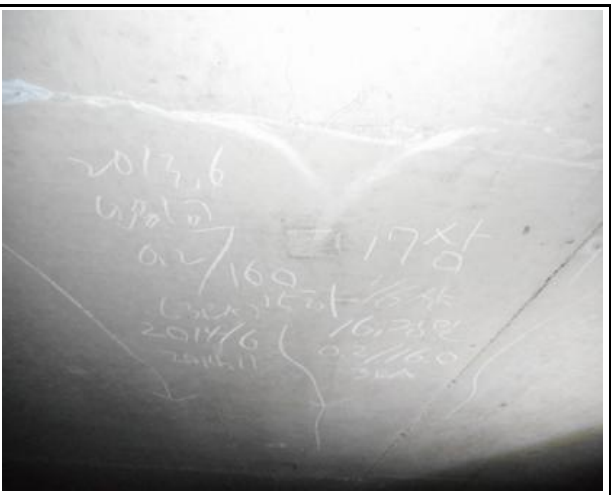
| <div data-bbox="130 1332 791 1373" data-label="Text"> <div>위치</div><div>S3</div><div>상부슬래브</div><div>도면번호</div><div>HK-오송1교(T1)-25</div> </div> <div data-bbox="130 1373 791 1444" data-label="Text"> <div>내용</div><div>균열(0.3mm미만)</div><div>0.2mm, 16m, 3EA</div><div>연번</div><div>HK-오송1교(T1)-25-5</div> </div> | <div data-bbox="791 1332 1453 1373" data-label="Text"> <div>위치</div><div>S3</div><div>상부슬래브</div><div>도면번호</div><div>HK-오송1교(T1)-25</div> </div> <div data-bbox="791 1373 1453 1444" data-label="Text"> <div>내용</div><div>백태</div><div>0.2m, 1m, 1EA</div><div>연번</div><div>HK-오송1교(T1)-25-6</div> </div> |

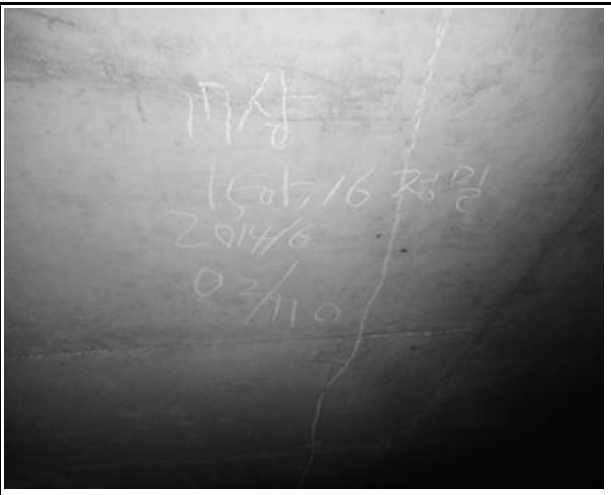
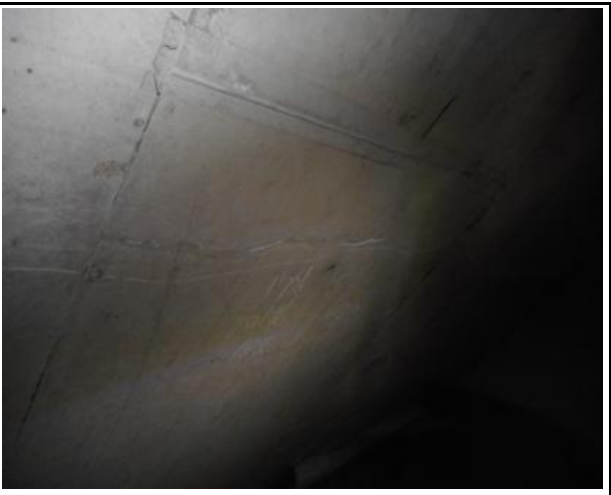
| <div data-bbox="130 1984 791 2024" data-label="Text"> <div>위치</div><div>S3</div><div>상부슬래브</div><div>도면번호</div><div>HK-오송1교(T1)-25</div> </div> <div data-bbox="130 2024 791 2085" data-label="Text"> <div>내용</div><div>균열(0.3mm미만)</div><div>0.2mm, 7m, 1EA</div><div>연번</div><div>HK-오송1교(T1)-25-7</div> </div> | <div data-bbox="791 1984 1453 2024" data-label="Text"> <div>위치</div><div>S3</div><div>상부슬래브</div><div>도면번호</div><div>HK-오송1교(T1)-25</div> </div> <div data-bbox="791 2024 1453 2085" data-label="Text"> <div>내용</div><div>백태</div><div>0.2m, 3m, 1EA</div><div>연번</div><div>HK-오송1교(T1)-25-8</div> </div> |

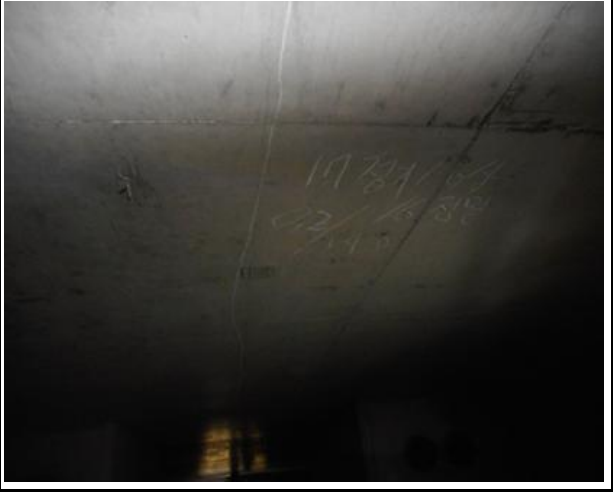
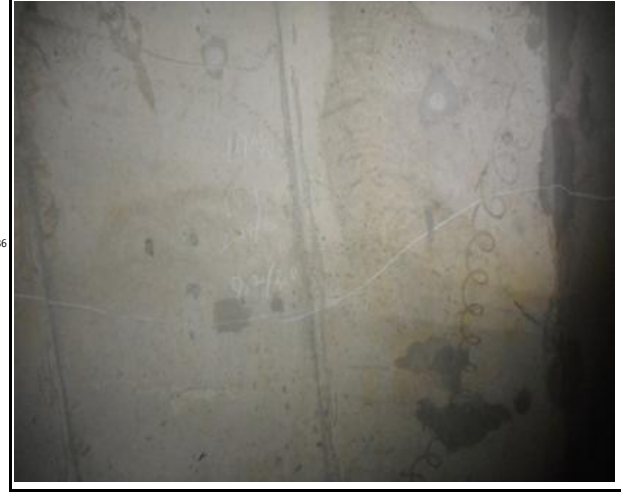
| <div data-bbox="140 683 790 728"> <div>위치</div><div>S3상부슬래브</div><div>도면번호</div><div>HK-오송1교(T1)-25</div> </div> <div data-bbox="140 739 790 795"> <div>내용</div><div>균열(0.3mm미만) 0.2mm, 19m, 1EA</div><div>연번</div><div>HK-오송1교(T1)-25-9</div> </div> | <div data-bbox="790 683 1455 728"> <div>위치</div><div>S3좌벽체</div><div>도면번호</div><div>HK-오송1교(T1)-25</div> </div> <div data-bbox="790 739 1455 795"> <div>내용</div><div>균열(0.3mm미만) 0.2mm, 3m, 1EA</div><div>연번</div><div>HK-오송1교(T1)-25-10</div> </div> |

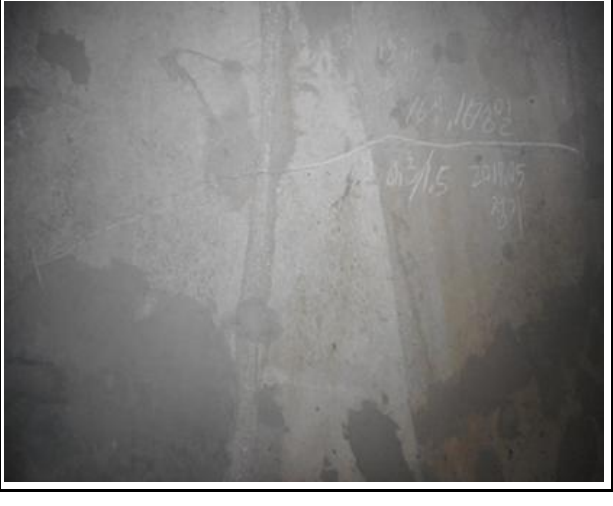
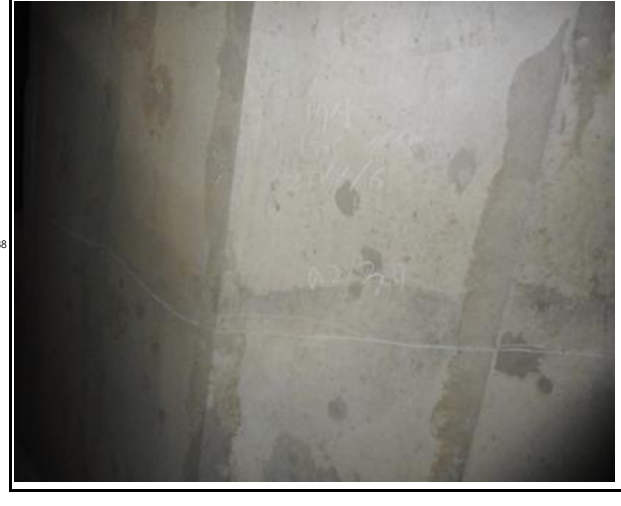
| <div data-bbox="140 1332 790 1377"> <div>위치</div><div>S3좌벽체</div><div>도면번호</div><div>HK-오송1교(T1)-25</div> </div> <div data-bbox="140 1388 790 1444"> <div>내용</div><div>균열(0.3mm미만) 0.2mm, 1.5m, 1EA</div><div>연번</div><div>HK-오송1교(T1)-25-11</div> </div> | <div data-bbox="790 1332 1455 1377"> <div>위치</div><div>S3우벽체</div><div>도면번호</div><div>HK-오송1교(T1)-25</div> </div> <div data-bbox="790 1388 1455 1444"> <div>내용</div><div>균열(0.3mm미만) 0.2mm, 3m, 1EA</div><div>연번</div><div>HK-오송1교(T1)-25-12</div> </div> |

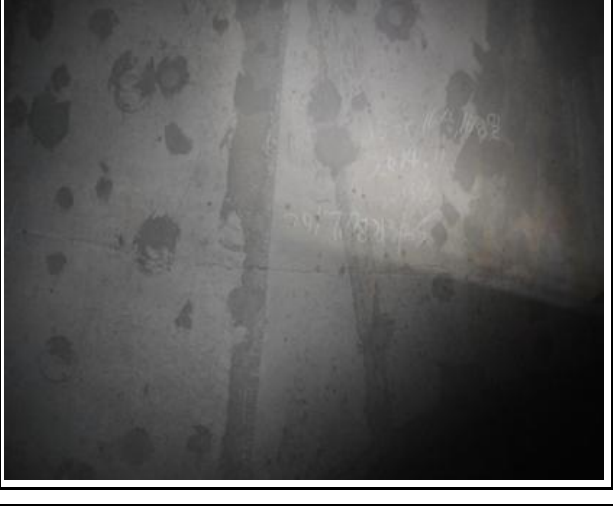
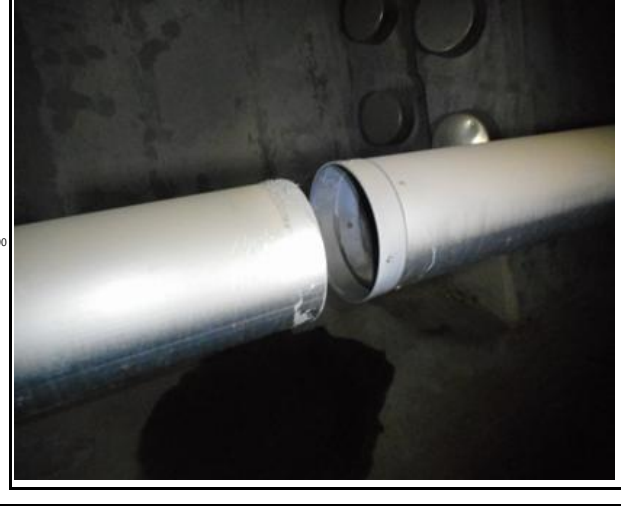
| <div data-bbox="140 1982 790 2027"> <div>위치</div><div>S3우벽체</div><div>도면번호</div><div>HK-오송1교(T1)-25</div> </div> <div data-bbox="140 2038 790 2094"> <div>내용</div><div>균열(0.3mm이상) 0.3mm, 2.5m, 1EA</div><div>연번</div><div>HK-오송1교(T1)-25-13</div> </div> | <div data-bbox="790 1982 1455 2027"> <div>위치</div><div>S3배수시설</div><div>도면번호</div><div>HK-오송1교(T1)-25</div> </div> <div data-bbox="790 2038 1455 2094"> <div>내용</div><div>배수관탈락 --, --, 1EA</div><div>연번</div><div>HK-오송1교(T1)-25-14</div> </div> |

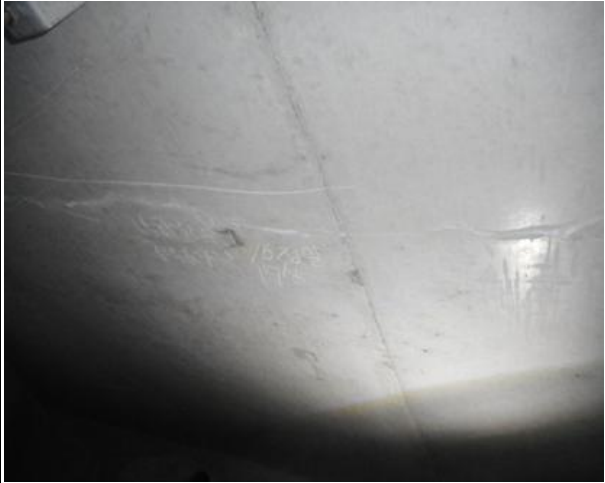
| 위치 | S3 | 상부슬래브 | 도면번호 | HK-오송1교(T1)-25 | 위치 | S3 | 상부슬래브 | 도면번호 | HK-오송1교(T1)-25 |
| 내용 | 백태 | 0.2m, 2m, 1EA | 연번 | HK-오송1교(T1)-25-15 | 내용 | 콘크리트파손 | 0.3m, 0.2m, 2EA | 연번 | HK-오송1교(T1)-25-16 |

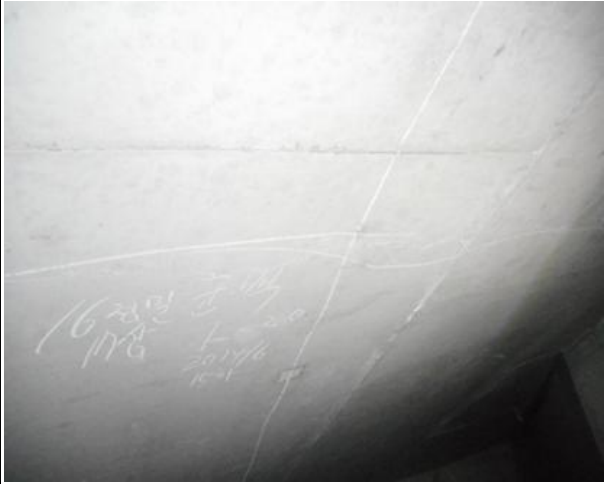
| 93 | | | | | 94 | | | | |

| 위치 | S3 | 상부슬래브 | 도면번호 | HK-오송1교(T1)-25 | 위치 | S3 | 좌벽체 | 도면번호 | HK-오송1교(T1)-25 |
| 내용 | 균열부백태 | 0.2m, 2m, 1EA | 연번 | HK-오송1교(T1)-25-17 | 내용 | 균열(0.3mm미만) | 0.2mm, 3m, 1EA | 연번 | HK-오송1교(T1)-25-19 |

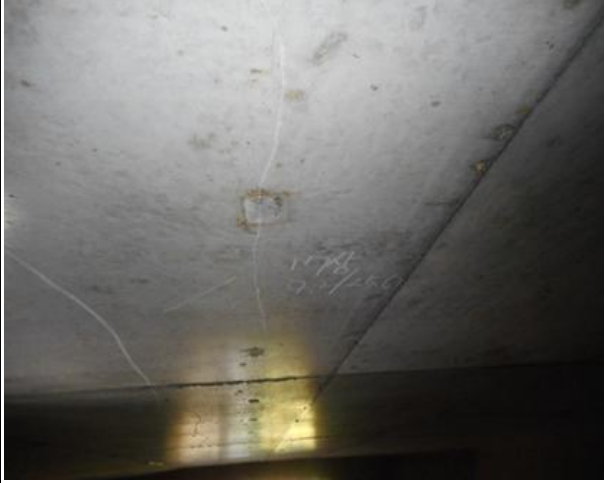
| 95 | | | | | 96 | | | | |

| 위치 | S4 | 상부슬래브 | 도면번호 | HK-오송1교(T1)-26 | 위치 | S4 | 상부슬래브 | 도면번호 | HK-오송1교(T1)-26 |
| 내용 | 균열(0.3mm미만) | 0.2mm, 25m, 1EA | 연번 | HK-오송1교(T1)-26-1 | 내용 | 균열(0.3mm미만) | 0.2mm, 9m, 1EA | 연번 | HK-오송1교(T1)-26-2 |

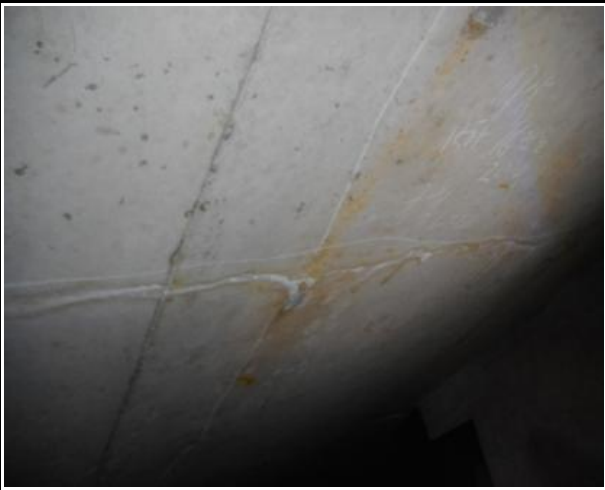
| 위치 | S4 | 상부슬래브 | 도면번호 | HK-오송1교(T1)-26 | 위치 | S4 | 상부슬래브 | 도면번호 | HK-오송1교(T1)-26 |
| 내용 | 백태 | 0.2m, 2m, 1EA | 연번 | HK-오송1교(T1)-26-9 | 내용 | 균열(0.3mm미만) | 0.2mm, 3m, 1EA | 연번 | HK-오송1교(T1)-26-10 |

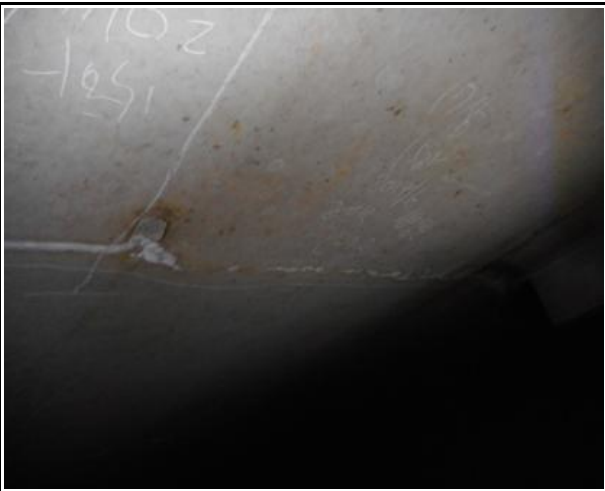
| 위치 | S4 | 상부슬래브 | 도면번호 | HK-오송1교(T1)-26 | 위치 | S4 | 상부슬래브 | 도면번호 | HK-오송1교(T1)-26 |
| 내용 | 백태 | 0.2m, 3m, 1EA | 연번 | HK-오송1교(T1)-26-11 | 내용 | 백태 | 0.2m, 3.5m, 1EA | 연번 | HK-오송1교(T1)-26-12 |

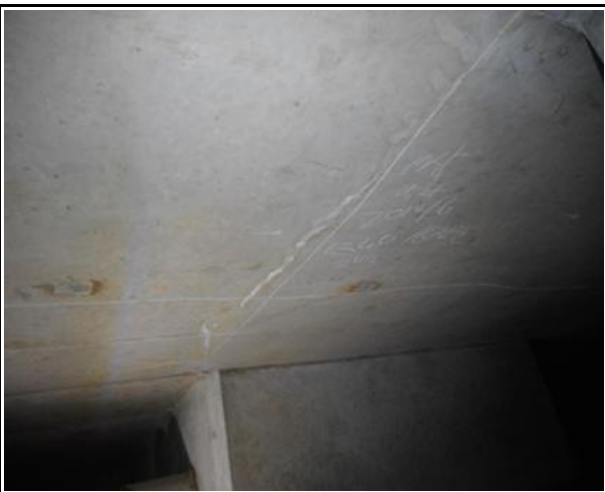
| 위치 | S4 | 상부슬래브 | 도면번호 | HK-오송1교(T1)-26 | 위치 | S4 | 상부슬래브 | 도면번호 | HK-오송1교(T1)-26 |
| 내용 | 백태 | 0.2m, 2m, 1EA | 연번 | HK-오송1교(T1)-26-13 | 내용 | 백태 | 0.2m, 1m, 1EA | 연번 | HK-오송1교(T1)-26-14 |

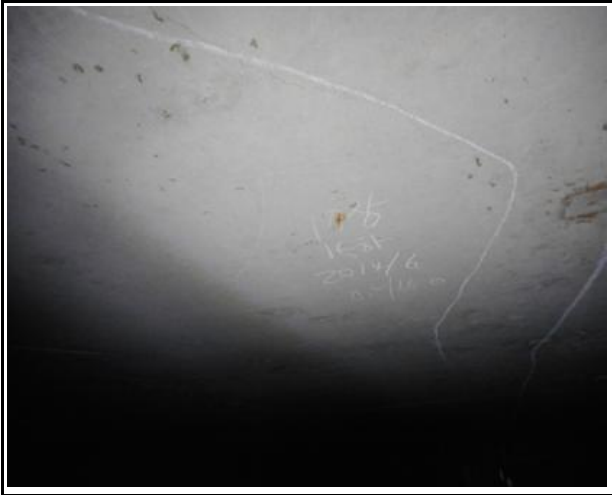
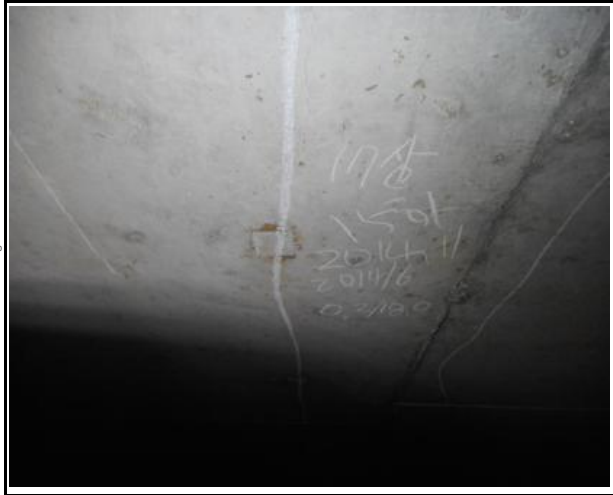
| <div> <div>109</div> <div> <div>위치</div> <div>S4상부슬래브</div> <div>도면번호</div> <div>HK-오송1교(T1)-26</div> </div> </div> | <div> <div>110</div> <div> <div>위치</div> <div>S4상부슬래브</div> <div>도면번호</div> <div>HK-오송1교(T1)-26</div> </div> </div> |
| <div> <div>내용</div> <div>균열(0.3mm미만) 0.2mm, 15m, 1EA</div> <div>연번</div> <div>HK-오송1교(T1)-26-15</div> </div> | <div> <div>내용</div> <div>균열(0.3mm미만) 0.2mm, 18m, 1EA</div> <div>연번</div> <div>HK-오송1교(T1)-26-16</div> </div> |
