## 02. 오송1교(T1)

## 2.현황사진

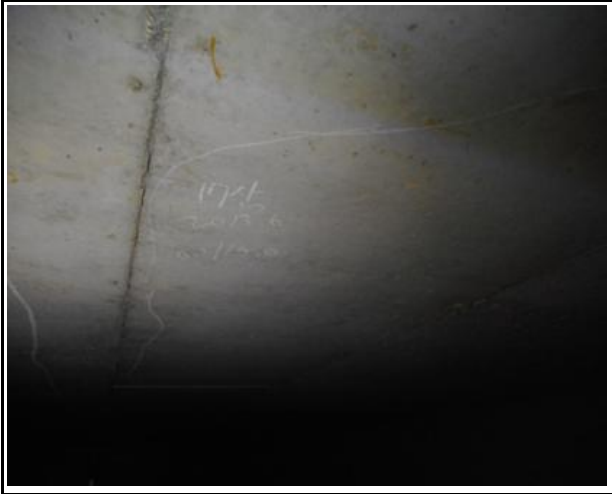
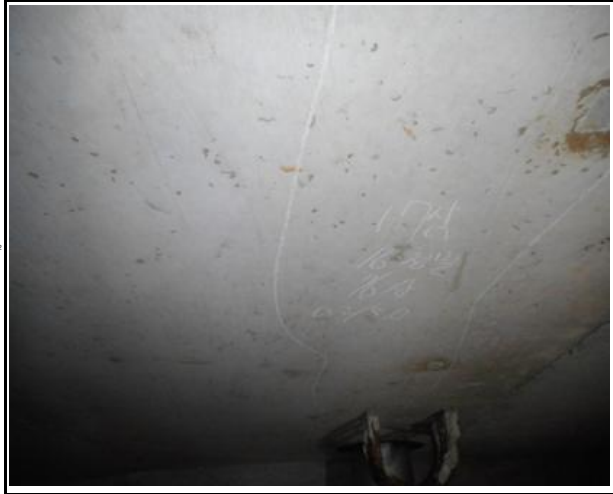
| <div> <div>111</div> <div> <div>위치</div> <div>S4상부슬래브</div> <div>도면번호</div> <div>HK-오송1교(T1)-26</div> </div> </div> | <div> <div>112</div> <div> <div>위치</div> <div>S4상부슬래브</div> <div>도면번호</div> <div>HK-오송1교(T1)-26</div> </div> </div> |
| <div> <div>내용</div> <div>균열(0.3mm미만) 0.2mm, 15m, 1EA</div> <div>연번</div> <div>HK-오송1교(T1)-26-17</div> </div> | <div> <div>내용</div> <div>균열(0.3mm미만) 0.2mm, 5m, 1EA</div> <div>연번</div> <div>HK-오송1교(T1)-26-18</div> </div> |

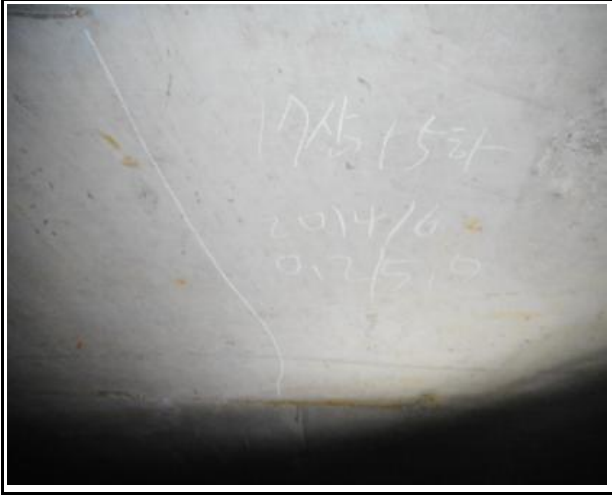
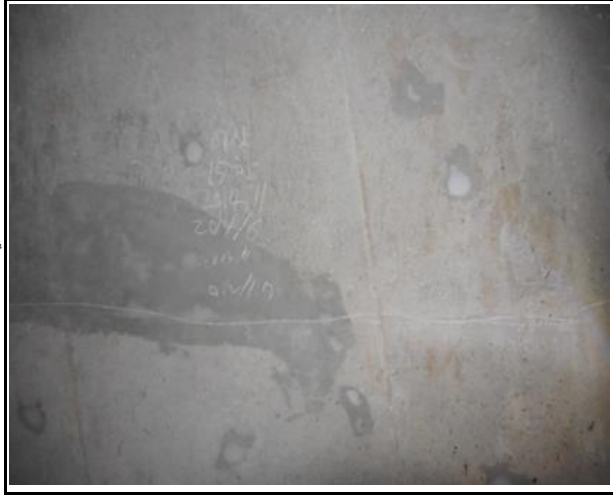
| <div> <div>113</div> <div> <div>위치</div> <div>S4상부슬래브</div> <div>도면번호</div> <div>HK-오송1교(T1)-26</div> </div> </div> | <div> <div>114</div> <div> <div>위치</div> <div>S4우벽체</div> <div>도면번호</div> <div>HK-오송1교(T1)-26</div> </div> </div> |
| <div> <div>내용</div> <div>균열(0.3mm미만) 0.2mm, 5m, 1EA</div> <div>연번</div> <div>HK-오송1교(T1)-26-19</div> </div> | <div> <div>내용</div> <div>균열(0.3mm미만) 0.2mm, 1.7m, 1EA</div> <div>연번</div> <div>HK-오송1교(T1)-26-20</div> </div> |

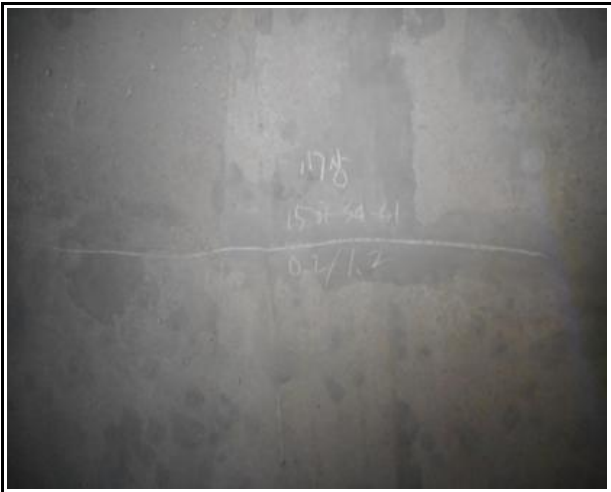
| <div>115</div> | | | | <div>116</div> | | | | | |

| 위치 | S4 | 우벽체 | 도면번호 | HK-오송1교(T1)-26 | 위치 | S4 | 상부슬래브 | 도면번호 | HK-오송1교(T1)-26 |
| 내용 | 균열(0.3mm미만) 0.2mm, 1.2m, 1EA | | 연번 | HK-오송1교(T1)-26-21 | 내용 | 배수관불량 --, --, 1EA | | 연번 | HK-오송1교(T1)-26-22 |

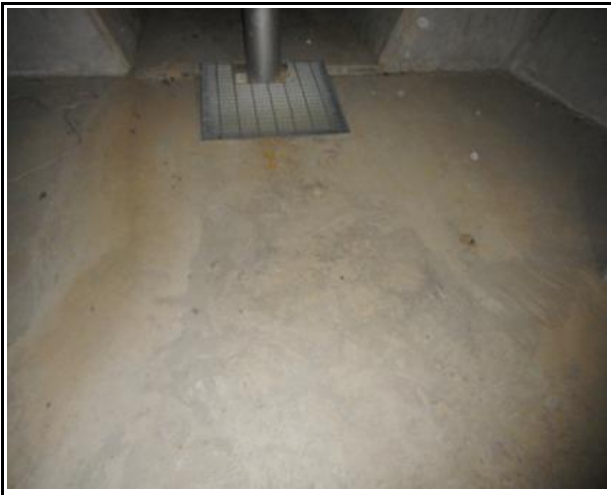
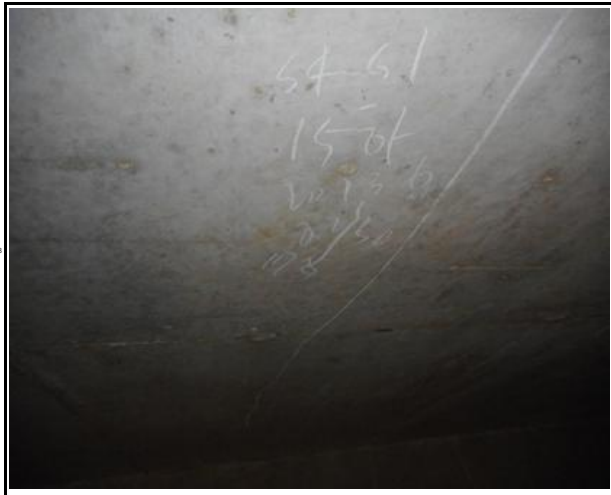
| <div>117</div> | | | | <div>118</div> | | | | | |

| 위치 | S4 | 바닥판하면 | 도면번호 | HK-오송1교(T1)-26 | 위치 | S4 | 상부슬래브 | 도면번호 | HK-오송1교(T1)-26 |
| 내용 | 체수 | 2m, 7m, 1EA | 연번 | HK-오송1교(T1)-26-23 | 내용 | 균열(0.3mm미만) 0.1mm, 5m, 1EA | | 연번 | HK-오송1교(T1)-26-24 |

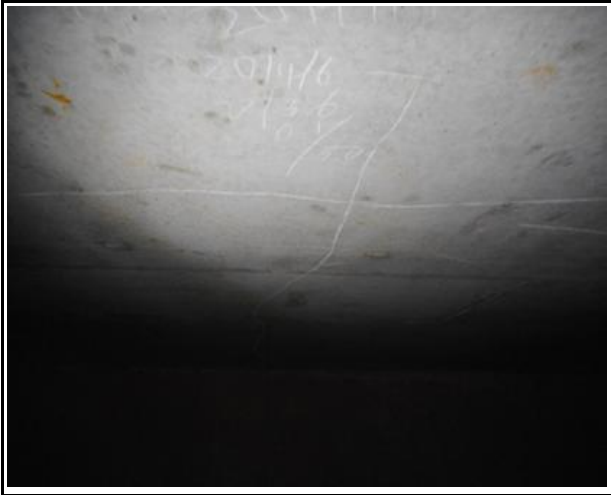
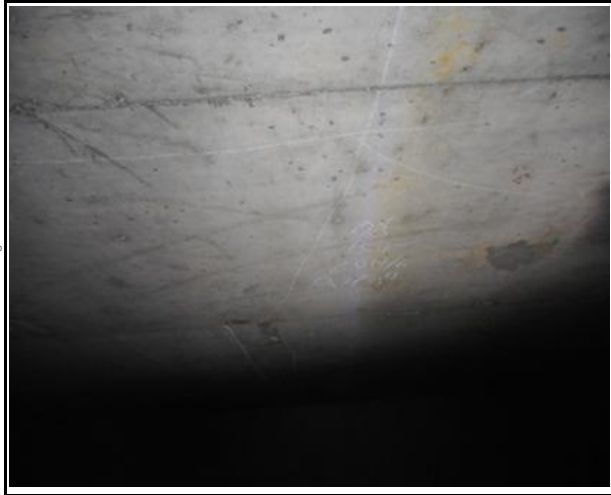
| <div>119</div> | | | | <div>120</div> | | | | | |

| 위치 | S4 | 상부슬래브 | 도면번호 | HK-오송1교(T1)-26 | 위치 | S4 | 상부슬래브 | 도면번호 | HK-오송1교(T1)-26 |
| 내용 | 균열(0.3mm미만) 0.1mm, 3m, 1EA | | 연번 | HK-오송1교(T1)-26-25 | 내용 | 균열(0.3mm미만) 0.2mm, 5m, 1EA | | 연번 | HK-오송1교(T1)-26-26 |

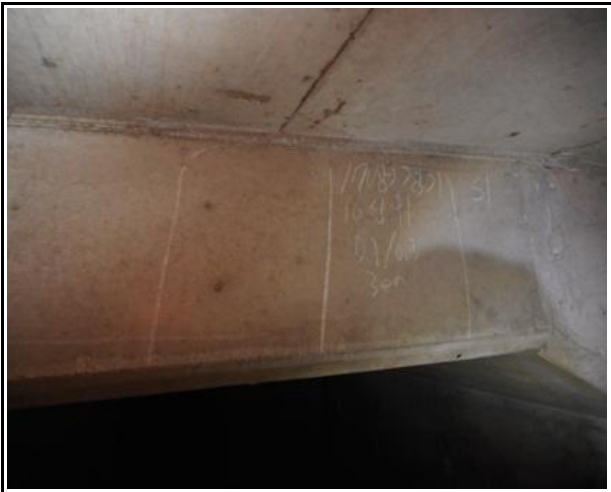
| <div><div>121</div><div></div></div> | | | | <div><div>122</div><div></div></div> | | | | | |

| 위치 | S1 | 격벽 | 도면번호 | HK-오송1교(T1)-27 | 위치 | S1 | 격벽 | 도면번호 | HK-오송1교(T1)-27 |
| 내용 | 망상균열 | 0.3m, 1m, 1EA | 연번 | HK-오송1교(T1)-27-1 | 내용 | 균열(0.3mm미만) | 0.1mm, 0.3m, 3EA | 연번 | HK-오송1교(T1)-27-2 |

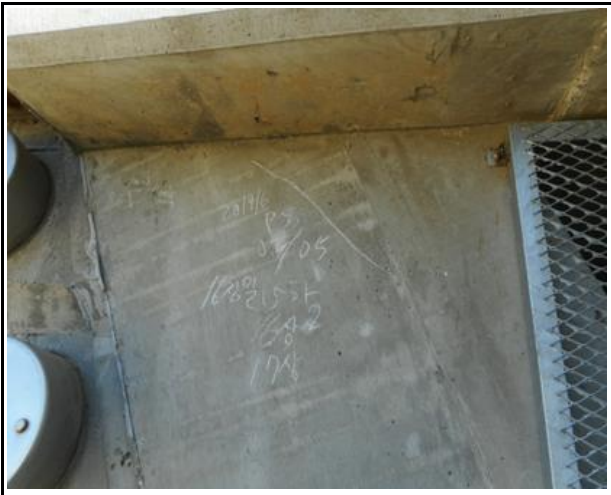
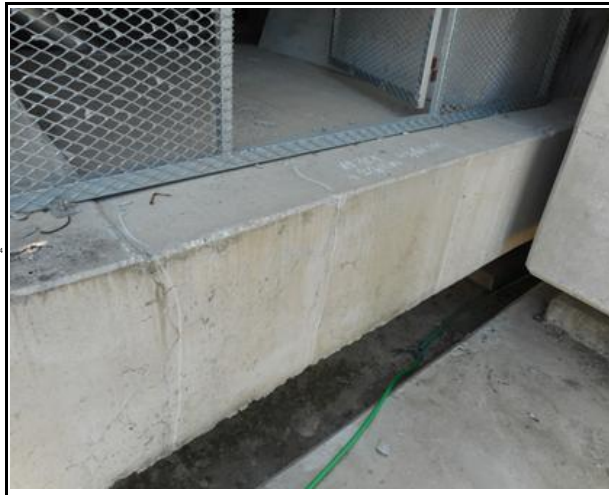
| <div><div>123</div><div></div></div> | | | | <div><div>124</div><div></div></div> | | | | | |

| 위치 | S2 | 격벽 | 도면번호 | HK-오송1교(T1)-30 | 위치 | S2 | 격벽 | 도면번호 | HK-오송1교(T1)-30 |
| 내용 | 균열(0.3mm미만) | 0.2mm, 0.5m, 1EA | 연번 | HK-오송1교(T1)-30-1 | 내용 | 균열(0.3mm이상) | 0.3mm, 1m, 4EA | 연번 | HK-오송1교(T1)-30-2 |

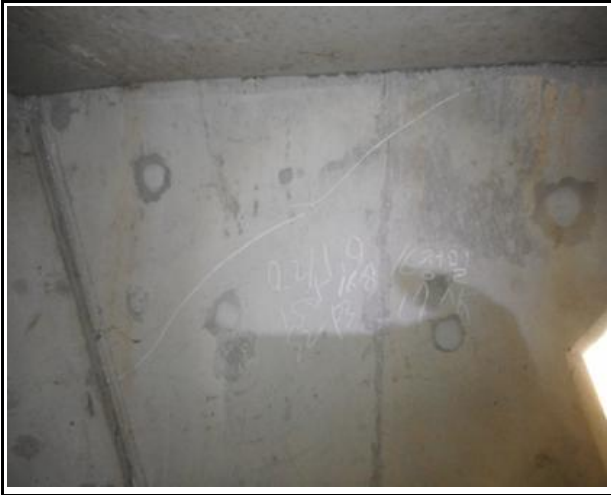
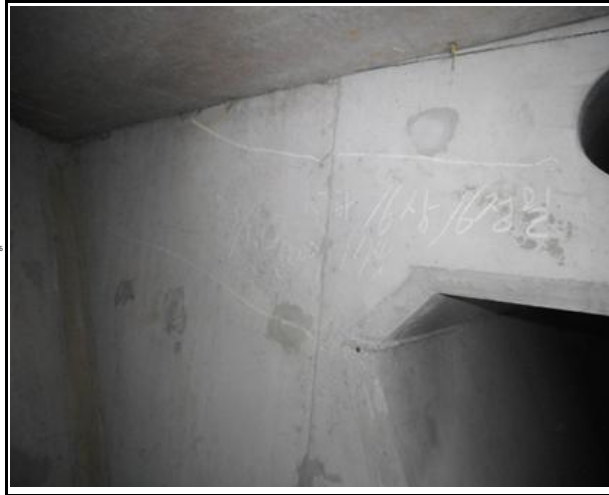
| <div><div>125</div><div></div></div> | | | | <div><div>126</div><div></div></div> | | | | | |

| 위치 | S2 | 격벽 | 도면번호 | HK-오송1교(T1)-30 | 위치 | S2 | 격벽 | 도면번호 | HK-오송1교(T1)-31 |
| 내용 | 균열(0.3mm미만) | 0.2mm, 1m, 1EA | 연번 | HK-오송1교(T1)-30-5 | 내용 | 균열(0.3mm이상) | 0.3mm, 1m, 1EA | 연번 | HK-오송1교(T1)-31-1 |

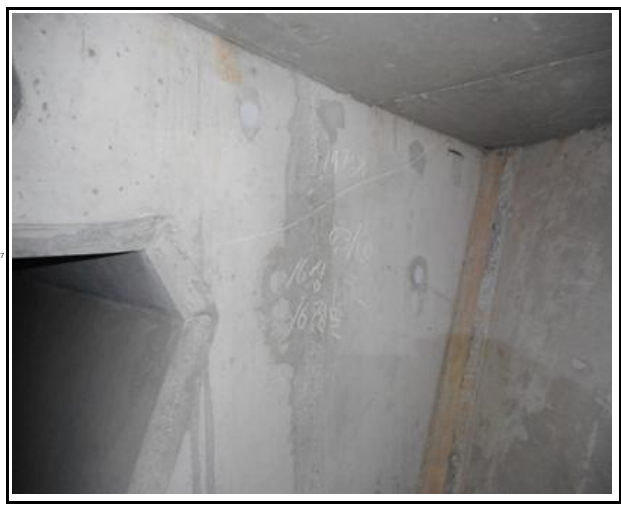
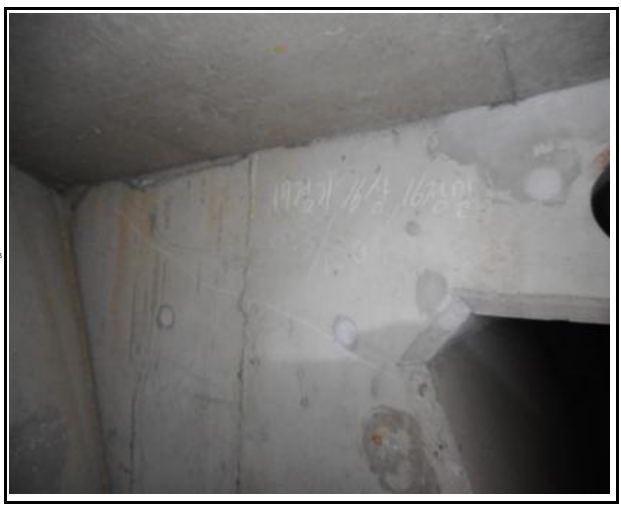
| <div data-bbox="130 660 790 728"> <div>위치</div> <div>S2      격벽</div> <div>도면번호</div> <div>HK-오송1교(T1)-31</div> </div> <div data-bbox="130 728 790 795"> <div>내용</div> <div>균열(0.3mm이상) 0.3mm, 1m, 1EA</div> <div>연번</div> <div>HK-오송1교(T1)-31-2</div> </div> | <div data-bbox="790 660 1455 728"> <div>위치</div> <div>S2      격벽</div> <div>도면번호</div> <div>HK-오송1교(T1)-31</div> </div> <div data-bbox="790 728 1455 795"> <div>내용</div> <div>균열(0.3mm이상) 0.3mm, 1m, 2EA</div> <div>연번</div> <div>HK-오송1교(T1)-31-3</div> </div> |

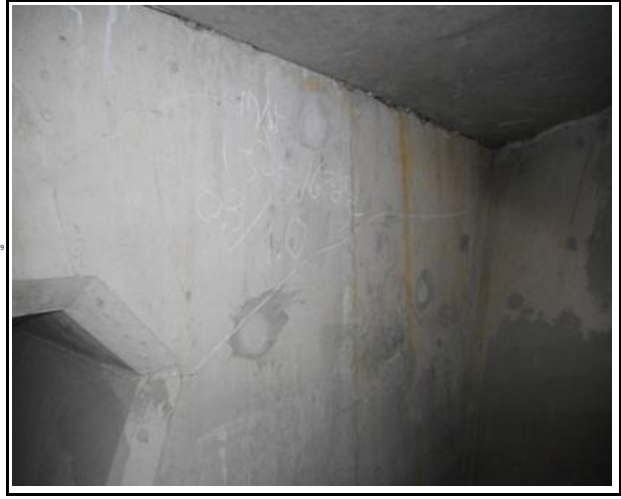
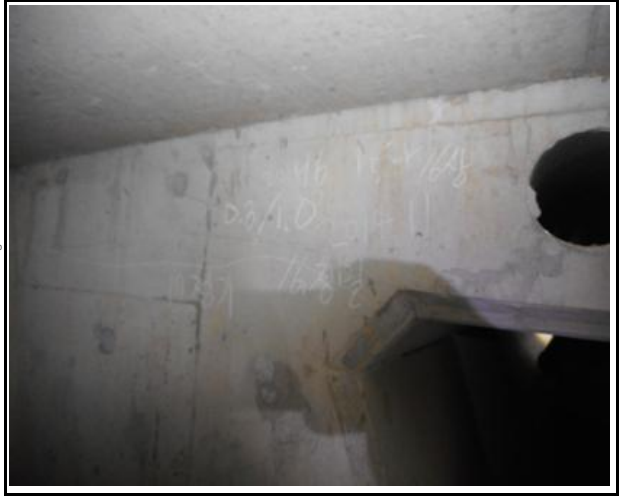
| <div data-bbox="130 1321 790 1388"> <div>위치</div> <div>S2      격벽</div> <div>도면번호</div> <div>HK-오송1교(T1)-31</div> </div> <div data-bbox="130 1388 790 1444"> <div>내용</div> <div>균열(0.3mm이상) 0.3mm, 1m, 1EA</div> <div>연번</div> <div>HK-오송1교(T1)-31-4</div> </div> | <div data-bbox="790 1321 1455 1388"> <div>위치</div> <div>S2      격벽</div> <div>도면번호</div> <div>HK-오송1교(T1)-32</div> </div> <div data-bbox="790 1388 1455 1444"> <div>내용</div> <div>균열(0.3mm이상) 0.3mm, 1m, 1EA</div> <div>연번</div> <div>HK-오송1교(T1)-32-1</div> </div> |

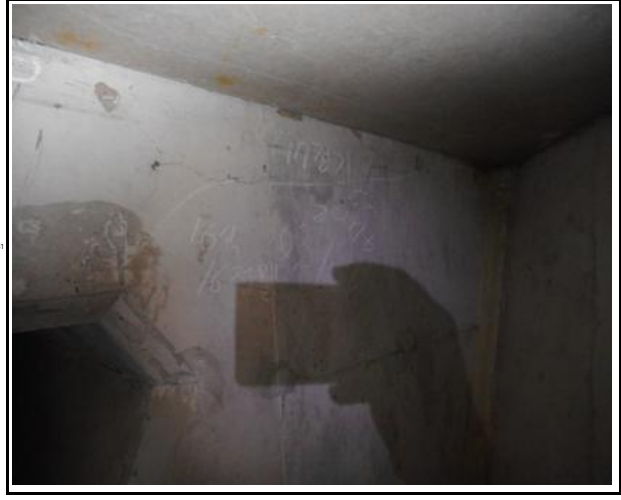
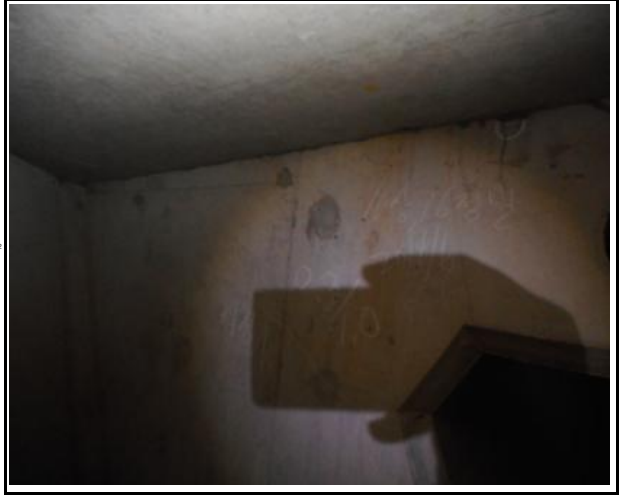
| <div data-bbox="130 1968 790 2036"> <div>위치</div> <div>S2      격벽</div> <div>도면번호</div> <div>HK-오송1교(T1)-32</div> </div> <div data-bbox="130 2036 790 2085"> <div>내용</div> <div>균열(0.3mm이상) 0.3mm, 0.8m, 1EA</div> <div>연번</div> <div>HK-오송1교(T1)-32-2</div> </div> | <div data-bbox="790 1968 1455 2036"> <div>위치</div> <div>S2      격벽</div> <div>도면번호</div> <div>HK-오송1교(T1)-32</div> </div> <div data-bbox="790 2036 1455 2085"> <div>내용</div> <div>균열(0.3mm이상) 0.3mm, 1m, 1EA</div> <div>연번</div> <div>HK-오송1교(T1)-32-3</div> </div> |

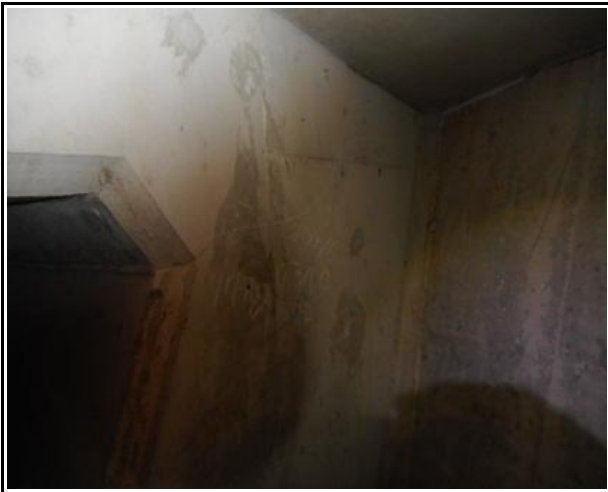
| 위치 | S2 | 격벽 | 도면번호 | HK-오송1교(T1)-32 | 위치 | S2 | 격벽 | 도면번호 | HK-오송1교(T1)-33 |
| 내용 | 균열(0.3mm이상) 0.3mm, 1m, 1EA | | 연번 | HK-오송1교(T1)-32-4 | 내용 | 균열(0.3mm미만) 0.2mm, 0.6m, 6EA | | 연번 | HK-오송1교(T1)-33-1 |

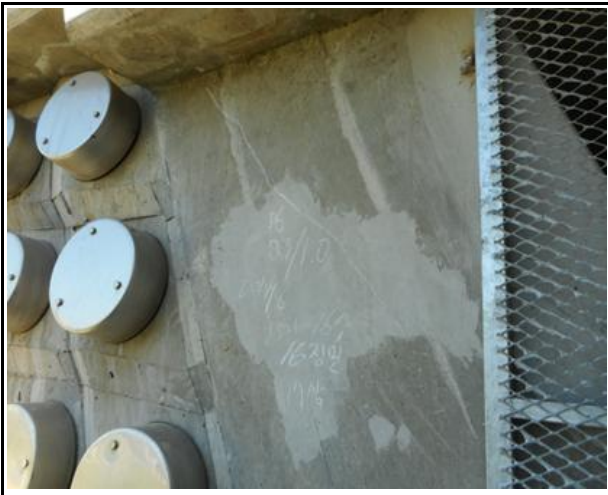
| 위치 | S3 | 격벽 | 도면번호 | HK-오송1교(T1)-34 | 위치 | S3 | 격벽 | 도면번호 | HK-오송1교(T1)-34 |
| 내용 | 균열(0.3mm이상) 0.3mm, 1m, 1EA | | 연번 | HK-오송1교(T1)-34-1 | 내용 | 균열(0.3mm미만) 0.2mm, 0.6m, 3EA | | 연번 | HK-오송1교(T1)-34-2 |

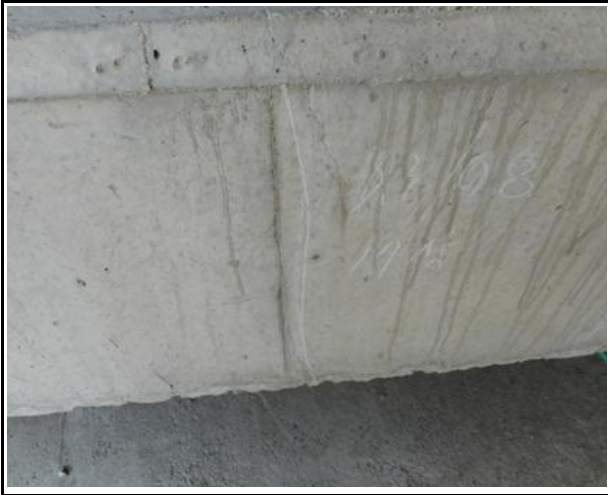
| 위치 | S3 | 격벽 | 도면번호 | HK-오송1교(T1)-34 | 위치 | S3 | 격벽 | 도면번호 | HK-오송1교(T1)-34 |
| 내용 | 균열(0.3mm이상) 0.3mm, 0.8m, 1EA | | 연번 | HK-오송1교(T1)-34-3 | 내용 | 균열(0.3mm미만) 0.2mm, 0.6m, 1EA | | 연번 | HK-오송1교(T1)-34-4 |

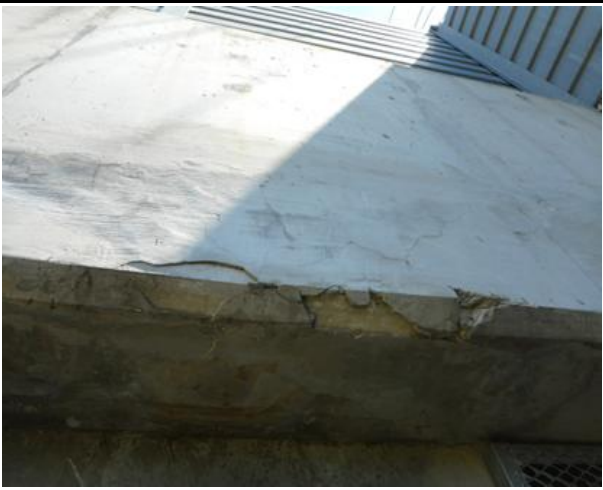
| 위치 | S3 | 격벽 | 도면번호 | HK-오송1교(T1)-34 | 위치 | S3 | 격벽 | 도면번호 | HK-오송1교(T1)-35 |
| 내용 | 박락 | 0.2m, 0.7m, 1EA | 연번 | HK-오송1교(T1)-34-5 | 내용 | 균열(0.3mm이상) 0.3mm, 1m, 1EA | 연번 | HK-오송1교(T1)-35-1 | |

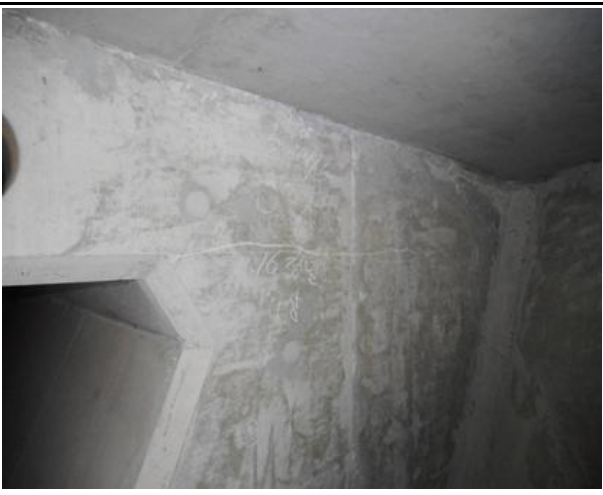
| 위치 | S3 | 격벽 | 도면번호 | HK-오송1교(T1)-35 | 위치 | S3 | 격벽 | 도면번호 | HK-오송1교(T1)-35 |
| 내용 | 균열(0.3mm이상) 0.3mm, 1m, 1EA | 연번 | HK-오송1교(T1)-35-2 | | 내용 | 균열(0.3mm이상) 0.3mm, 1m, 1EA | 연번 | HK-오송1교(T1)-35-3 | |

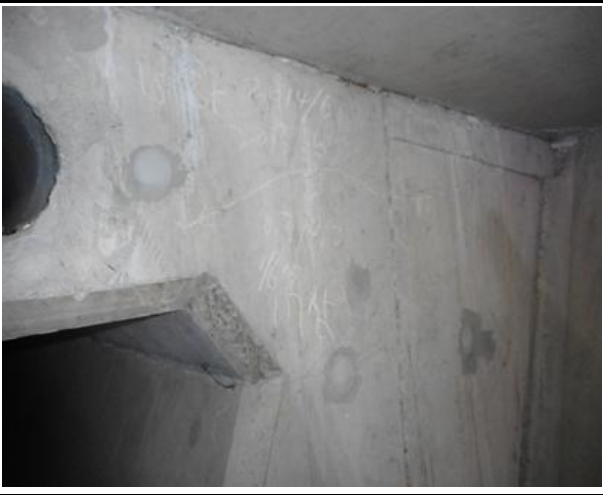
| 위치 | S3 | 격벽 | 도면번호 | HK-오송1교(T1)-35 | 위치 | S3 | 격벽 | 도면번호 | HK-오송1교(T1)-36 |
| 내용 | 균열(0.3mm이상) 0.3mm, 1m, 1EA | 연번 | HK-오송1교(T1)-35-4 | | 내용 | 균열(0.3mm이상) 0.3mm, 1m, 1EA | 연번 | HK-오송1교(T1)-36-1 | |

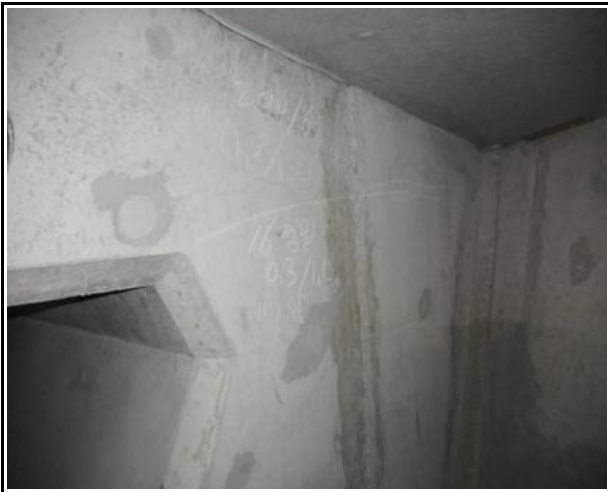
| 위치 | S3 | 격벽 | 도면번호 | HK-오송1교(T1)-36 | 위치 | S3 | 격벽 | 도면번호 | HK-오송1교(T1)-36 |
| 내용 | 균열(0.3mm이상) 0.3mm, 1m, 1EA | | 연번 | HK-오송1교(T1)-36-2 | 내용 | 균열(0.3mm이상) 0.3mm, 1m, 1EA | | 연번 | HK-오송1교(T1)-36-3 |

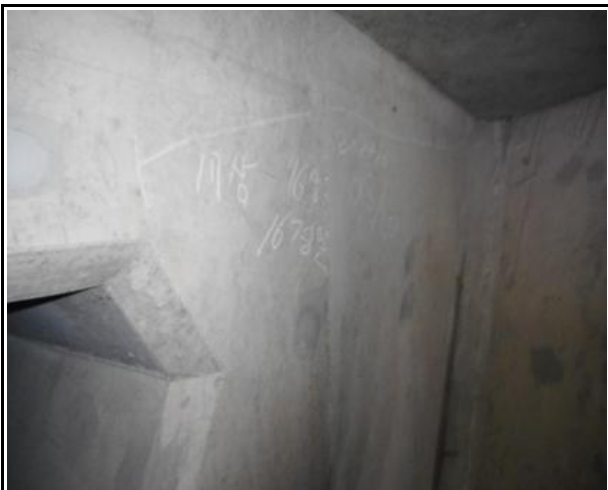
| 위치 | S3 | 격벽 | 도면번호 | HK-오송1교(T1)-36 | 위치 | S3 | 격벽 | 도면번호 | HK-오송1교(T1)-37 |
| 내용 | 균열(0.3mm이상) 0.3mm, 1m, 1EA | | 연번 | HK-오송1교(T1)-36-4 | 내용 | 균열(0.3mm미만) 0.2mm, 1.5m, 1EA | | 연번 | HK-오송1교(T1)-37-1 |

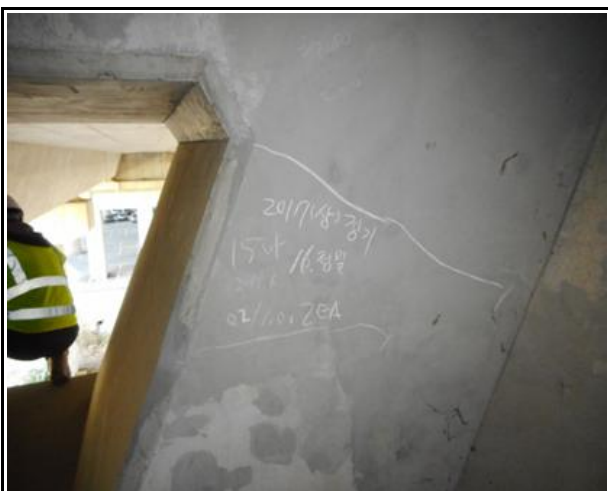
| 위치 | S3 | 격벽 | 도면번호 | HK-오송1교(T1)-37 | 위치 | S3 | 격벽 | 도면번호 | HK-오송1교(T1)-37 |
| 내용 | 균열(0.3mm미만) 0.2mm, 1m, 2EA | | 연번 | HK-오송1교(T1)-37-2 | 내용 | 균열(0.3mm이상) 0.3mm, 0.8m, 6EA | | 연번 | HK-오송1교(T1)-37-3 |

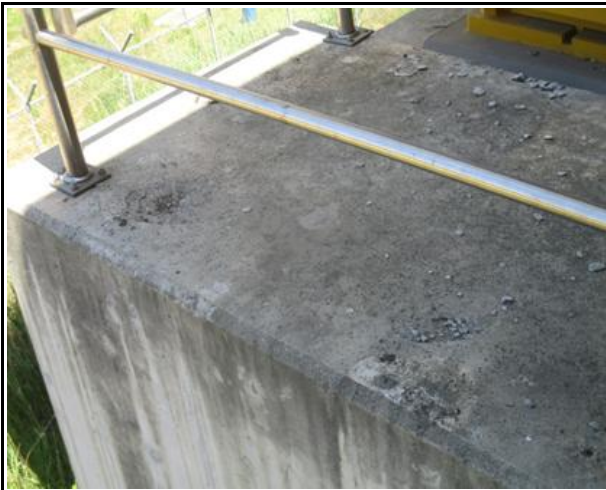
| <div>157</div> | | | | <div>158</div> | | | | | |

| 위치 | P3 | 코핑 | 도면번호 | HK-오송1교(T1)-43 | 위치 | P3 | 코핑 | 도면번호 | HK-오송1교(T1)-43 |
| 내용 | 콘크리트파손 0.5m, 0.5m, 3EA | | 연번 | HK-오송1교(T1)-43-1 | 내용 | 균열(0.3mm이상) 0.3mm, 0.6m, 1EA | | 연번 | HK-오송1교(T1)-43-2 |

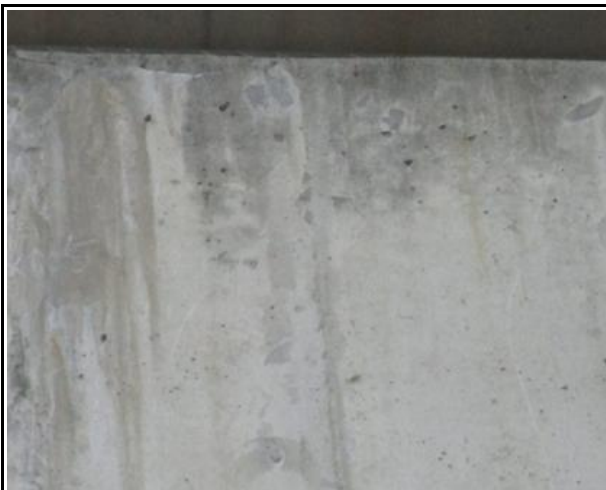
| <div>159</div> | | | | <div>160</div> | | | | | |

| 위치 | P3 | 코핑 | 도면번호 | HK-오송1교(T1)-43 | 위치 | P3 | 코핑 | 도면번호 | HK-오송1교(T1)-43 |
| 내용 | 균열부백태 0.1mm, 0.8m, 1EA | | 연번 | HK-오송1교(T1)-43-3 | 내용 | 누수오염 1.5m, 1.5m, 1EA | | 연번 | HK-오송1교(T1)-43-4 |

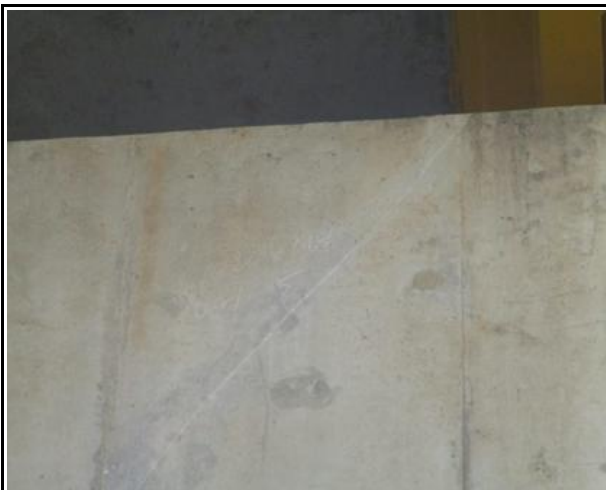
| <div>161</div> | | | | <div>162</div> | | | | | |

| 위치 | P3 | 코핑 | 도면번호 | HK-오송1교(T1)-43 | 위치 | P3 | 코핑 | 도면번호 | HK-오송1교(T1)-43 |
| 내용 | 균열(0.3mm미만) 0.2mm, 2.5m, 1EA | | 연번 | HK-오송1교(T1)-43-5 | 내용 | 누수흔적 1.5m, 2m, 1EA | | 연번 | HK-오송1교(T1)-43-6 |

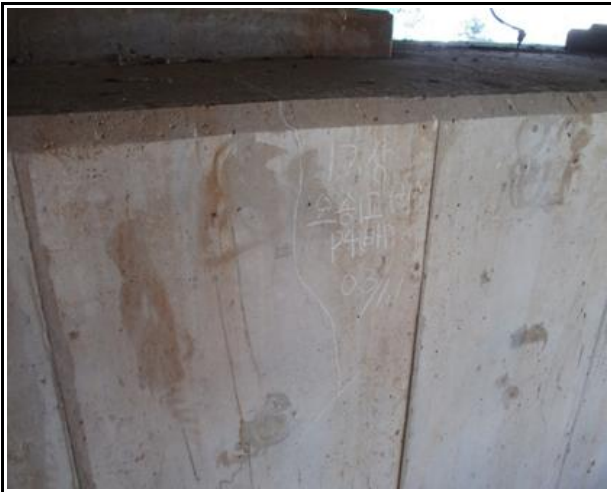
| 위치 | P4 | 코핑 | 도면번호 | HK-오송1교(T1)-44 | 위치 | P4 | 코핑 | 도면번호 | HK-오송1교(T1)-44 |
| 내용 | 균열(0.3mm이상) 0.3mm, 1.1m, 1EA | | 연번 | HK-오송1교(T1)-44-1 | 내용 | 균열(0.3mm이상) 0.3mm, 0.8m, 1EA | | 연번 | HK-오송1교(T1)-44-2 |

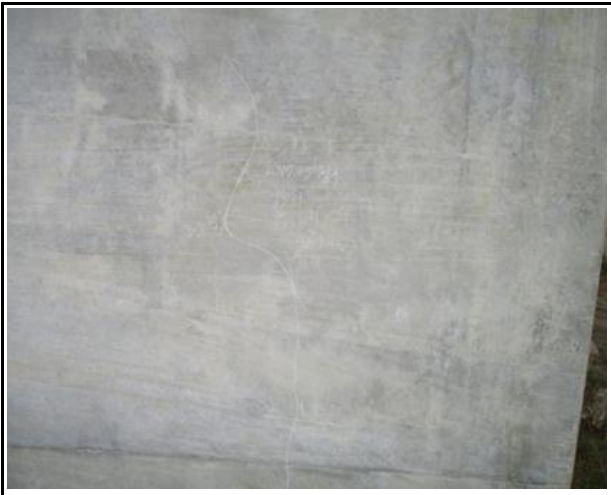
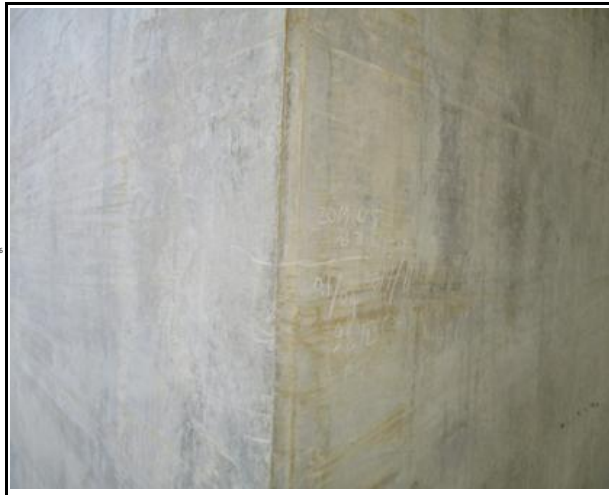
| 위치 | P5 | 기둥 | 도면번호 | HK-오송1교(T1)-45 | 위치 | P5 | 기둥 | 도면번호 | HK-오송1교(T1)-46 |
| 내용 | 균열(0.3mm미만) 0.2mm, 4m, 1EA | | 연번 | HK-오송1교(T1)-45-1 | 내용 | 균열(0.3mm미만) 0.1mm, 0.4m, 1EA | | 연번 | HK-오송1교(T1)-46-1 |

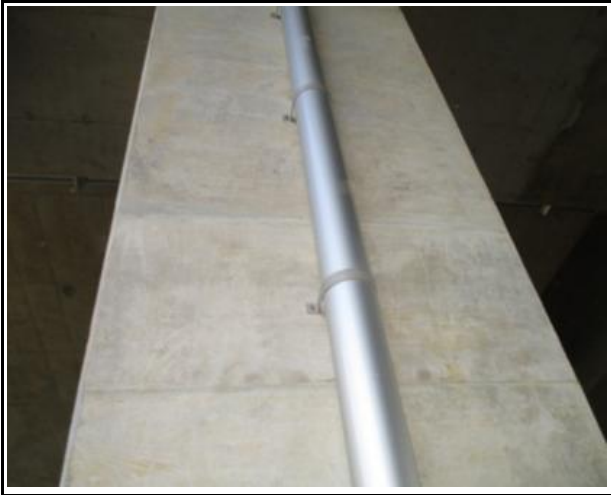
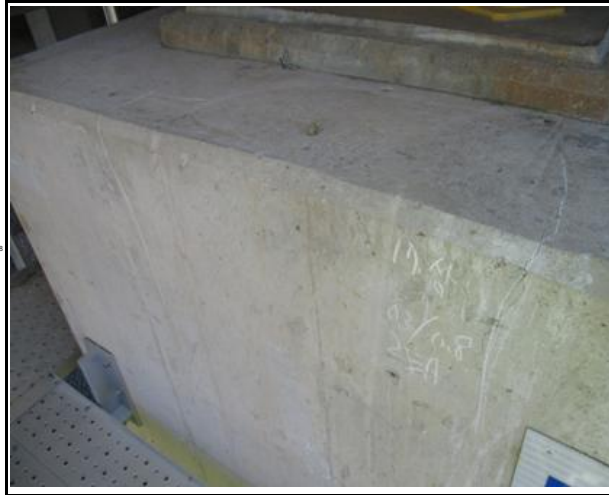
| 위치 | P6 | 기둥 | 도면번호 | HK-오송1교(T1)-46 | 위치 | P6 | 기둥 | 도면번호 | HK-오송1교(T1)-46 |
| 내용 | 망상균열 1m, 2m, 1EA | | 연번 | HK-오송1교(T1)-46-1 | 내용 | 균열(0.3mm미만) 0.2mm, 0.8m, 1EA | | 연번 | HK-오송1교(T1)-46-2 |

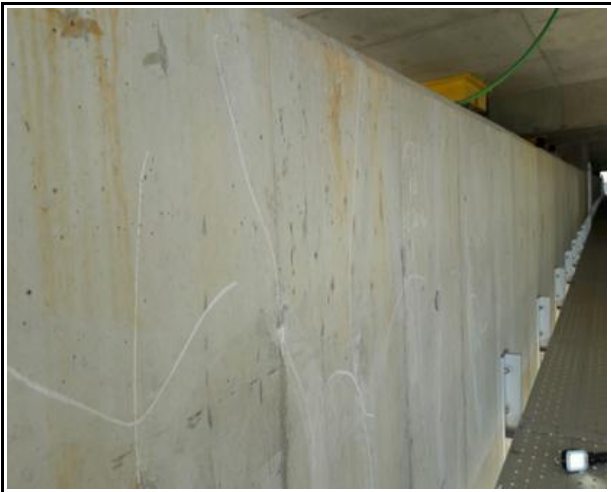
| 위치 | P6 | 코핑 | 도면번호 | HK-오송1교(T1)-46 | 위치 | P6 | 기둥 | 도면번호 | HK-오송1교(T1)-46 |
| 내용 | 망상균열 | 1m, 2m, 1EA | 연번 | HK-오송1교(T1)-46-3 | 내용 | 균열(0.3mm미만) | 0.2mm, 0.6m, 5EA | 연번 | HK-오송1교(T1)-46-4 |

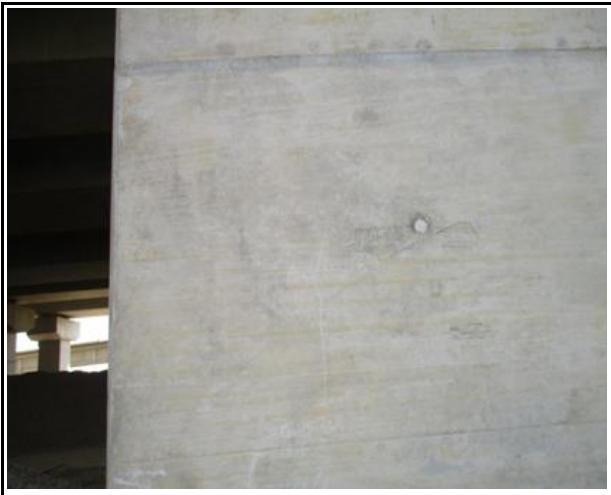
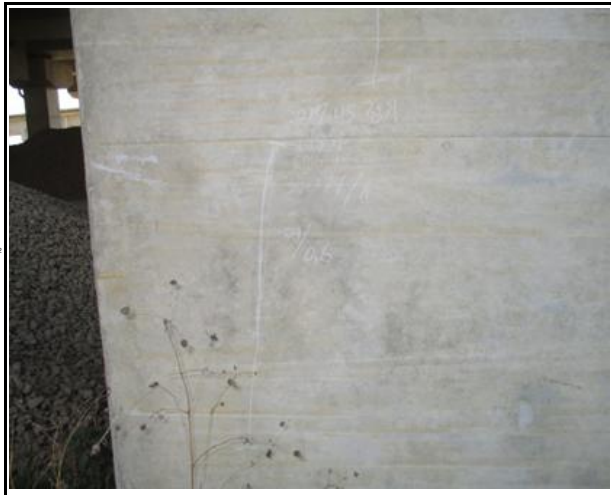
| 위치 | P6 | 기둥 | 도면번호 | HK-오송1교(T1)-46 | 위치 | P6 | 기둥 | 도면번호 | HK-오송1교(T1)-46 |
| 내용 | 균열(0.3mm미만) | 0.1mm, 0.6m, 2EA | 연번 | HK-오송1교(T1)-46-5 | 내용 | 균열(0.3mm미만) | 0.1mm, 0.6m, 2EA | 연번 | HK-오송1교(T1)-46-6 |

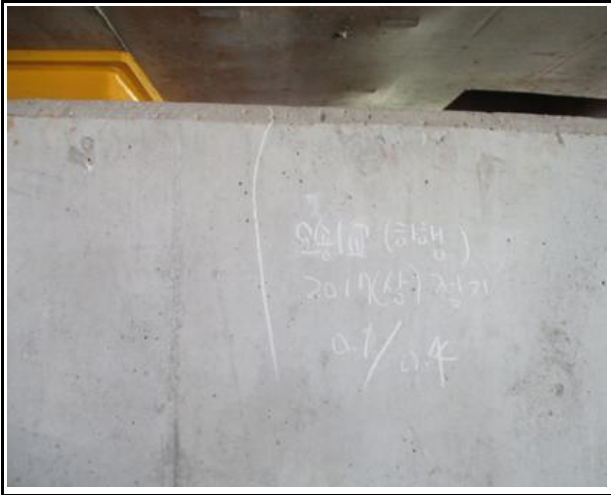
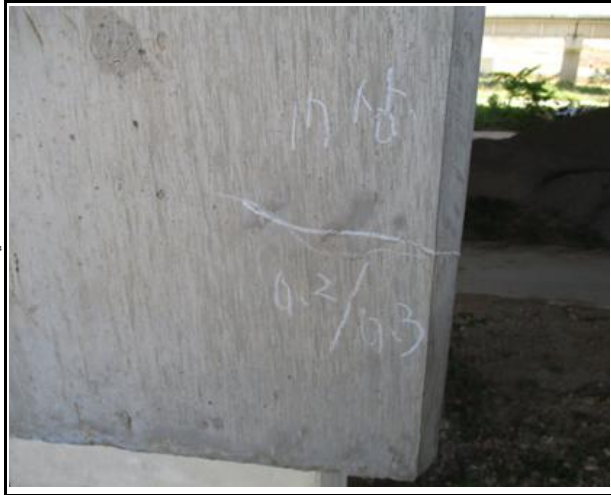
| 위치 | P7 | 코핑 | 도면번호 | HK-오송1교(T1)-47 | 위치 | P8 | 코핑 | 도면번호 | HK-오송1교(T1)-48 |
| 내용 | 균열(0.3mm미만) | 0.1mm, 0.4m, 1EA | 연번 | HK-오송1교(T1)-47-1 | 내용 | 균열(0.3mm미만) | 0.2mm, 0.3m, 1EA | 연번 | HK-오송1교(T1)-48-1 |
