호남고속선 오송고가(T2)\_100(2.525~2.540km, S26-1, S26-2)

P25

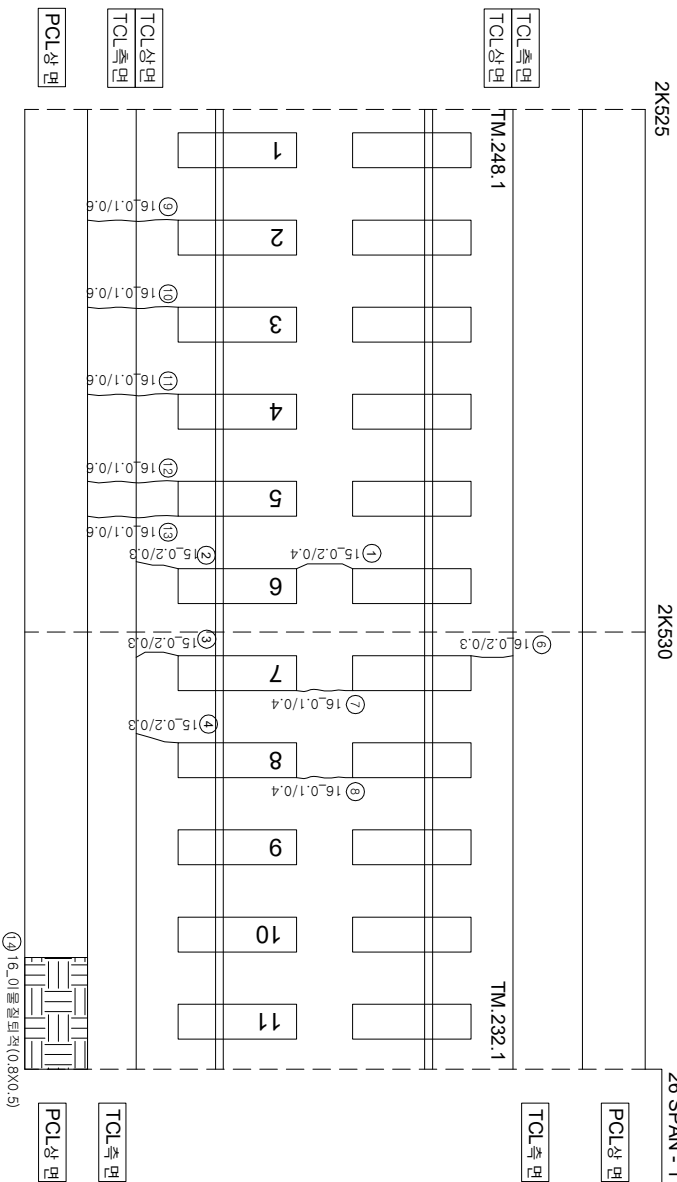
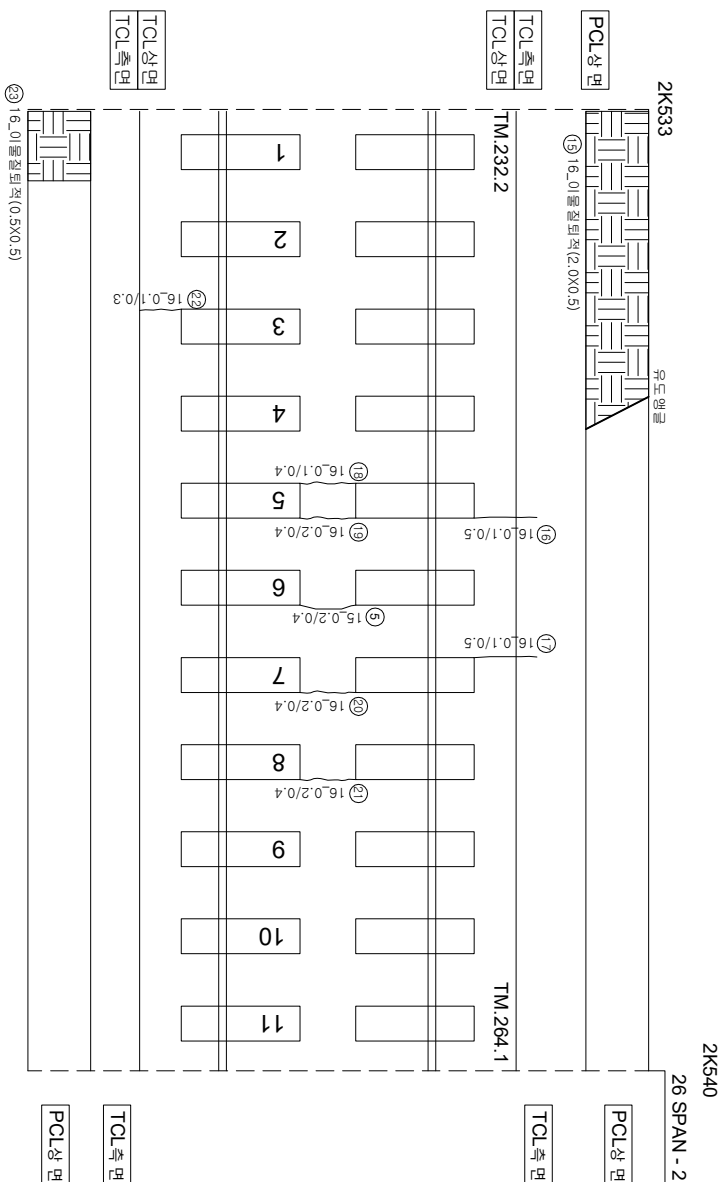
12 (주요)

(악화)

(약 10분)

| 연번 | 순상 | 폭 | 연장 | 비고 | 연번 | 순상 | 폭 | 연장 | 비고 |
| 1 | 균열 0.2 | mm | 0.4 m | | 56 | | | | |
| 2 | 균열 0.2 | mm | 0.3 m | | 57 | | | | |
| 3 | 균열 0.2 | mm | 0.3 m | | 58 | | | | |
| 4 | 균열 0.2 | mm | 0.3 m | | 59 | | | | |
| 5 | 균열 0.2 | mm | 0.4 m | | 60 | | | | |
| 6 | 균열 0.2 | mm | 0.3 m | | 61 | | | | |
| 7 | 균열 0.1 | mm | 0.4 m | | 62 | | | | |
| 8 | 균열 0.1 | mm | 0.4 m | | 63 | | | | |
| 9 | 균열 0.1 | mm | 0.6 m | | 64 | | | | |
| 10 | 균열 0.1 | mm | 0.6 m | | 65 | | | | |
| 11 | 균열 0.1 | mm | 0.6 m | | 66 | | | | |
| 12 | 균열 0.1 | mm | 0.6 m | | 67 | | | | |
| 13 | 균열 0.1 | mm | 0.6 m | | 68 | | | | |
| 14 | 이물침투적 0.8 | m | 0.5 m | | 69 | | | | |
| 15 | 이물침투적 2.0 | m | 0.5 m | | 70 | | | | |
| 16 | 균열 0.1 | mm | 0.5 m | | 71 | | | | |
| 17 | 균열 0.1 | mm | 0.5 m | | 72 | | | | |
| 18 | 균열 0.1 | mm | 0.4 m | | 73 | | | | |
| 19 | 균열 0.2 | mm | 0.4 m | | 74 | | | | |
| 20 | 균열 0.2 | mm | 0.4 m | | 75 | | | | |
| 21 | 균열 0.2 | mm | 0.4 m | | 76 | | | | |
| 22 | 균열 0.1 | mm | 0.6 m | | 77 | | | | |
| 23 | 이물침투적 0.5 | m | 0.5 m | | 78 | | | | |
