# 호남고속선 공주고가\_3(43.671~43.679km, S2)

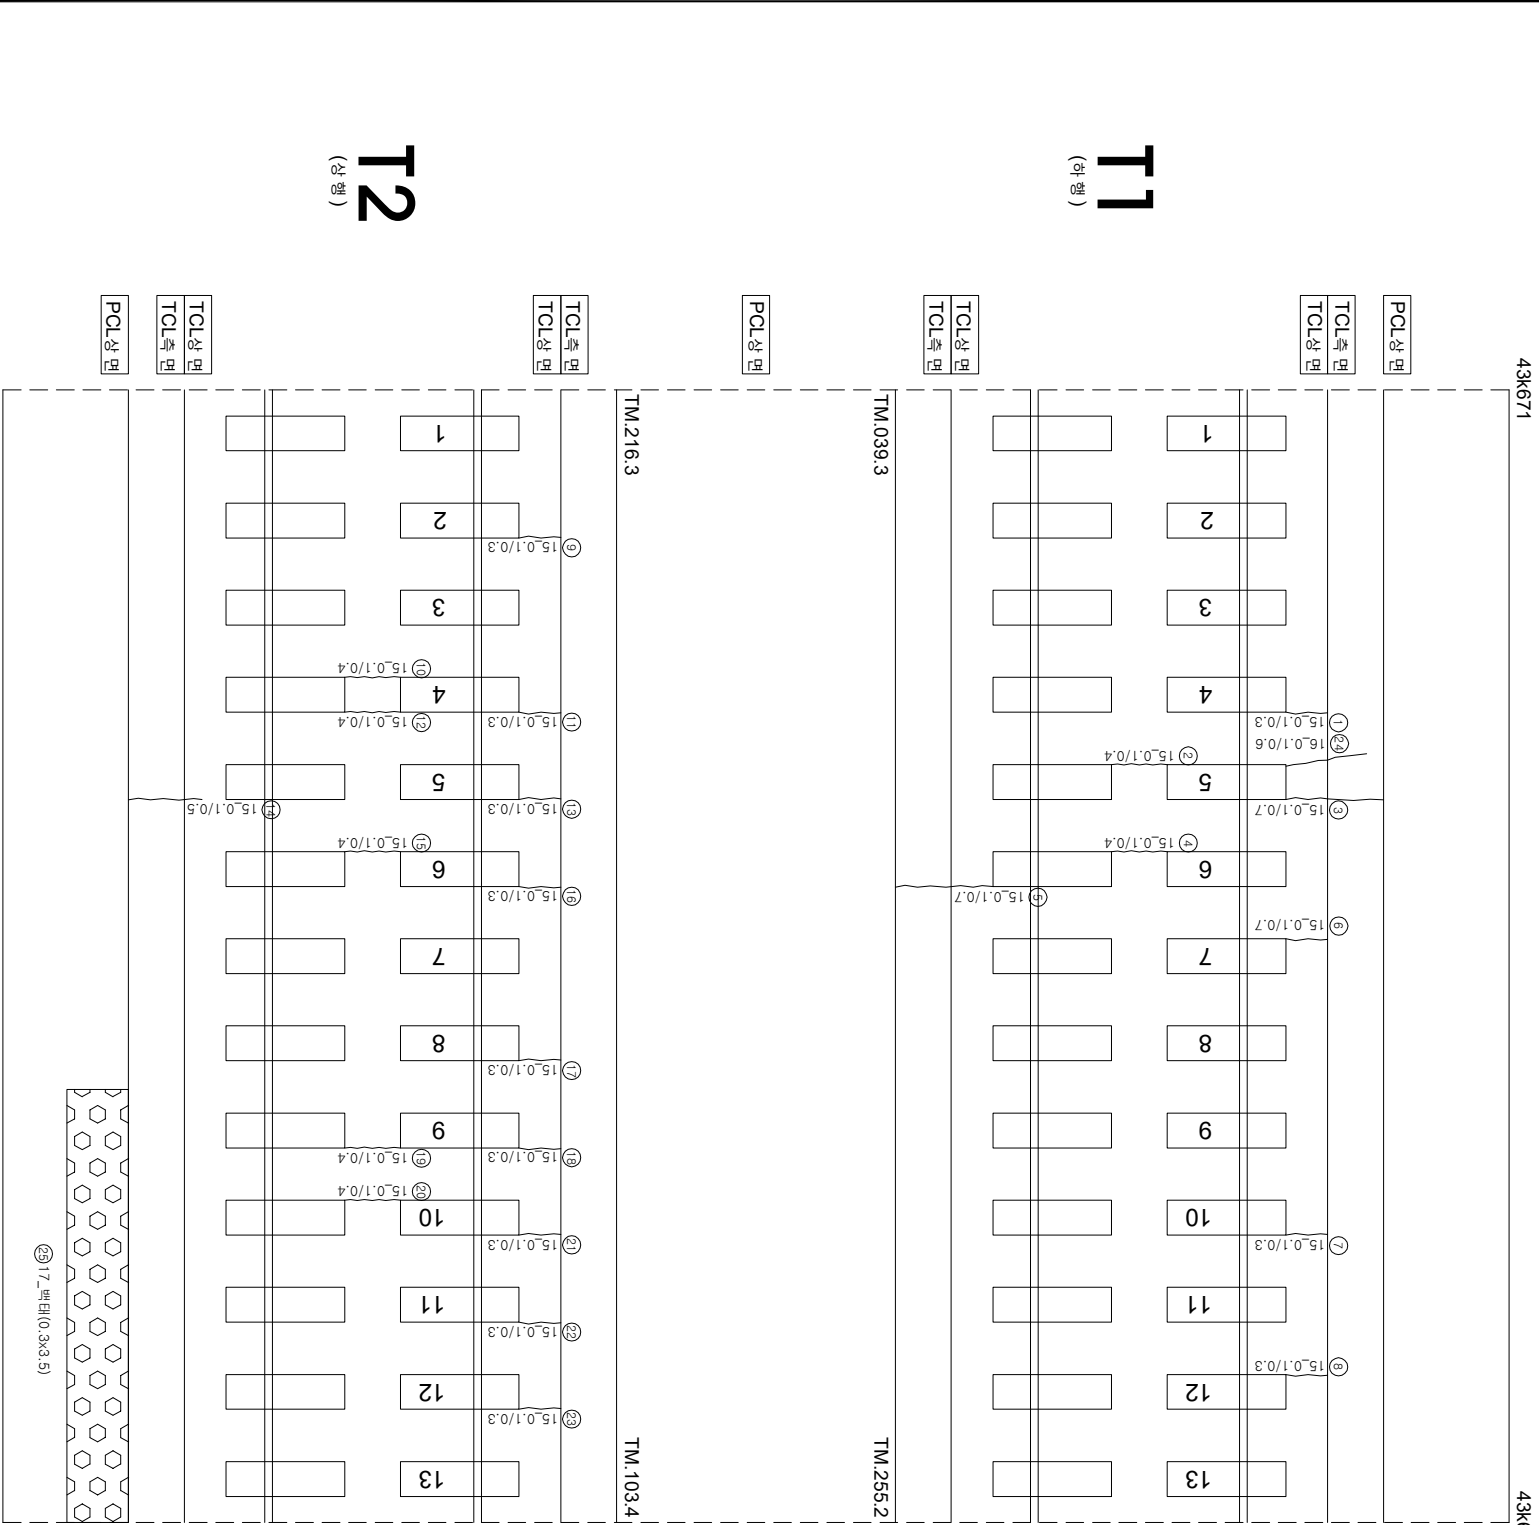
| 연번 | 손상 | 폭 | 연장 | 비고 | 연번 | 손상 | 폭 | 연장 | 비고 |
|---|---|---|---|---|---|---|---|---|---|
| 1 | 균열 | 0.1 | 0.3 m | | 56 | | | | |
| 2 | 균열 | 0.1 | 0.4 m | | 57 | | | | |
| 3 | 균열(배경) | 0.1 | 0.7 m | | 58 | | | | |
| 4 | 균열 | 0.1 | 0.4 m | | 59 | | | | |
| 5 | 균열 | 0.1 | 0.7 m | | 60 | | | | |
| 6 | 균열 | 0.1 | 0.3 m | | 61 | | | | |
| 7 | 균열 | 0.1 | 0.3 m | | 62 | | | | |
| 8 | 균열 | 0.1 | 0.3 m | | 63 | | | | |
| 9 | 균열 | 0.1 | 0.3 m | | 64 | | | | |
| 10 | 균열 | 0.1 | 0.4 m | | 65 | | | | |
| 11 | 균열 | 0.1 | 0.3 m | | 66 | | | | |
| 12 | 균열 | 0.1 | 0.4 m | | 67 | | | | |
| 13 | 균열 | 0.1 | 0.3 m | | 68 | | | | |
| 14 | 균열 | 0.1 | 0.5 m | | 69 | | | | |
| 15 | 균열 | 0.1 | 0.4 m | | 70 | | | | |
| 16 | 균열 | 0.1 | 0.3 m | | 71 | | | | |
| 17 | 균열 | 0.1 | 0.3 m | | 72 | | | | |
| 18 | 균열 | 0.1 | 0.3 m | | 73 | | | | |
| 19 | 균열 | 0.1 | 0.4 m | | 74 | | | | |
| 20 | 균열 | 0.1 | 0.4 m | | 75 | | | | |
| 21 | 균열 | 0.1 | 0.3 m | | 76 | | | | |
| 22 | 균열 | 0.1 | 0.3 m | | 77 | | | | |
| 23 | 균열 | 0.1 | 0.3 m | | 78 | | | | |
| 24 | 균열 | 0.1 | 0.6 m | | 79 | | | | |
| 25 | 배경 | 0.3 m | 3.5 m | 신규 | 80 | | | | |
