화남고속선장구교-103(49.209~49.216km, S21-2)

49K209

49K216  
21 SPAN -2

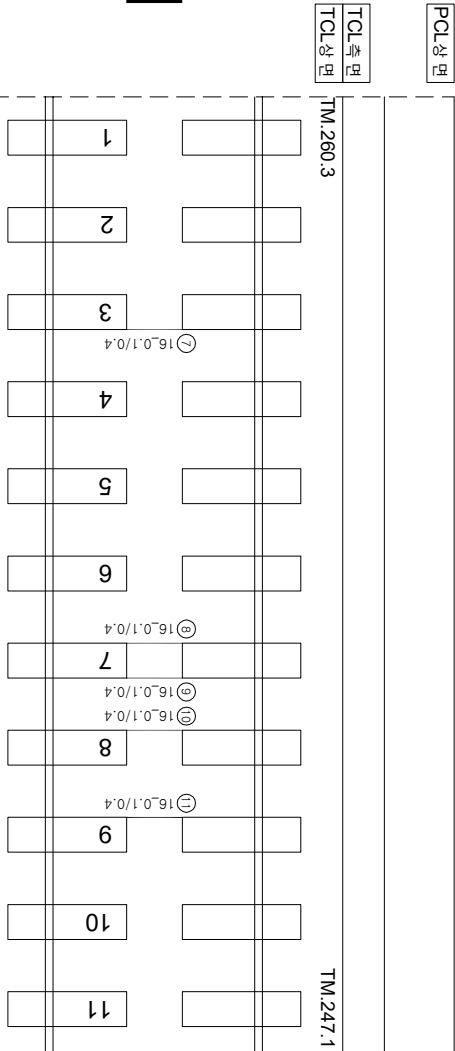
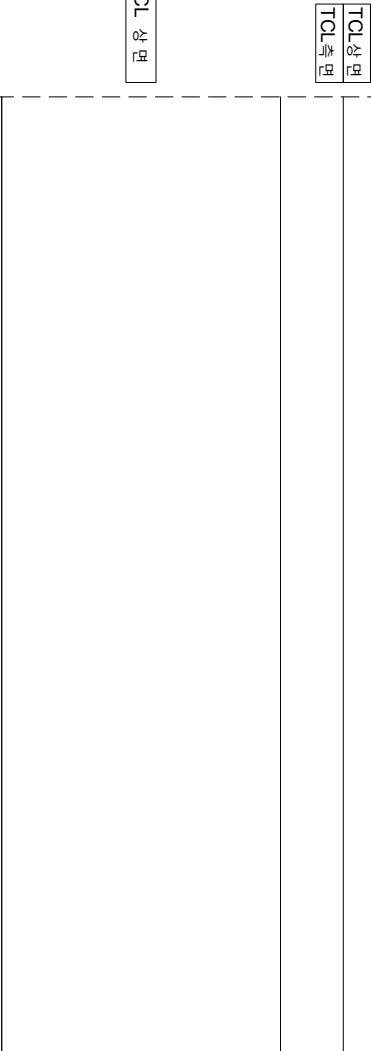
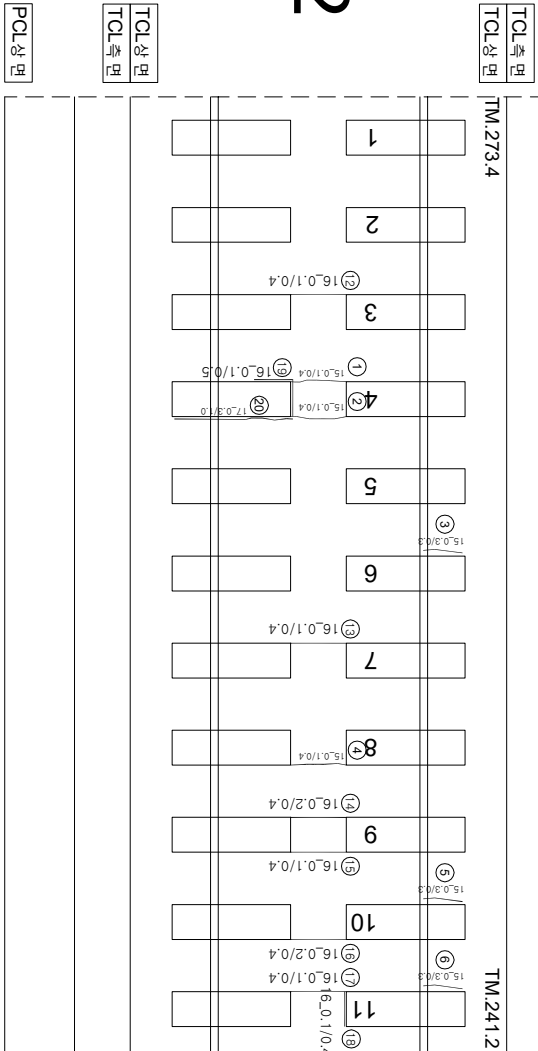
| 연번 | 손상 | 폭 | 연장 | 비고 | 연번 | 손상 | 폭 | 연장 | 비고 |
|---|---|---|---|---|---|---|---|---|---|
| 1 | 균열 | 0.1 mm | 0.4 m | | 55 | | | | |
| 2 | 균열 | 0.1 mm | 0.4 m | | 56 | | | | |
| 3 | 강재부 균열 | 0.3 mm | 0.3 m | | 57 | | | | |
| 4 | 균열 | 0.1 mm | 0.4 m | | 58 | | | | |
| 5 | 강재부 균열 | 0.3 mm | 0.3 m | | 59 | | | | |
| 6 | 강재부 균열 | 0.3 mm | 0.3 m | | 60 | | | | |
| 7 | 균열 | 0.1 mm | 0.4 m | | 61 | | | | |
| 8 | 균열 | 0.1 mm | 0.4 m | | 62 | | | | |
| 9 | 균열 | 0.1 mm | 0.4 m | | 63 | | | | |
| 10 | 균열 | 0.1 mm | 0.4 m | | 64 | | | | |
| 11 | 균열 | 0.1 mm | 0.4 m | | 65 | | | | |
| 12 | 균열 | 0.1 mm | 0.4 m | | 66 | | | | |
| 13 | 균열 | 0.1 mm | 0.4 m | | 67 | | | | |
| 14 | 균열 | 0.2 mm | 0.4 m | | 68 | | | | |
| 15 | 균열 | 0.1 mm | 0.4 m | | 69 | | | | |
| 16 | 균열 | 0.2 mm | 0.4 m | | 70 | | | | |
| 17 | 균열 | 0.1 mm | 0.4 m | | 71 | | | | |
| 18 | 강재부 균열 | 0.1 mm | 0.4 m | | 72 | | | | |
| 19 | 강재부 균열 | 0.1 mm | 0.5 m | | 73 | | | | |
| 20 | 강재부 균열 | 0.3 mm | 1.0 m | 신규 | 74 | | | | |
