호남고속선 정지코가\_183(58.165~58.172km, S33-1)

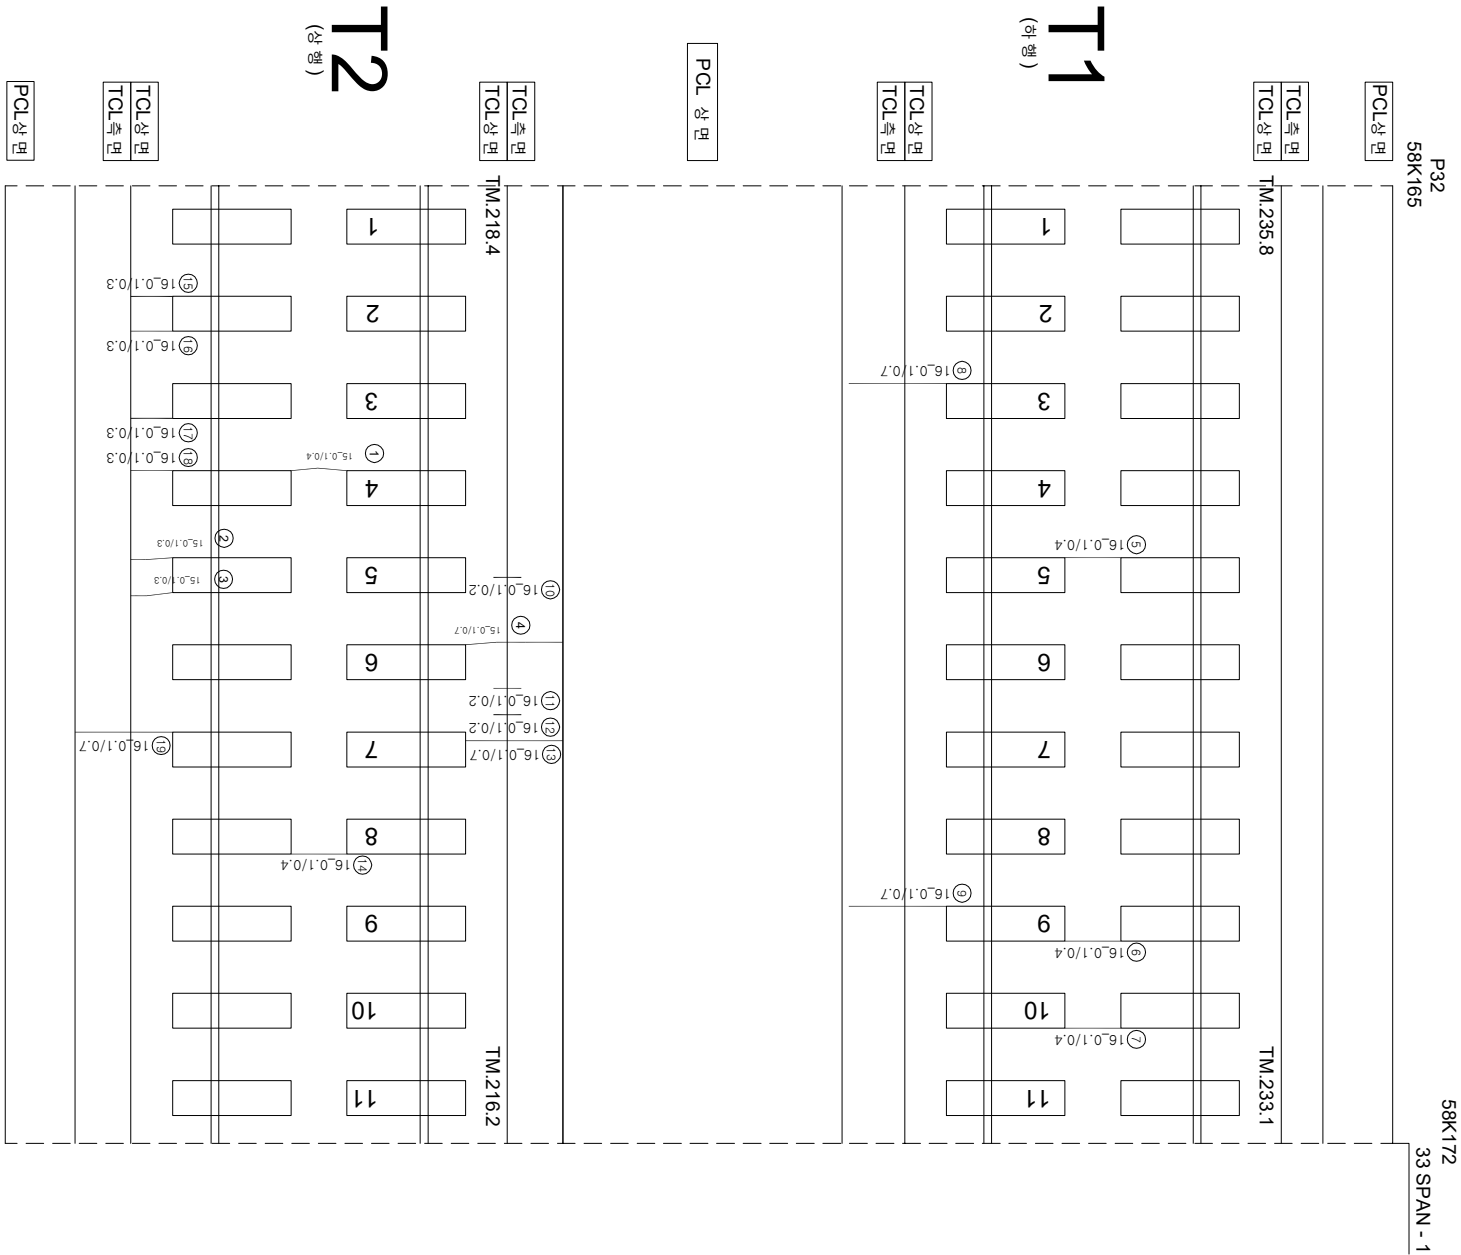
| 원본 | 손상 | 폭 | 연장 | 비고 | 원본 | 손상 | 폭 | 연장 | 비고 |
|---|---|---|---|---|---|---|---|---|---|
| 1 | 균열 | 0.1 mm | 0.4 m | | 55 | | | | |
| 2 | 균열 | 0.1 mm | 0.3 m | | 56 | | | | |
| 3 | 균열 | 0.1 mm | 0.3 m | | 57 | | | | |
| 4 | 균열 | 0.1 mm | 0.7 m | | 58 | | | | |
| 5 | 균열 | 0.1 mm | 0.4 m | | 59 | | | | |
| 6 | 균열 | 0.1 mm | 0.4 m | | 60 | | | | |
| 7 | 균열 | 0.1 mm | 0.4 m | | 61 | | | | |
| 8 | 균열 | 0.1 mm | 0.7 m | | 62 | | | | |
| 9 | 균열 | 0.1 mm | 0.7 m | | 63 | | | | |
| 10 | 균열 | 0.1 mm | 0.2 m | | 64 | | | | |
| 11 | 균열 | 0.1 mm | 0.2 m | | 65 | | | | |
| 12 | 균열 | 0.1 mm | 0.2 m | | 66 | | | | |
| 13 | 균열 | 0.1 mm | 0.7 m | | 67 | | | | |
| 14 | 균열 | 0.1 mm | 0.4 m | | 68 | | | | |
| 15 | 균열 | 0.1 mm | 0.3 m | | 69 | | | | |
| 16 | 균열 | 0.1 mm | 0.3 m | | 70 | | | | |
| 17 | 균열 | 0.1 mm | 0.3 m | | 71 | | | | |
| 18 | 균열 | 0.1 mm | 0.3 m | | 72 | | | | |
| 19 | 균열 | 0.1 mm | 0.7 m | | 73 | | | | |
