호남고속선 아랑곡\_토공노반\_22(70.800~70.810km, L=10m)

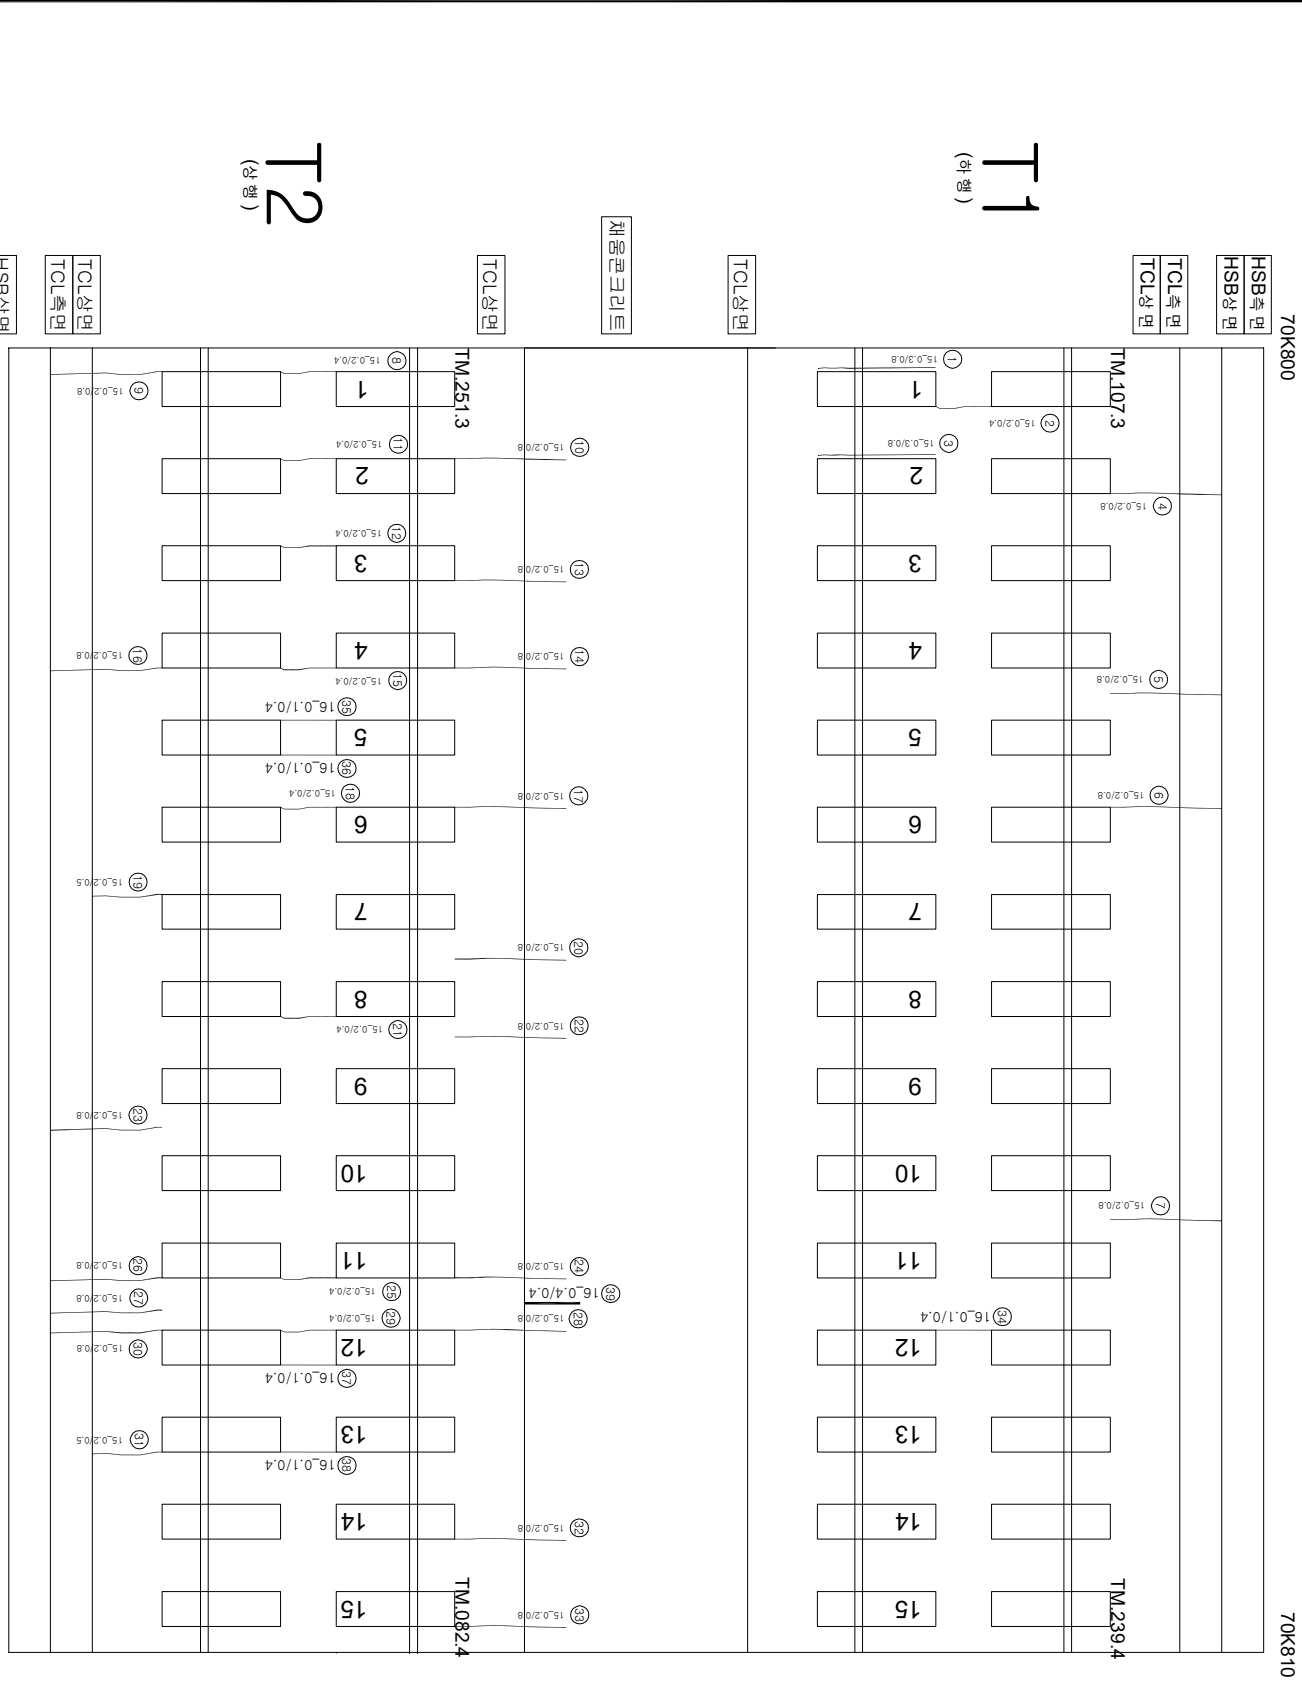
| 연번 | 순상 | 폭 | 연장 | 비고 | 연번 | 순상 | 폭 | 연장 | 비고 |
|---|---|---|---|---|---|---|---|---|---|
| 1 | 강계부 균열 | 0.3 mm | 0.8 m | | 55 | | | | |
| 2 | 균열 | 0.2 mm | 0.4 m | | 56 | | | | |
| 3 | 강계부 균열 | 0.3 mm | 0.8 m | | 57 | | | | |
| 4 | 균열 | 0.2 mm | 0.8 m | | 58 | | | | |
| 5 | 균열 | 0.2 mm | 0.8 m | | 59 | | | | |
| 6 | 균열 | 0.2 mm | 0.8 m | | 60 | | | | |
| 7 | 균열 | 0.2 mm | 0.8 m | | 61 | | | | |
| 8 | 균열 | 0.2 mm | 0.4 m | | 62 | | | | |
| 9 | 균열 | 0.2 mm | 0.8 m | | 63 | | | | |
| 10 | 균열 | 0.2 mm | 0.8 m | | 64 | | | | |
| 11 | 균열 | 0.2 mm | 0.4 m | | 65 | | | | |
| 12 | 균열 | 0.2 mm | 0.4 m | | 66 | | | | |
| 13 | 균열 | 0.2 mm | 0.8 m | | 67 | | | | |
| 14 | 균열 | 0.2 mm | 0.8 m | | 68 | | | | |
| 15 | 균열 | 0.2 mm | 0.4 m | | 69 | | | | |
| 16 | 균열 | 0.2 mm | 0.8 m | | 70 | | | | |
| 17 | 균열 | 0.2 mm | 0.8 m | | 71 | | | | |
| 18 | 균열 | 0.2 mm | 0.4 m | | 72 | | | | |
| 19 | 균열 | 0.2 mm | 0.5 m | | 73 | | | | |
| 20 | 균열 | 0.2 mm | 0.8 m | | 74 | | | | |
| 21 | 균열 | 0.2 mm | 0.4 m | | 75 | | | | |
| 22 | 균열 | 0.2 mm | 0.8 m | | 76 | | | | |
| 23 | 균열 | 0.2 mm | 0.8 m | | 77 | | | | |
| 24 | 균열 | 0.2 mm | 0.8 m | | 78 | | | | |
| 25 | 균열 | 0.2 mm | 0.4 m | | 79 | | | | |
| 26 | 균열 | 0.2 mm | 0.8 m | | 80 | | | | |
| 27 | 균열 | 0.2 mm | 0.8 m | | 81 | | | | |
| 28 | 균열 | 0.2 mm | 0.8 m | | 82 | | | | |
| 29 | 균열 | 0.2 mm | 0.4 m | | 83 | | | | |
| 30 | 균열 | 0.2 mm | 0.8 m | | 84 | | | | |
| 31 | 균열 | 0.2 mm | 0.5 m | | 85 | | | | |
| 32 | 균열 | 0.2 mm | 0.8 m | | 86 | | | | |
| 33 | 균열 | 0.2 mm | 0.8 m | | 87 | | | | |
| 34 | 균열 | 0.1 mm | 0.4 m | | 88 | | | | |
| 35 | 균열 | 0.1 mm | 0.4 m | | 89 | | | | |
| 36 | 균열 | 0.1 mm | 0.4 m | | 90 | | | | |
| 37 | 균열 | 0.1 mm | 0.4 m | | 91 | | | | |
| 38 | 균열 | 0.1 mm | 0.4 m | | 92 | | | | |
| 39 | 균열 | 0.4 mm | 0.4 m | | 93 | | | | |
