# 38. G65\_정읍천교\_토공노반

| 점검 일자 | 2017. 07.12~2017. 10.25 |

호남고속선 정읍천교\_토공노반\_17(132.610~132.620km, L=10m)

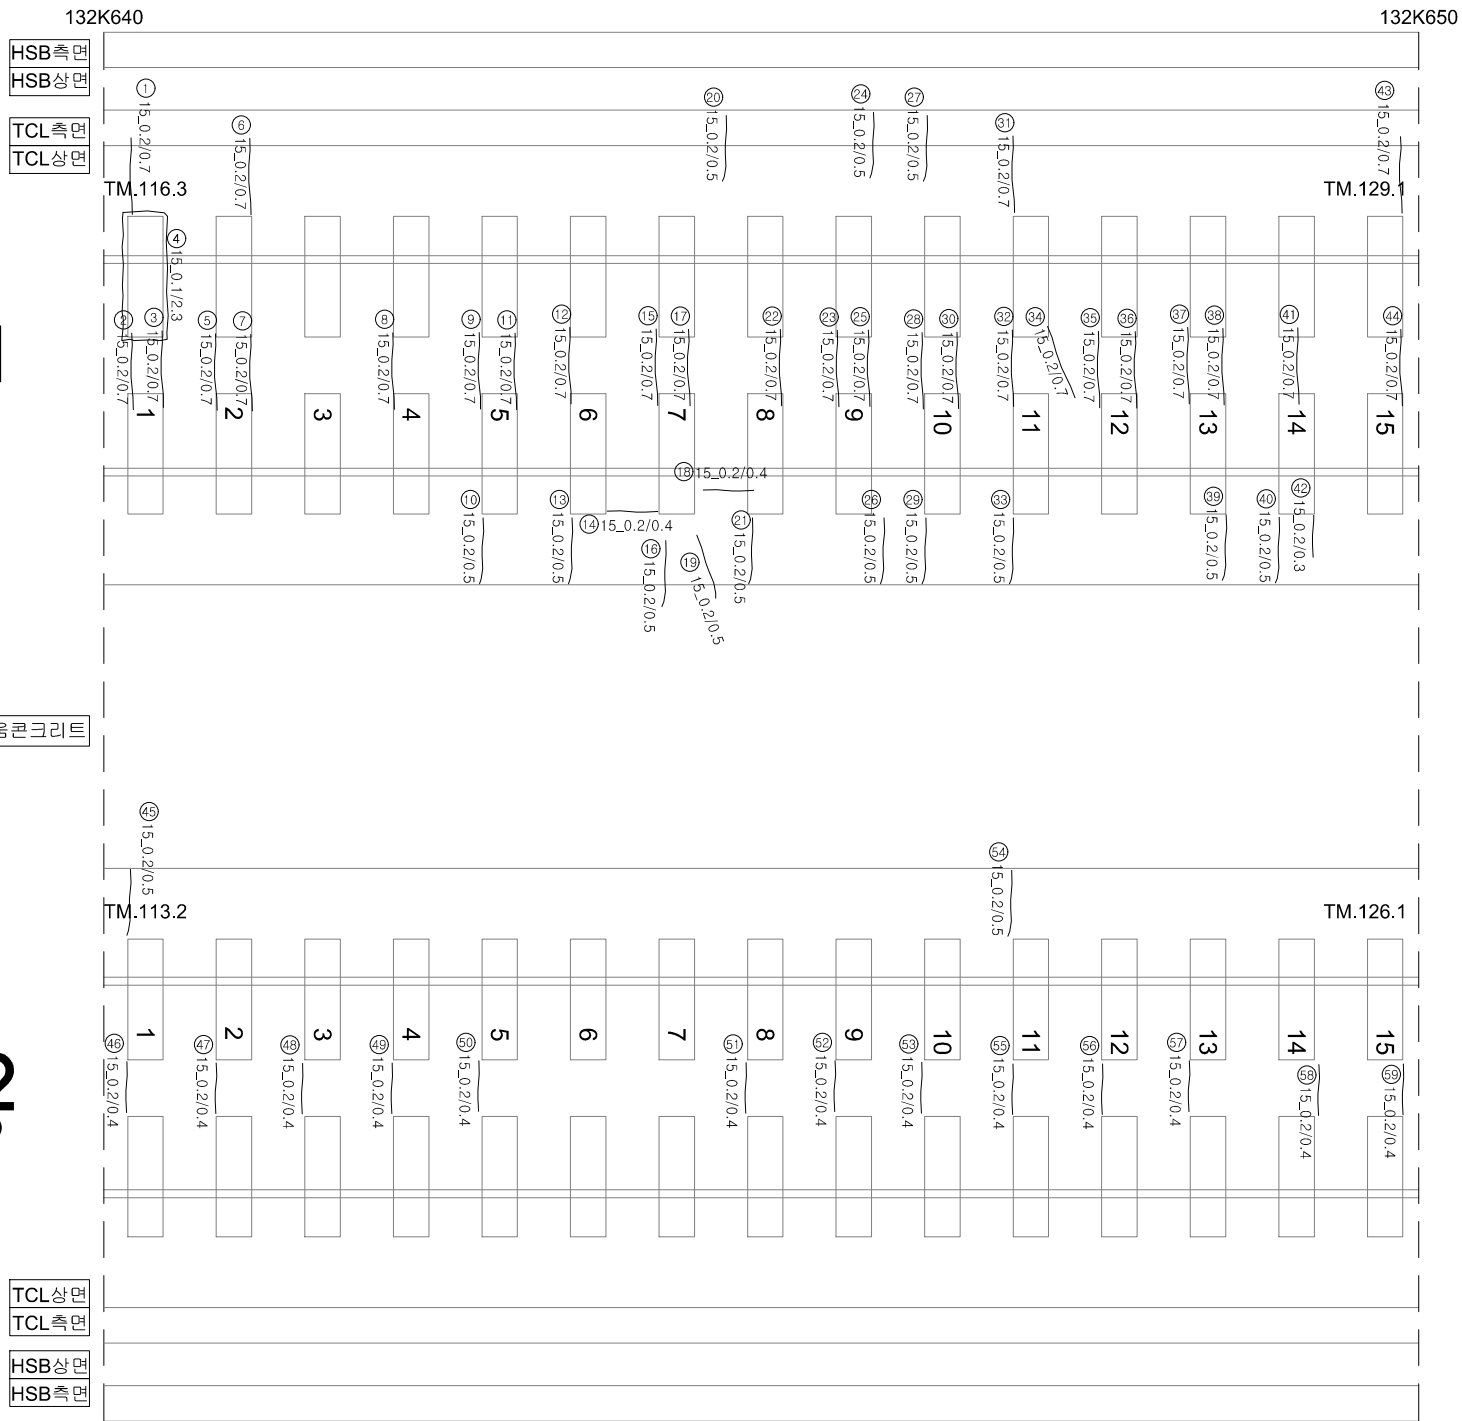
# 호남고속선 정읍천교\_토공노반\_20(132.640~132.650km, L=10m)

| 연번 | 손상 | 폭 | | 연장 | | 비고 | 연번 | 손상 | 폭 | | 연장 | | 비고 |
| 1 | 균열 | 0.2 | mm | 0.7 | m | | 56 | 균열 | 0.2 | mm | 0.4 | m | |
| 4 | 균열 | 0.1 | mm | 2.3 | m | | 59 | 균열 | 0.2 | mm | 0.4 | m | |
| 10 | 균열 | 0.2 | mm | 0.5 | m | | | | | | | | |
| 42 | 균열 | 0.2 | mm | 0.3 | m | | | | | | | | |

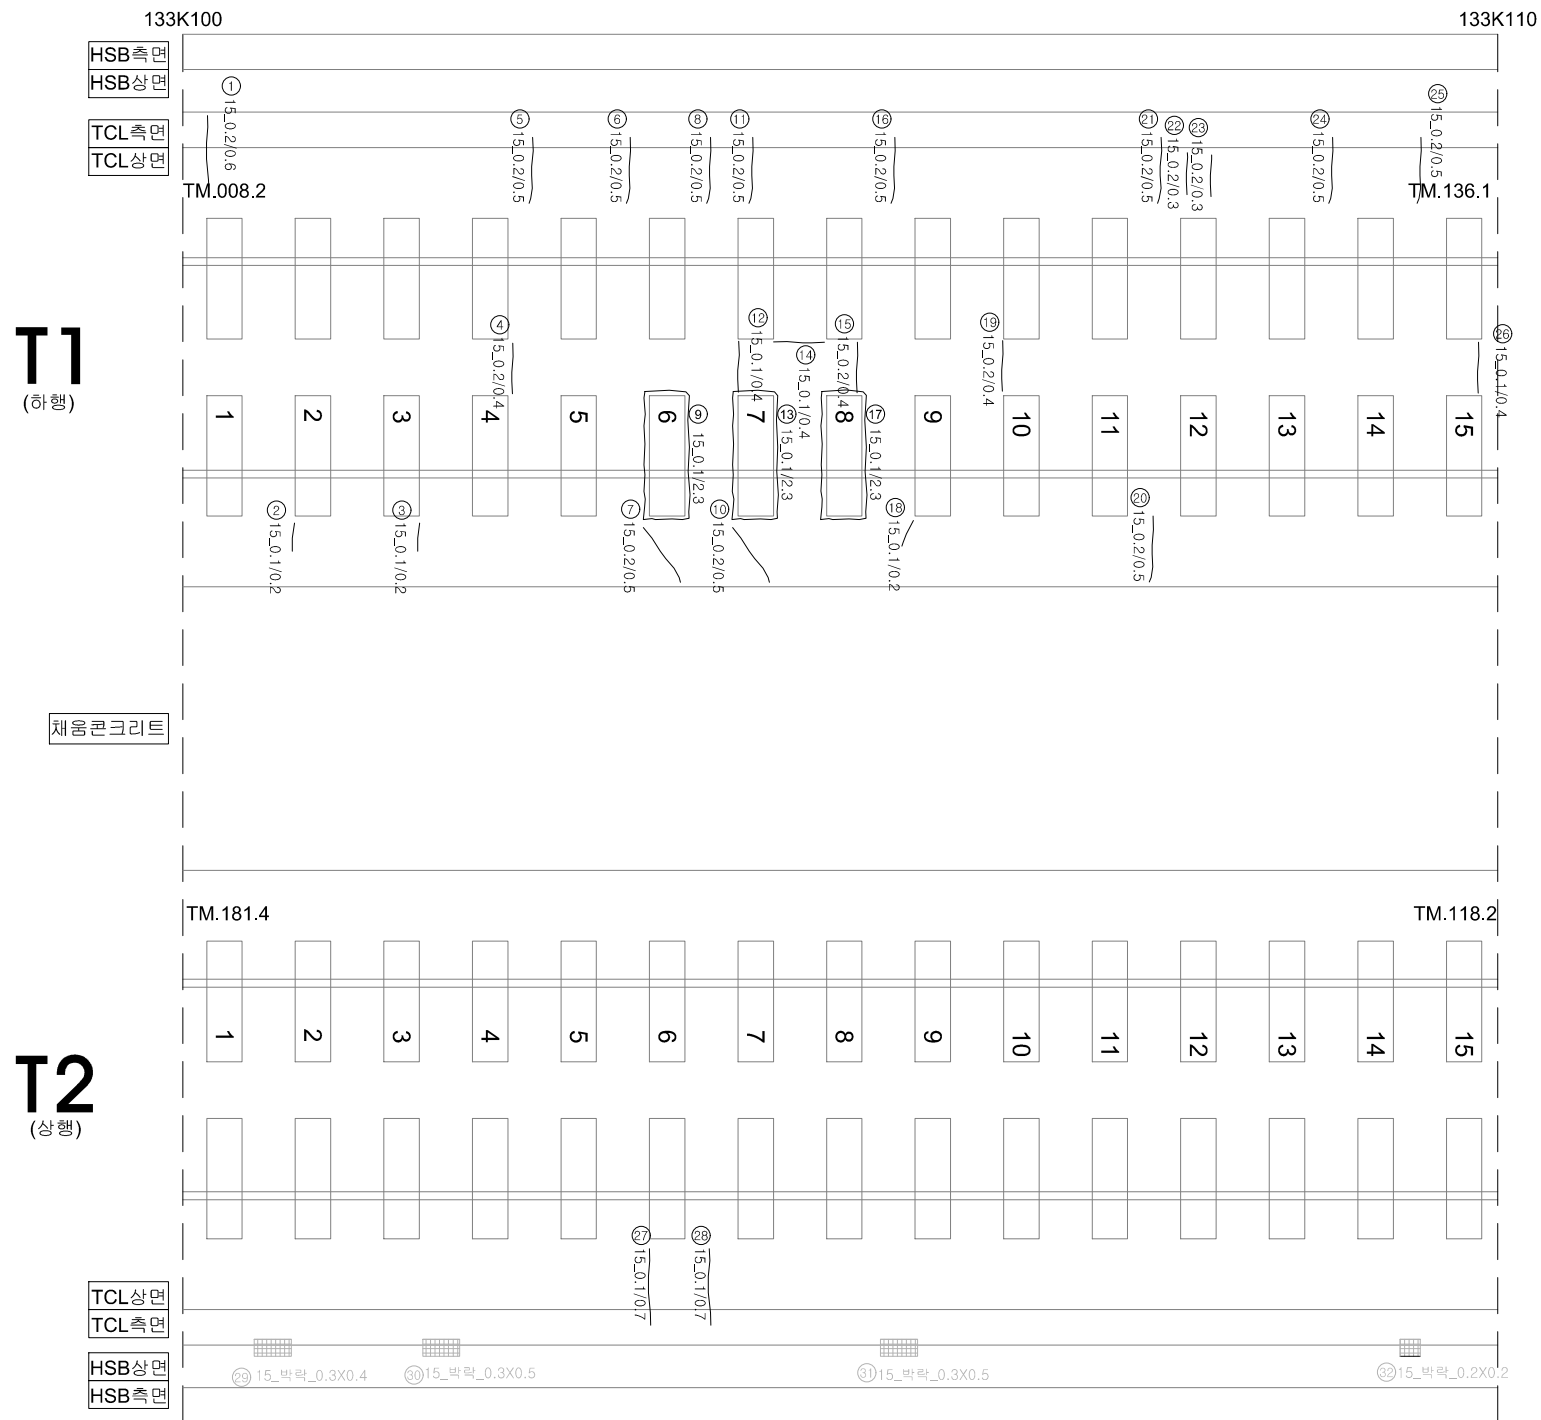
외관조사망도 번호  
G65\_정읍천교\_토공노반\_66(133.100~133.110)

| 연번 | 손상 | 폭 | 연장 | 비고 | 연번 | 손상 | 폭 | 연장 | 비고 |
| 1 | 균열 | 0.2 | mm | 0.6 | m | | | | |
| 9 | 경계부 균열 | 0.1 | mm | 2.3 | m | | | | |
| 13 | 경계부 균열 | 0.1 | mm | 2.3 | m | | | | |
| 17 | 경계부 균열 | 0.1 | mm | 2.3 | m | | | | |
| 29 | 균열 | 0.3 | m | 0.4 | m | | | | |
