## **6. 현황조사 및 외관조사 사진첩**

## 01. 남전천교

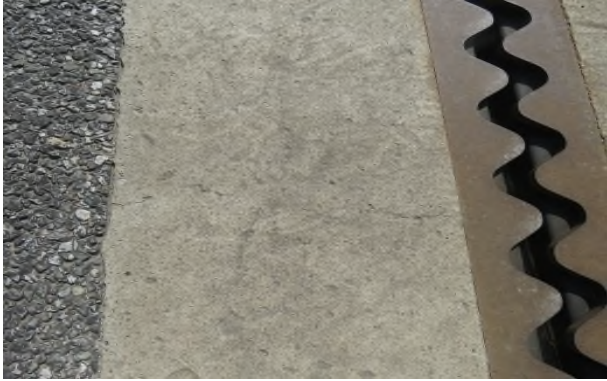
① 후타재 균열 (0.3mm미만)  $cw=0.1mm$  / 0.4m (2EA)

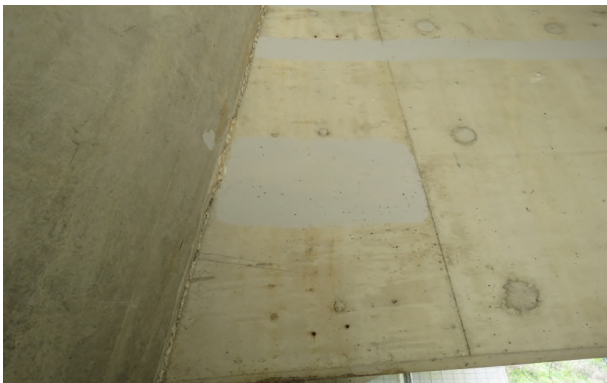
③ 가로보 균열 (0.3mm미만) cw=0.1mm / 2.0 m (보수완료)

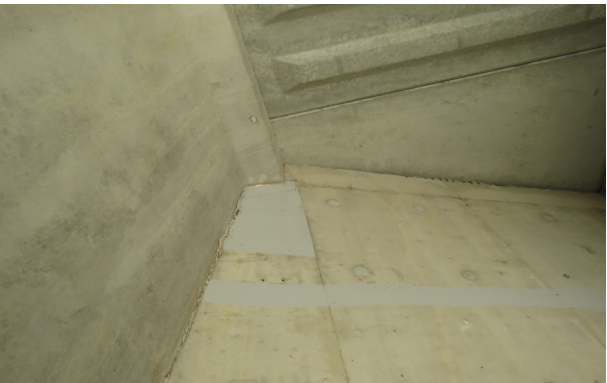
⑤ 가로보 재료분리 1.0m x 0.5m (보수완료)

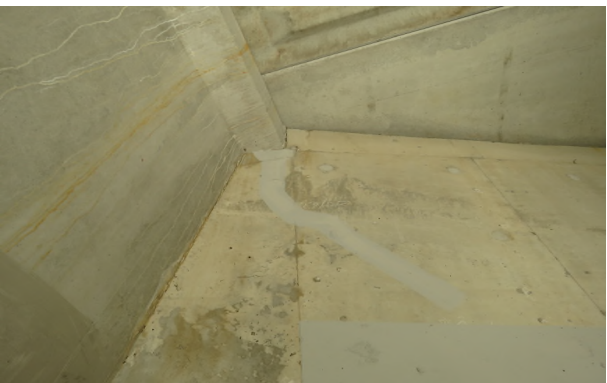
⑦ 가로보 망상균열 (0.3mm미만) cw=0.2mm / 1.0m x 1.0m (보수완료)

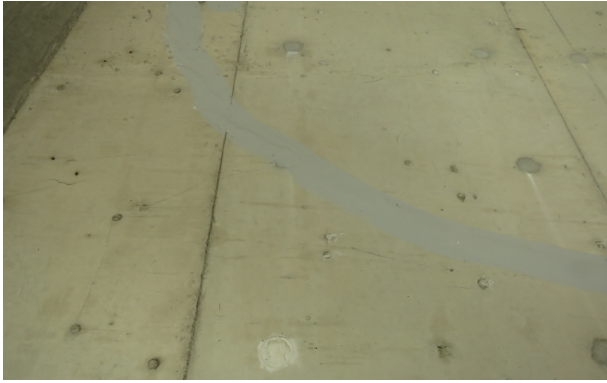
① 가로보 파손 0.1m x 0.5m (보수완료)

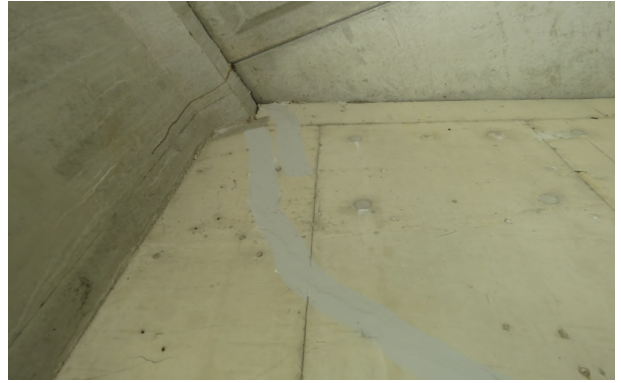
② 가로보 균열  $cw=0.3mm$  / 1.0m (보수완료)

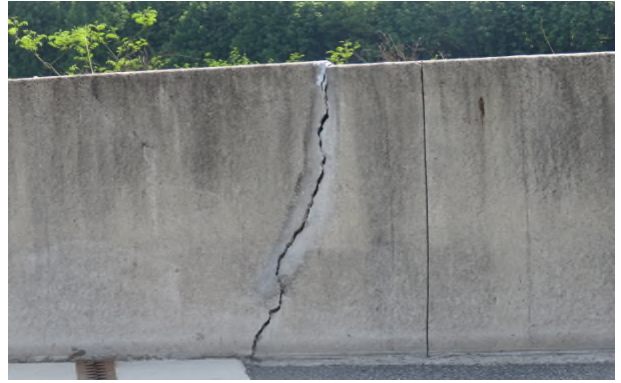
㉖ 파손 0.05m x 1.6m

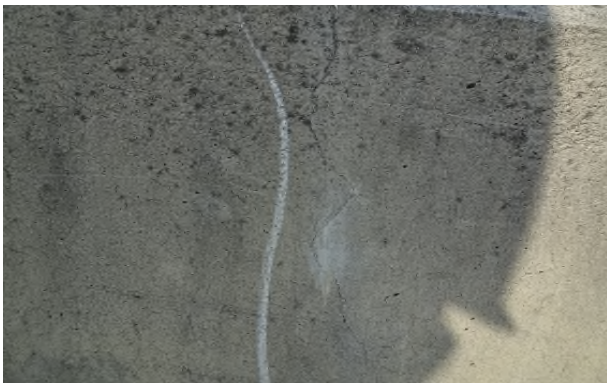
㉗ 균열 (0.3mm미만) cw=0.1mm / 0.3m

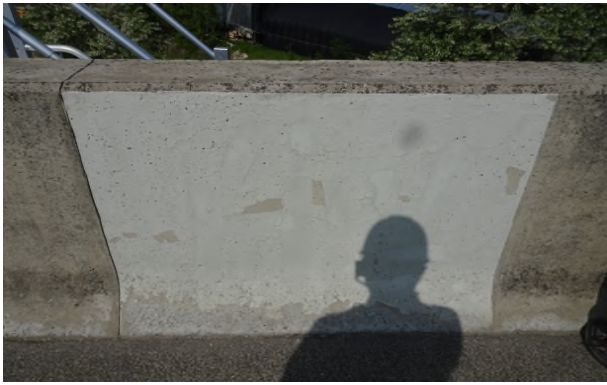
① 망상균열 (0.3mm미만) cw=0.2mm / 1.2m x 0.4m  
(보수완료)

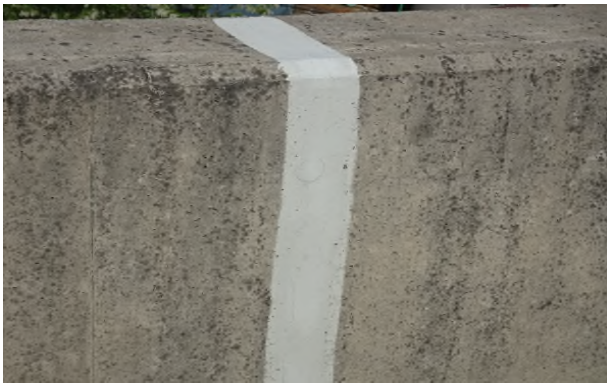
③ 균열 (0.3mm미만) cw=0.1mm / 0.5m (2EA)  
(보수완료)

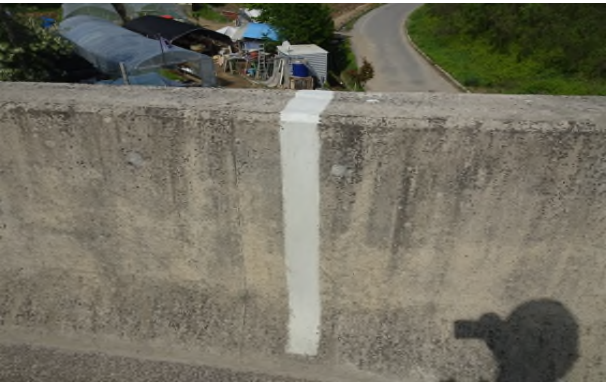
⑤ 균열 (0.3mm미만) cw=0.1mm / 0.8m(보수완료)

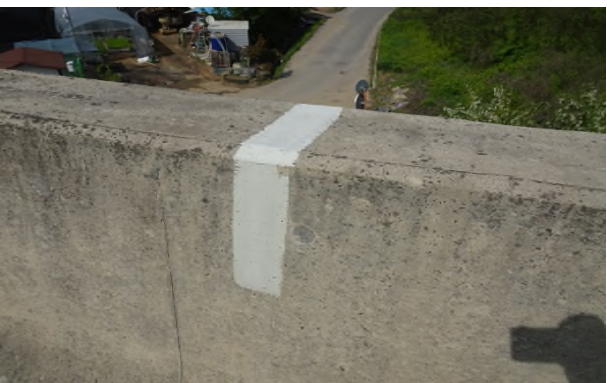
⑦ 균열(0.3mm미만) cw=0.2mm / 0.8m(보수완료)

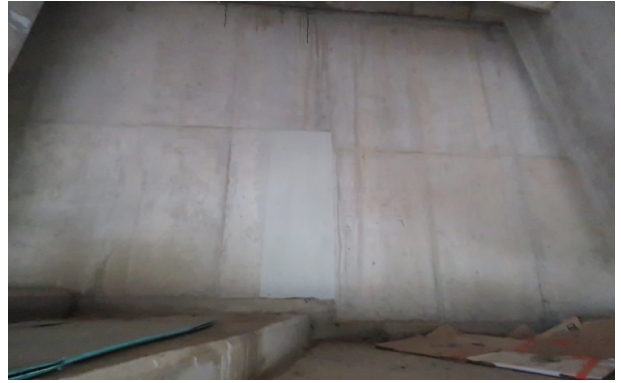
② 균열  $cw=0.3mm$  / 1.2m (보수완료)

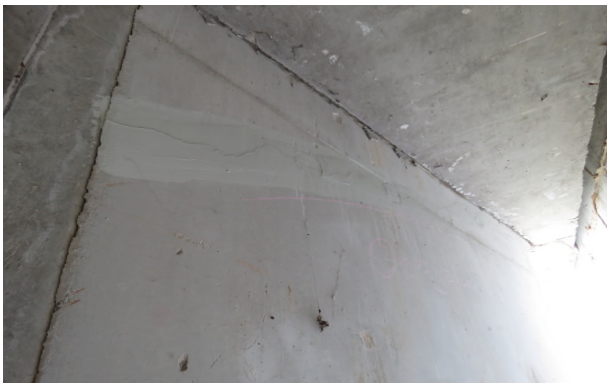
③ 균열  $cw=0.3mm$  / 1.2m (보수완료)

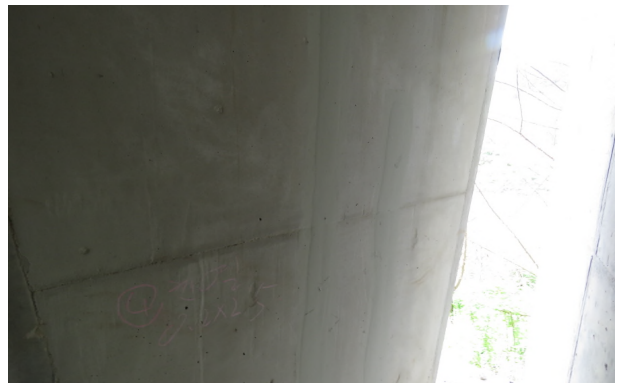
④ 균열 (0.3mm미만)  $cw=0.2mm$  / 2.5m (보수완료)

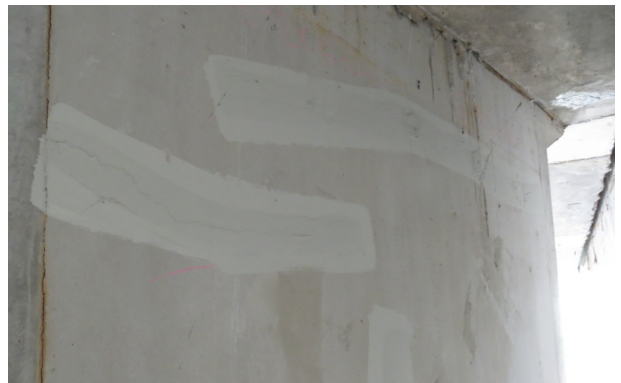
⑥ 균열  $cw=0.3mm$  / 5.0m (보수완료)

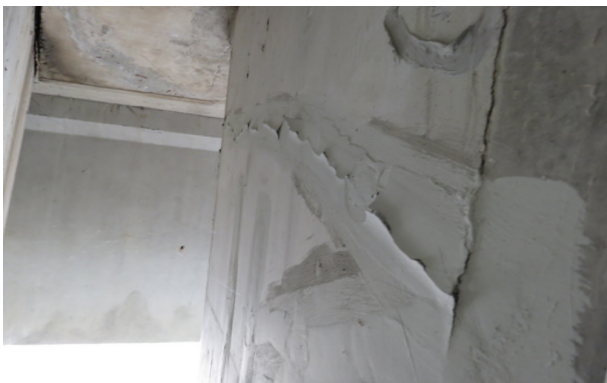
⑦ 균열  $cw=0.3mm$  / 3.5m (보수완료)

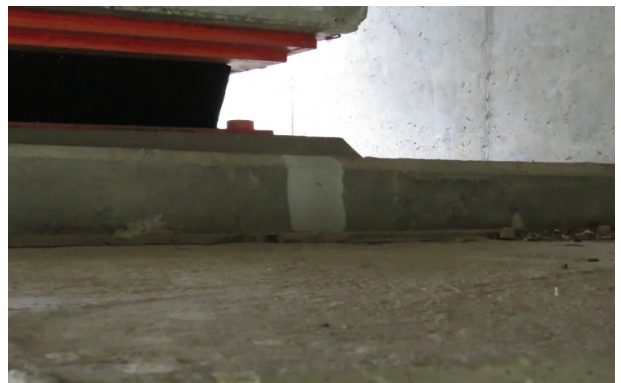
⑧ 받침콘크리트 균열 (0.3mm미만)  $cw=0.2mm$  / 0.5m (보수완료)

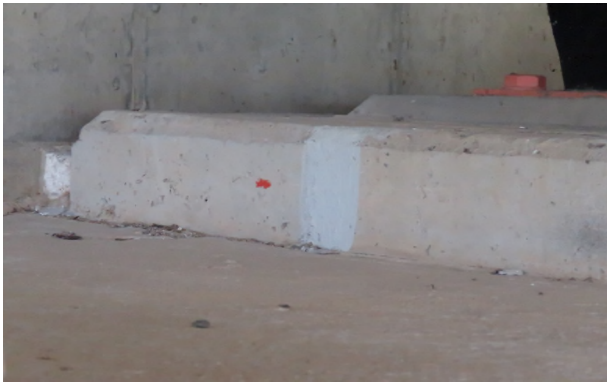
⑩ 받침콘크리트 균열 (0.3mm미만)  $cw=0.2mm$  / 0.3m (2EA) (보수완료)

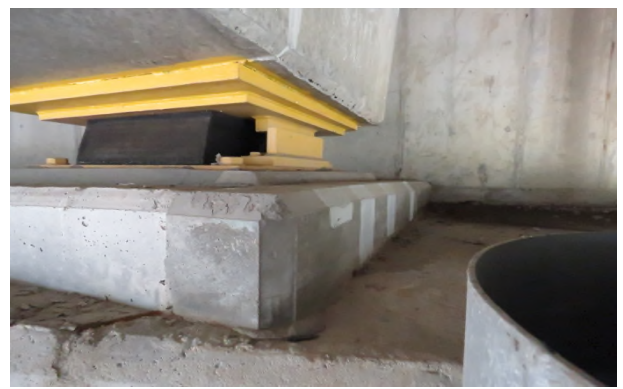
⑬ 받침콘크리트 파손 0.1m x 0.1m (보수완료)

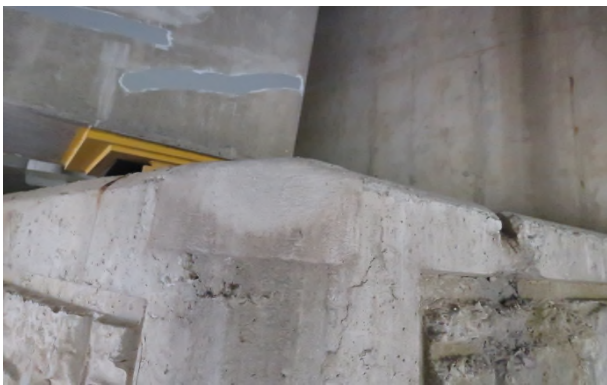
⑭ 파손 0.1m x 0.1m (보수완료)

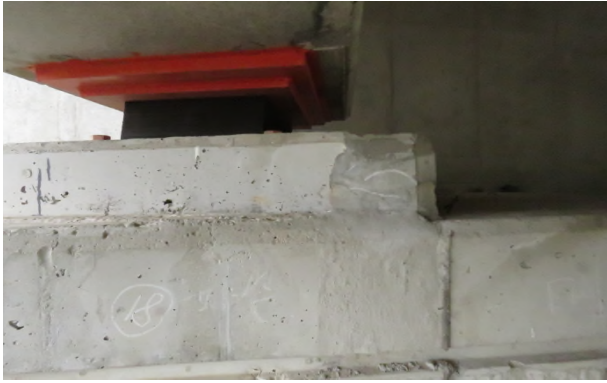
⑱ 파손 0.1m x 0.1m (보수완료)

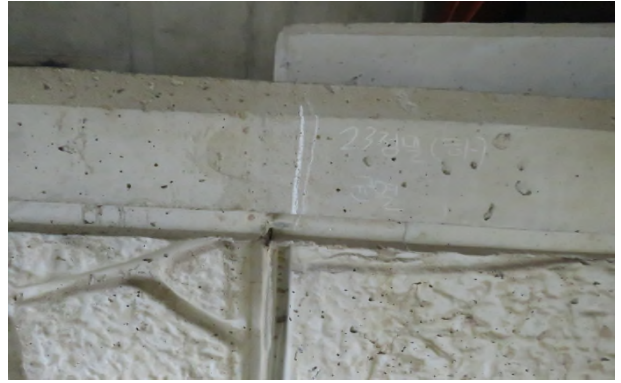
⑳ 균열 (0.3mm미만) cw=0.1mm / 0.5m

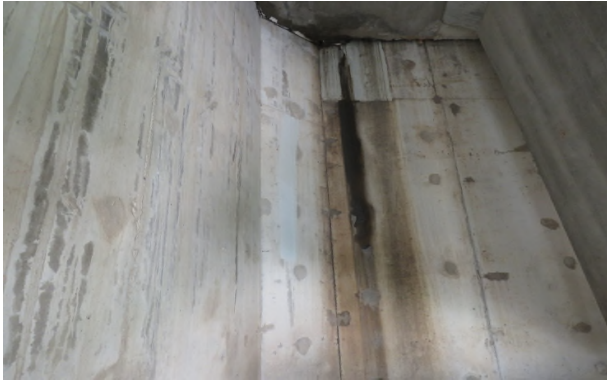
⑤ 균열 (0.3mm미만)  $cw=0.1mm$  / 1.0m (보수완료)

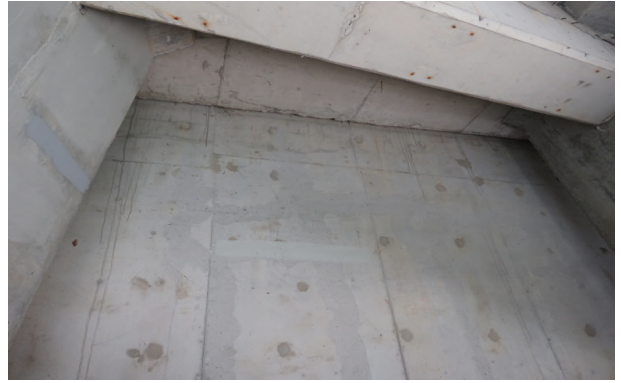
⑥ 균열부 백태  $cw=0.3mm$  / 0.2m (보수완료)

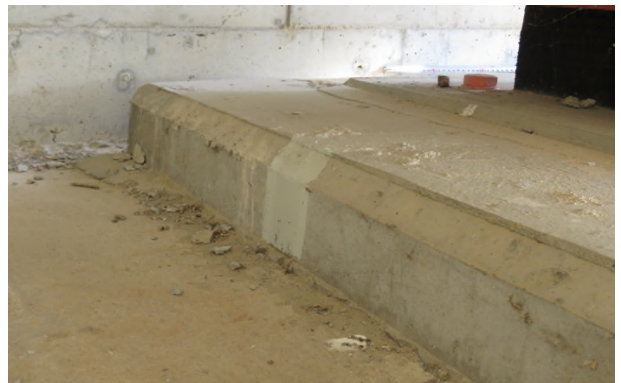
⑧ 받침콘크리트 균열 (0.3mm미만)  $cw=0.2mm$  / 0.1m (보수완료)

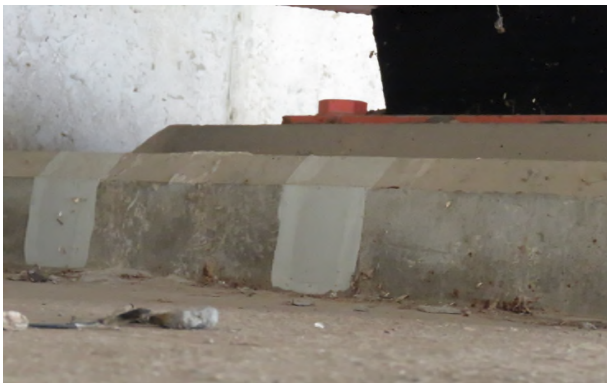
③ 받침콘크리트 균열 (0.3mm미만) cw=0.2mm / 0.2m (3EA) (보수완료)

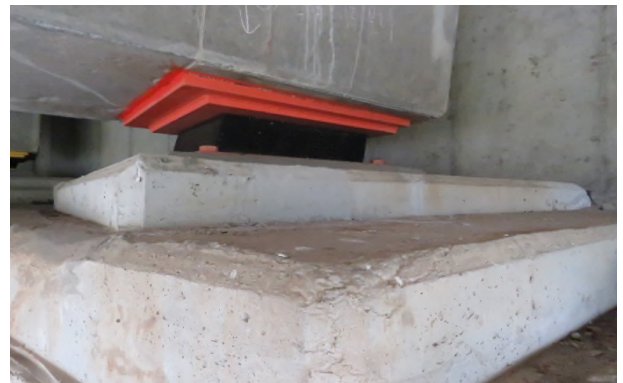
④ 받침콘크리트 재료분리 0.1m x 0.1m (보수완료)

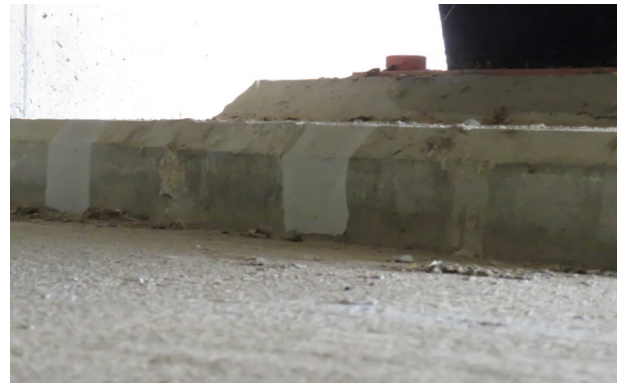
⑥ 받침콘크리트 균열 (0.3mm미만) cw=0.2mm / 0.5m (2EA) (보수완료)

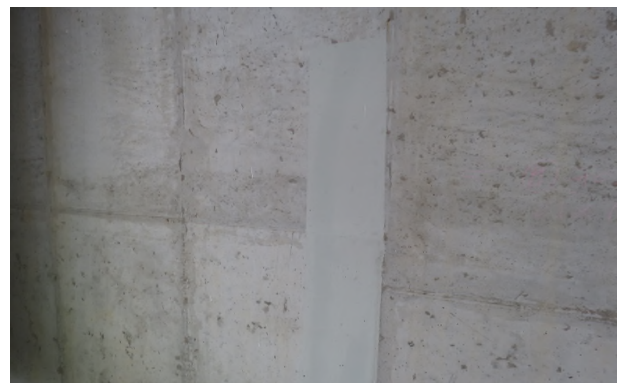
⑧ 균열 (0.3mm미만) cw=0.1mm / 1.5m (보수완료)

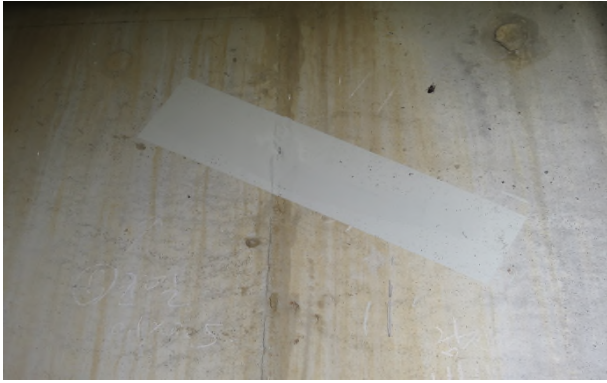
⑨ 균열 (0.3mm미만) cw=0.1mm / 0.5m (보수완료)

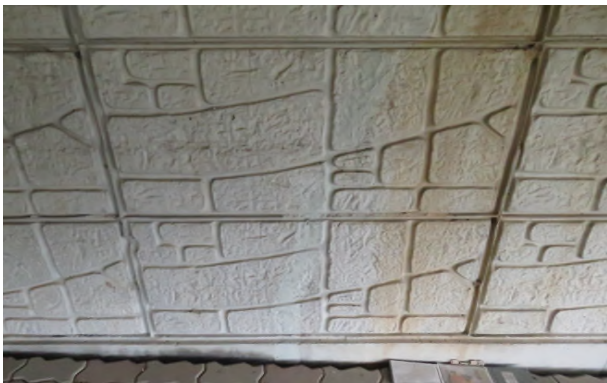
⑪ 균열 cw=0.3mm / 1.5m (2EA) (보수완료)

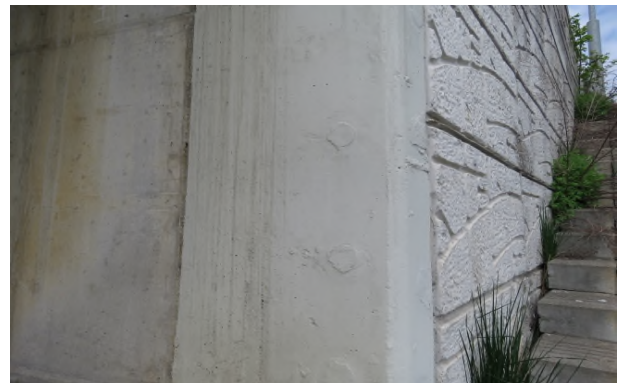
⑫ 보수부 콘크리트박리 0.1m x 0.1 (7EA) (보수완료)

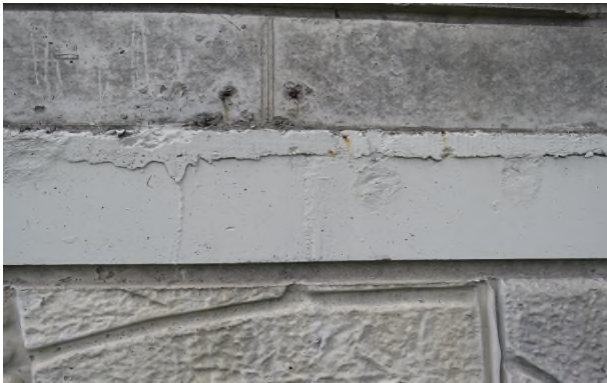
⑬ 파손 0.1m x 0.1m (9EA) (보수완료)

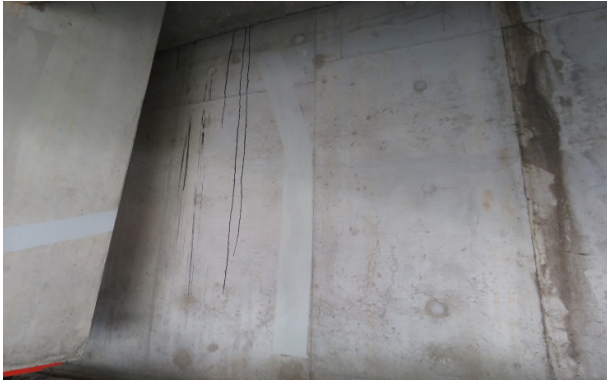
① 균열  $cw=0.3mm$  / 2.0m (보수완료)

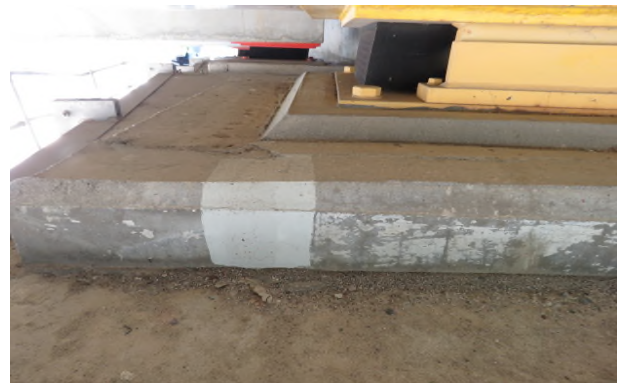
⑥ 받침콘크리트 균열 (0.3mm미만)  $cw=0.2mm$  / 0.2m (3EA) (보수완료)

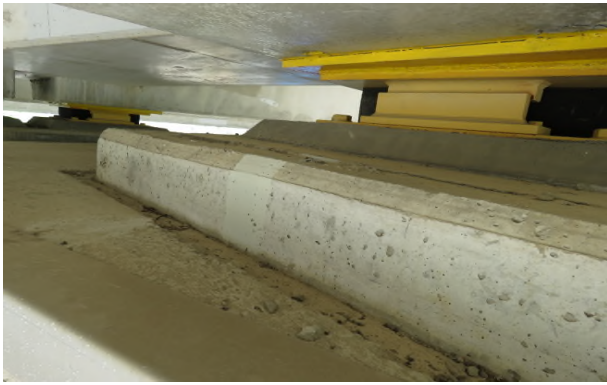
③ 받침콘크리트 균열  $cw=0.3\text{mm}$  /  $0.3\text{m}$  (보수완료)

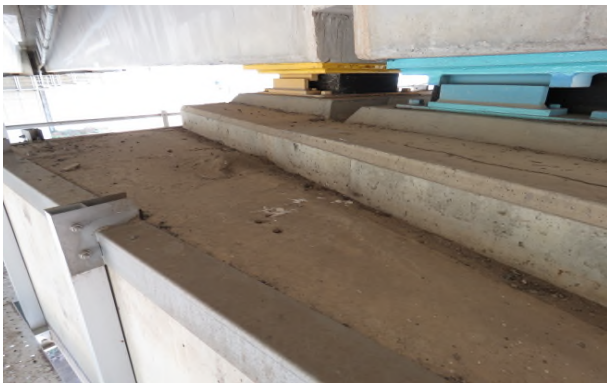
⑦ 받침콘크리트 잡철물미제거 1(EA)

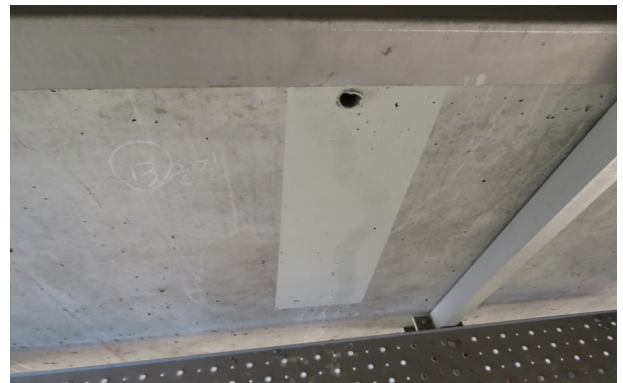
⑬ 균열(0.3mm미만)  $cw=0.1mm$  / 0.3m (보수완료)

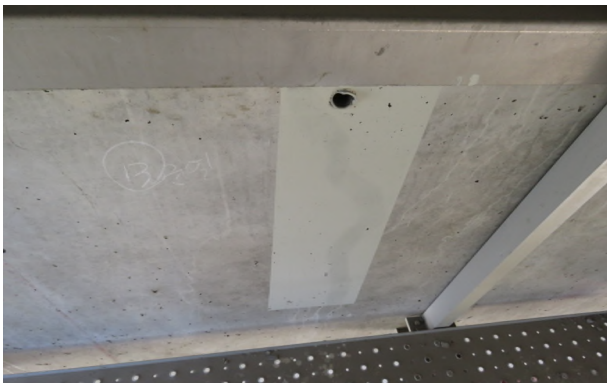
⑭ 균열(0.3mm미만)  $cw=0.05mm$  / 0.2m (보수완료)

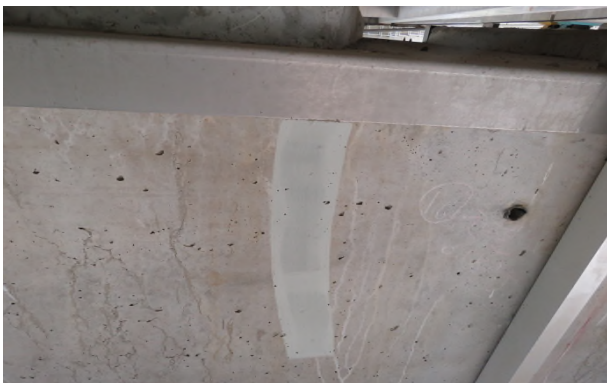
⑯ 균열(0.3mm미만)  $cw=0.1mm$  / 0.5m (2EA)  
(보수완료)

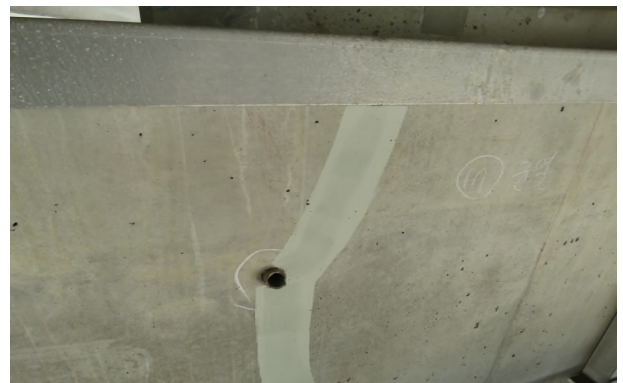
⑰ 균열 (0.3mm미만)  $cw=0.05mm$  / 0.5m (보수완료)

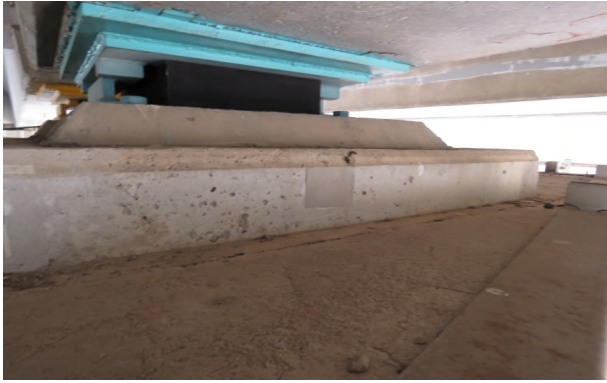
⑱ 파손 0.1m x 0.1m (보수완료)

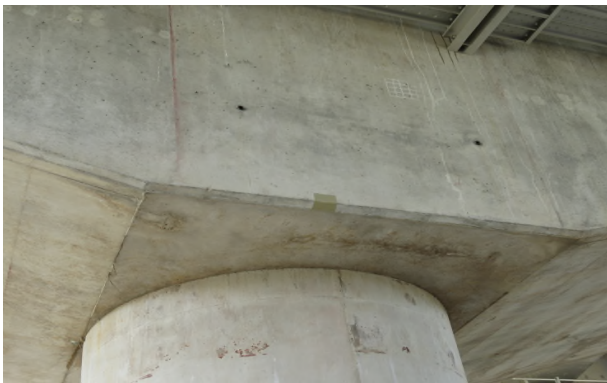
⑳ 파손 0.1m x 0.1m (보수완료)

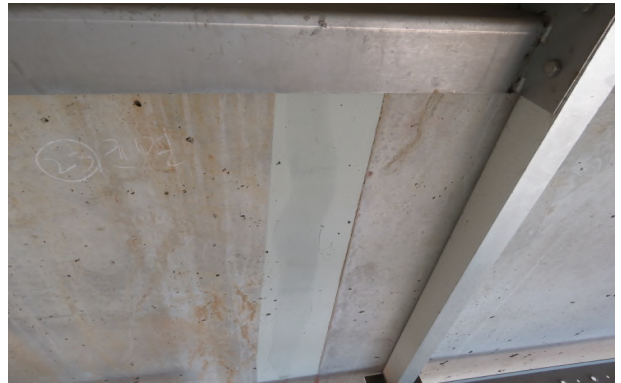
㉓ 균열(0.3mm미만) cw=0.05mm / 0.3m (보수완료)

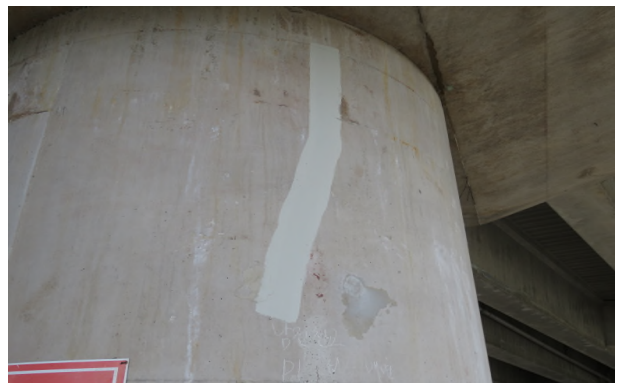
㉕ 균열 (0.3mm미만) cw=0.1mm / 1.0m (보수완료)

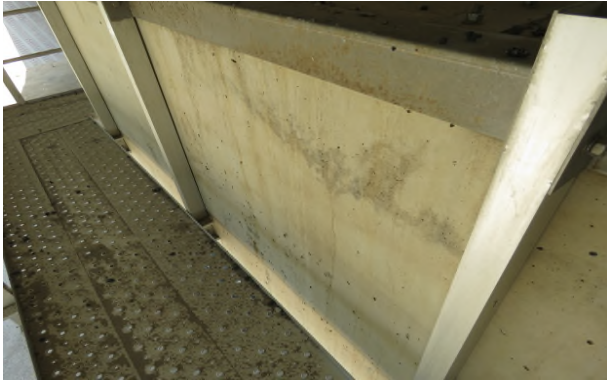
㉔ 파손(균함) 0.1m x 0.5m (2EA) (보수완료)

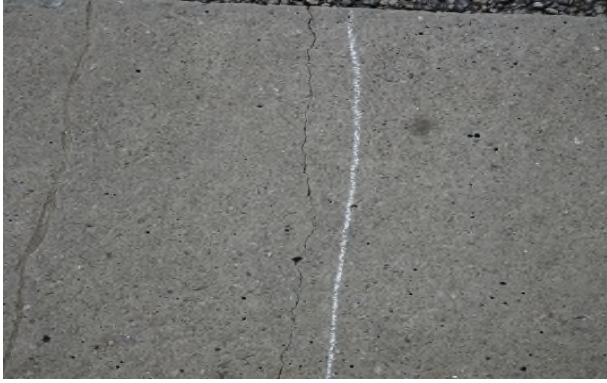
⑥ 후타재 균열 (0.3mm미만)  $cw=0.1\text{mm} / 0.2\text{m}$  (9EA)

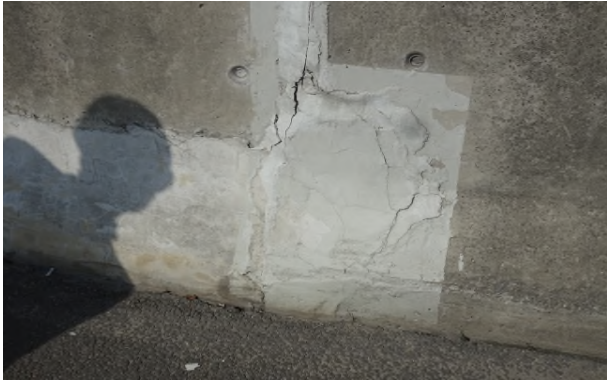
① 파손 0.6m x 0.4m (보수완료)

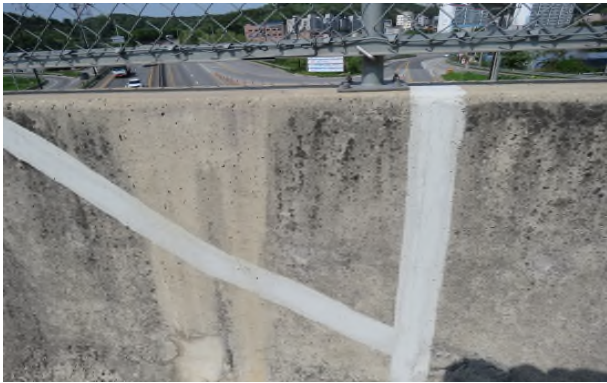
③ 균열 (0.3mm미만) cw=0.1mm / 2.0 m(보수완료)

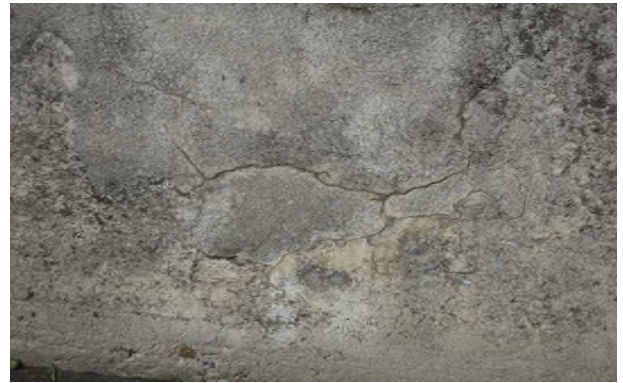
④ 망상균열 (0.3mm미만) cw=0.1mm / 0.6m x 0.5m

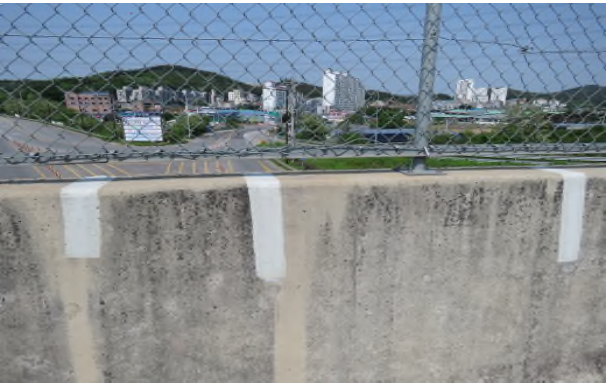
⑤ 균열 (0.3mm미만) cw=0.1mm / 0.3m (4EA)  
(보수완료)

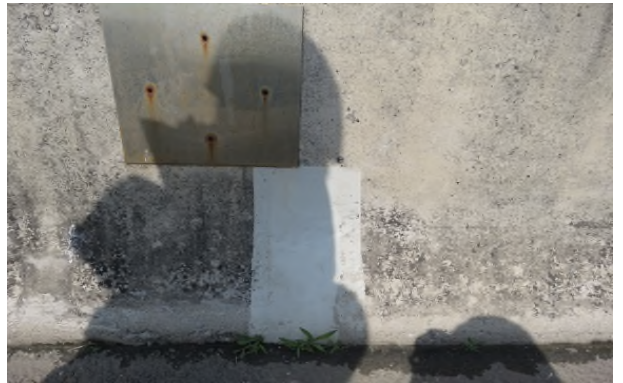
⑥ 균열부 백태 (0.3mm미만) cw=0.2mm / 0.6m

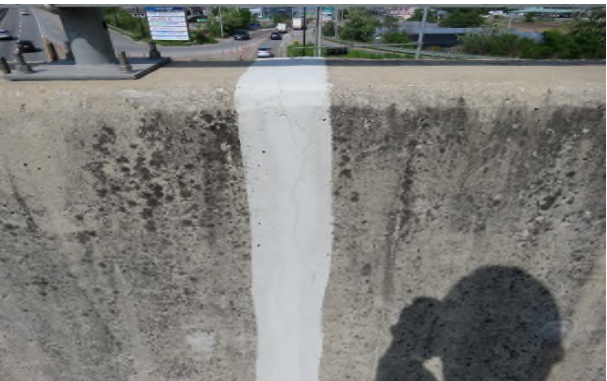
⑦ 균열 (0.3mm미만) cw=0.2mm / 1.5m (보수완료)

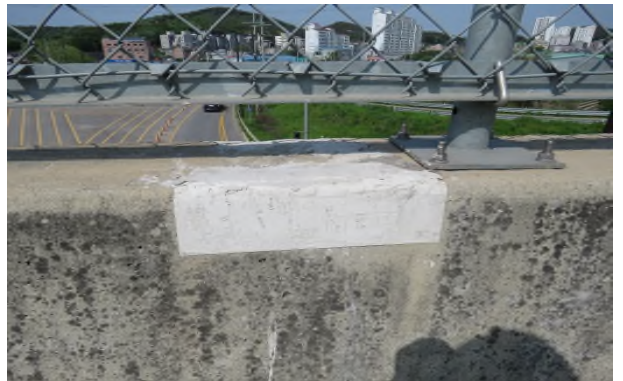
⑧ 파손 0.2m x 0.3m (보수완료)

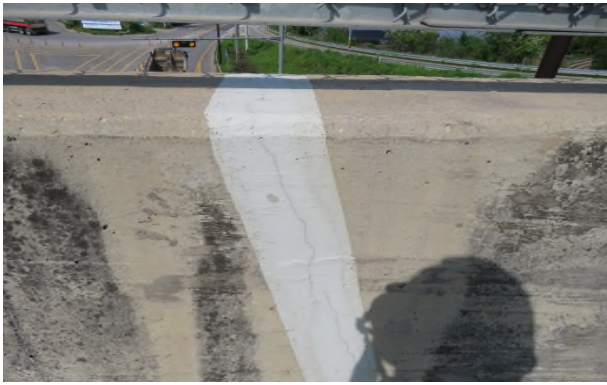
⑨ 균열 (0.3mm미만) cw=0.1mm / 0.5m (보수완료)

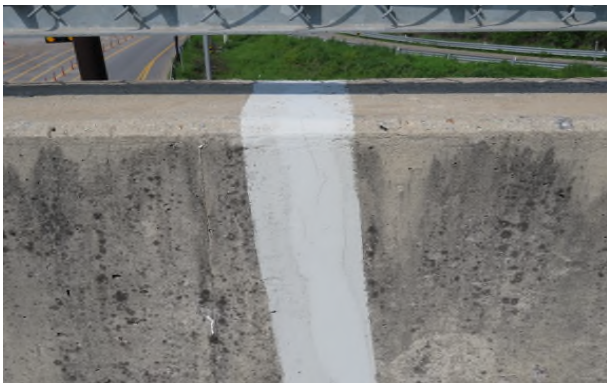
⑪ 균열 (0.3mm미만) cw=0.1mm / 0.3m (4EA)  
(보수완료)

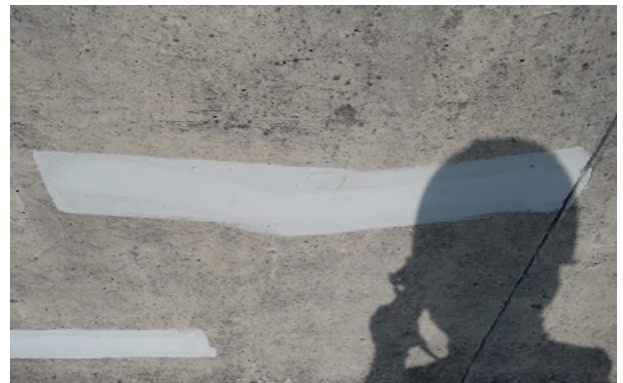
⑫ 균열 (0.3mm미만) 0.1m / 0.5m (2EA) (보수완료)

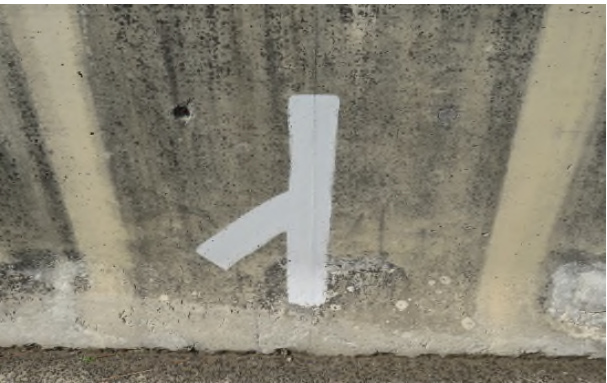
⑬ 균열 (0.3mm미만) cw=0.1mm / 0.5m (보수완료)

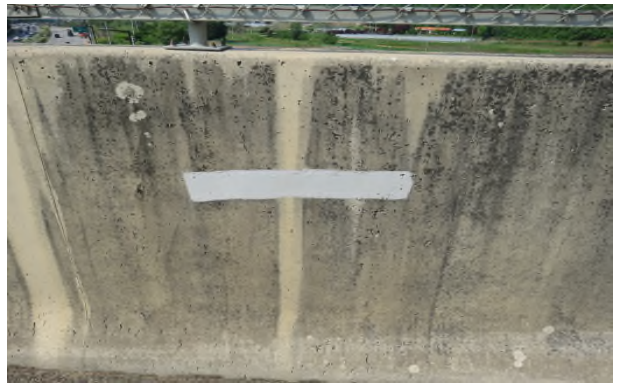
⑭ 균열 (0.3mm미만) cw=0.1mm / 0.3m (보수완료)

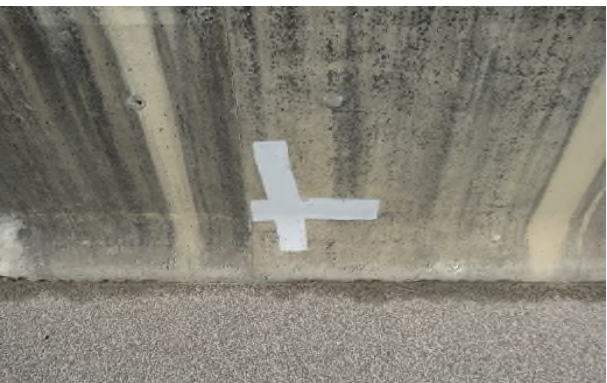
⑮ 균열 (0.3mm미만) cw=0.1mm / 0.8m (보수완료)

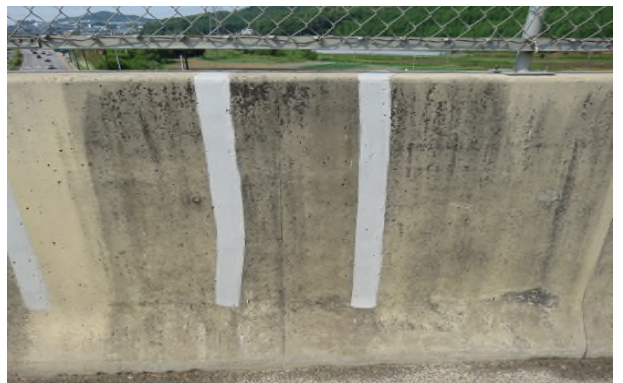
⑯ 균열 cw=0.3mm / 1.5m (2EA) (보수완료)

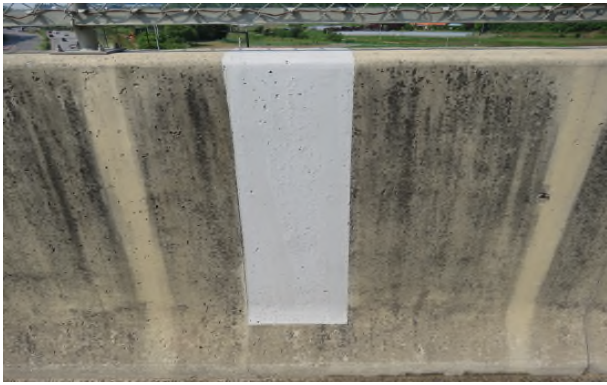
⑰ 균열 (0.3mm미만)  $cw=0.2mm$  / 1.3m (보수완료)

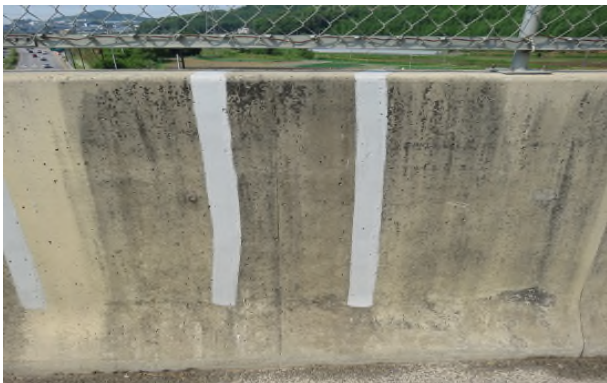
⑲ 균열  $cw=0.3mm$  / 1.5m (2EA) (보수완료)

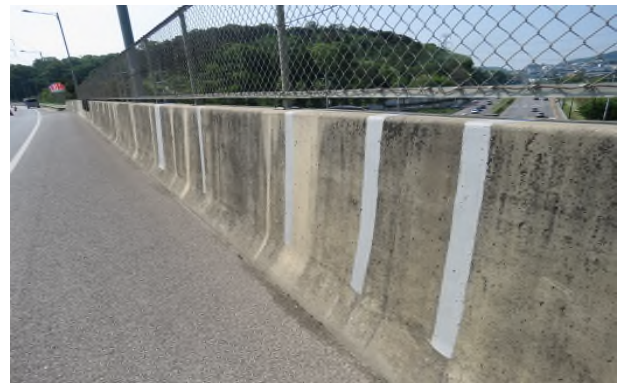
⑳ 균열  $cw=0.3mm$  / 1.5m (보수완료)

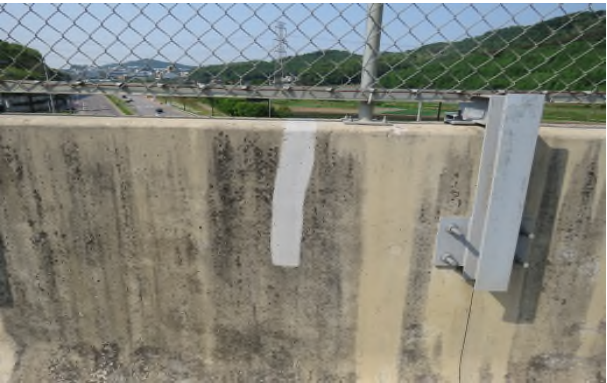
㉑ 균열  $cw=0.3mm$  / 1.0m (보수완료)

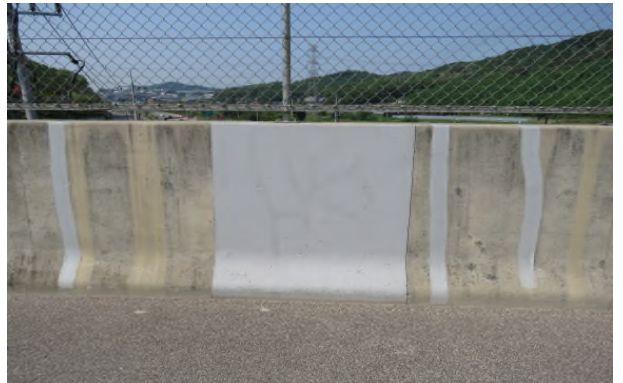
㉒ 망상균열  $cw=0.3mm$  / 1.2m x 1.2m (보수완료)

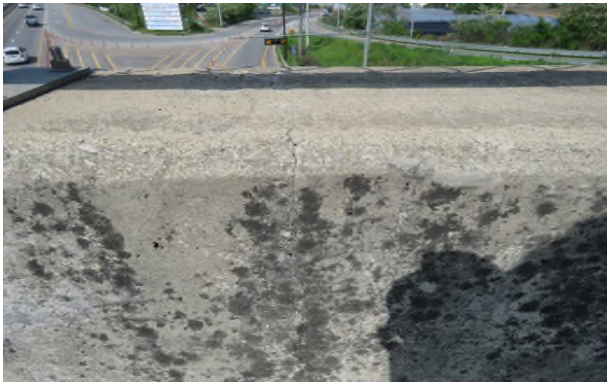
㉟ 균열 (0.3mm미만) cw=0.1mm / 1.5m

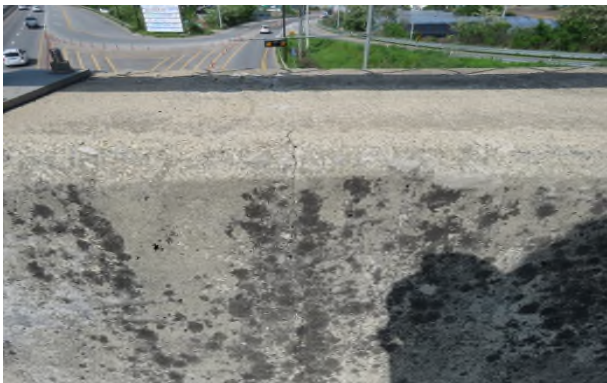
㉡ 균열 (0.3mm미만) cw=0.1mm / 0.3m (15EA)

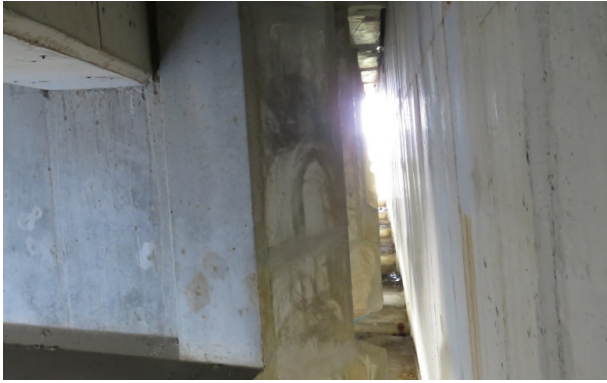
④ 균열 (0.3mm미만)  $cw=0.2mm$  / 0.5m (5EA)  
(보수완료)

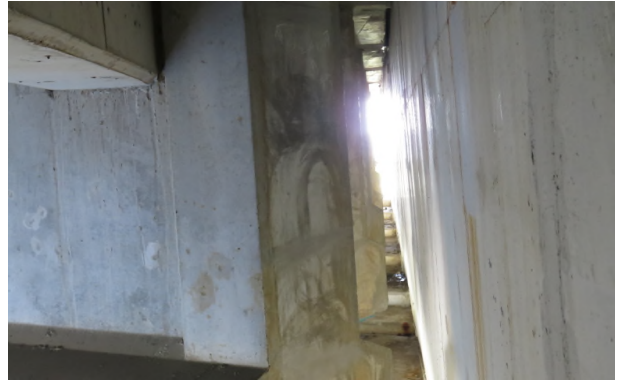
⑤ 균열 (0.3mm미만)  $cw=0.2mm$  / 0.5m (4EA)  
(보수완료)

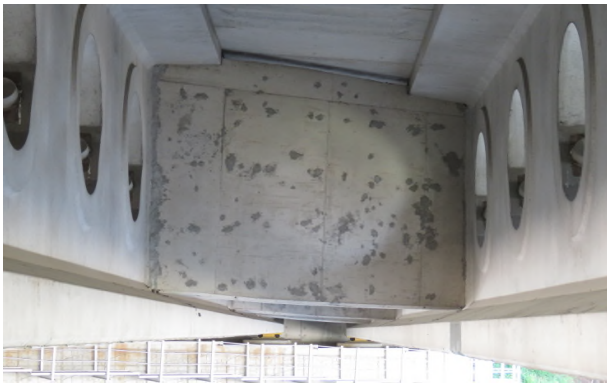
⑥ 균열 0.8m x 0.1m (2EA) (보수완료)

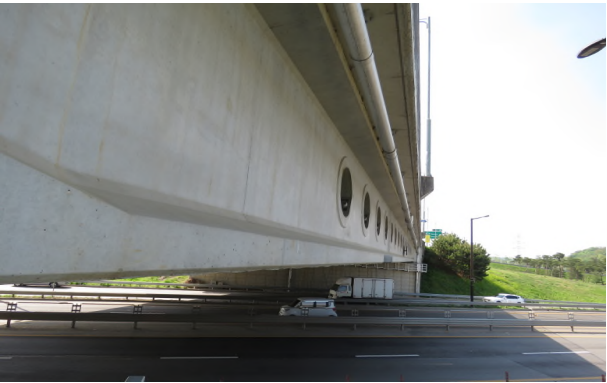
⑧ 파손 및 균열 0.8m x 0.1m (보수완료)

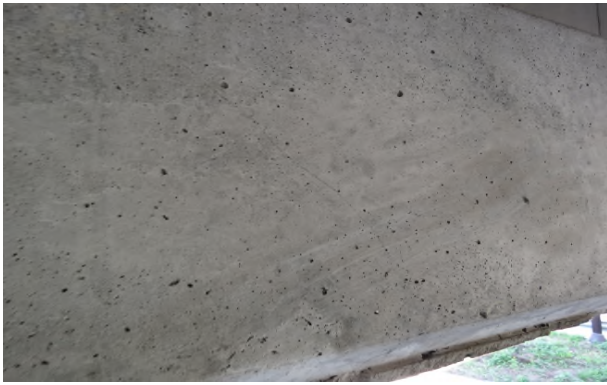
① 균열 (0.3mm미만)  $cw=0.1mm / 0.1m$  (3EA)

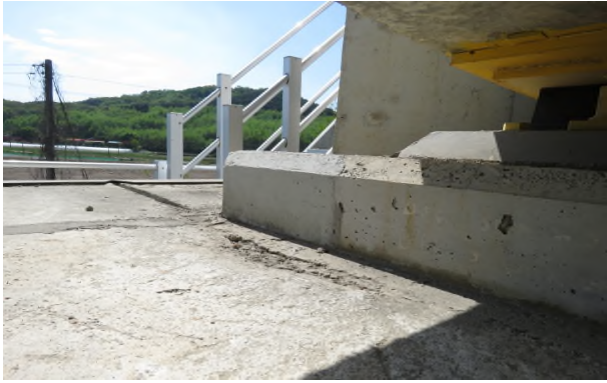
⑩ 받침콘크리트 재료분리 0.1m x 0.1m (보수완료)

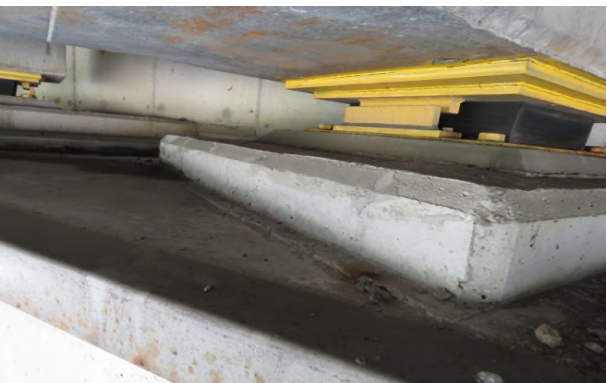
⑯ 받침콘크리트 파손 0.2m x 0.4m (보수완료)

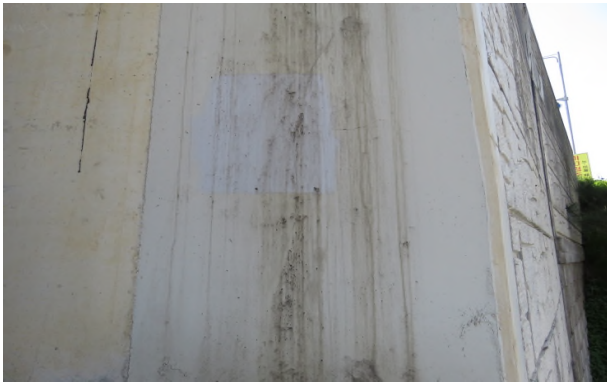
⑲ 망상균열 (0.3mm미만) cw=0.1mm / 1.0m x 2.5m  
(보수완료)

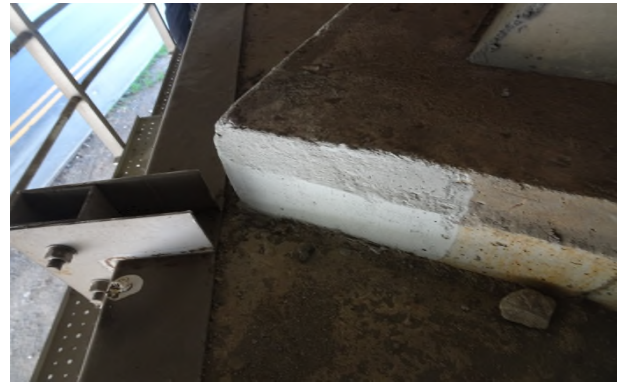
⑨ 받침콘크리트 재료분리 0.1m x 0.1m (보수완료)

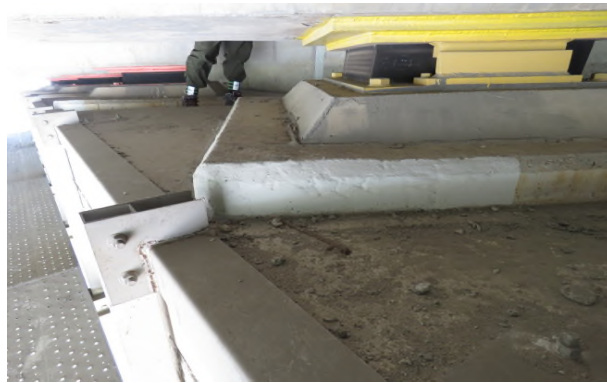
⑩ 받침콘크리트 재료분리 0.1m x 0.1m (보수완료)

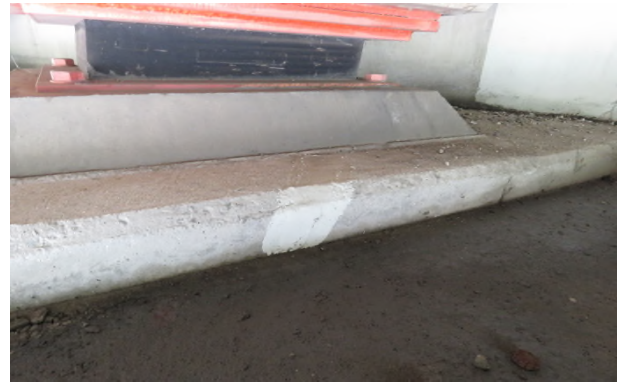
⑪ 받침콘크리트 균열 (0.3mm미만) cw=0.1mm / 0.1m (보수완료)

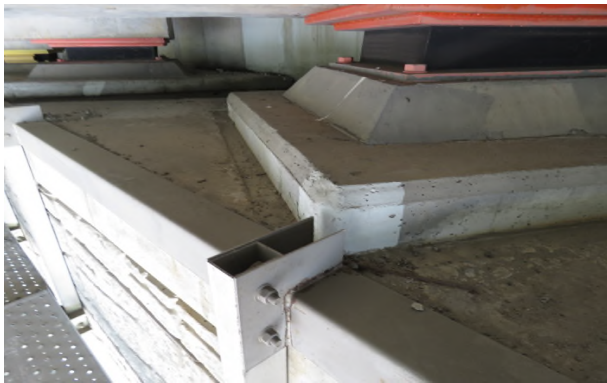
⑫ 받침콘크리트 철근노출 (1EA) (보수완료)

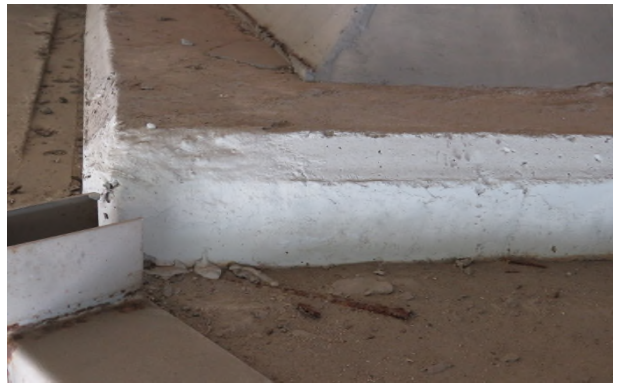
⑬ 받침콘크리트 재료분리 0.1m x 0.1m (보수완료)

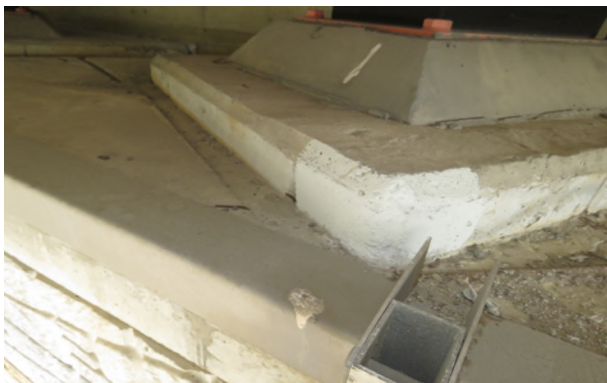
⑭ 받침콘크리트 파손 0.1m x 0.1m (보수완료)

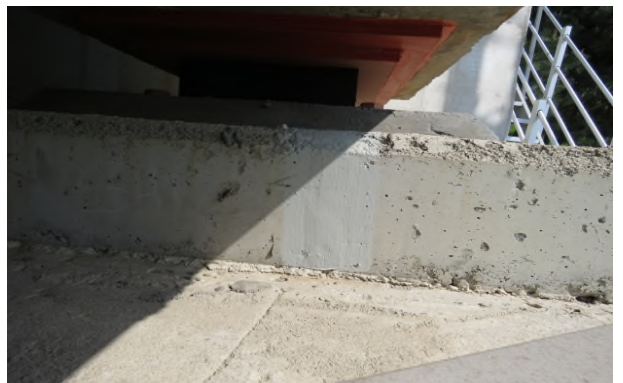
⑮ 받침콘크리트 균열 (0.3mm미만) cw=0.1mm / 0.3m (보수완료)

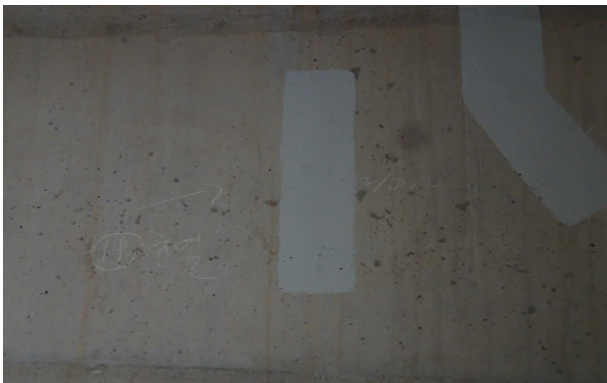
⑲ 균열 (0.3mm미만)  $cw=0.02mm$  / 0.2m (보수완료)

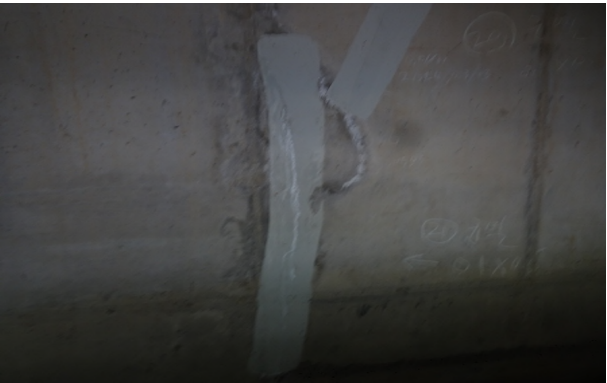
㉑ 균열 (0.3mm미만)  $cw=0.1mm$  / 0.6m (보수완료)

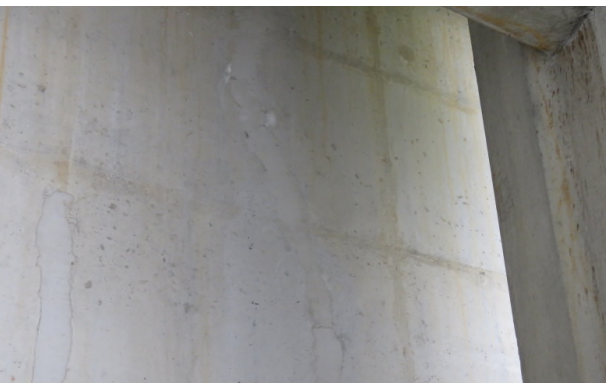
㉓ 균열 (0.3mm미만)  $cw=0.2mm$  / 2.5m (보수완료)

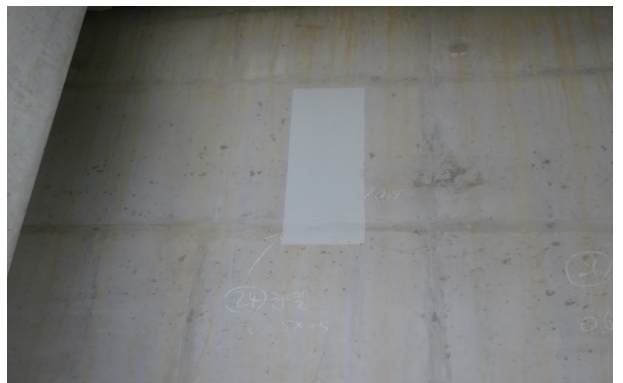
㉔ 균열 (0.3mm미만)  $cw=0.05mm$  / 0.5m (보수완료)

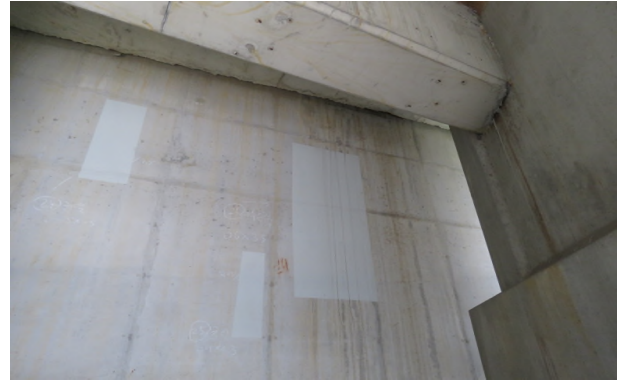
㉕ 누수흔적 0.6m x 3.5m (보수완료)

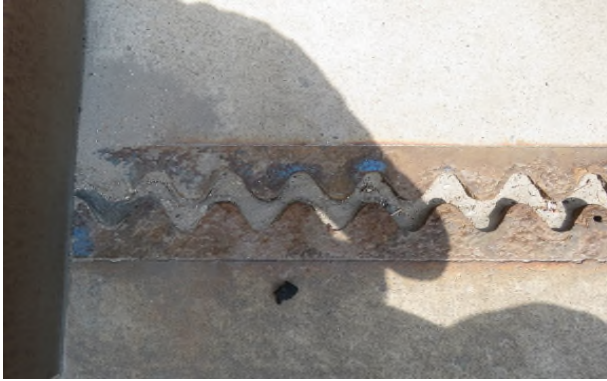
② 신축이음 토사퇴적 및 부식 0.5m (보수완료)

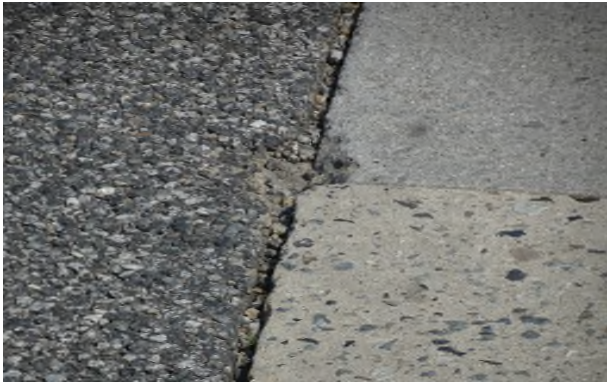
④ 후타재 파손 0.1m x 0.1m

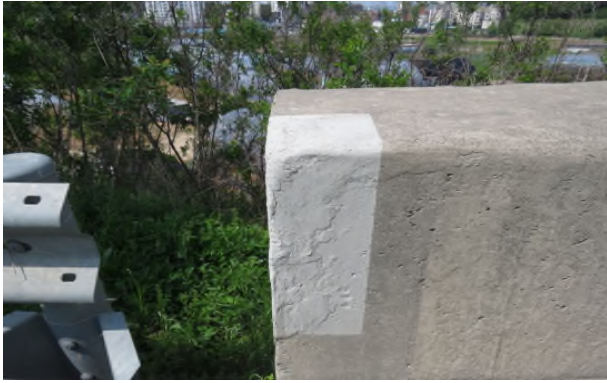
① 파손 0.1m x 0.1m (보수완료)

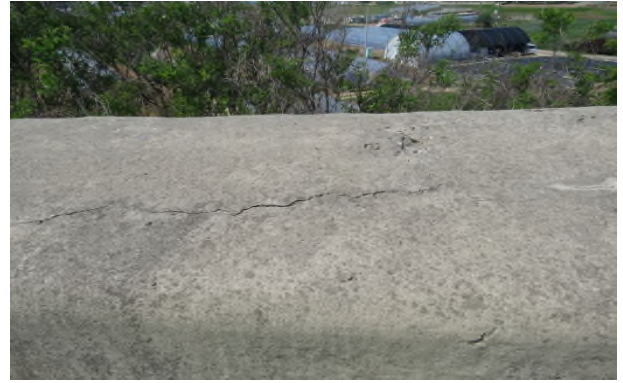
② 균열  $cw=0.3\text{mm}$  / 0.5m

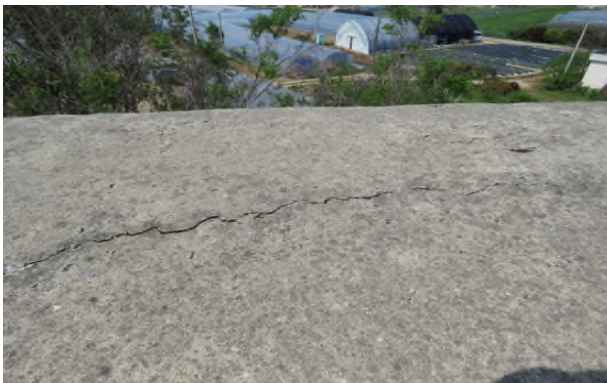
③ 균열  $cw=0.3\text{mm}$  / 0.4m

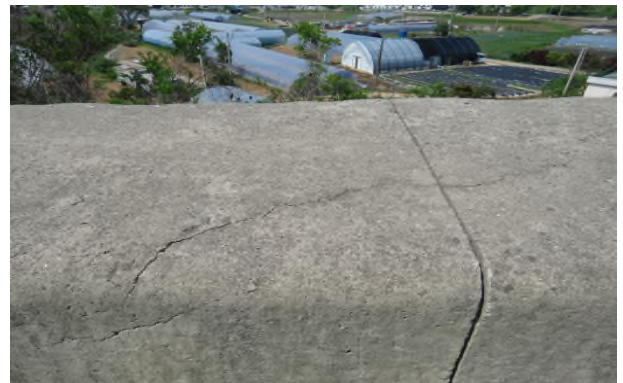
④ 균열 (0.3mm미만)  $cw=0.2\text{mm}$  / 0.6m
