## **6. 현황조사 및 외관조사 사진첩**

## 01. 남전천교

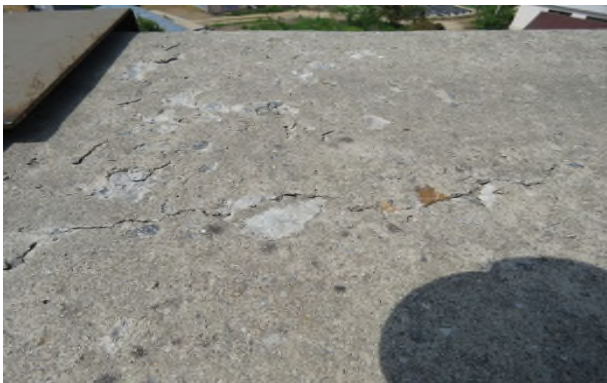
⑤ 균열  $cw=0.3\text{mm}$  / 3.0m

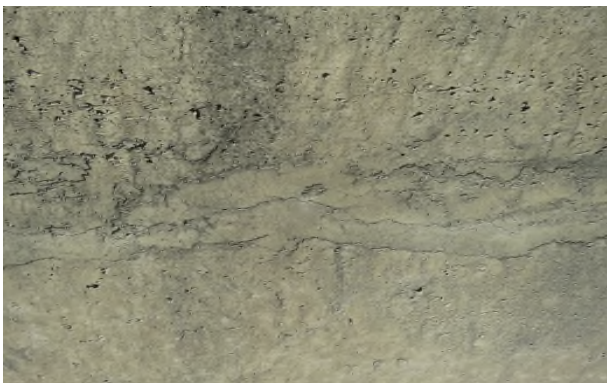
⑦ 균열 (0.3mm미만)  $cw=0.1\text{mm}$  / 4.0m

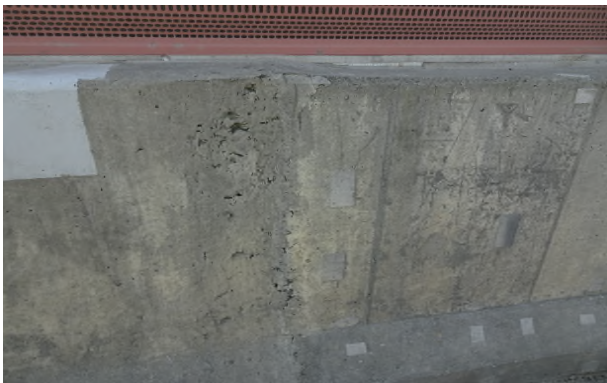
⑪ 파손 0.1m x 0.1m (보수완료)

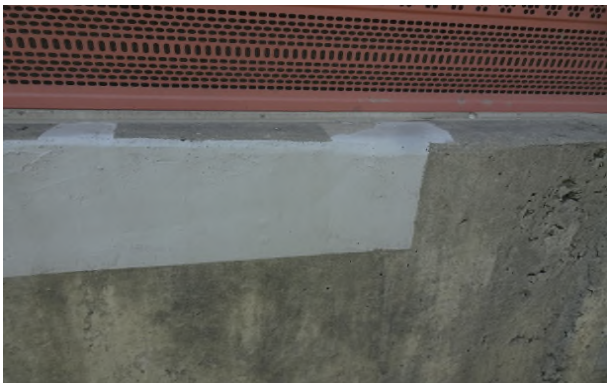
⑬ 균열 (0.3mm미만) cw=0.1mm / 4.0m (보수완료)

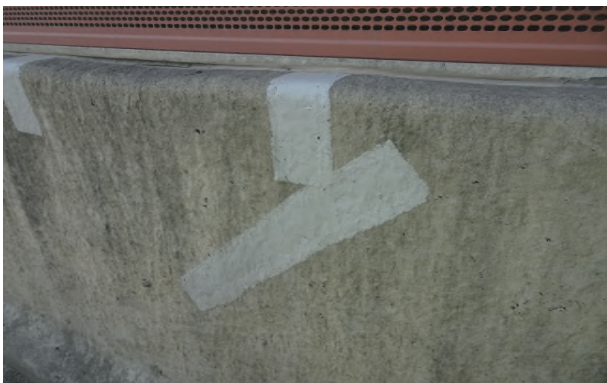
⑯ 균열 (0.3mm미만) cw=0.1mm / 0.2m (5EA)  
(보수완료)

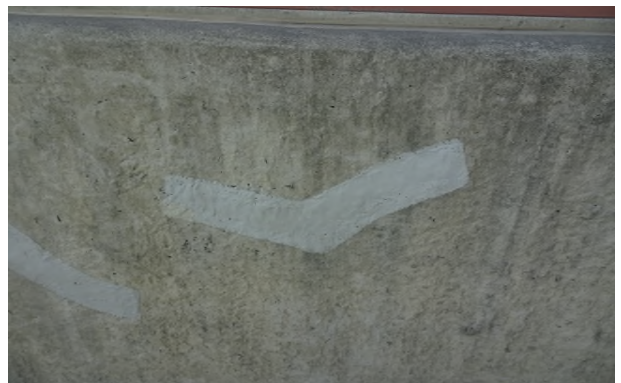
⑰ 균열 (0.3mm미만) cw=0.1mm / 0.5m (보수완료)

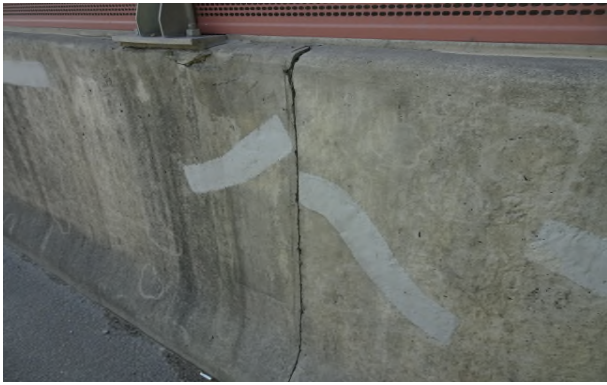
⑱ 균열 (0.3mm미만)  $cw=0.1mm$  / 0.3m (보수완료)

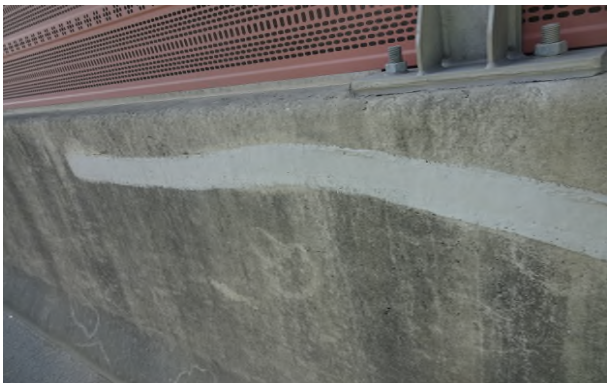
㉒ 균열 (0.3mm미만)  $cw=0.1mm$  / 0.4m (보수완료)

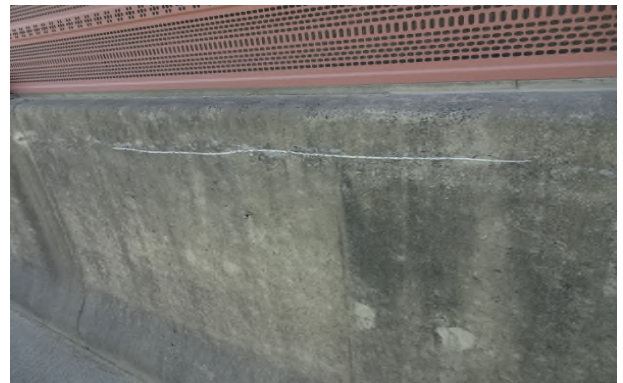
㉓ 균열 (0.3mm미만)  $cw=0.2mm$  / 1.0m

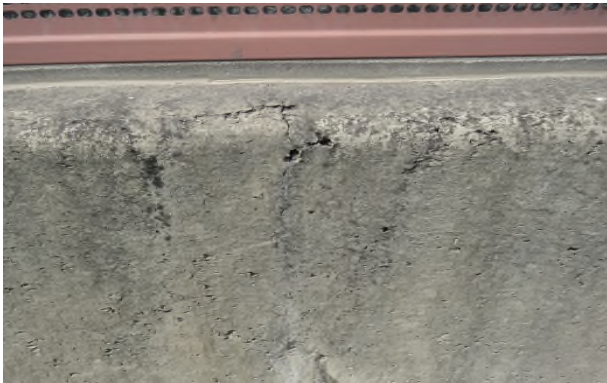
㉔ 균열 (0.3mm미만)  $cw=0.1mm$  / 0.4m (4EA)

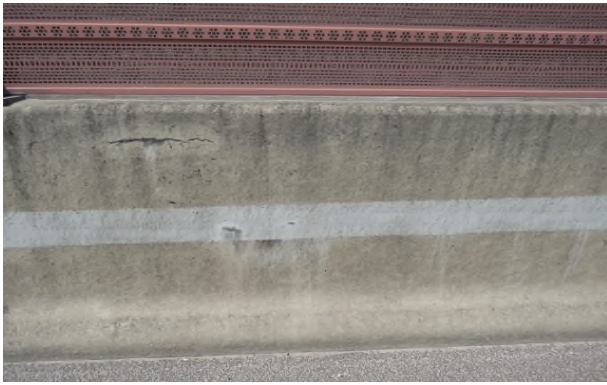
① 균열 (0.3mm미만)  $cw=0.2mm$  / 2.0m (4EA)  
(보수완료)

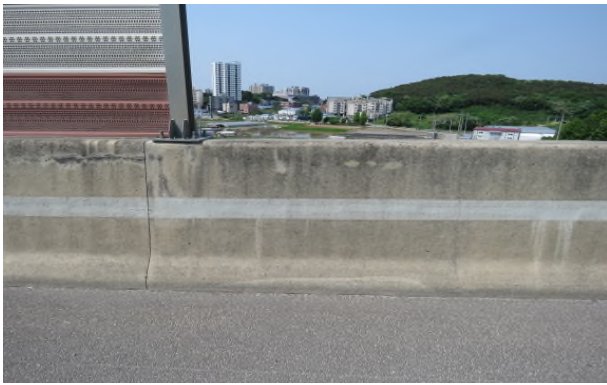
③ 균열 (0.3mm미만)  $cw=0.2mm$  / 22.0m (보수완료)

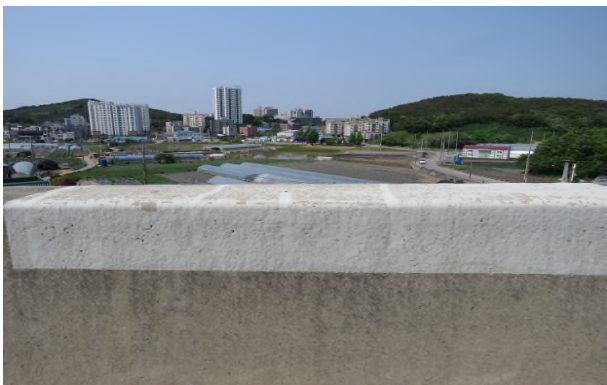
⑤ 균열 (0.3mm미만)  $cw=0.1mm$  / 0.5m (5EA)  
(보수완료)

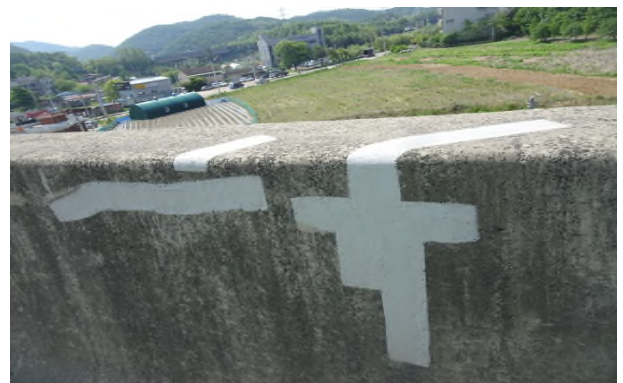
⑧ 균열 (0.3mm미만)  $cw=0.2mm$  / 0.3m (보수완료)

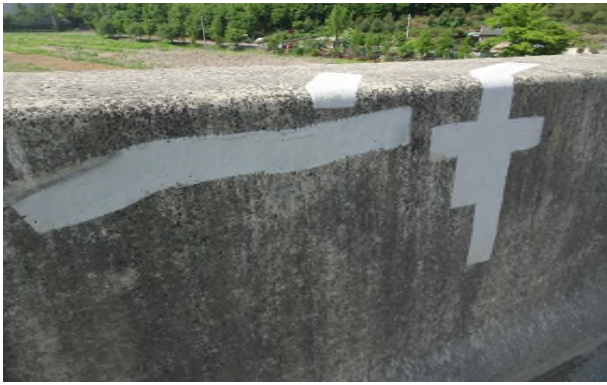
⑨ 균열 (0.3mm미만)  $cw=0.1mm$  / 0.4m (보수완료)

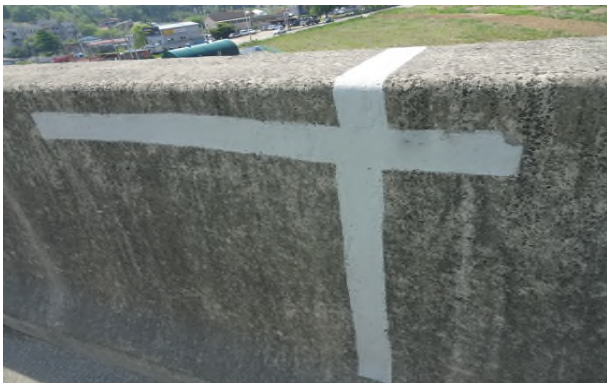
⑪ 균열 (0.3mm미만)  $cw=0.1mm$  / 0.8m (보수완료)

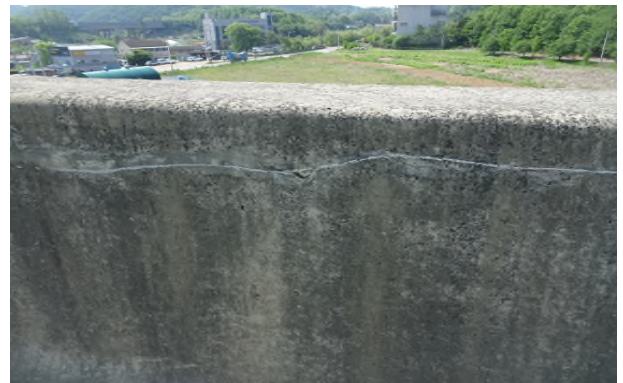
⑫ 균열  $cw=0.3mm$  / 2.0m

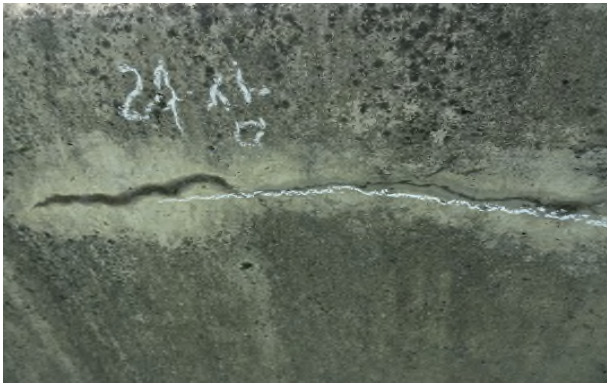
⑬ 균열 (0.3mm미만)  $cw=0.2mm$  / 1.3m

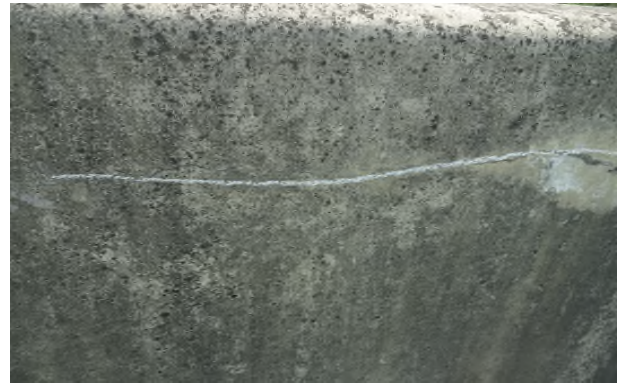
⑭ 균열 (0.3mm미만)  $cw=0.1mm$  / 0.7m

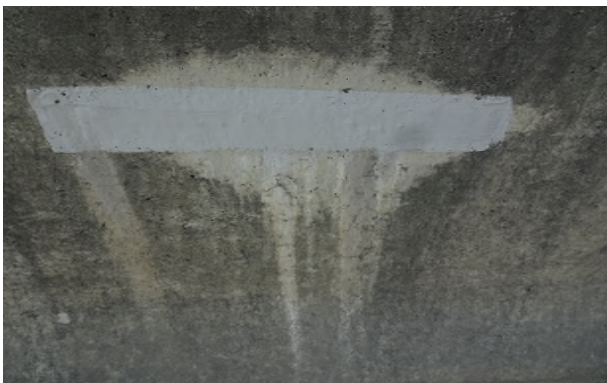
⑮ 균열부 백태 (0.3mm미만)  $cw=0.2mm$  / 0.5m  
(보수완료)

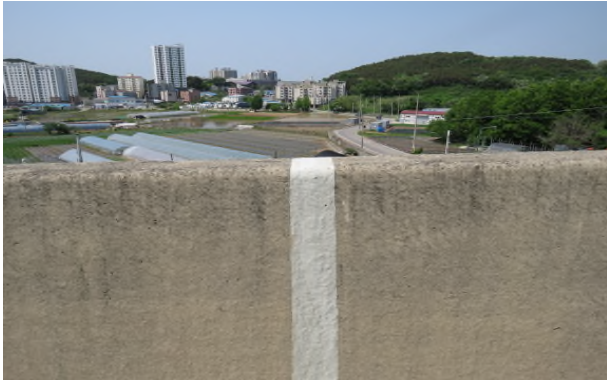
① 균열 (0.3mm미만)  $cw=0.1mm$  / 1.5m (보수완료)

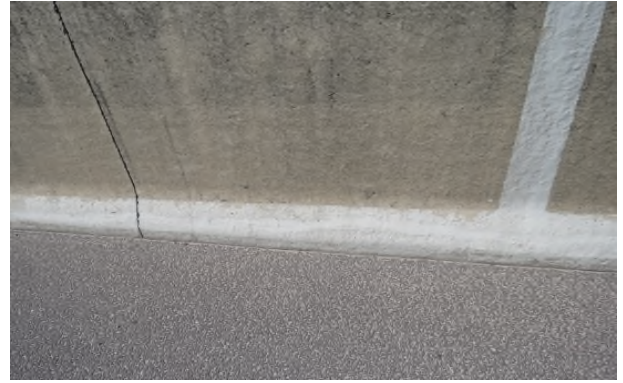
② 균열  $cw=0.3mm$  / 3.0m (보수완료)

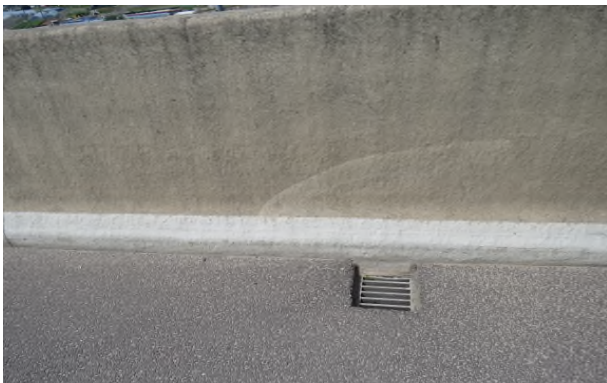
③ 균열 (0.3mm미만)  $cw=0.2mm$  / 5.0m (보수완료)

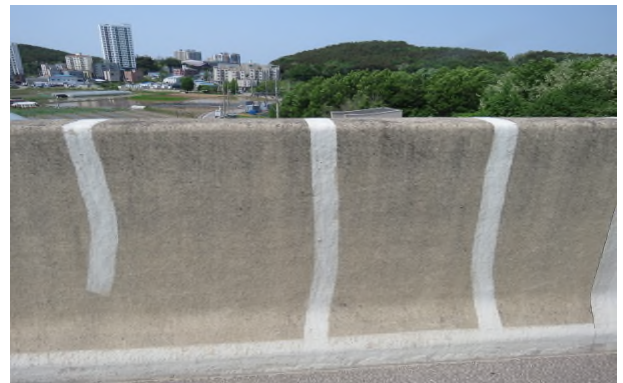
④ 균열 (0.3mm미만)  $cw=0.2mm$  / 1.5m (12EA)  
(보수완료)

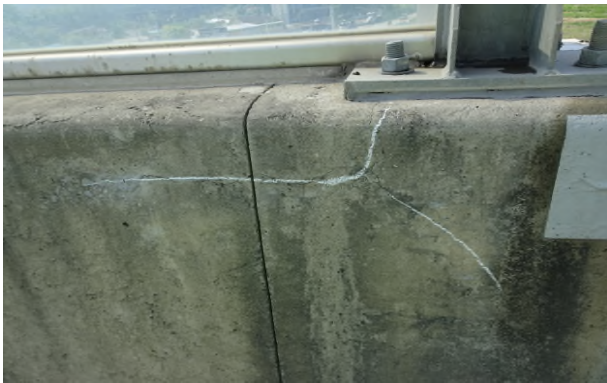
②② 균열 (0.3mm미만)  $cw=0.2mm$  / 0.5m

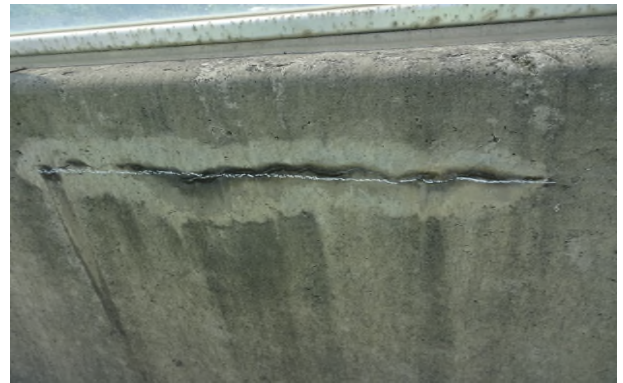
②③ 균열 (0.3mm미만)  $cw=0.2mm$  / 0.8m

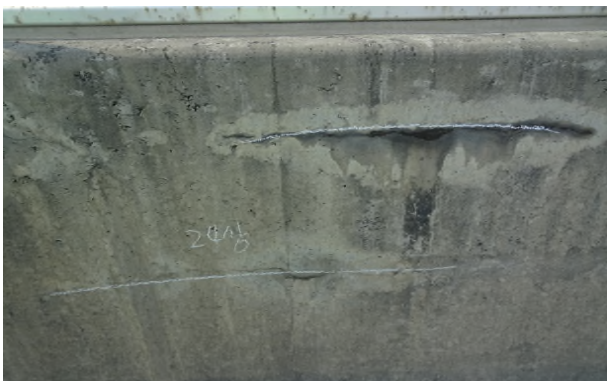
②④ 균열 (0.3mm미만)  $cw=0.2mm$  / 0.8m (3EA)

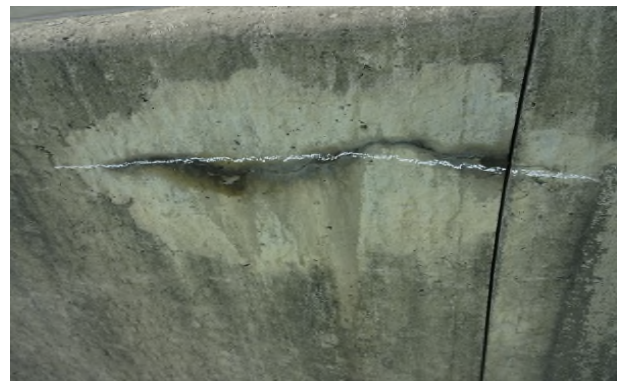
②⑤ 균열 (0.3mm미만)  $cw=0.2mm$  / 0.6m

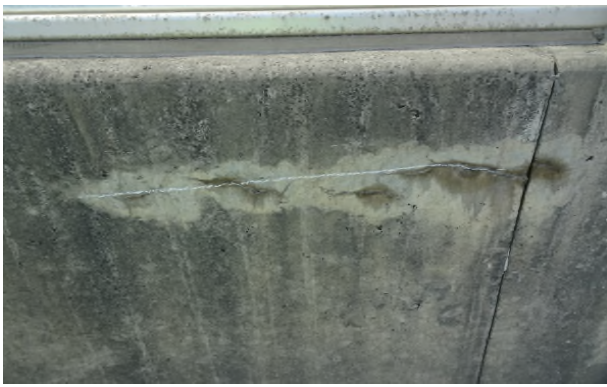
㉔ 균열 (0.3mm미만) cw=0.2mm / 0.6m

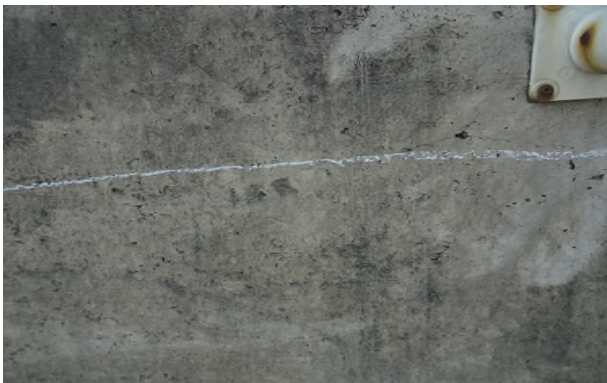
⑲ 균열 (0.3mm미만)  $cw=0.2mm$  / 1.0m

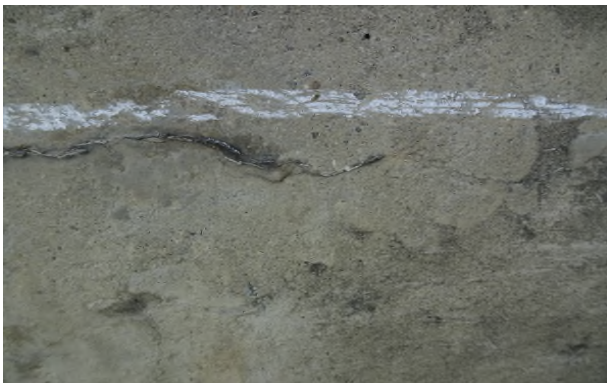
㉑ 균열 (0.3mm미만)  $cw=0.2mm$  / 1.0m

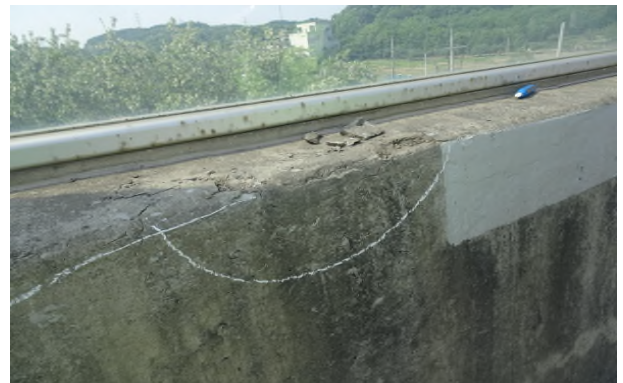
㉒ 파손 0.2m x 0.1m

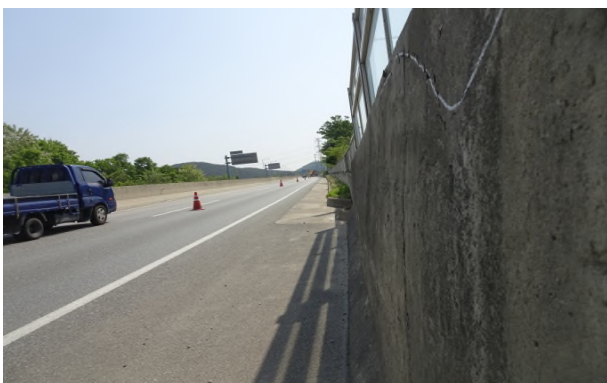
㉓ 균열  $cw=0.3mm$  / 1.5m

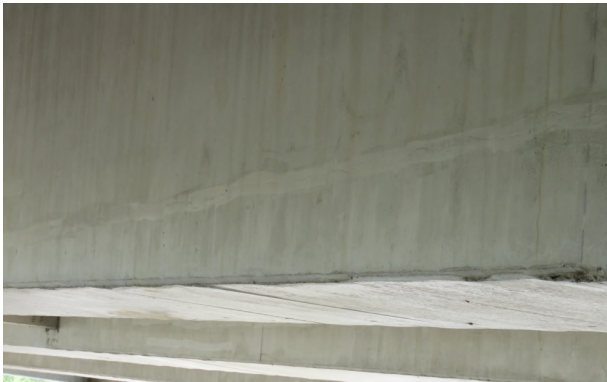
② 균열 (0.3mm미만) cw=0.2mm / 4.3m (보수완료)

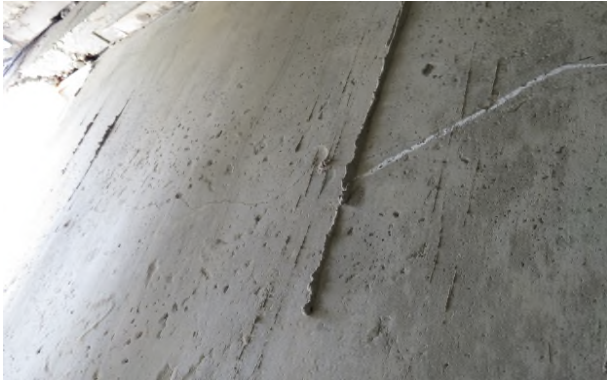
㉔ 거더 단부 균열 (0.3mm미만) cw=0.2mm / 1.2m

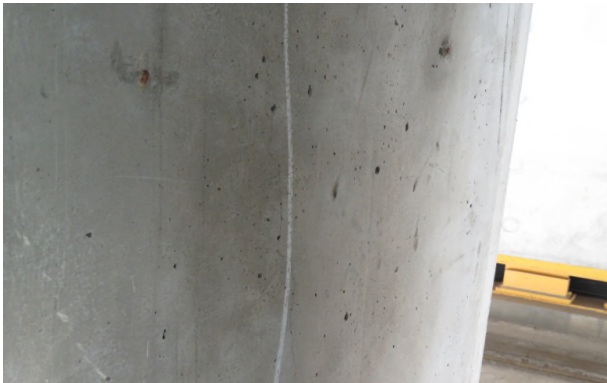
㉘ 거더 단부 균열 (0.3mm미만) cw=0.1mm / 1.0m

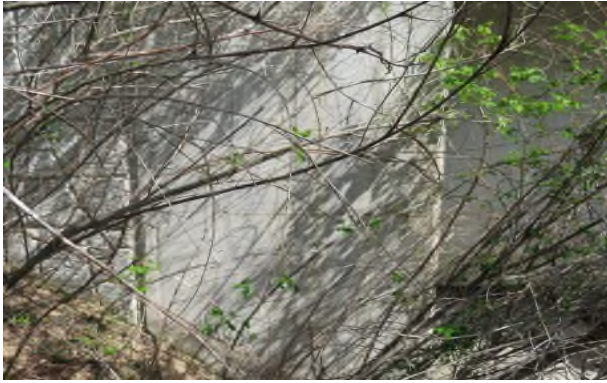
② 균열  $cw=0.3mm$  / 1.0m (보수완료)

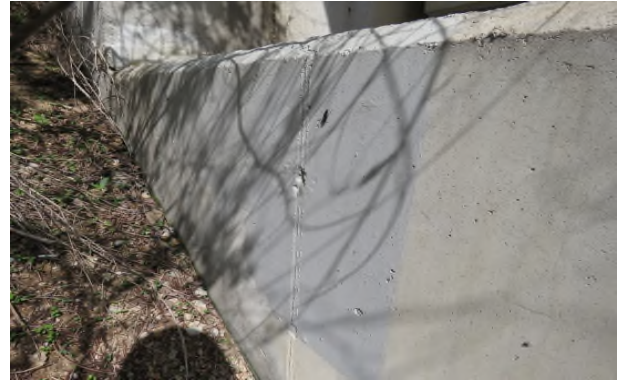
③ 균열 (0.3mm미만)  $cw=0.2mm$  / 0.9m (보수완료)

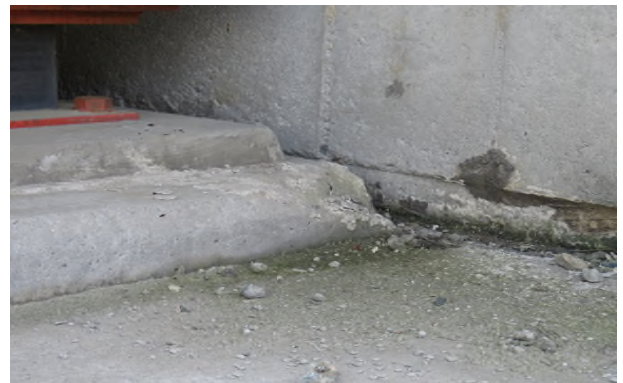
⑥ 받침콘크리트 파손 0.1m x 0.1m

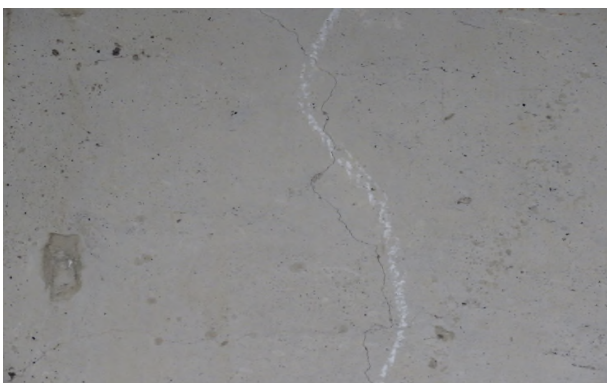
⑨ 균열 (0.3mm미만)  $cw=0.2mm$  / 1.0m

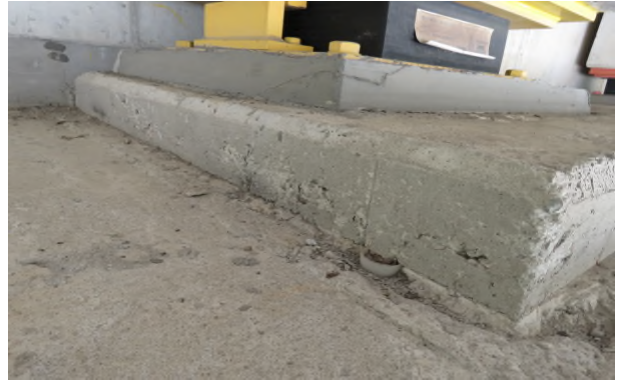
⑦ 받침콘크리트 재료분리 0.1m x 0.3m

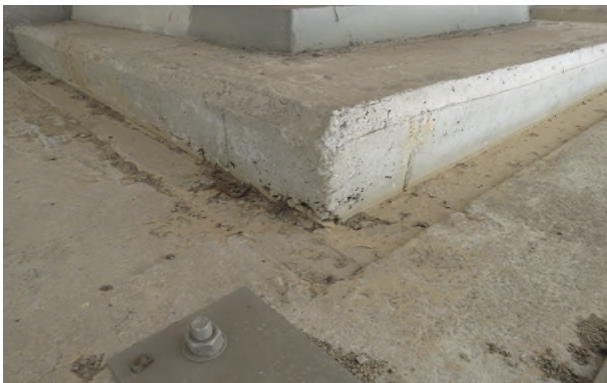
⑧ 받침콘크리트 재료분리 0.1m x 0.4m

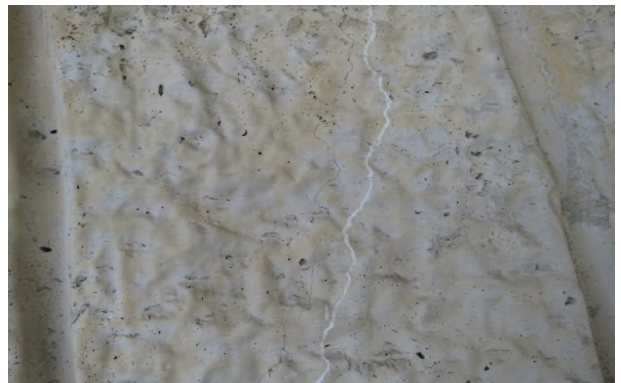
⑪ 균열 (0.3mm미만) cw=0.1mm / 0.6m

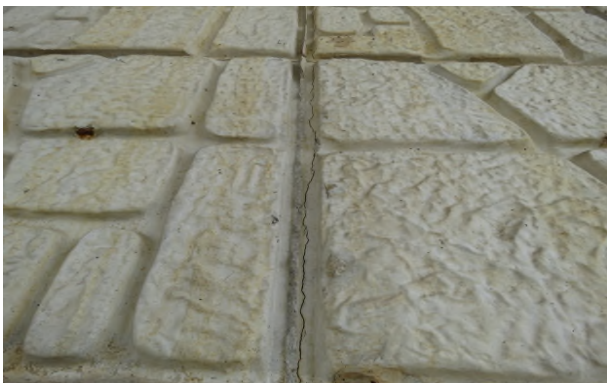
⑫ 균열 cw=0.3mm / 3.0m

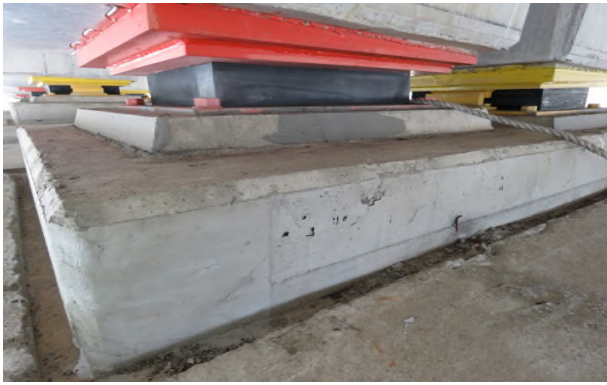
⑬ 받침콘크리트 재료분리 0.2m x 0.1m

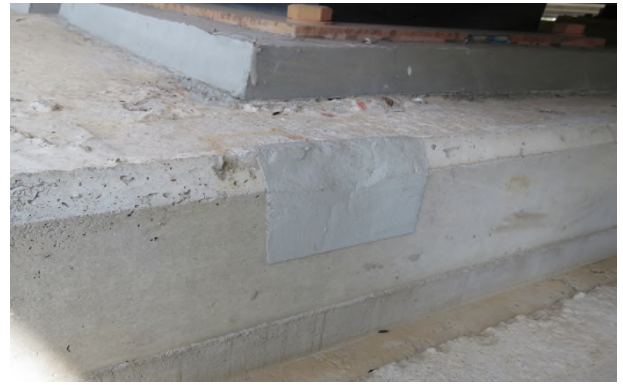
⑭ 받침콘크리트 파손 0.2m x 0.1m (보수완료)

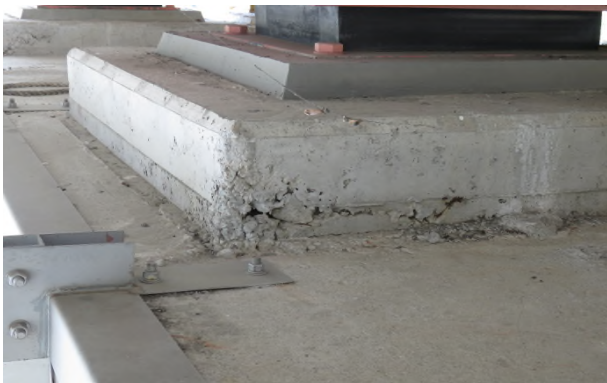
⑮ 받침콘크리트 재료분리 0.2m x 0.3m

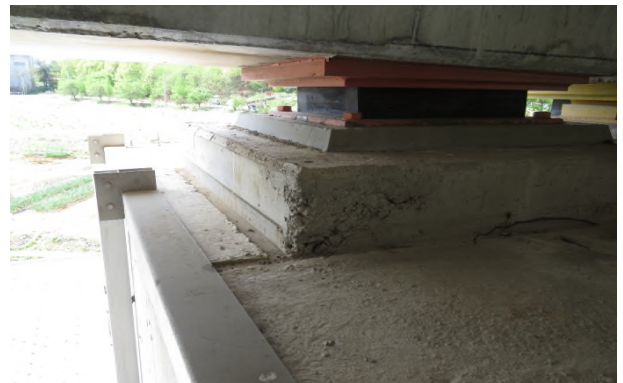
⑯ 받침콘크리트 재료분리 0.1m x 0.3m

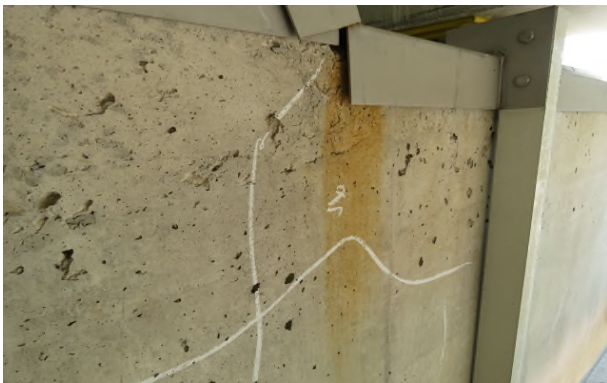
⑰ 균열 (0.3mm미만) cw=0.1mm / 0.4m

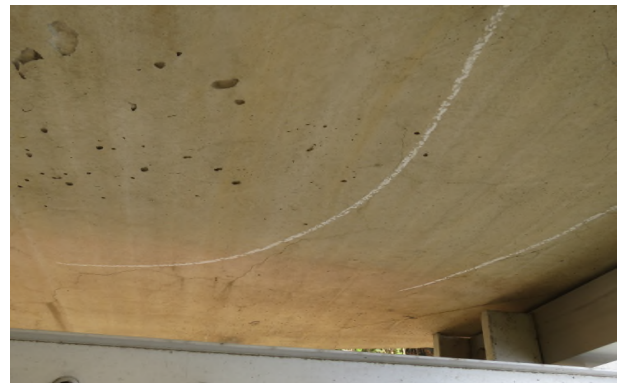
⑱ 균열 (0.3mm미만) cw=0.2mm / 1.0m (2EA)

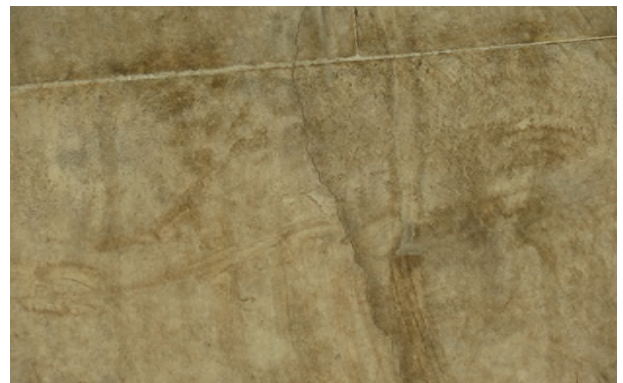
⑳ 균열 (0.3mm미만) cw=0.2mm / 2.5m

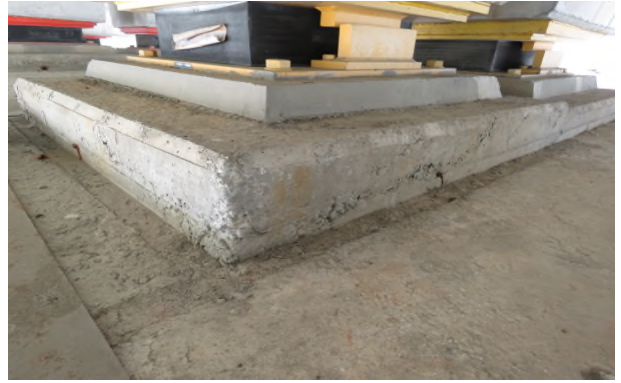
⑬ 받침콘크리트 재료분리 0.2m x 0.2m

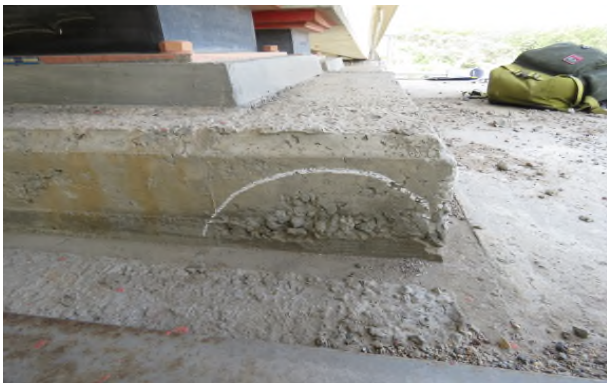
⑮ 받침콘크리트 재료분리 0.1m x 0.2m (2EA)  
(보수완료)

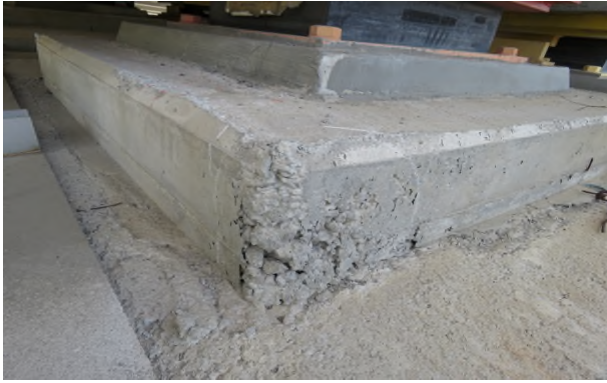
⑨ 받침콘크리트 재료분리 0.2m x 0.2m

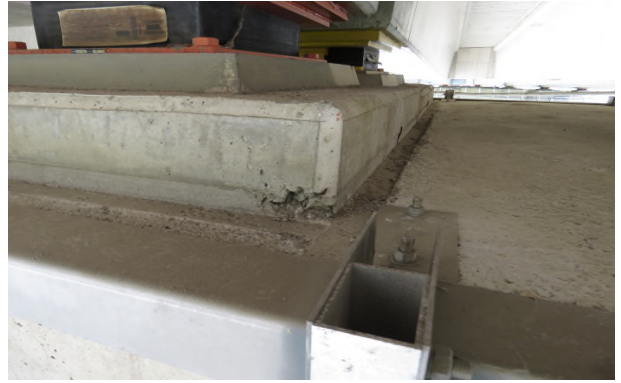
⑩ 받침콘크리트 파손 0.1m x 0.1m

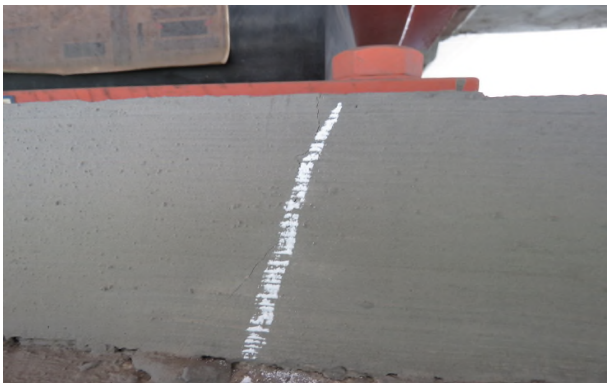
⑫ 무수축물탈균열 (0.3mm미만) cw=0.1mm / 0.1m

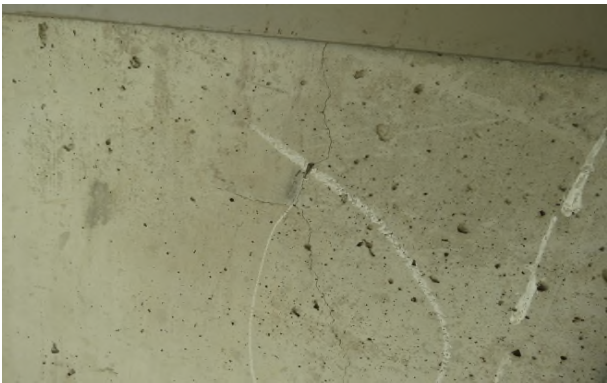
⑭ 균열 (0.3mm미만) cw=0.1mm / 0.6m

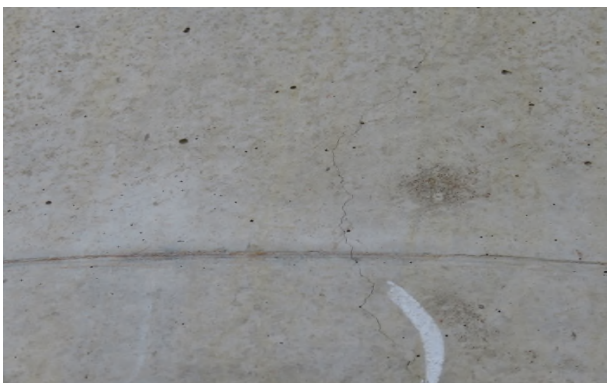
⑯ 균열 (0.3mm미만) cw=0.1mm / 2.5m

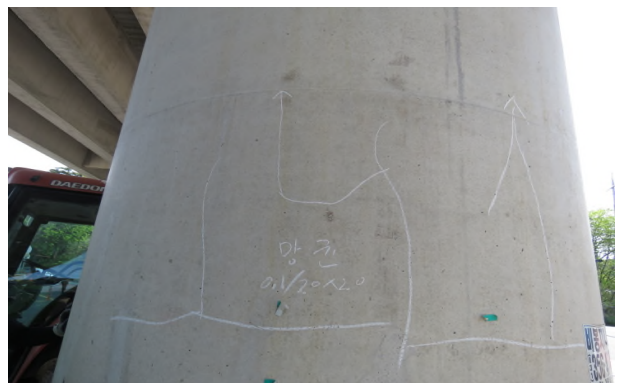
⑰ 망상균열 (0.3mm미만) cw=0.1mm / 2.0m x 2.0m

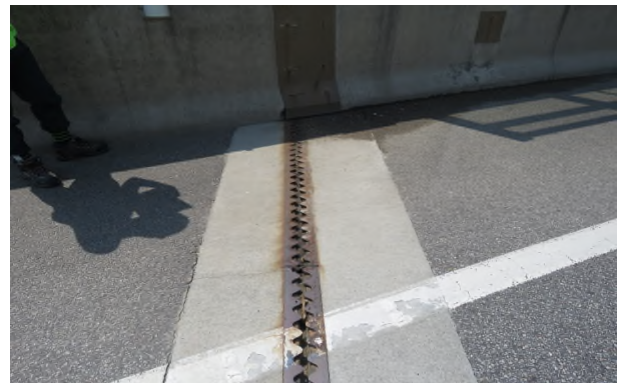
⑦ 신축이음 부식 및 퇴적 L=2.0m

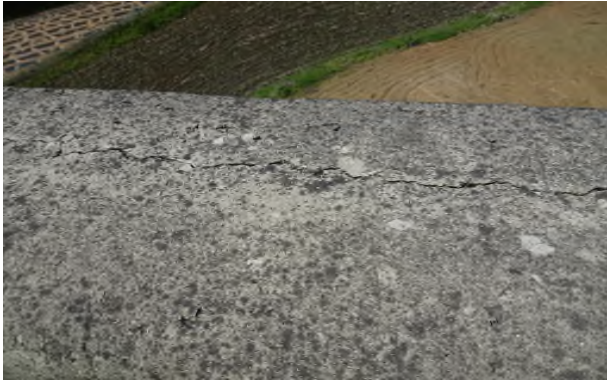
① 균열 0.2mm / 2.0m

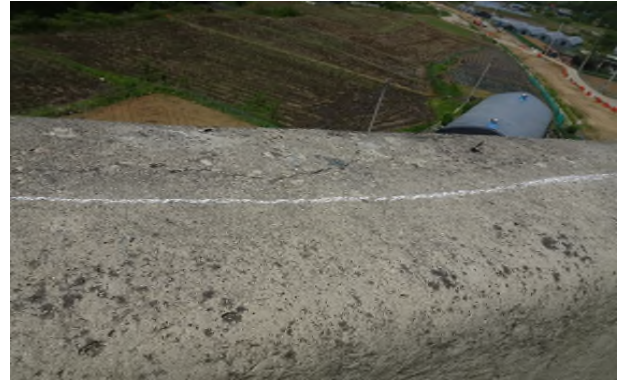
② 균열 0.2mm / 1.5m

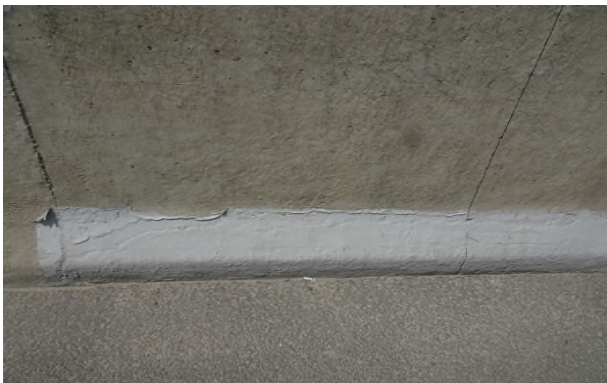
⑭ 균열 0.3mm / 2.5m (보수완료)

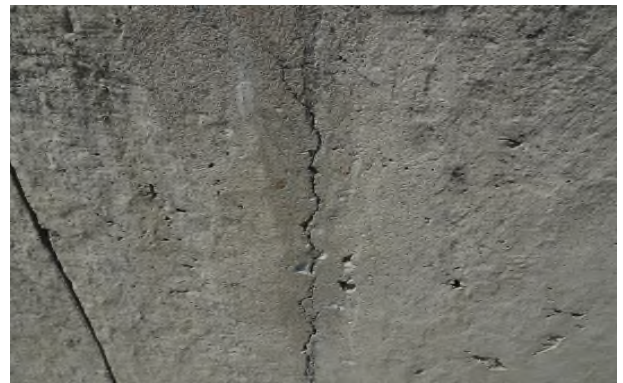
⑮ 균열 0.3mm / 1.0m

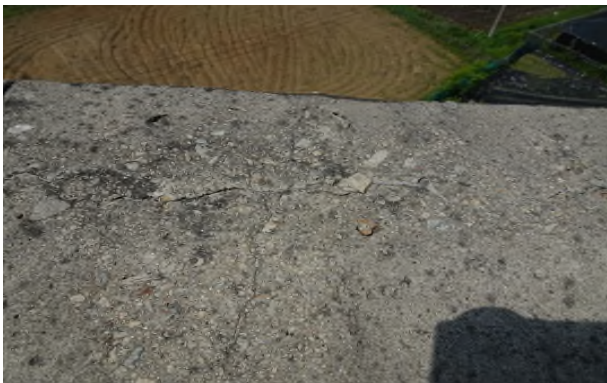
⑰ 균열 0.1mm / 10.0m

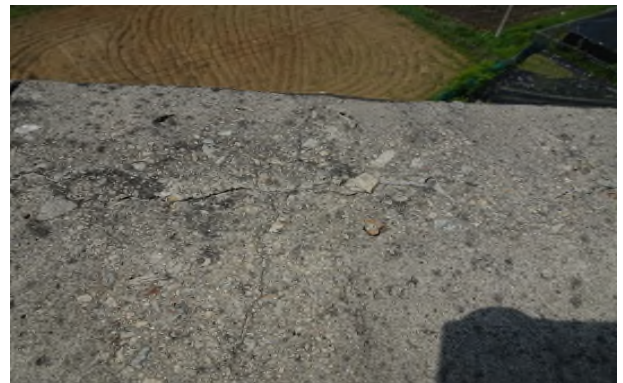
⑱ 균열 1.0mm / 0.8m

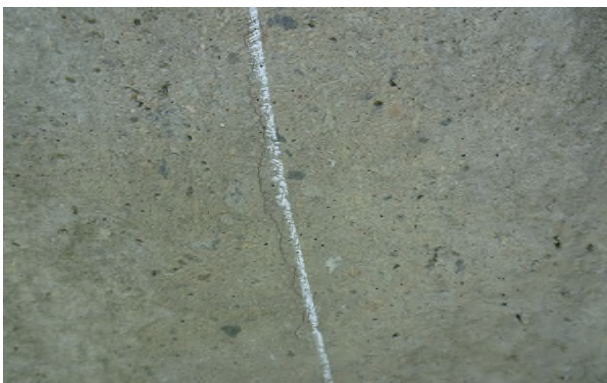
⑲ 균열 0.2mm / 1.2m

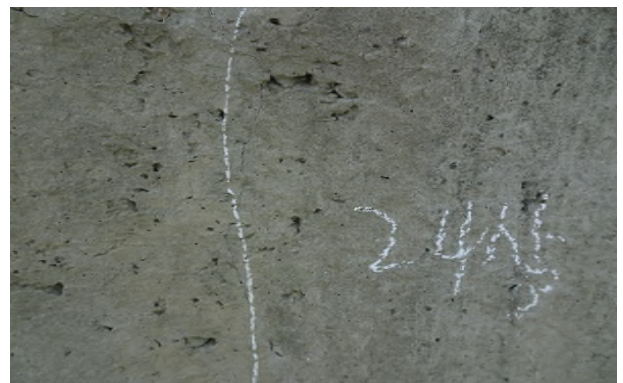
⑲ 균열 0.2mm / 1.2m

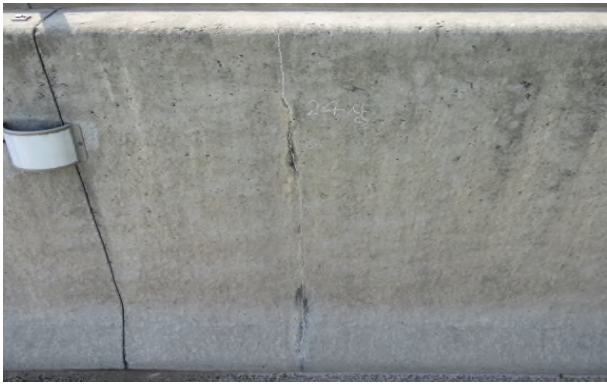
⑦ 균열 0.2mm / 1.4m

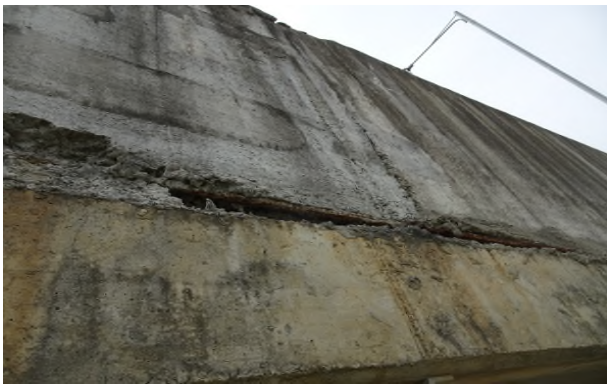
⑬ 파손 및 철근노출 0.2m x 1.0m

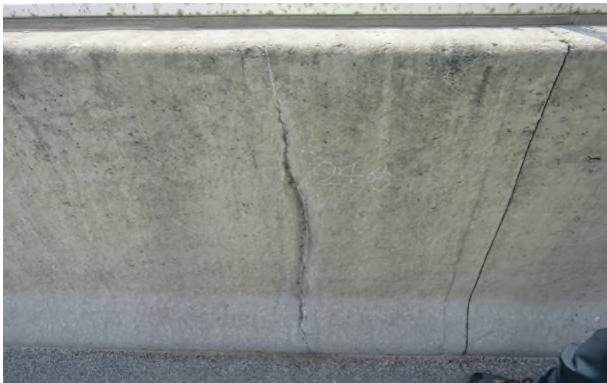
⑮ 균열 0.2mm / 1.4m

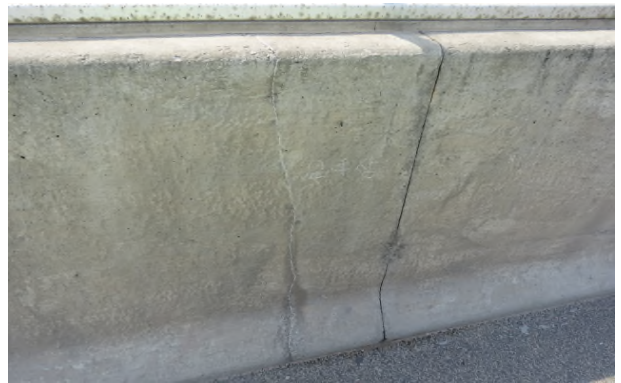
⑯ 균열 0.2mm / 1.4m

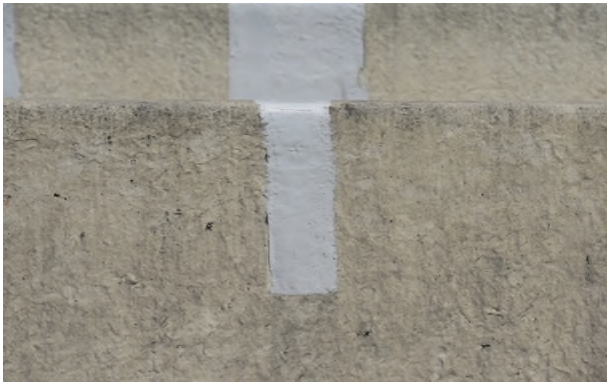
② 균열 0.2mm / 0.3m (보수완료)

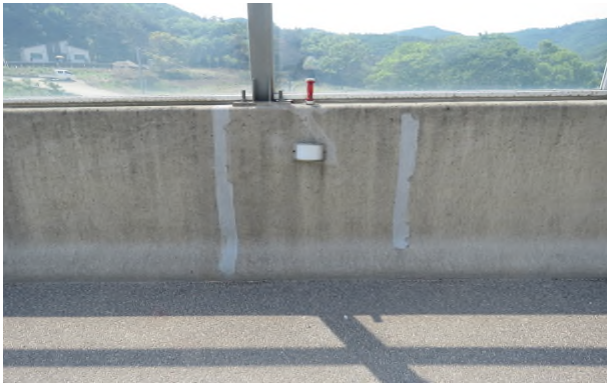
⑮ 균열 0.2mm / 1.5m (보수완료)

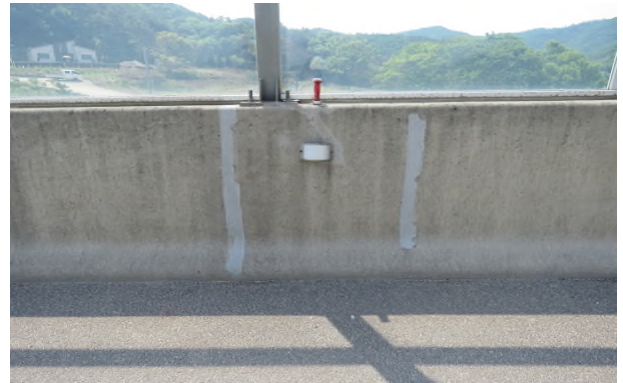
⑯ 균열 0.3mm / 1.5m (보수완료)

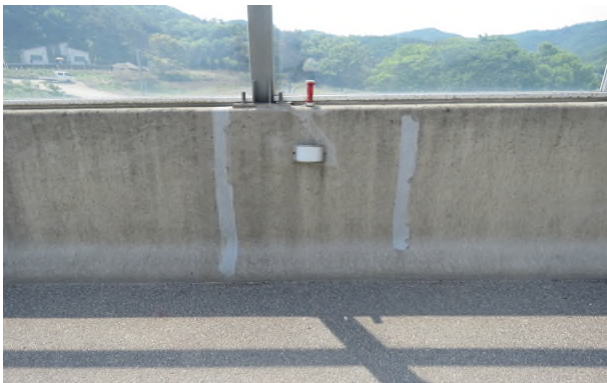
⑰ 균열 0.2mm / 1.5m (보수완료)

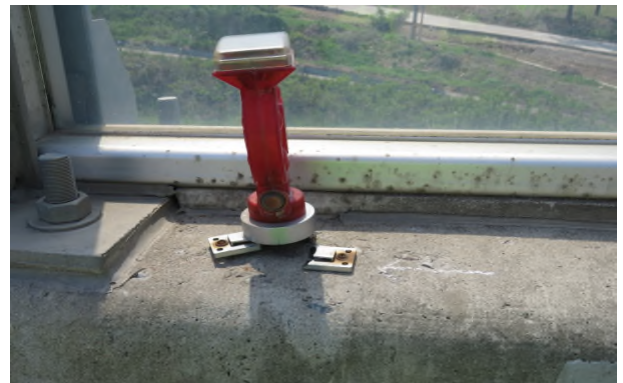
㉔ 델리네이트 파손 (1EA)

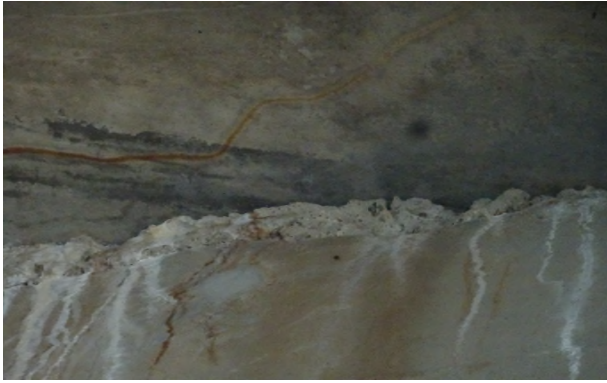
⑤ 파손 0.1m x 0.5m

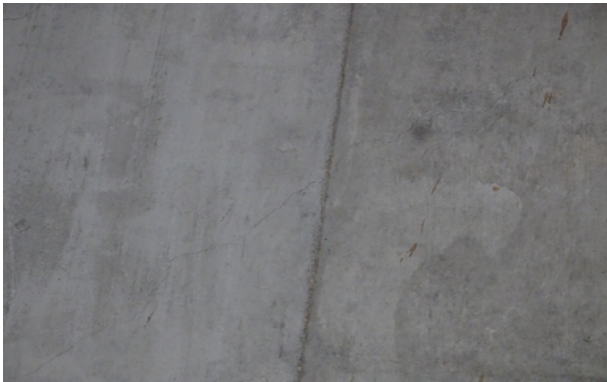
① 균열 0.2mm / 1.0m

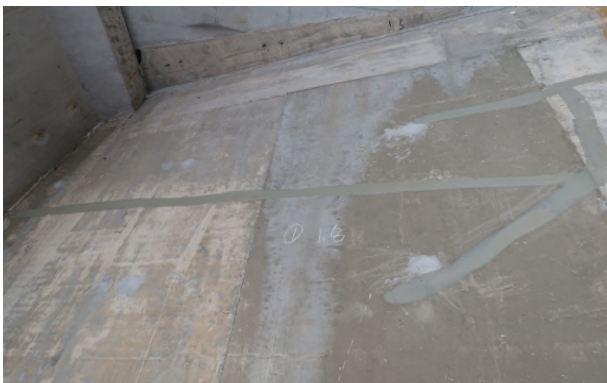
① 균열 0.1mm / 1.8m (보수완료)

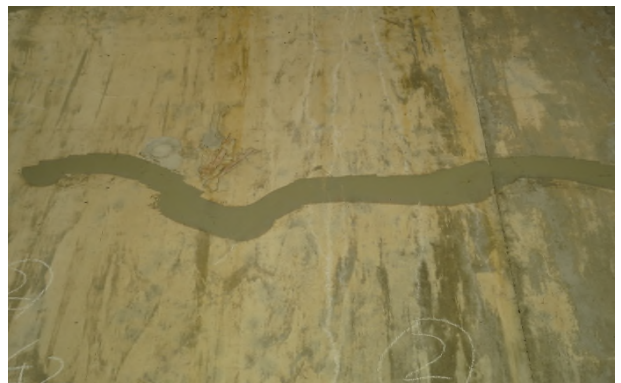
② 균열 0.5mm / 1.4m (보수완료)

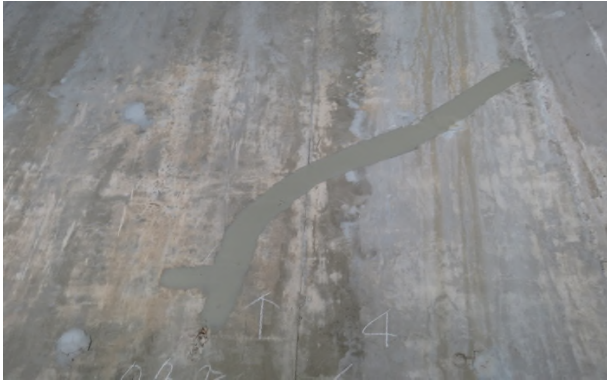
④ 균열 0.3mm / 0.8m (보수완료)

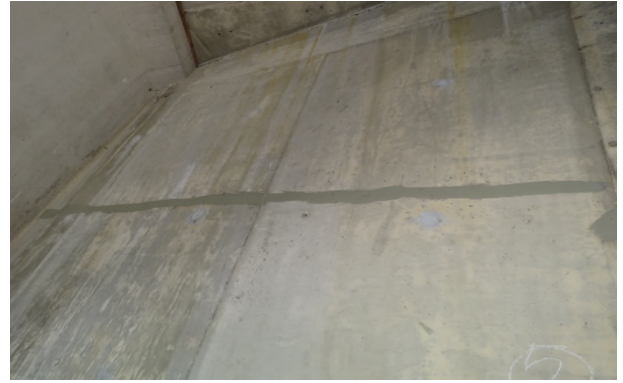
⑤ 균열 0.5mm / 2.0m (보수완료)

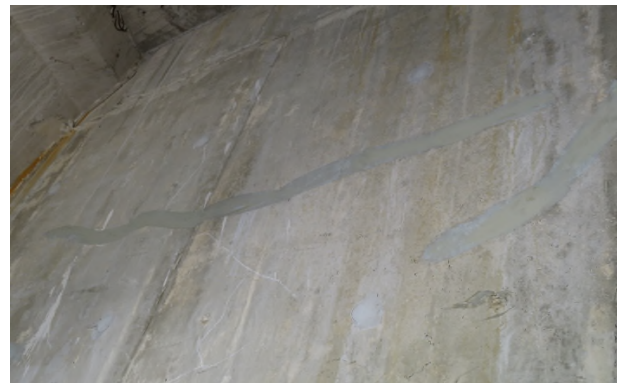
⑦ 균열 0.5mm / 1.5m (보수완료)

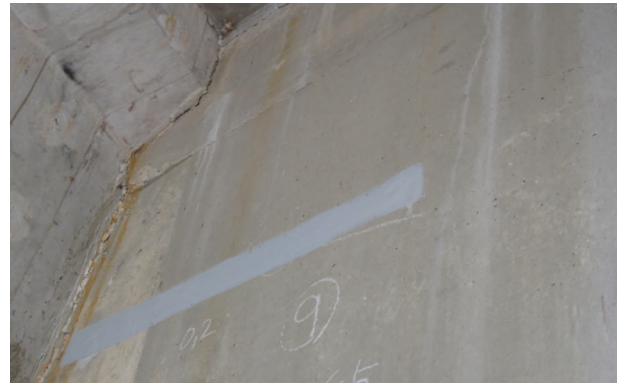
⑨ 균열 0.2mm / 0.6m (보수완료)

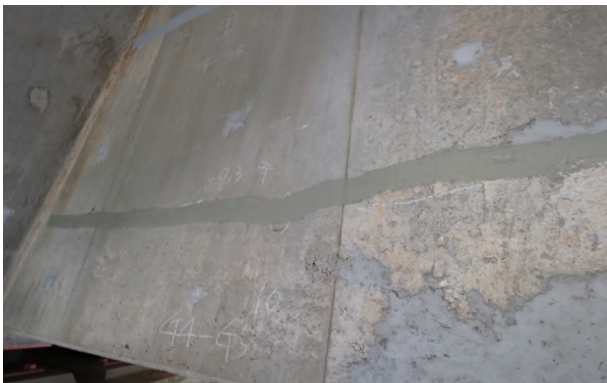
⑩ 균열 0.3mm / 2.0m (보수완료)

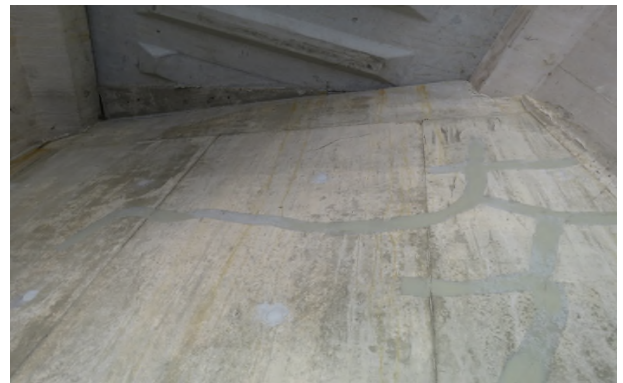
⑪ 균열 0.5mm / 1.5m (보수완료)

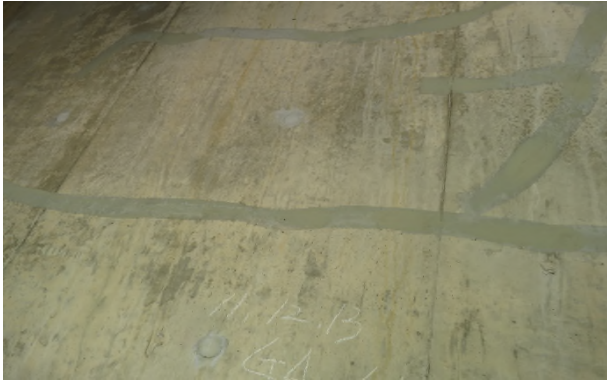
⑫ 균열 0.3mm / 0.5m (보수완료)

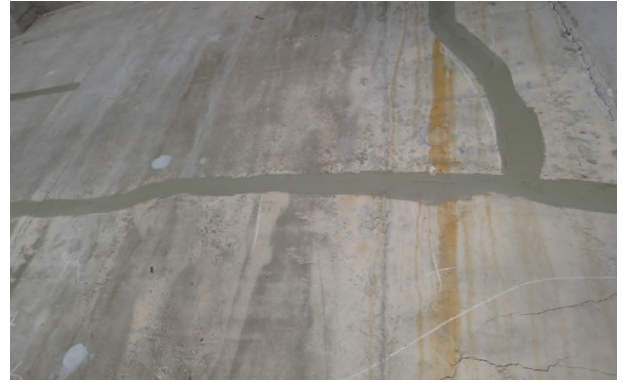
⑭ 균열 0.5mm / 1.4m (보수완료)

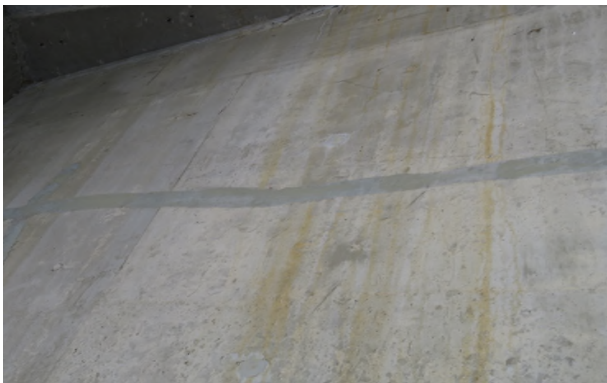
⑮ 균열 0.3mm / 2.0m (보수완료)

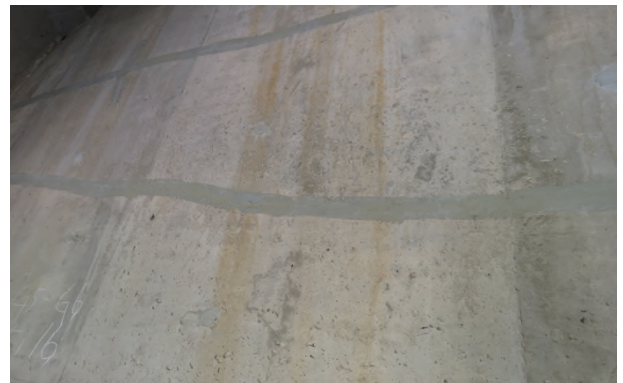
⑯ 균열 0.5mm / 2.0m (보수완료)

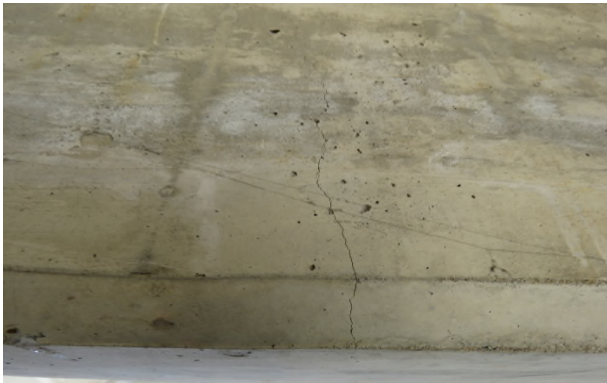
⑰ 균열 0.2mm / 0.4m

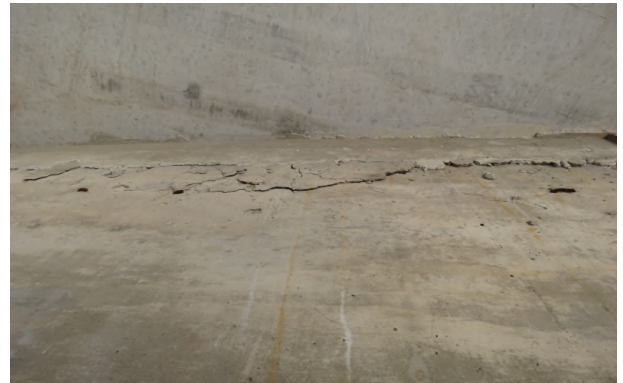
⑱ 파손 0.1m x 0.4m

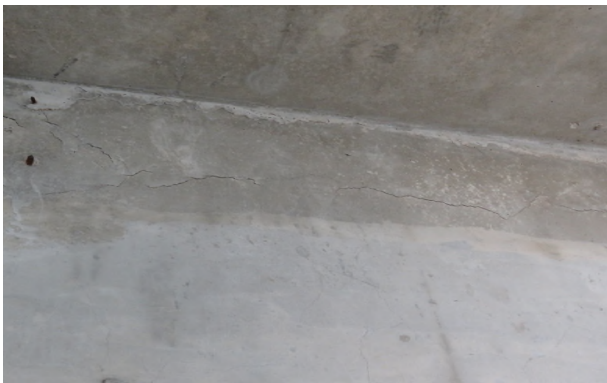
⑲ 균열 0.3mm / 1.0m

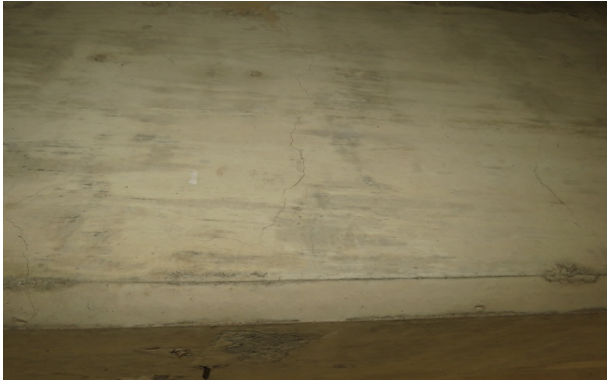
㉑ 균열 0.2mm / 0.4m (8EA)
