## **6. 현황조사 및 외관조사 사진첩**

## 01. 남전천교

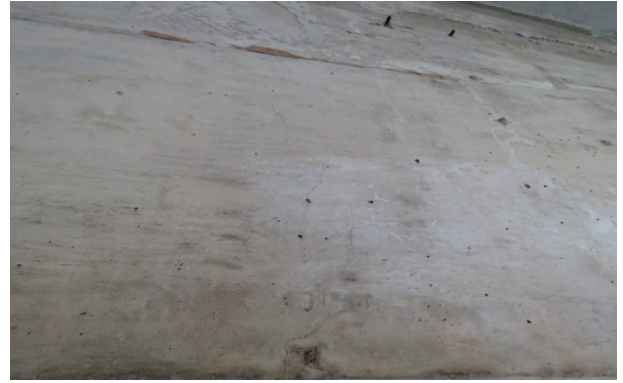
㉒ 균열 0.2mm / 0.4m (3EA)

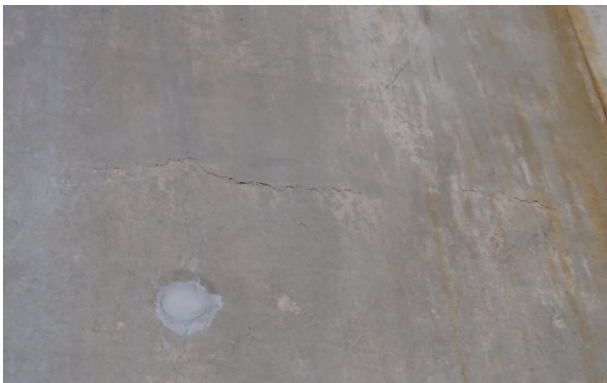
㉓ 균열 0.3mm / 1.0m

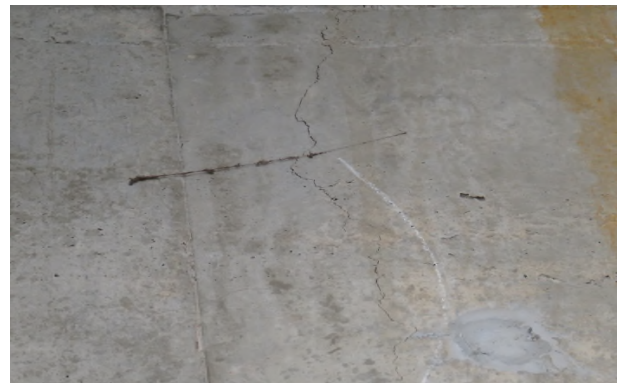
㉔ 균열 0.3mm / 1.0m

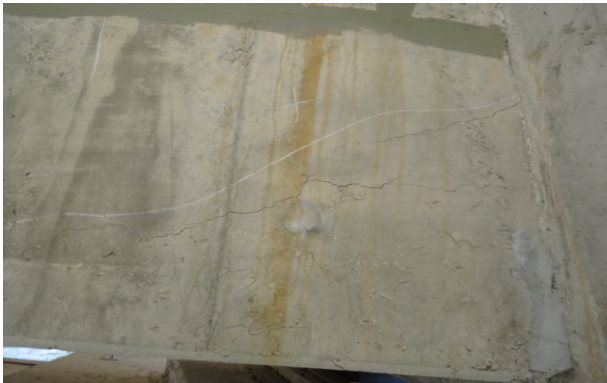
㉕ 균열 0.3mm / 0.6m

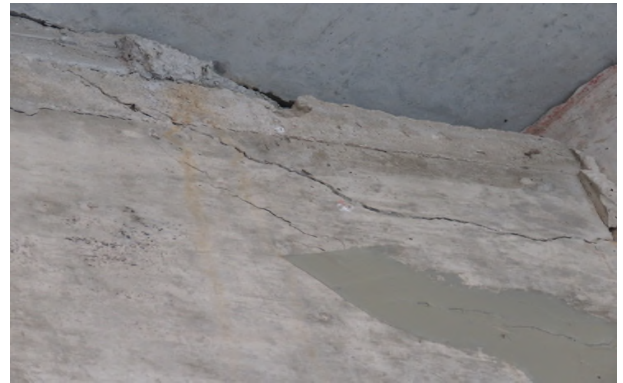
㉖ 균열 0.5mm / 0.4m

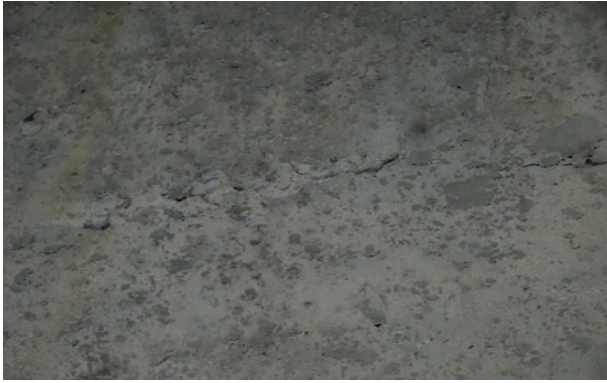
① 균열 0.3mm / 0.2m

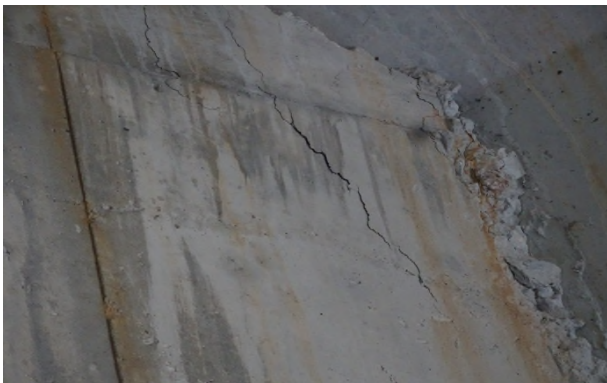
③ 균열 0.1mm / 0.5m

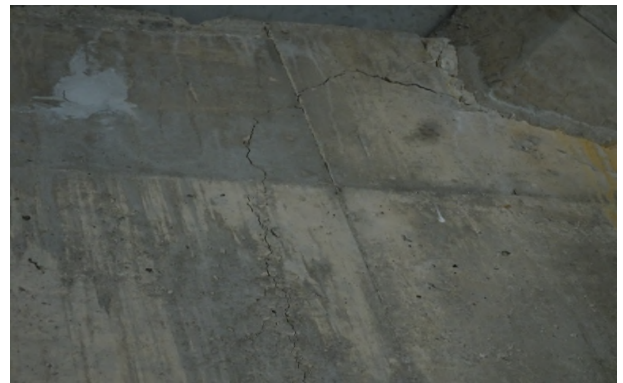
④ 균열 0.1mm / 2.0m

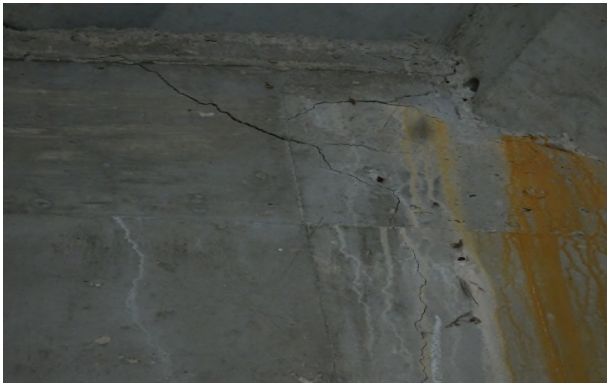
⑤ 균열 0.1mm / 1.0m

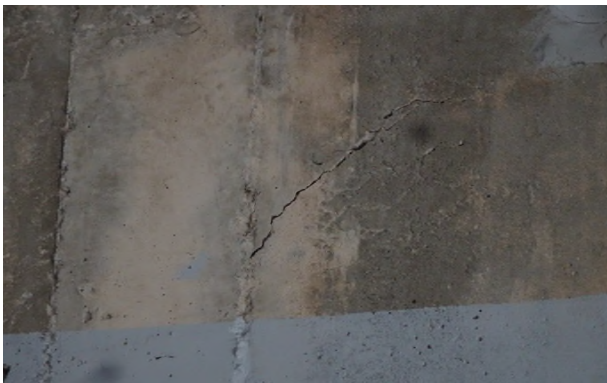
⑦ 균열 0.1mm / 0.1m

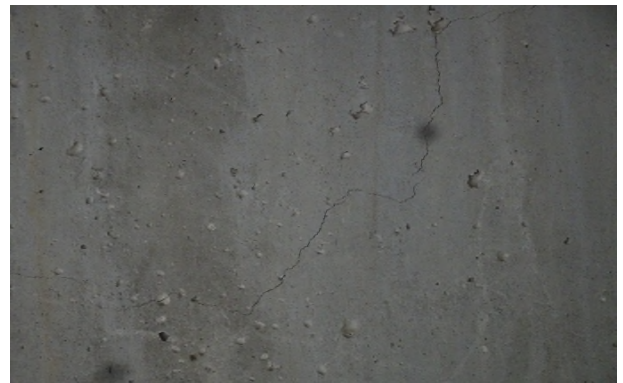
⑧ 균열 0.1mm / 0.1m

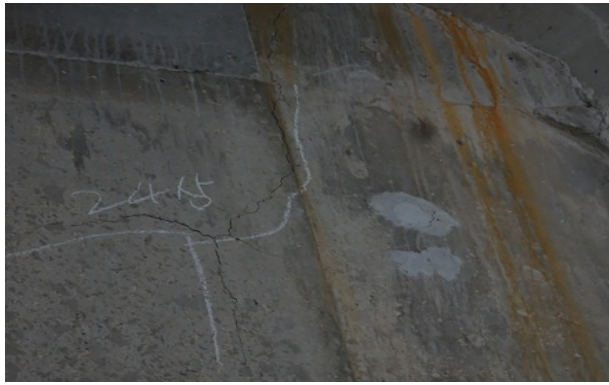
⑨ 균열 0.1mm / 0.5m

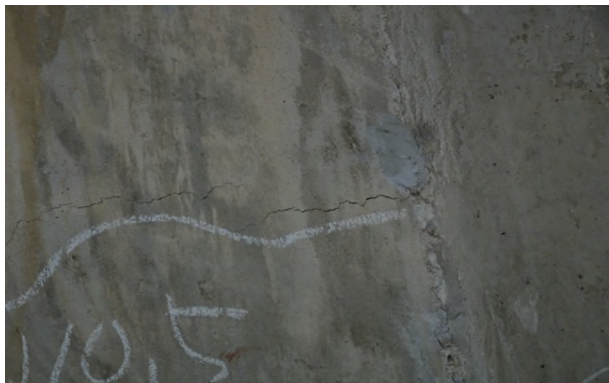
⑪ 균열 0.1mm / 0.5m

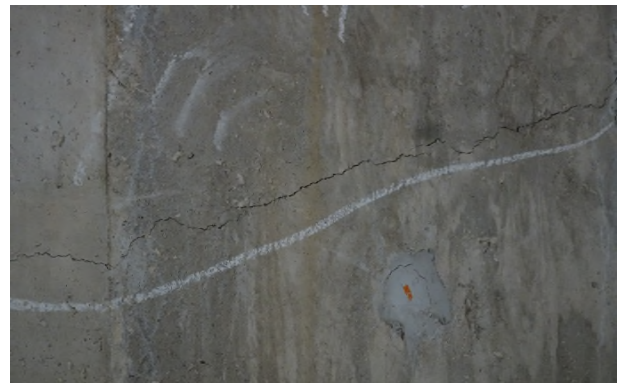
⑫ 균열 0.1mm / 0.7m

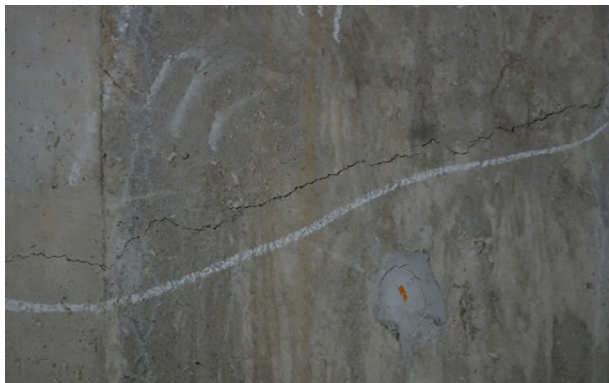
⑬ 균열 0.2mm / 1.0m

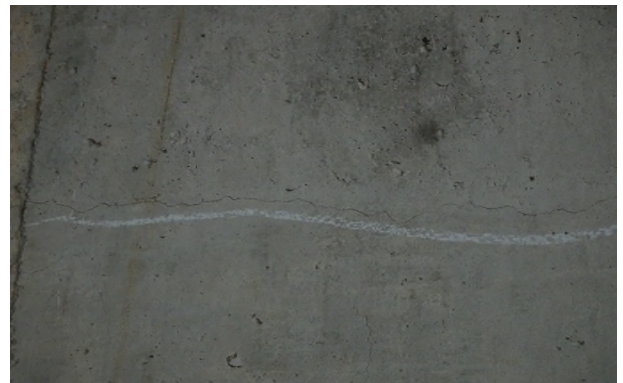
⑭ 균열 0.1mm / 1.0m

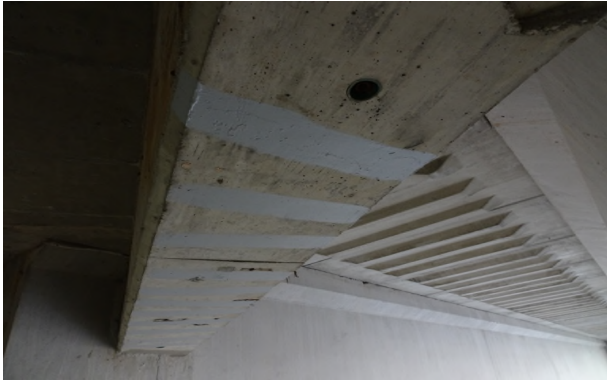
③ 균열 0.2mm / 0.6m (13EA) (보수완료)

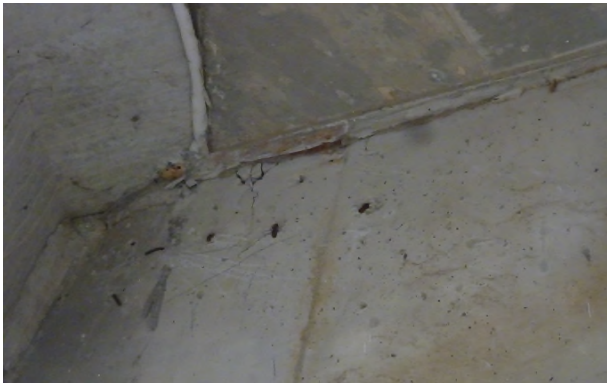
⑦ 균열 0.1mm / 0.1m

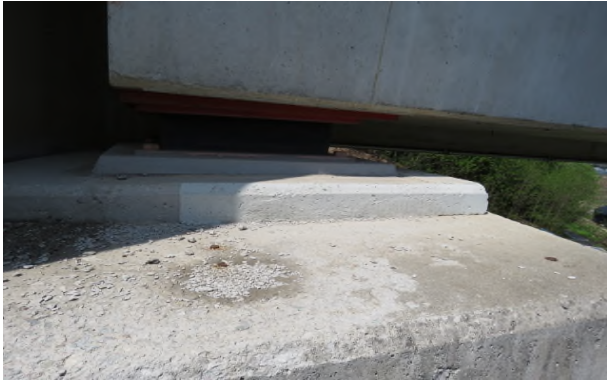
⑤ 받침콘크리트 재료분리 0.1m x 0.5m (보수완료)

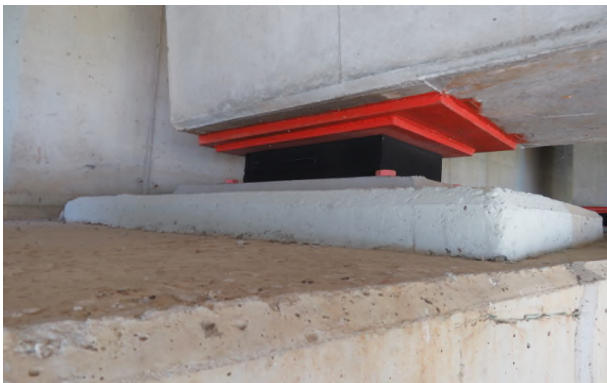
⑦ 받침콘크리트재료분리 0.1m x 1.0m (보수완료)

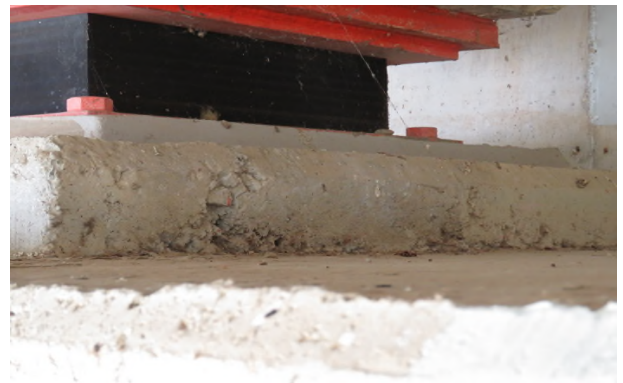
⑧ 받침콘크리트재료분리 0.1m x 0.2m

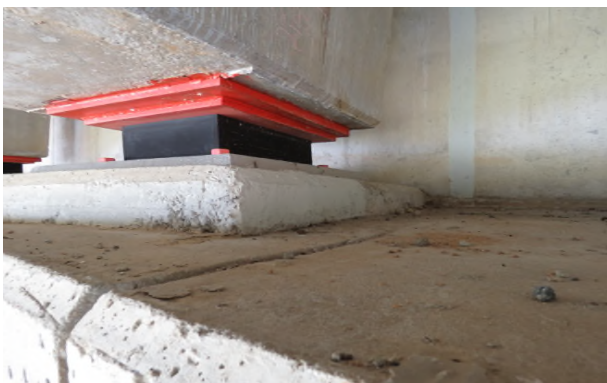
⑪ 받침콘크리트 재료분리 0.1m x 0.5m (보수완료)

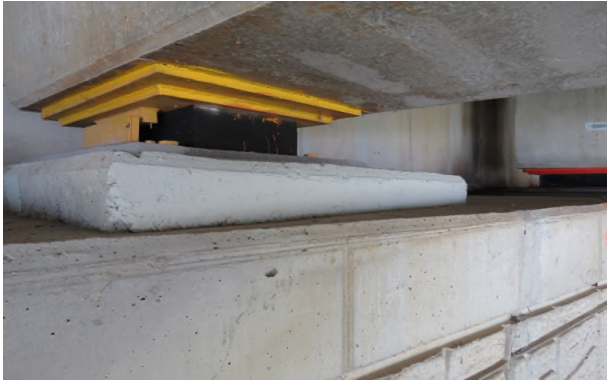
⑬ 받침콘크리트재료분리 0.1m x 1.0m (보수완료)

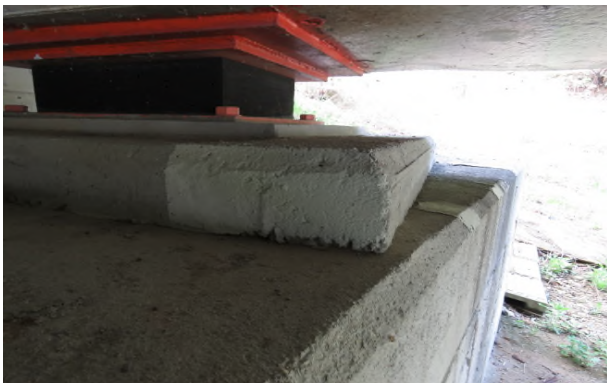
⑮ 받침콘크리트 재료분리 0.1m x 0.2m (보수완료)

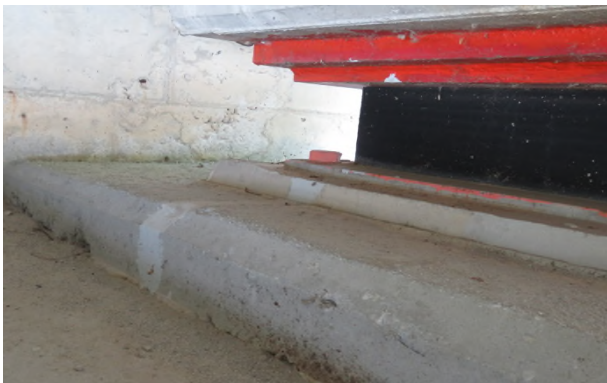
⑰ 받침콘크리트 재료분리 0.1m x 0.5m (보수완료)

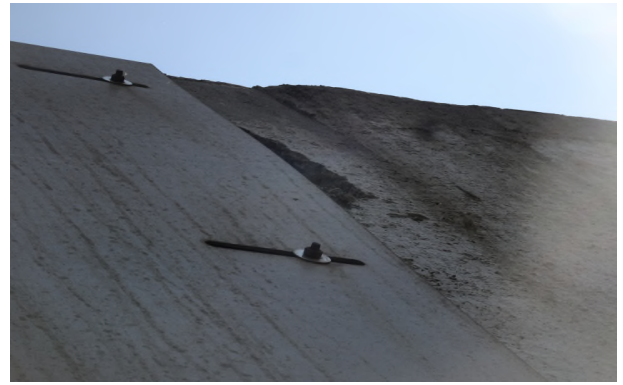
④ 파손 0.1m x 0.1m

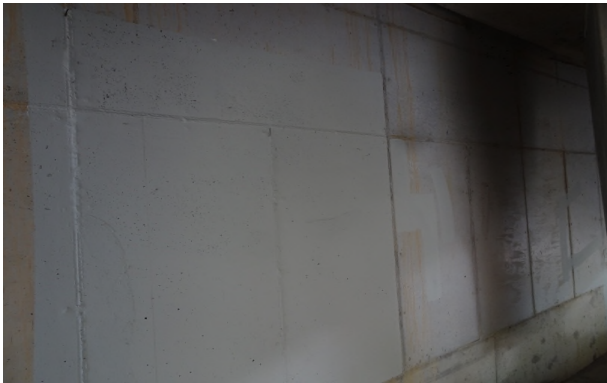
⑩ 균열 0.1mm / 5.0m (보수완료)

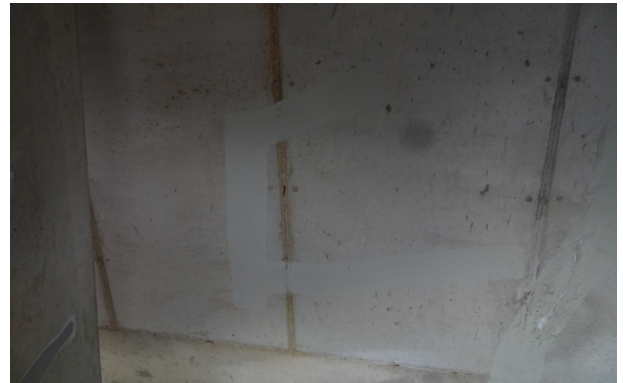
⑪ 균열 0.05mm / 1.2m (보수완료)

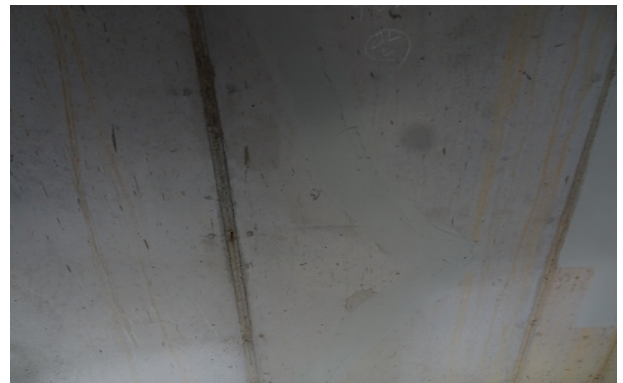
⑬ 균열 0.05mm / 0.8m (보수완료)

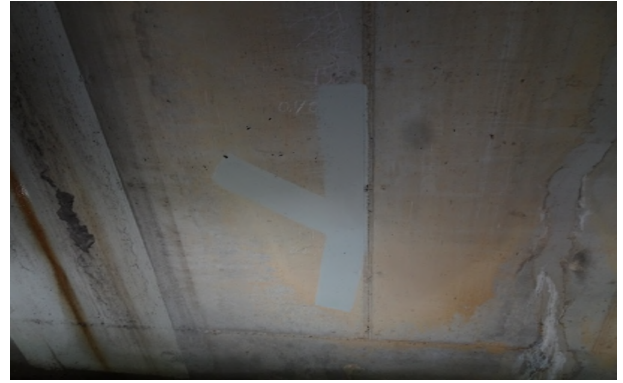
⑮ 균열 0.1mm / 0.9m (보수완료)

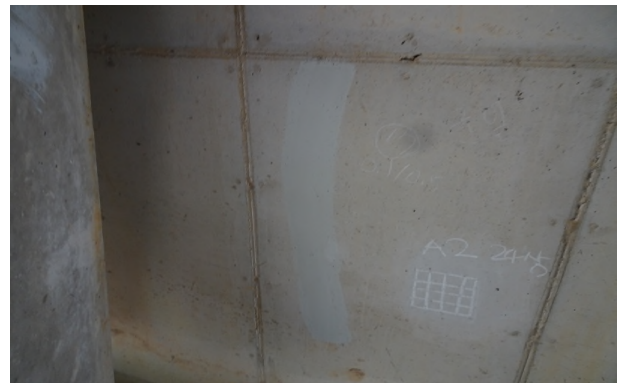
⑰ 균열 0.1mm / 0.5m (보수완료)

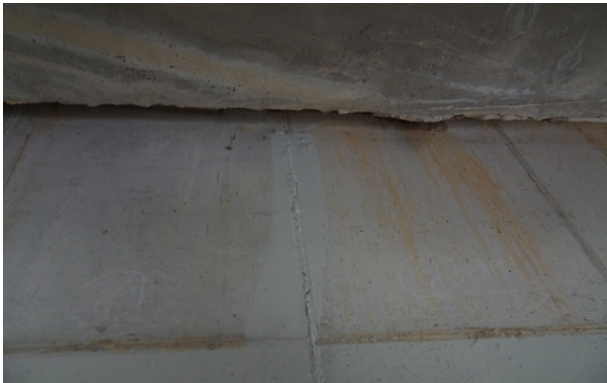
⑱ 균열 0.1mm / 0.8m (보수완료)

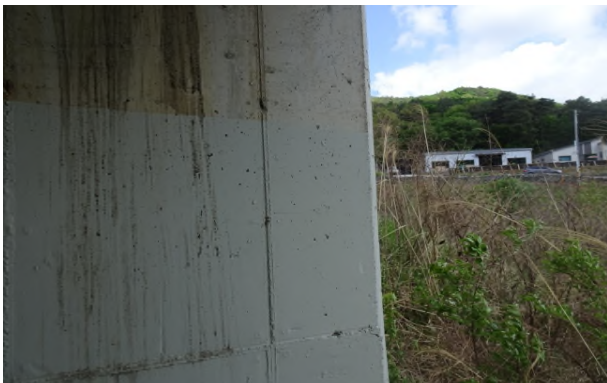
⑳ 균열 0.3mm / 0.6m (보수완료)

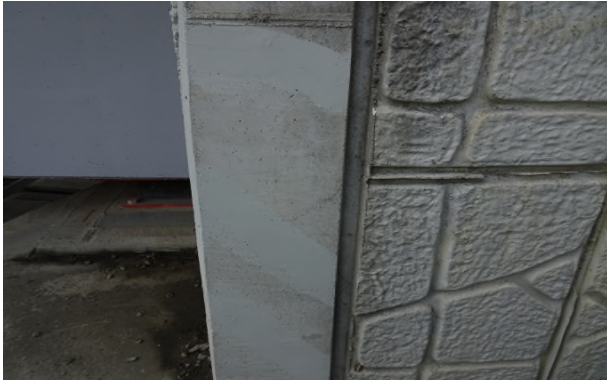
㉒ 균열 0.3mm / 0.3m (4EA) (보수완료)

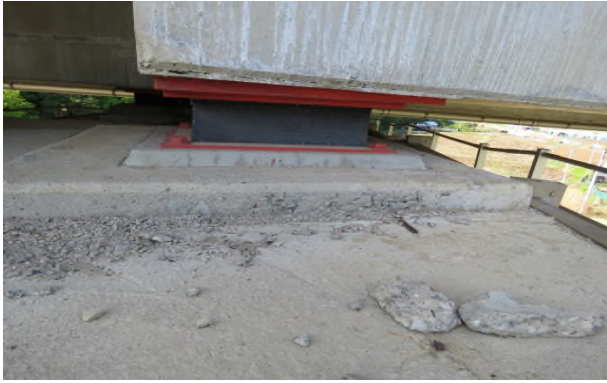
⑱ 받침콘크리트 재료분리 0.1m x 0.5m (2EA)

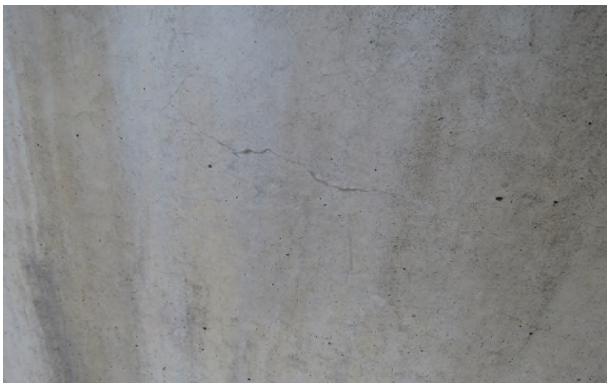
⑳ 균열 0.1mm / 0.5m

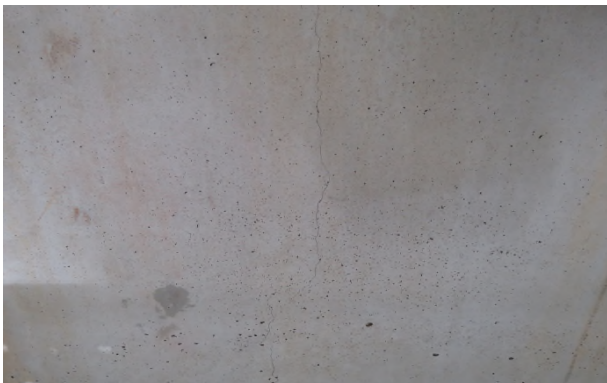
㉒ 균열 0.1mm / 1.5m

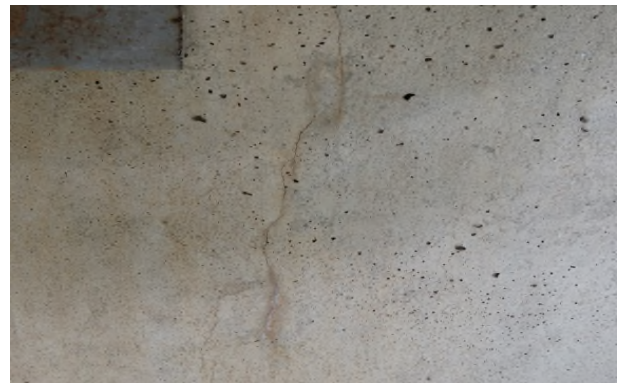
㉓ 균열 0.1mm / 0.7m

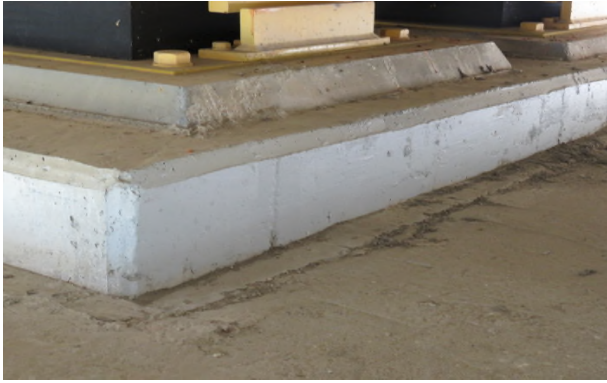
⑦ 받침콘크리트재료분리 0.15m x 2.5m (보수완료)

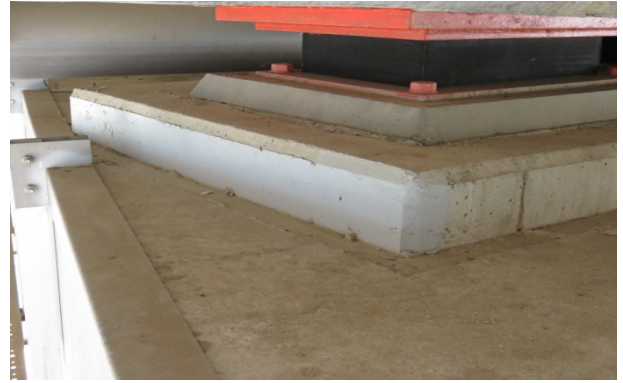
⑧ 받침콘크리트재료분리 0.15m x 1.0m (보수완료)

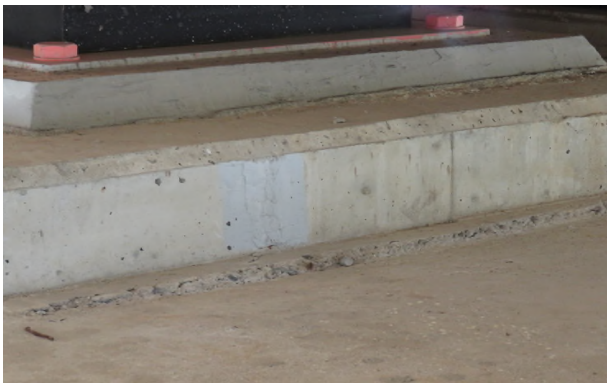
⑩ 받침콘크리트잡철근미제거 (보수완료)

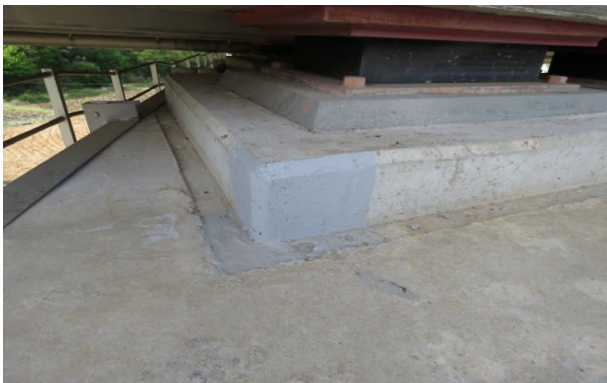
⑫ 받침콘크리트 잡철근미제거 (2EA) (보수완료)

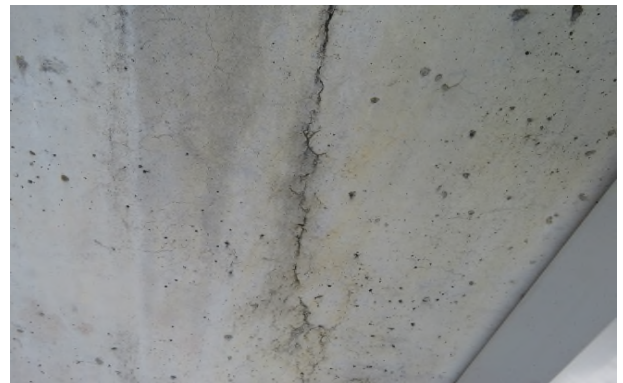
⑬ 균열 0.3mm / 0.9m

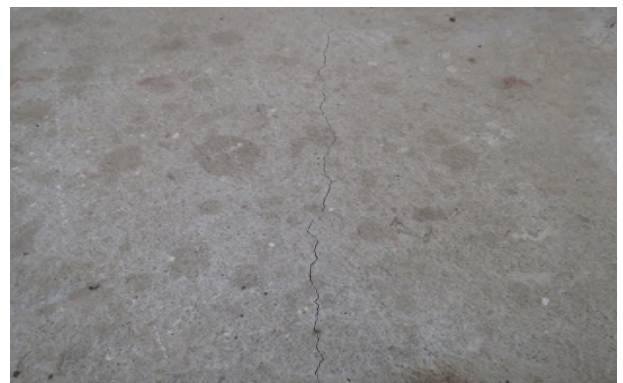
⑮ 균열 0.3mm / 3.0m

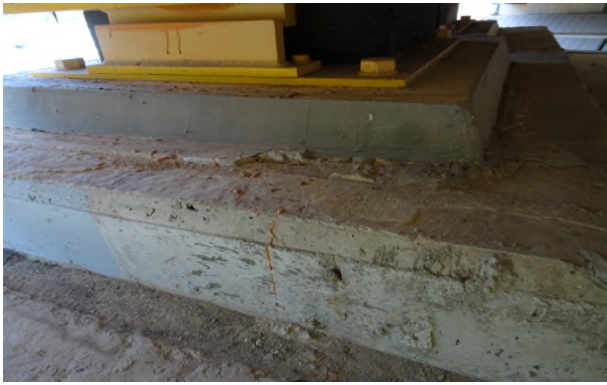
⑫ 받침콘크리트 재료분리 0.15m x 1.0m

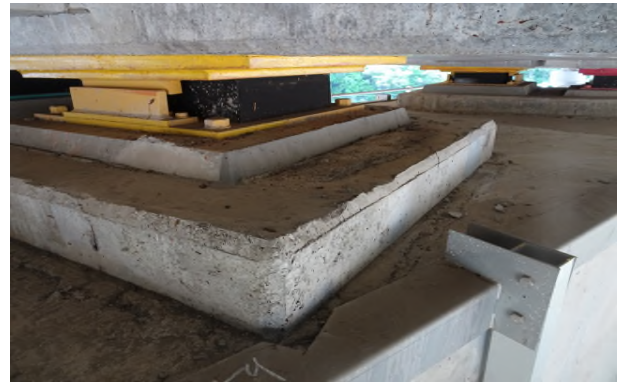
⑬ 받침콘크리트 표면불량 0.1m x 0.1m

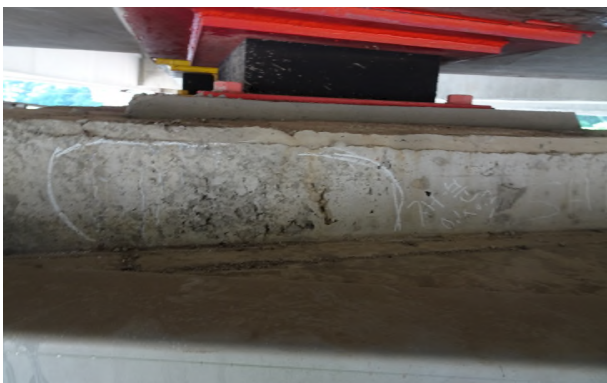
⑱ 받침콘크리트 재료분리 0.1m x 0.2m

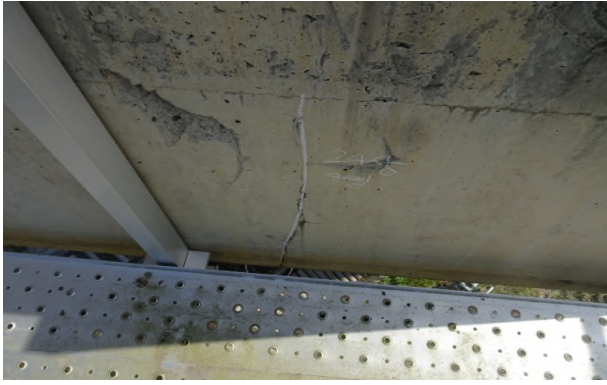
㉔ 균열 0.1mm / 0.7m

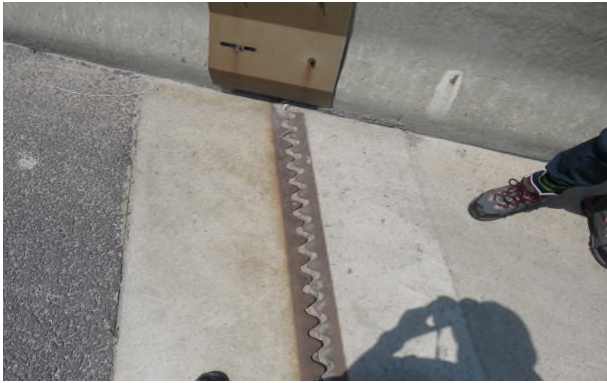
① 신축이음부 이물질퇴적 L=0.5m

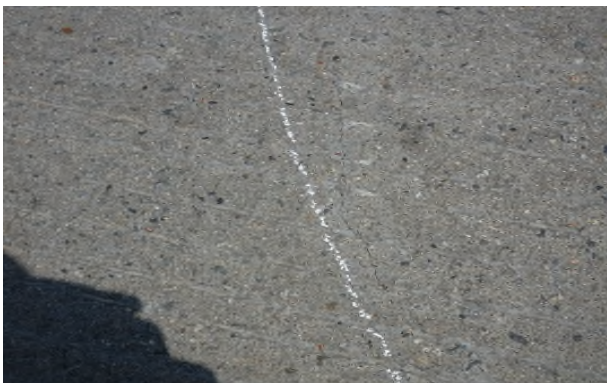
⑨ 균열 0.1mm / 43.0m

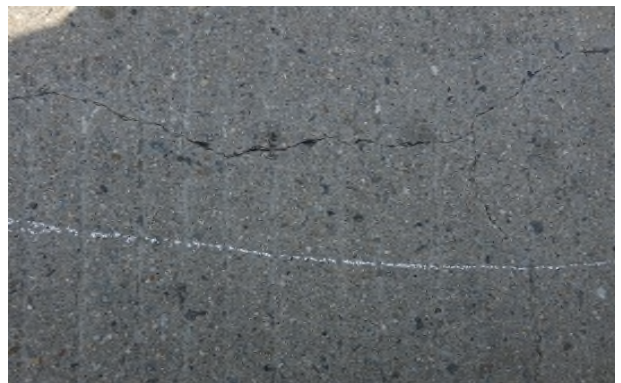
⑩ 균열 0.1mm / 3.0m

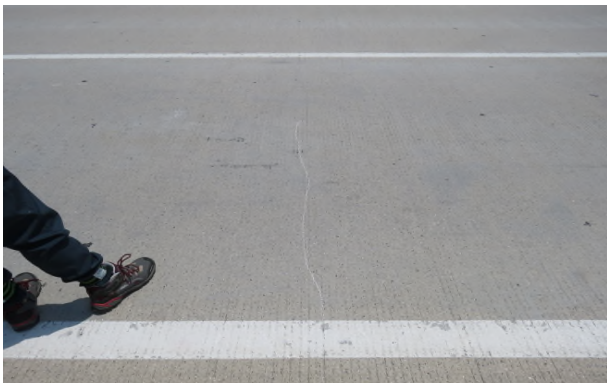
⑬ 균열 0.2mm / 1.0m

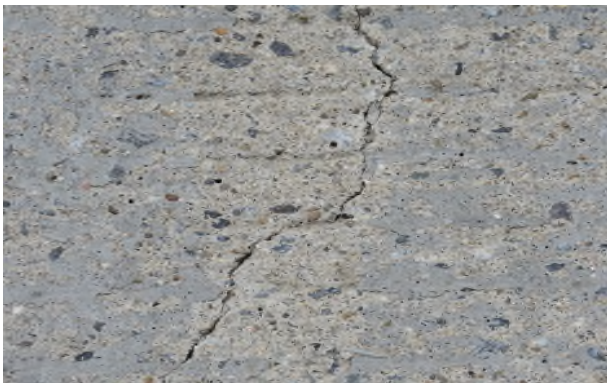
⑤ 균열 0.1mm / 2.0m

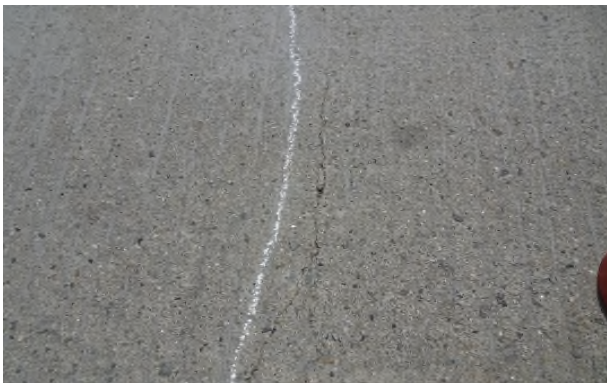
⑦ 균열 0.2mm / 2.0m

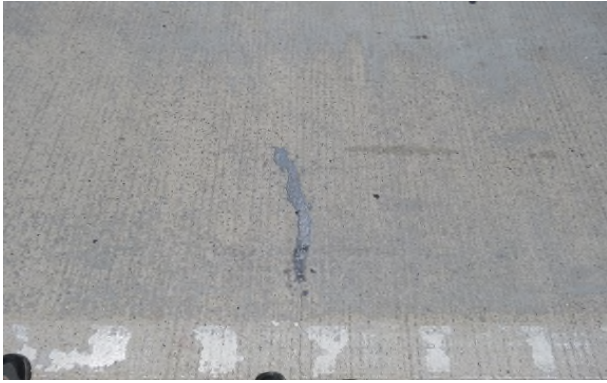
① 균열 0.1mm / 0.2m (보수완료)

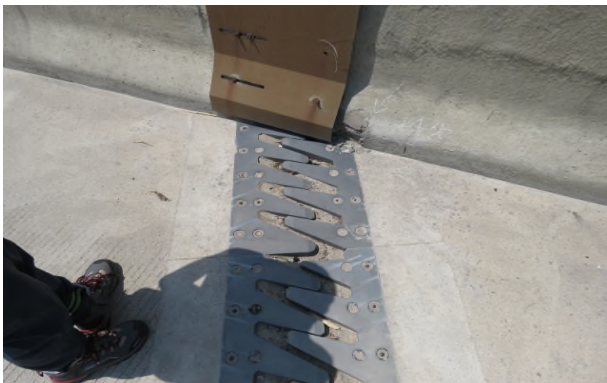
③ 신축이음부 이물질퇴적 L=1.0m

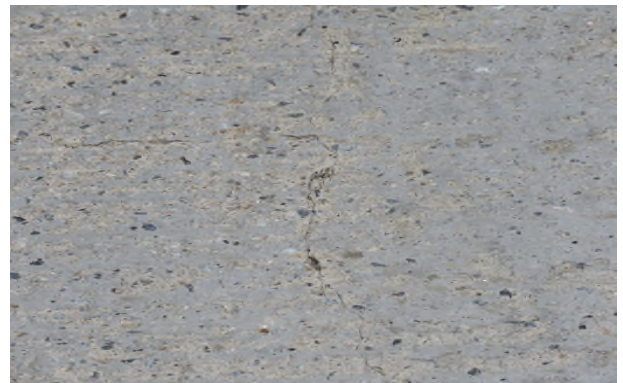
⑥ 균열 0.1mm / 43.0m

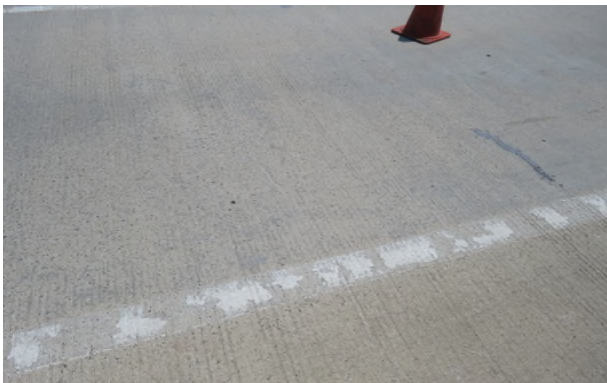
⑦ 균열 0.1mm / 1.2m

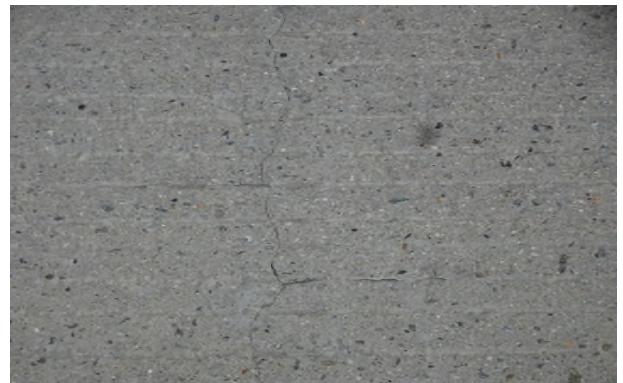
⑧ 균열 0.3mm / 37.0m

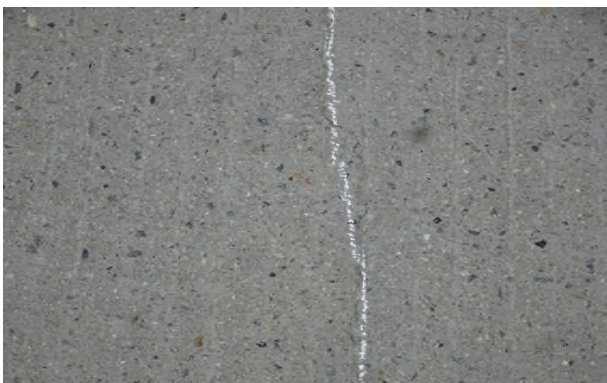
⑨ 균열 0.3mm / 2.0m

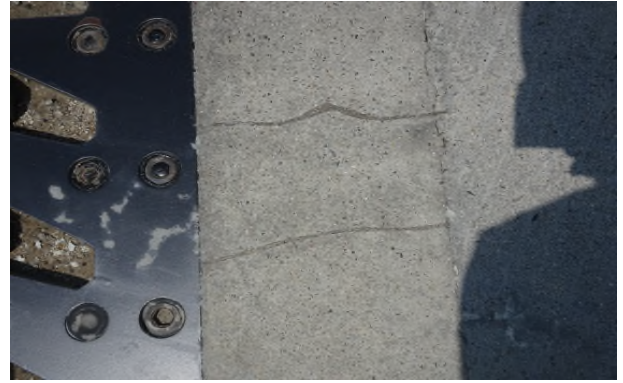
② 신축이음 토사퇴적 L=2.0m (보수완료)

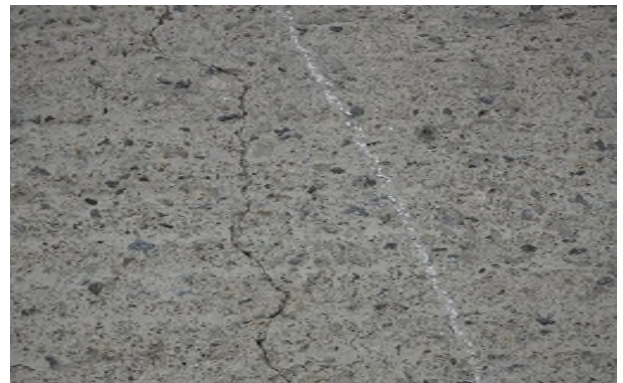
⑨ 균열 0.2mm / 2.0m

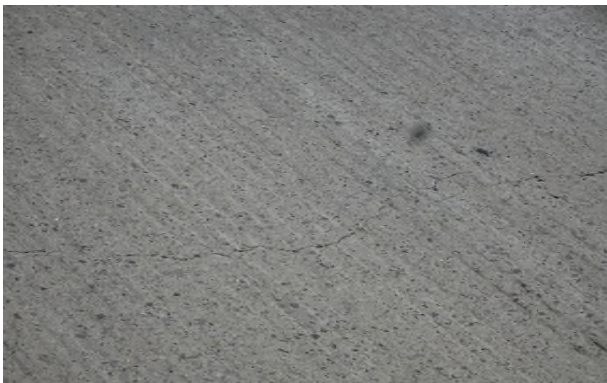
⑩ 균열 0.2mm / 5.0m

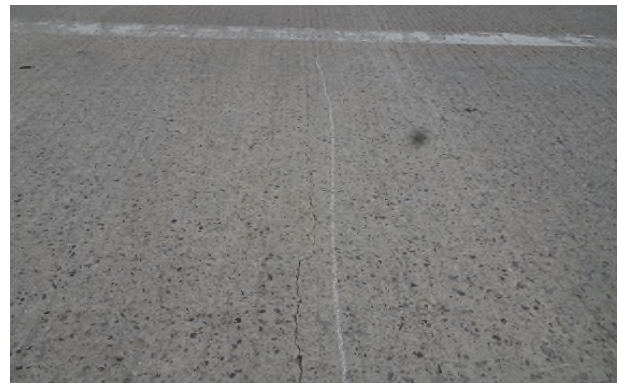
⑪ 균열 0.2mm / 1.0m (2EA)

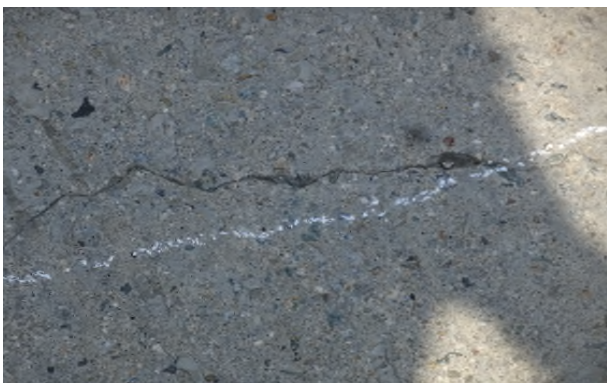
⑫ 균열 0.3mm / 1.0m

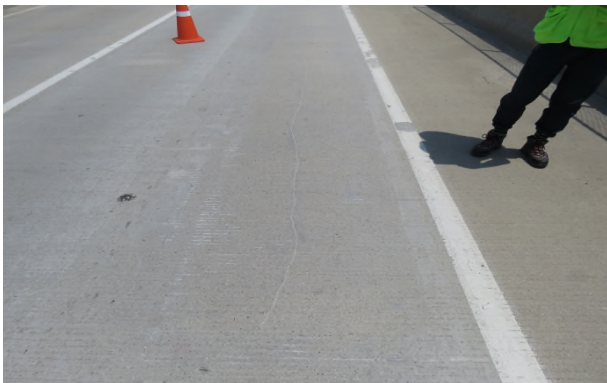
④ 균열 0.1mm / 69.0m

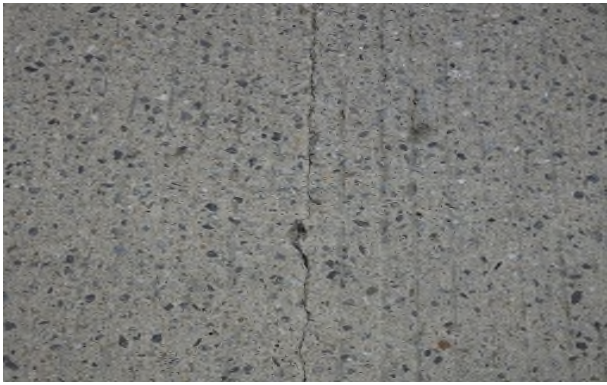
⑥ 균열 0.2mm / 2.5m

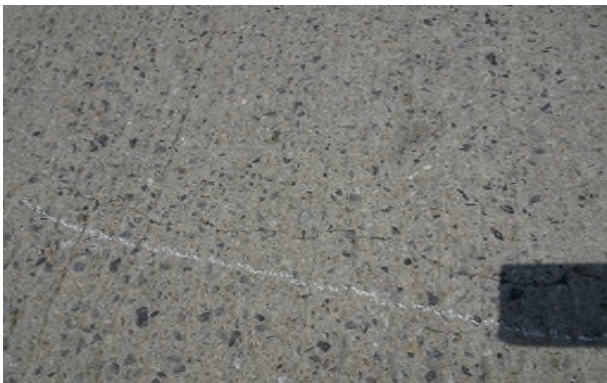
⑧ 균열 0.1mm / 0.4m

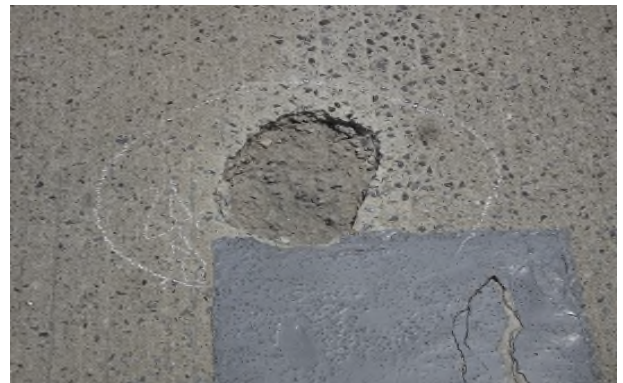
⑨ 파손 0.2m x 0.2m

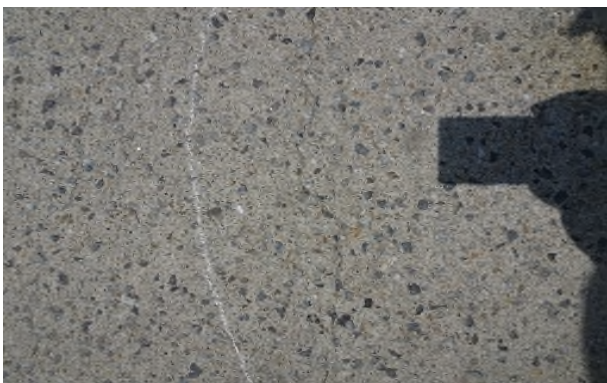
⑫ 균열 0.1mm / 2.0m

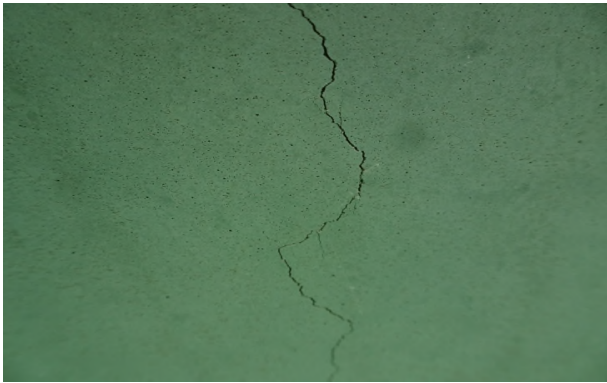
③ 균열 0.2mm / 0.3m (4EA)

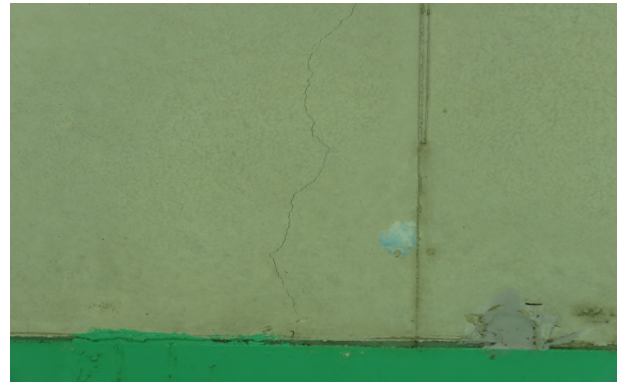
④ 균열 0.2mm / 0.8m (5EA)

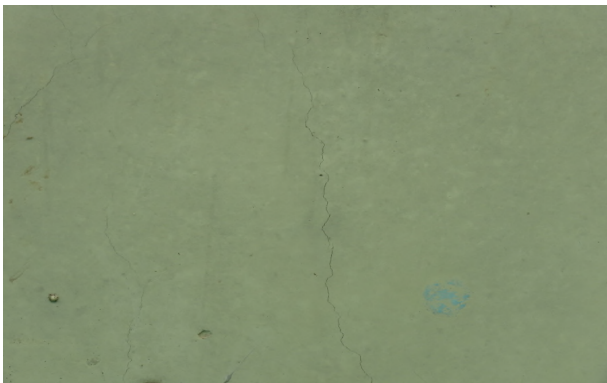
⑦ 균열 0.1mm / 0.8m (8EA)

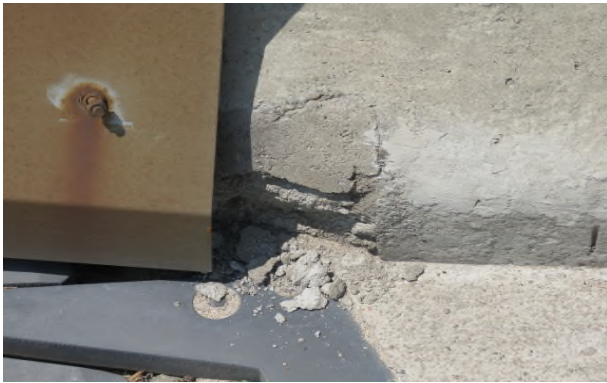
⑯ 파손 0.1m x 0.1m

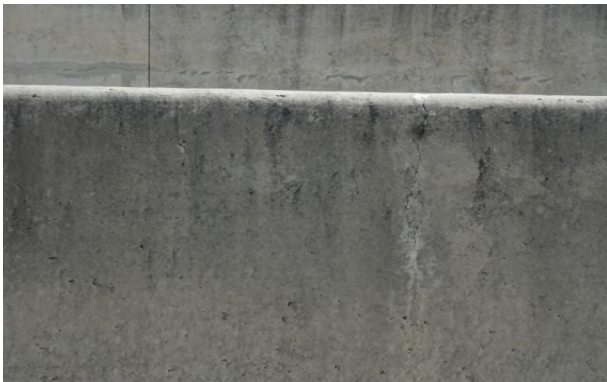
② 균열 0.3mm / 1.5m

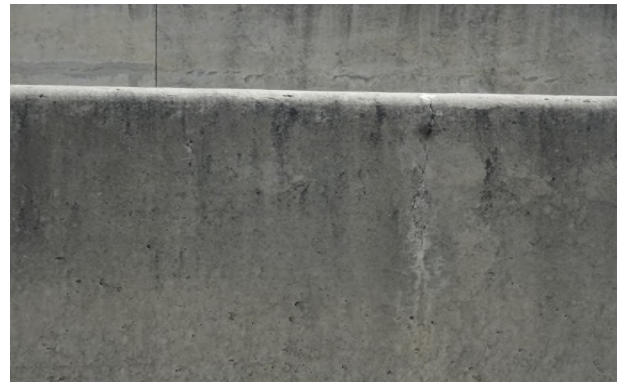
⑤ 균열 0.3mm / 0.7m

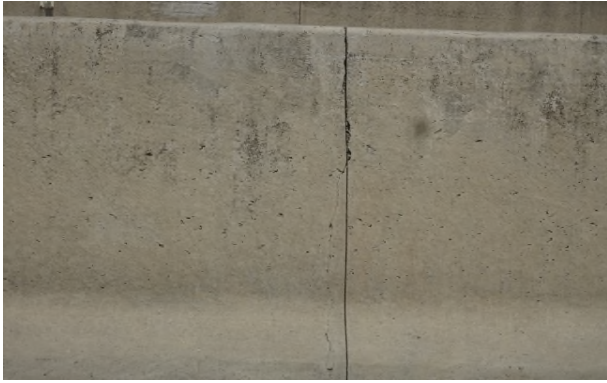
⑥ 균열 0.3mm / 1.0m

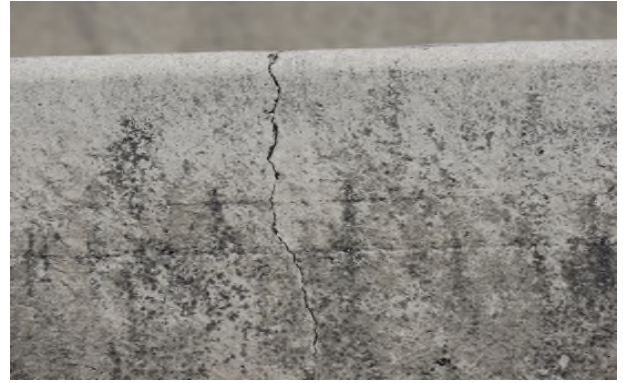
⑦ 균열 0.3mm / 1.0m

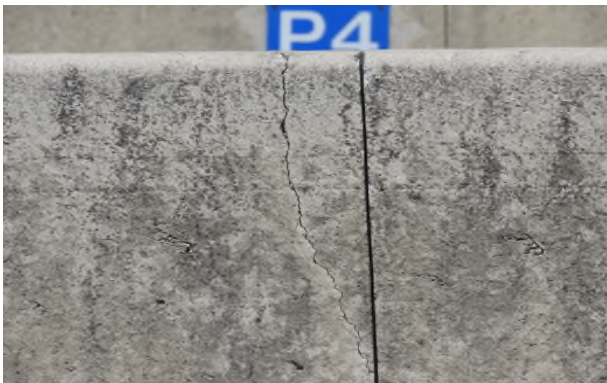
⑱ 균열 0.3mm / 1.0m

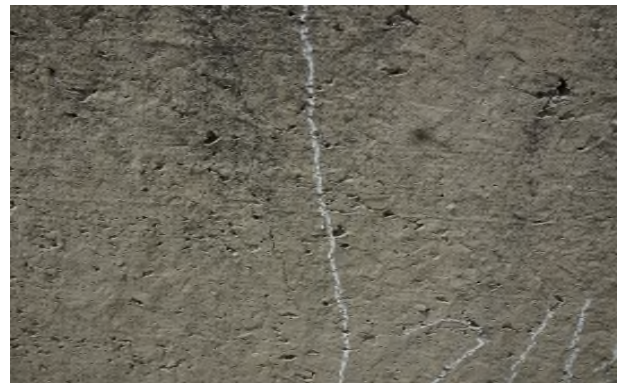
⑳ 균열 0.2mm / 1.2m

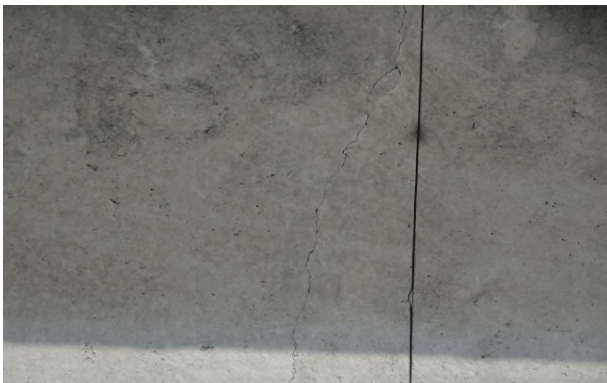
㉑ 균열 0.2mm / 1.2m

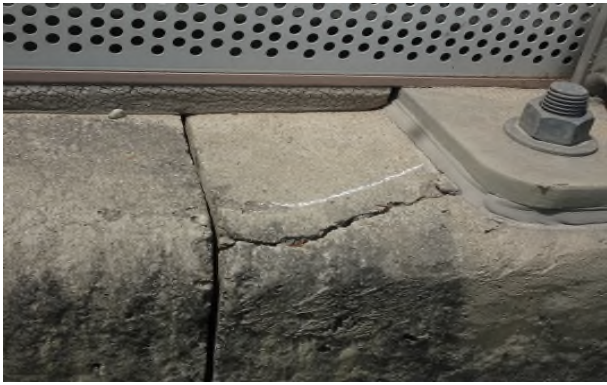
② 균열 0.3mm / 0.1m

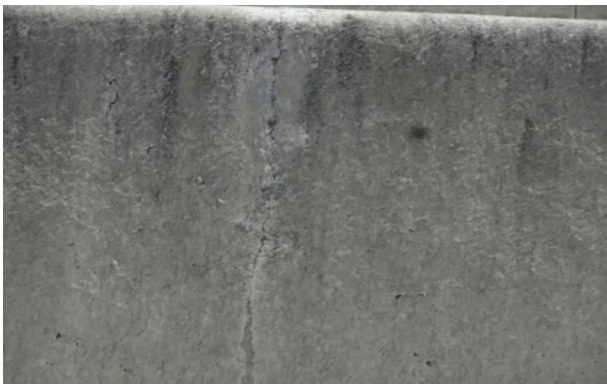
⑤ 균열 0.2mm / 1.5m

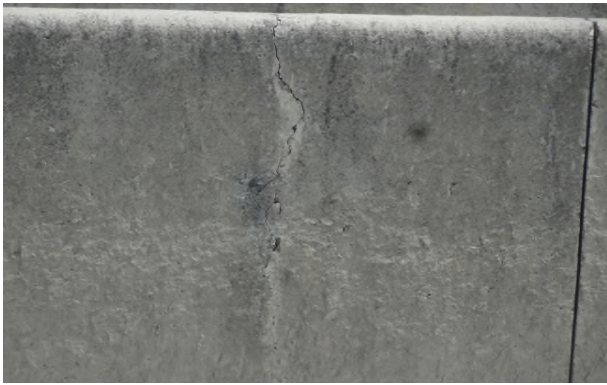
⑦ 균열 0.3mm / 0.5m

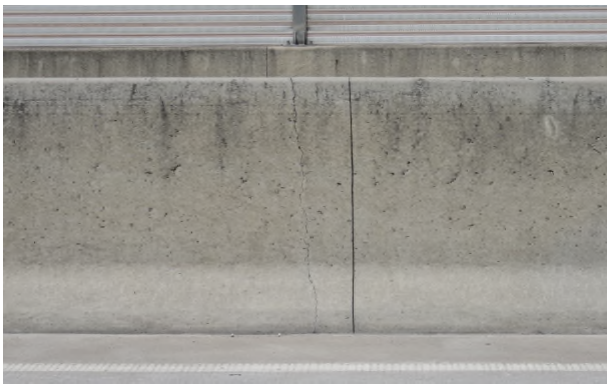
⑳ 균열 0.3mm / 1.5m

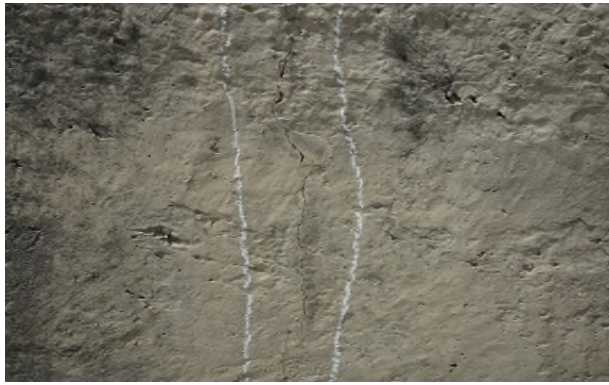
㉒ 균열 0.2mm / 1.0m

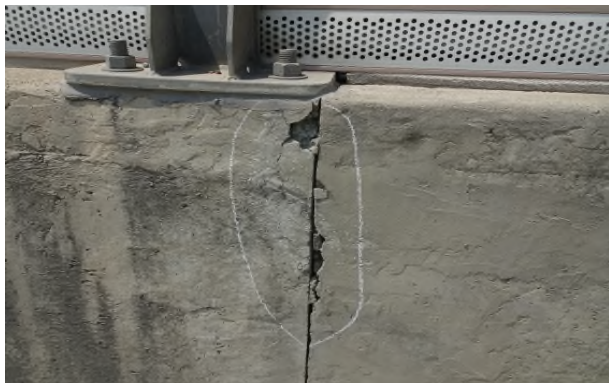
㉔ 파손 0.1m x 0.4m

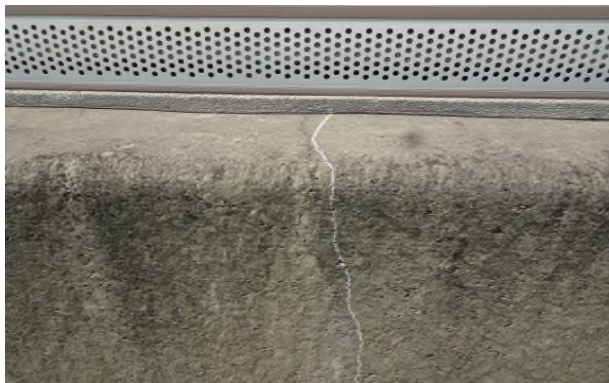
㉖ 균열 0.1mm / 0.4m

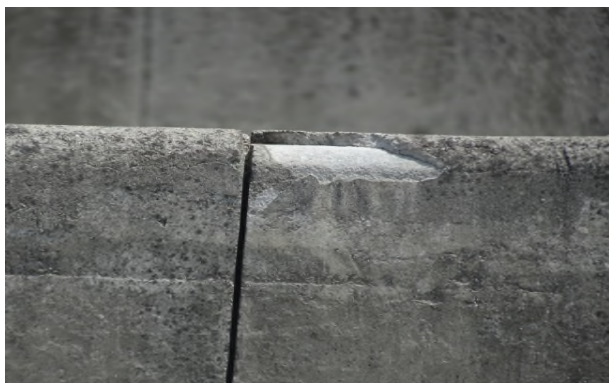
㉘ 파손 0.1m x 0.1m

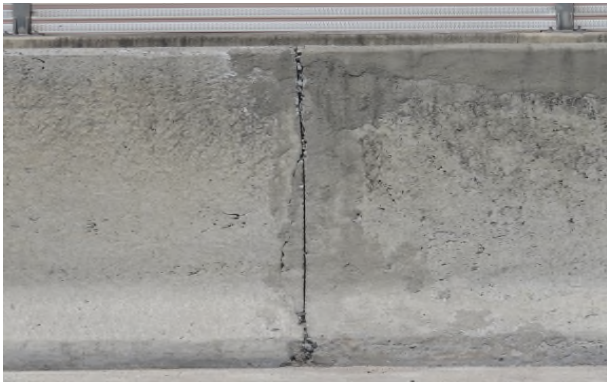
① 균열 0.2mm / 1.0m

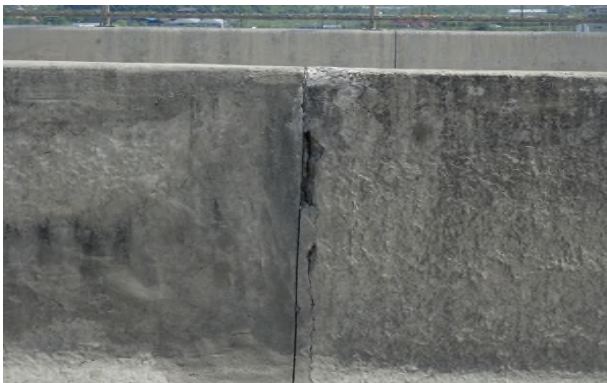
④ 균열 0.5mm / 1.5m (2EA)

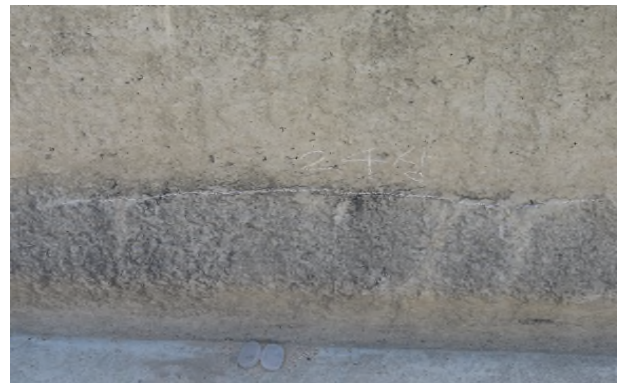
⑨ 균열 0.1mm / 1.1m

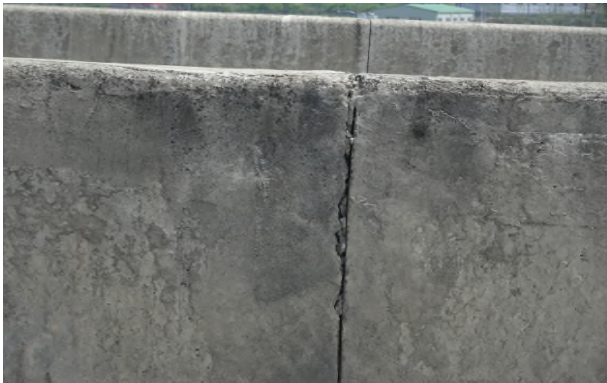
⑩ 파손 0.1m x 0.6m

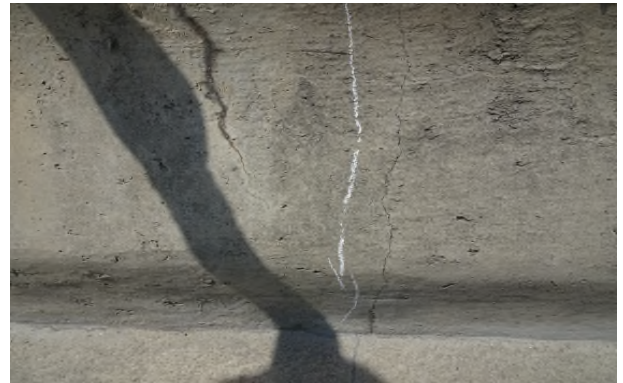
⑪ 균열 0.2mm / 0.6m

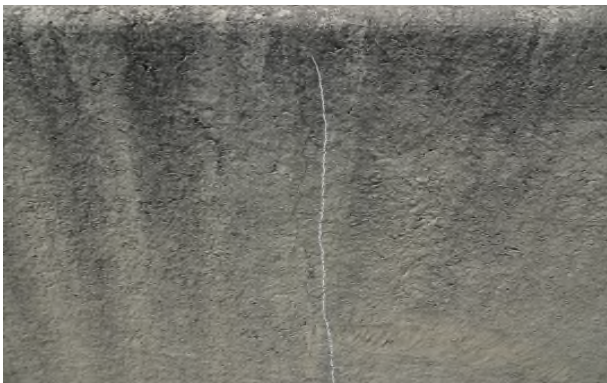
⑫ 균열 0.2mm / 1.2m

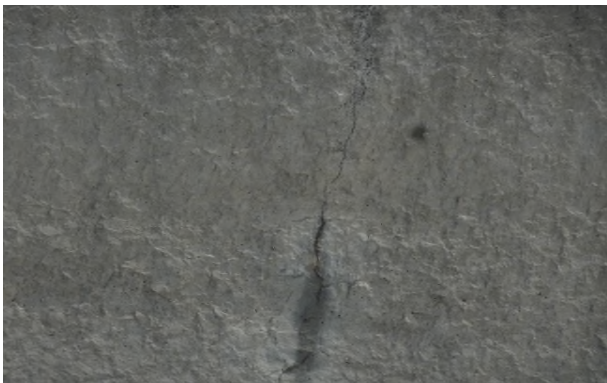
③ 균열 0.3mm / 0.5m

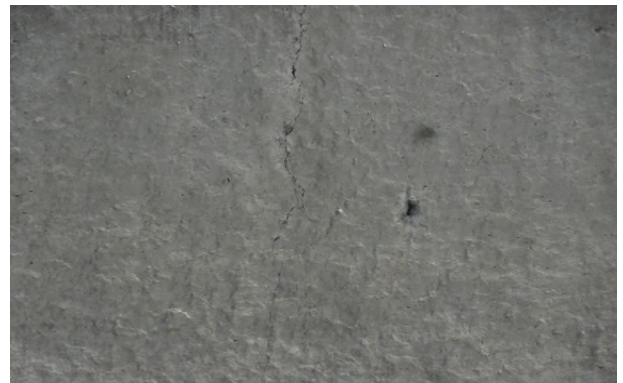
④ 균열 0.2mm / 1.5m (2EA)
