## **6. 현황조사 및 외관조사 사진첩**

## 01. 남전천교

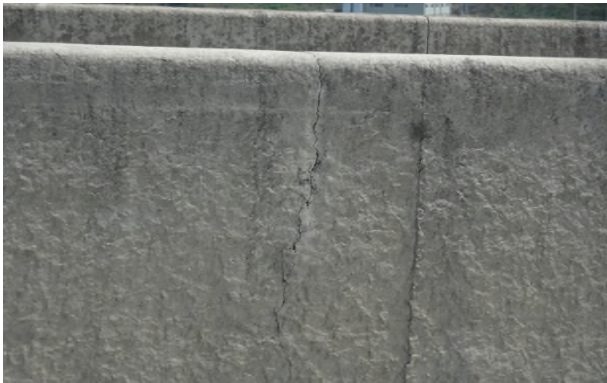
⑤ 균열 0.3mm / 1.5m

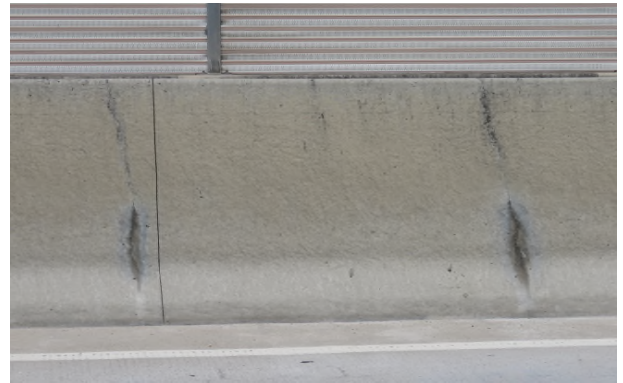
⑧ 균열 0.2mm / 1.4m (5EA) (보수완료)

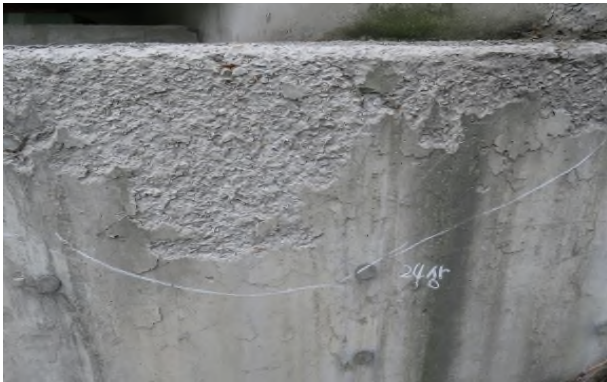
㉡ 콘크리트 열화 1.5m x 0.5m

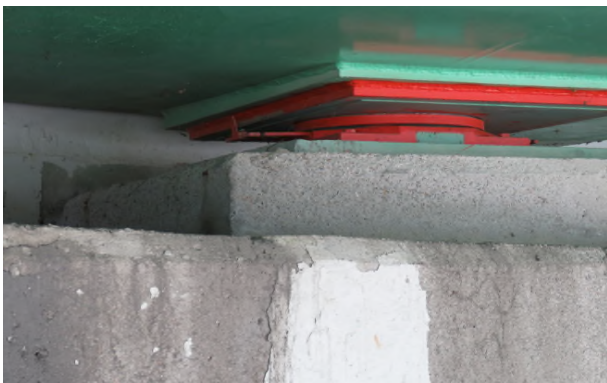
㉢ 받침콘크리트 열화 0.2m x 0.5m

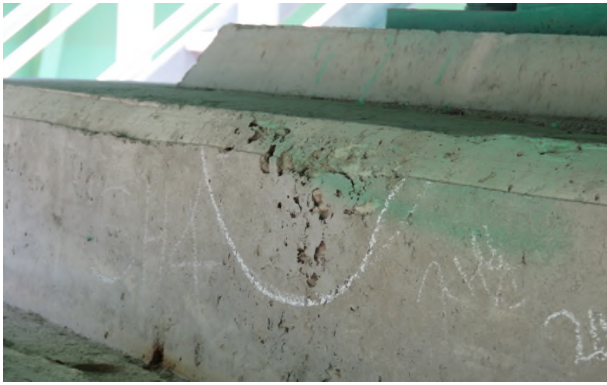
⑬ 받침콘크리트 재료분리 0.1m x 0.1m

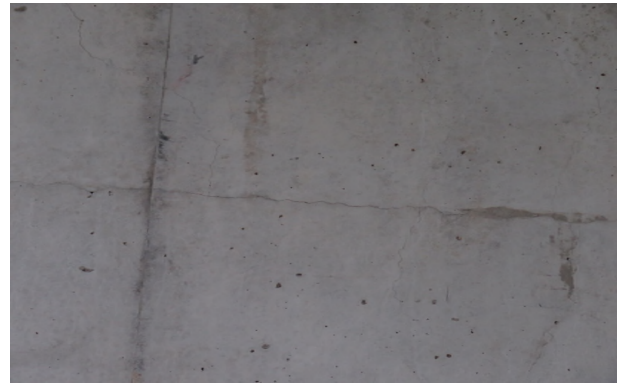
⑱ 균열 0.2mm / 2.0m

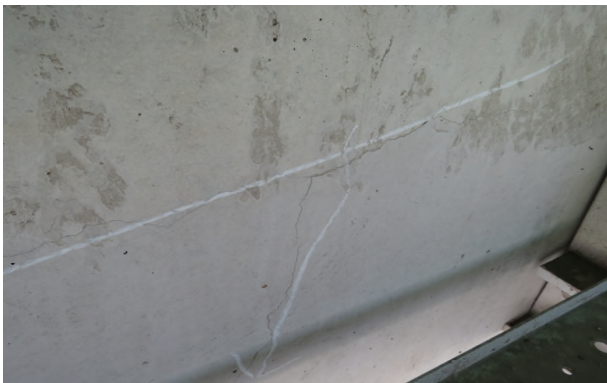
⑲ 균열 0.2mm / 2.0m

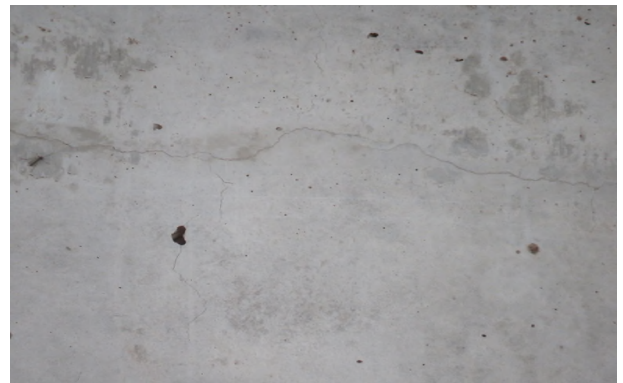
⑳ 균열 0.2mm / 1.5m

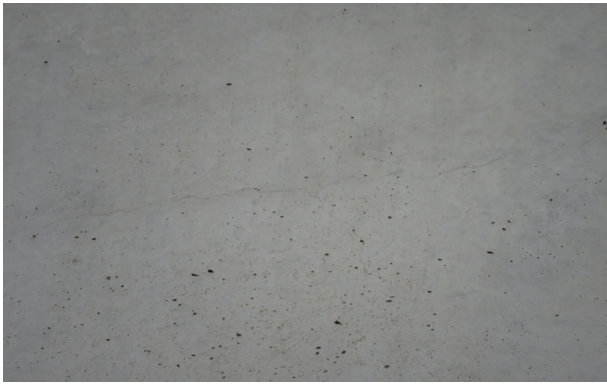
㉓ 균열 0.1mm / 1.0m

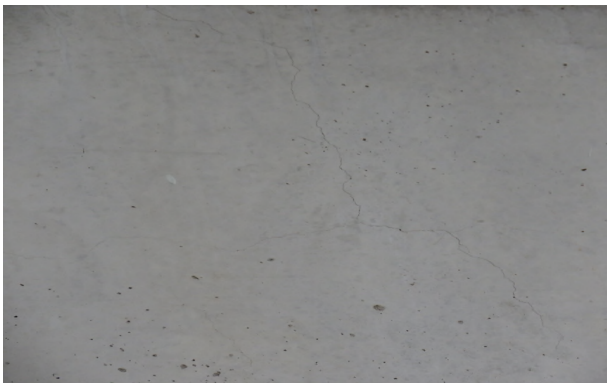
㉕ 균열 0.2mm / 2.0m

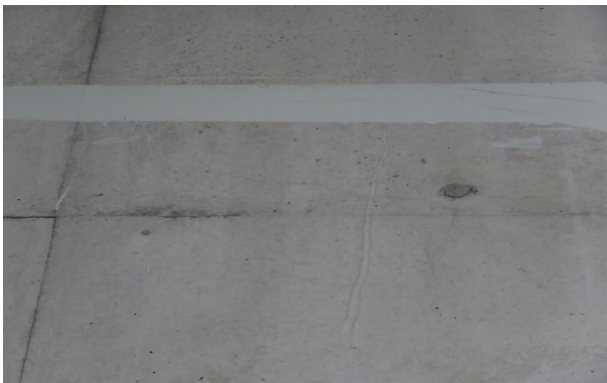
㉗ 균열 0.2mm / 2.0m

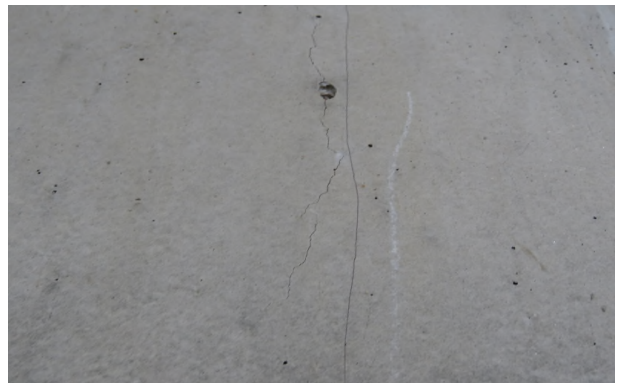
㉘ 균열 0.1mm / 0.1m (2EA)

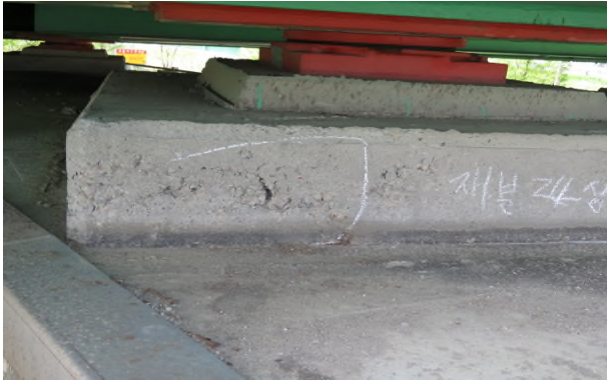
① 받침콘크리트 재료분리 0.3m x 0.6m

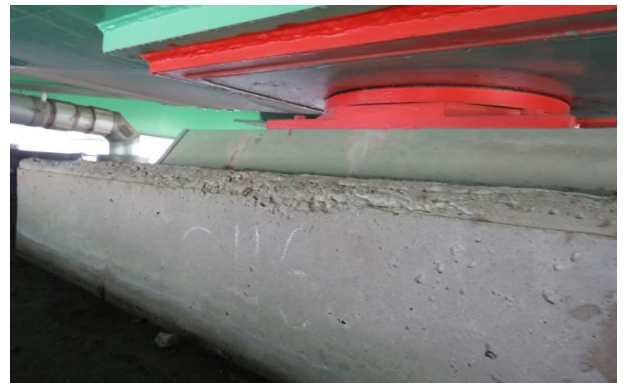
⑩ 받침콘크리트 재료분리 0.1m x 0.2m

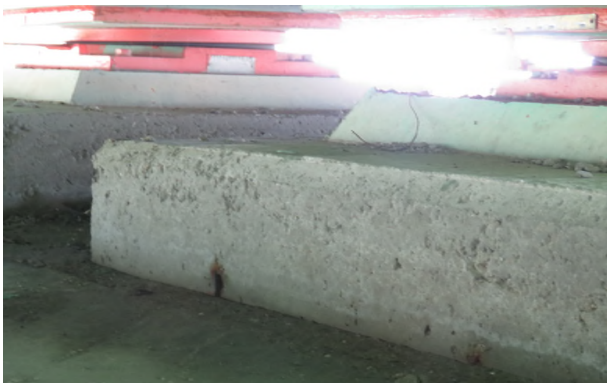
⑪ 받침콘크리트 재료분리 0.2m x 0.8m

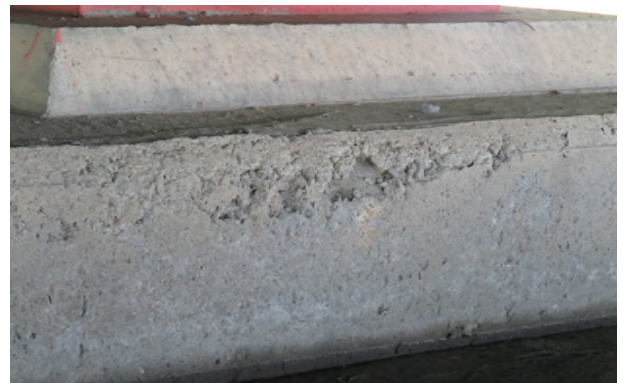
⑫ 받침콘크리트 재료분리 0.2m x 0.3m

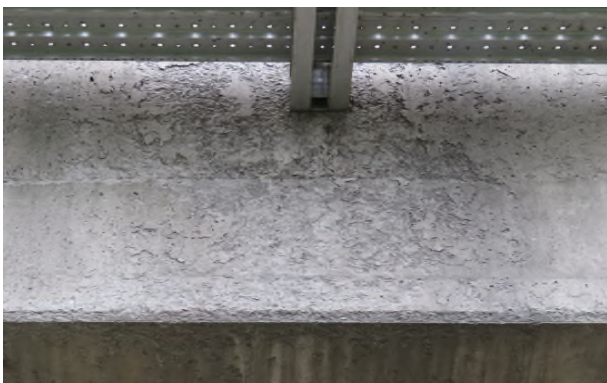
⑬ 콘크리트 열화 2.0m x 2.0m

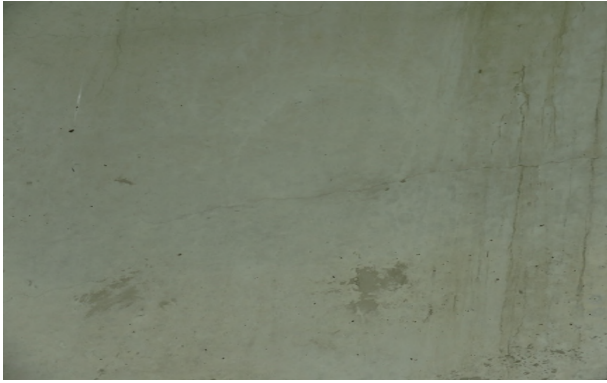
⑩ 균열 0.2mm / 8.0m

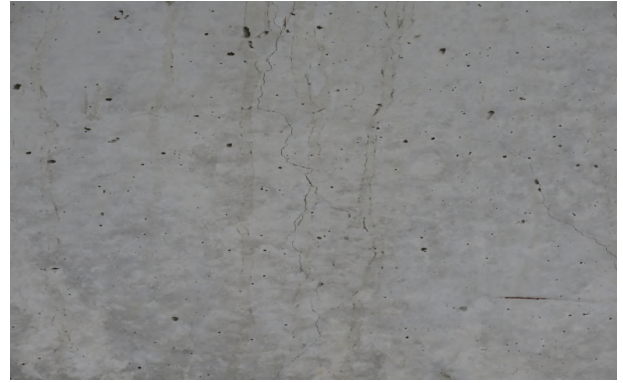
⑪ 균열 0.2mm / 2.0m

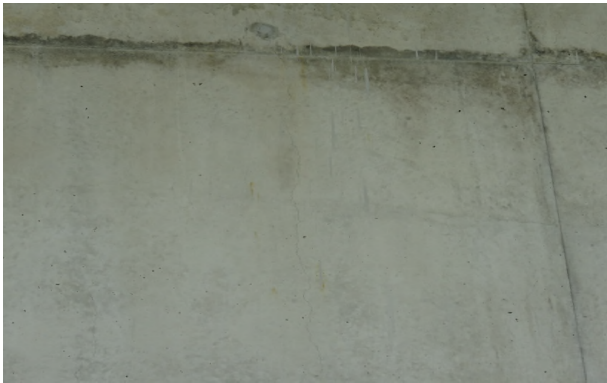
⑭ 균열 0.2mm / 3.0m

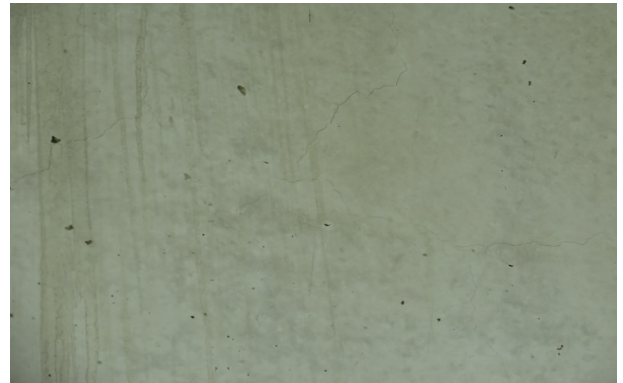
⑮ 균열 0.2mm / 1.0m

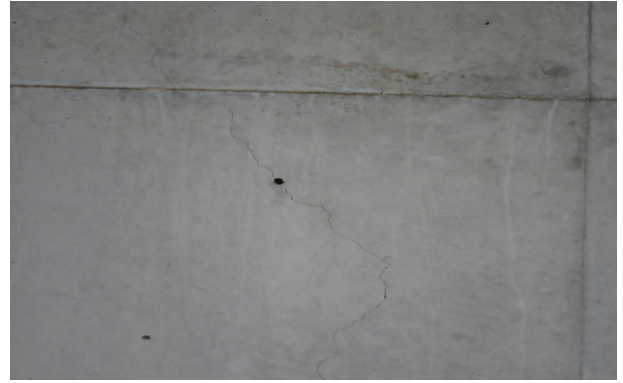
⑳ 균열 0.2mm / 1.0m

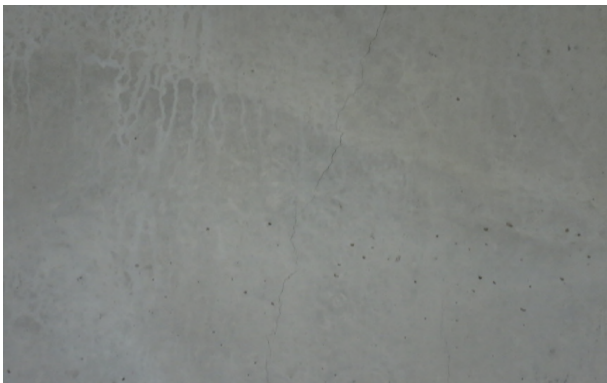
㉑ 균열 0.2mm / 3.0m

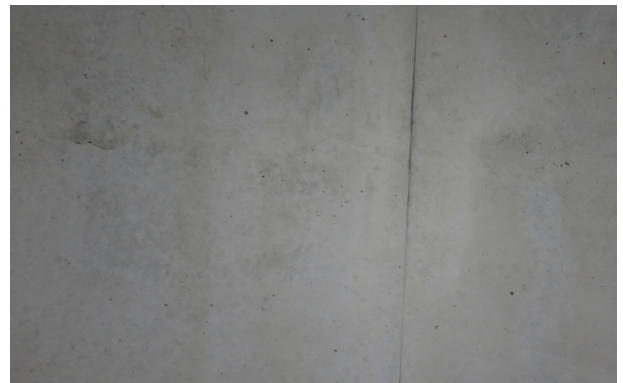
㉒ 균열 0.2mm / 2.0m

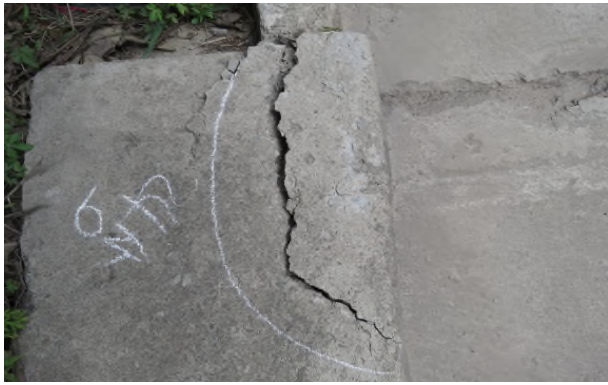
⑧ 균열  $cw=0.2\text{mm} / 2.0\text{m}$

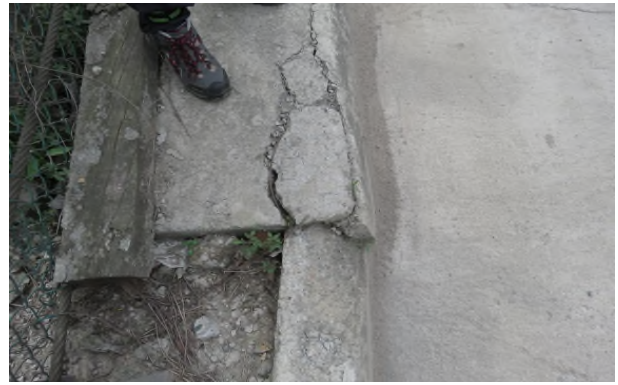
⑪ 파손 1.0m x 0.25m

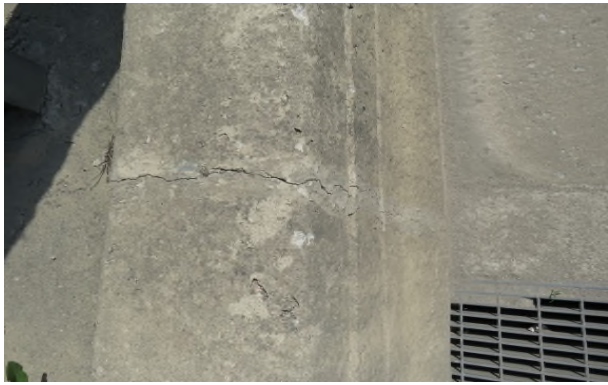
③ L형측구 균열 cw=0.5mm / 1.5m

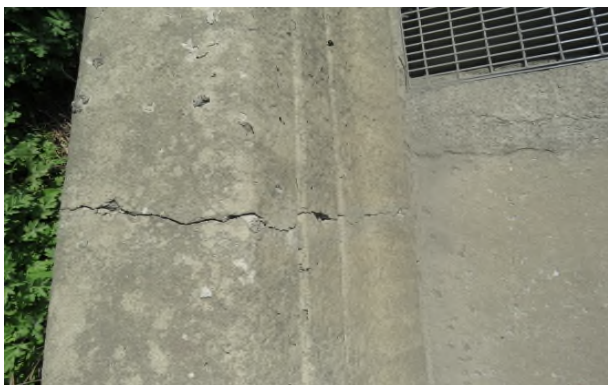
⑤ L형측구 균열 cw=0.5mm / 1.5m

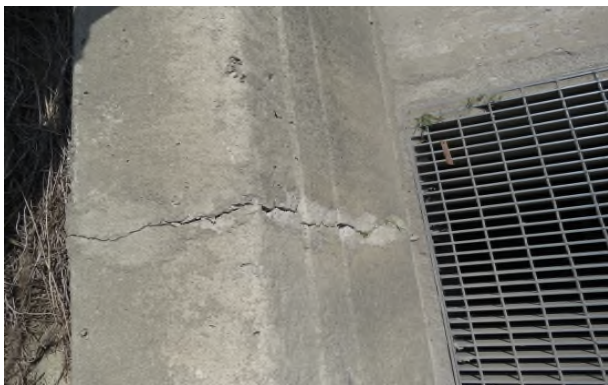
⑨ L형측구 균열 cw=0.5mm / 1.5m

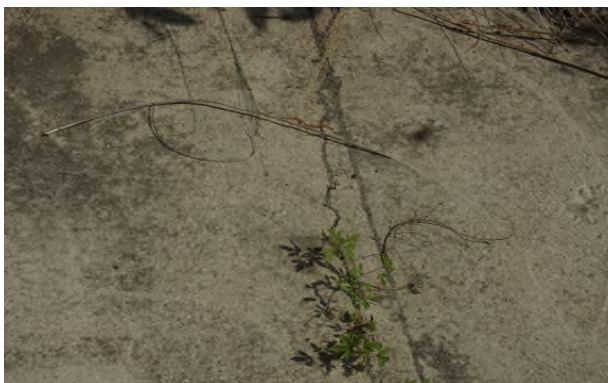
⑭ 균열 cw=1.0mm / 1.2m

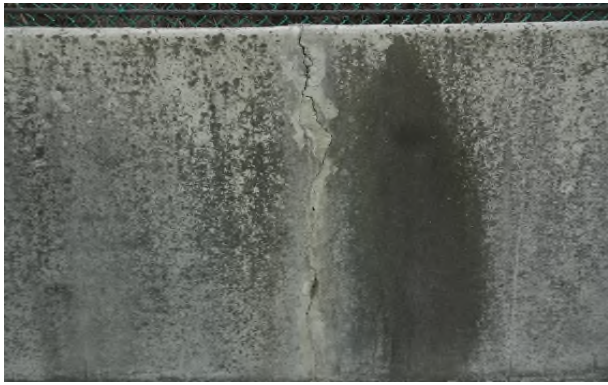
③ L형측구 균열 cw=2.0mm / 1.0m

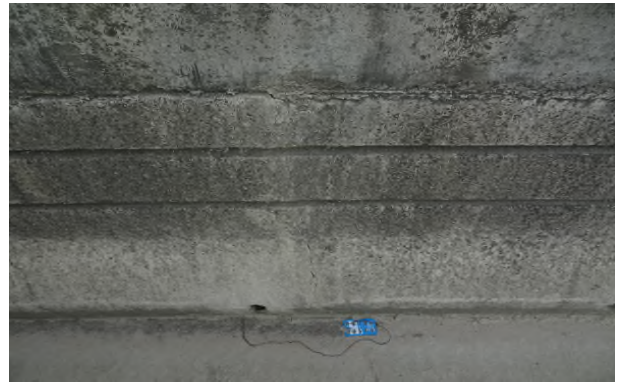
④ L형측구 균열 cw=0.6mm / 0.5m

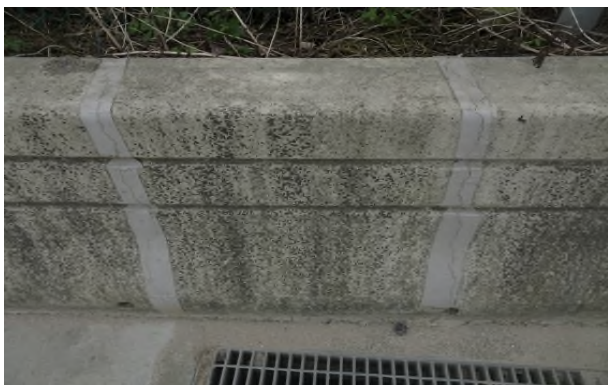
⑦ L형측구 균열 cw=0.5mm / 1.5m

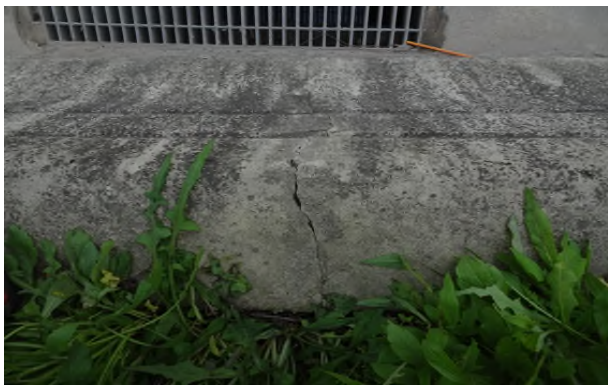
⑩ 균열 cw=0.2mm / 0.9m

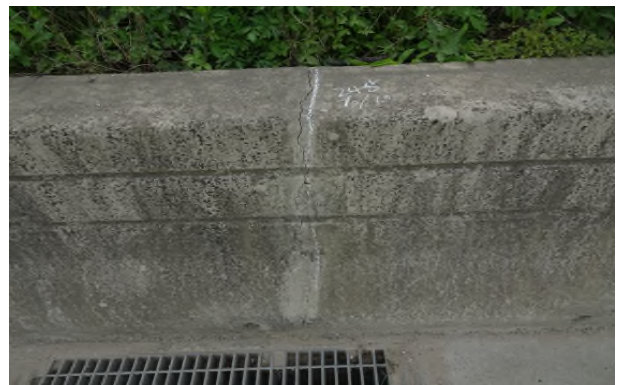
⑪ 균열 cw=1.0mm / 1.0m

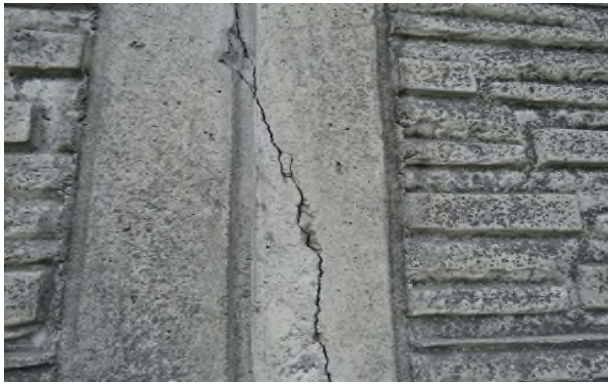
절토사면 백학IC R-D  
STA.0+530~0+702(우)

① L형측구 균열  $cw=1.0\text{mm}$  / 1.1m

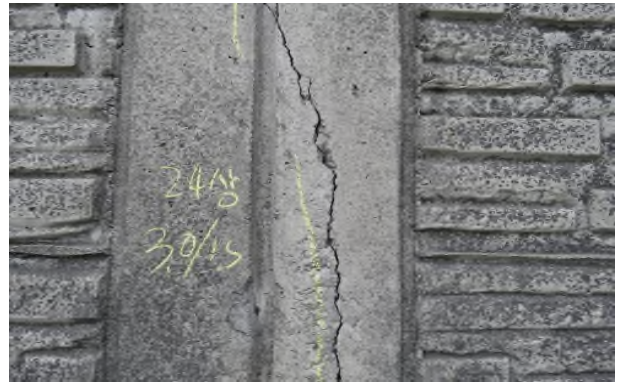
② L형측구 균열  $cw=1.0\text{mm}$  / 0.3m
