용소천교(울산) 교면포장 S1

용역명 2023년 부산울산고속도로 정밀안전점검 및 성능평가용역

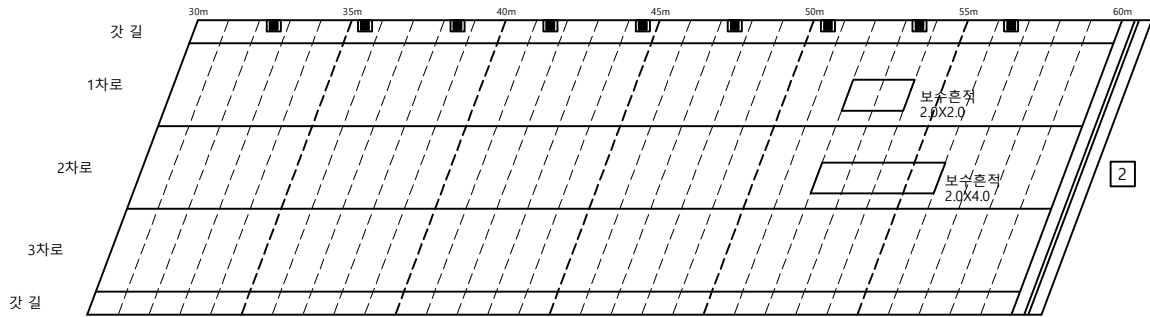
| 번호 | 신/구 | 부재명 | 손 상 현 황 | 손 상 규 모 | | | | | 비고 |
|---|---|---|---|---|---|---|---|---|---|
| 1 | 구 | 방호벽 | 균열 | 0.2 | 0.3 | | 1 | m | 0.30 |
| 2 | 구 | 방호벽 | 균열 | 0.2 | 0.4 | | 1 | m | 0.40 |
| 3 | 구 | 방호벽 | 균열 | 0.2 | 0.2 | | 1 | m | 0.20 |
| 4 | 구 | 방호벽 | 균열 | 0.2 | 1.2 | | 1 | m | 1.20 |
| 5 | 구 | 교면포장 | 모장균열 | 0.5 | 3.0 | | 1 | m | 3.00 |
| 6 | 신 | 교면포장 | 유공관 주변 패임 | | 0.2 | 0.4 | 1 | m | 0.08 |

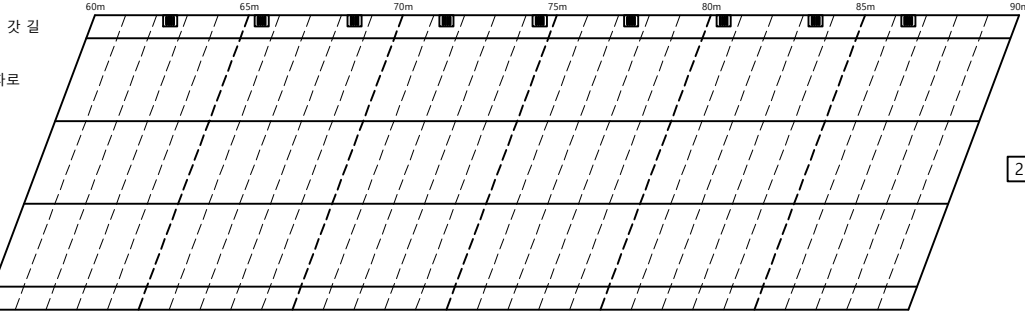
| 번호 | 신/구 | 부재명 | 손 상 현 황 | 손 상 규 모 | | | | | 비 고 |
|---|---|---|---|---|---|---|---|---|---|
| 1 | 구 | 방호벽 | 균열 | 0.2 | 2.0 | | 1 | m | 2.00 |
| 2 | 구 | 방호벽 | 균열 | 0.2 | 2.5 | | 1 | m | 2.50 |
| 3 | 구 | 방호벽 | 균열 | 0.2 | 2.5 | | 1 | m | 2.50 |
| 4 | 구 | 방호벽 | 균열 | 0.2 | 1.5 | | 1 | m | 1.50 |
| 5 | 구 | 방호벽 | 균열 | 0.2 | 0.5 | | 1 | m | 0.50 |
| 6 | 구 | 방호벽 | 균열 | 0.2 | 2.0 | | 1 | m | 2.00 |
| 7 | 구 | 방호벽 | 균열 | 0.2 | 0.8 | | 1 | m | 0.80 |

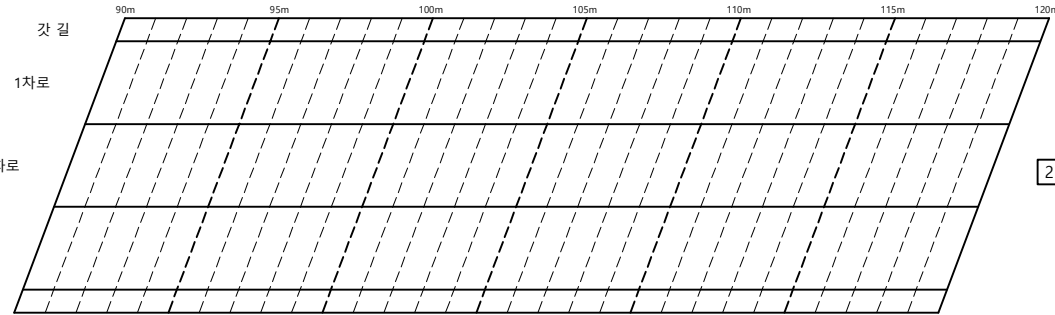
| 번호 | 선/구 | 부재명 | 손 상 원 인 | 손 상 규 모 | | | | | 비고 |
|---|---|---|---|---|---|---|---|---|---|
| 1 | 구 | 방호벽 | 균열 | 0.2 | 0.4 | | 1 | m | 0.40 |
| 2 | 구 | 방호벽 | 균열 | 0.2 | 1.2 | | 1 | m | 1.20 |
| 3 | 구 | 방호벽 | 균열 | 0.2 | 1.0 | | 1 | m | 1.00 |
| 4 | 구 | 방호벽 | 균열 | 0.2 | 1.1 | | 1 | m | 1.10 |
| 5 | 구 | 방호벽 | 균열 | 0.2 | 0.2 | | 1 | m | 0.20 |
| 6 | 구 | 방호벽 | 균열 | 0.2 | 2.0 | | 1 | m | 2.00 |
| 7 | 구 | 방호벽 | 균열 | 0.2 | 1.2 | | 1 | m | 1.20 |
| 8 | 구 | 방호벽 | 균열 | | 1.3 | 2.0 | 1 | m | 2.60 |

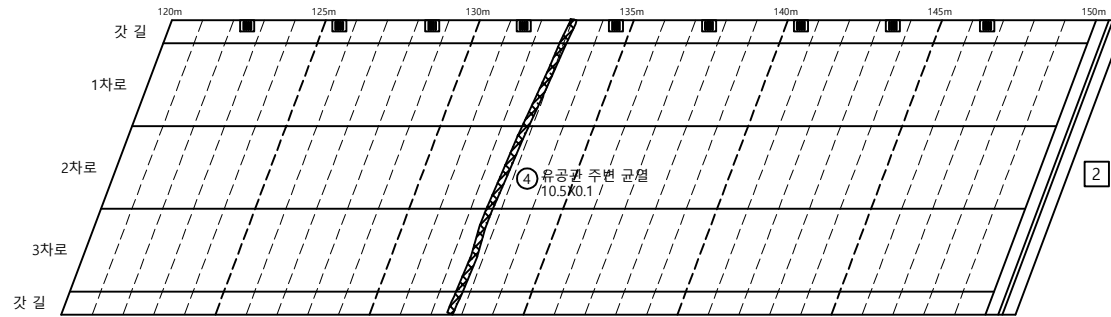
| 번호 | 선/구 | 부재명 | 손 상 원 인 | 손 상 규 모 | | | | | 비고 |
|---|---|---|---|---|---|---|---|---|---|
| 1 | 구 | 방호벽 | 균열 | 0.2 | 0.3 | | 1 | m | 0.30 |
| 2 | 구 | 방호벽 | 균열 | 0.2 | 0.4 | | 1 | m | 0.40 |
| 3 | 구 | 방호벽 | 균열 | 0.2 | 0.3 | | 1 | m | 0.30 |
| 4 | 구 | 방호벽 | 균열 | 0.2 | 2.2 | | 1 | m | 2.20 |
| 5 | 구 | 방호벽 | 균열 | 0.2 | 0.2 | | 1 | m | 0.20 |
| 6 | 구 | 방호벽 | 균열 | 0.2 | 0.2 | | 1 | m | 0.20 |
| 7 | 구 | 방호벽 | 균열 | 0.2 | 0.5 | | 1 | m | 0.50 |
| 8 | 구 | 방호벽 | 균열 | | 0.6 | 1.5 | 1 | m | 0.90 |
| 9 | 구 | 교면포장 | 유공관 주변 균열 | | 10.5 | 0.1 | 1 | m | 1.05 |

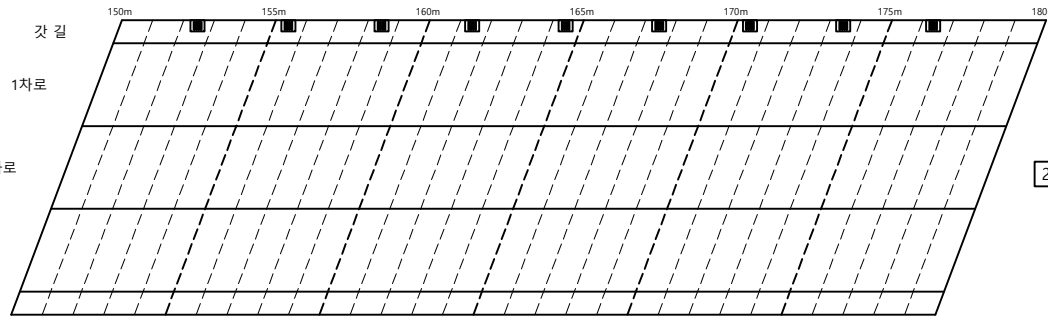
| 번호 | 신/구 | 부재명 | 손상원황 | 손상규모 | | | | | 비고 |
|---|---|---|---|---|---|---|---|---|---|
| 1 | 구 | 방호벽 | 균열 | 0.2 | 0.5 | | 1 | m | 0.50 |
| 2 | 구 | 방호벽 | 균열 | 0.2 | 0.3 | | 1 | m | 0.30 |
| 3 | 구 | 방호벽 | 균열 | 0.2 | 0.2 | | 1 | m | 0.20 |
| 4 | 구 | 방호벽 | 균열 | 0.2 | 0.2 | | 1 | m | 0.20 |

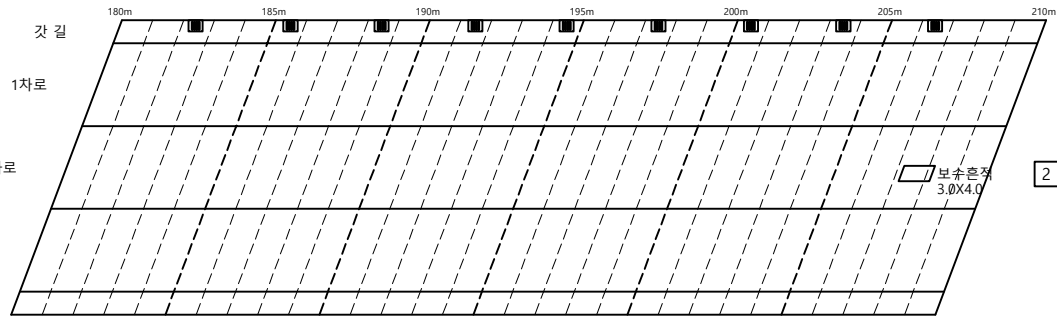
| 교면포장 | | | | | | | | | |
|---|---|---|---|---|---|---|---|---|---|
| 1 | 구 | 방호벽 | 균열 | 0.2 | 0.2 | | 1 | m | 0.20 |
| 2 | 구 | 방호벽 | 균열 | 0.2 | 0.2 | | 2 | m | 0.40 |
| 3 | 구 | 방호벽 | 균열 | 0.2 | 0.2 | | 1 | m | 0.20 |
| 4 | 구 | 방호벽 | 균열 | 0.2 | 0.4 | | 1 | m | 0.40 |
| 5 | 구 | 방호벽 | 균열 | 0.2 | 1.0 | | 1 | m | 1.00 |
| 6 | 구 | 방호벽 | 균열 | 0.2 | 1.5 | | 1 | m | 1.50 |
| 7 | 구 | 방호벽 | 균열 | 0.2 | 0.3 | | 2 | m | 0.60 |

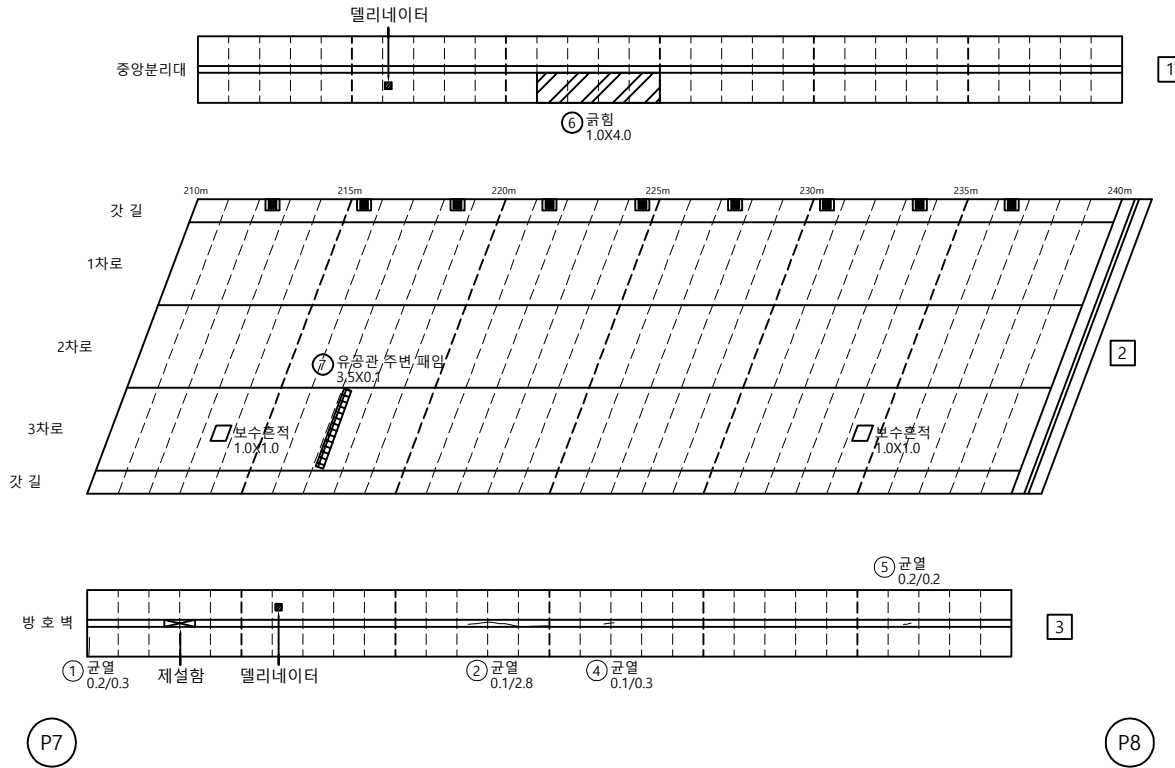
| 교면포장 | | | | | | | | | | |
|---|---|---|---|---|---|---|---|---|---|---|
| 1 | 구 | 방호벽 | 균열 | 0.2 | 0.3 | | 1 | m | 0.30 | |
| 2 | 구 | 방호벽 | 균열 | 0.1 | 2.8 | | 1 | m | 2.80 | |
| 3 | 구 | 방호벽 | 균열 | | | | 1 | EA | 1.00 | |
| 4 | 구 | 방호벽 | 균열 | 0.1 | 0.3 | | 1 | m | 0.30 | |
| 5 | 구 | 방호벽 | 균열 | 0.2 | 0.2 | | 1 | m | 0.20 | |

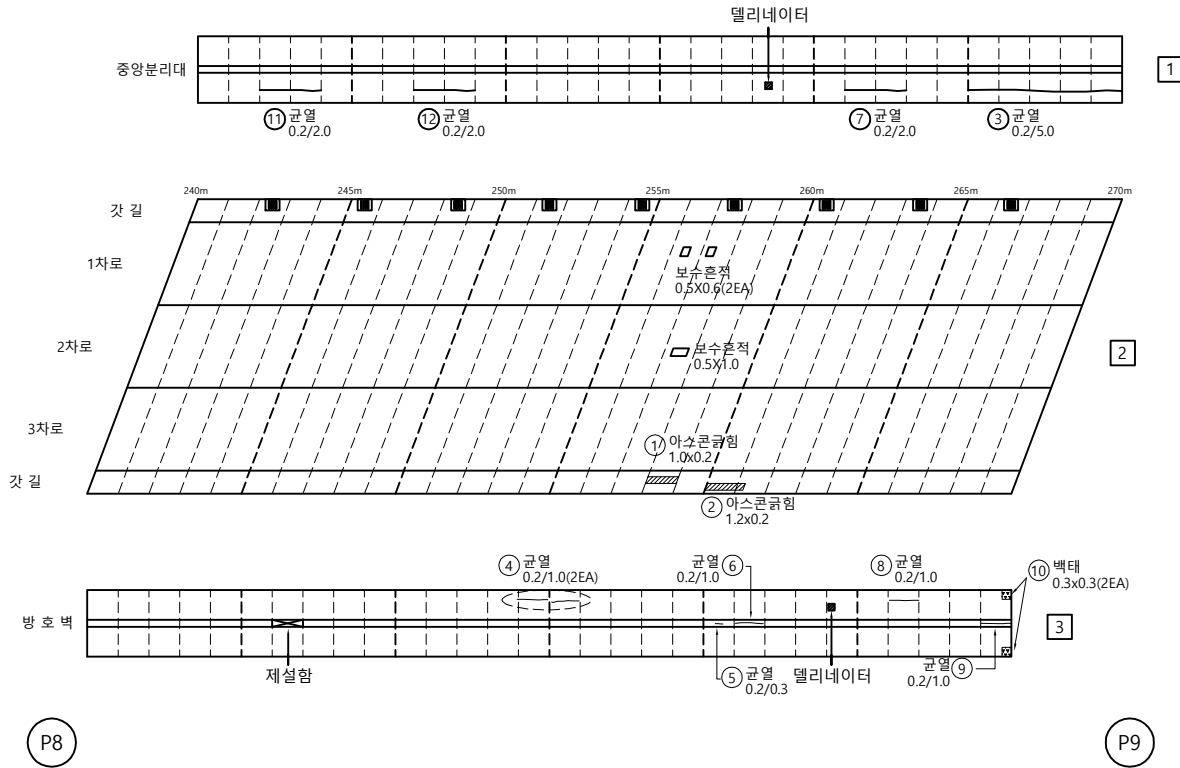
| 교면포장 | | | | | | | | | |
|---|---|---|---|---|---|---|---|---|---|
| 1 | 구 | 방호벽 | 포장 균열 | | 1.0 | 0.2 | 1 | m | 0.20 |
| 2 | 구 | 방호벽 | 포장 균열 | | 1.2 | 0.2 | 1 | m | 0.24 |
| 3 | 구 | 방호벽 | 균열 | 0.2 | 5.0 | | 1 | m | 5.00 |
| 4 | 구 | 방호벽 | 균열 | 0.2 | 1.0 | | 2 | m | 2.00 |
| 5 | 구 | 방호벽 | 균열 | 0.2 | 0.3 | | 1 | m | 0.30 |
| 6 | 구 | 방호벽 | 균열 | 0.2 | 1.0 | | 1 | m | 1.00 |
| 7 | 구 | 방호벽 | 균열 | 0.2 | 2.0 | | 1 | m | 2.00 |
| 8 | 구 | 방호벽 | 균열 | 0.2 | 1.0 | | 1 | m | 1.00 |
| 9 | 구 | 방호벽 | 균열 | 0.2 | 1.0 | | 1 | m | 1.00 |
| 11 | 구 | 방호벽 | 균열 | 0.2 | 2.0 | | 1 | m | 2.00 |
| 12 | 구 | 방호벽 | 균열 | 0.2 | 2.0 | | 1 | m | 2.00 |

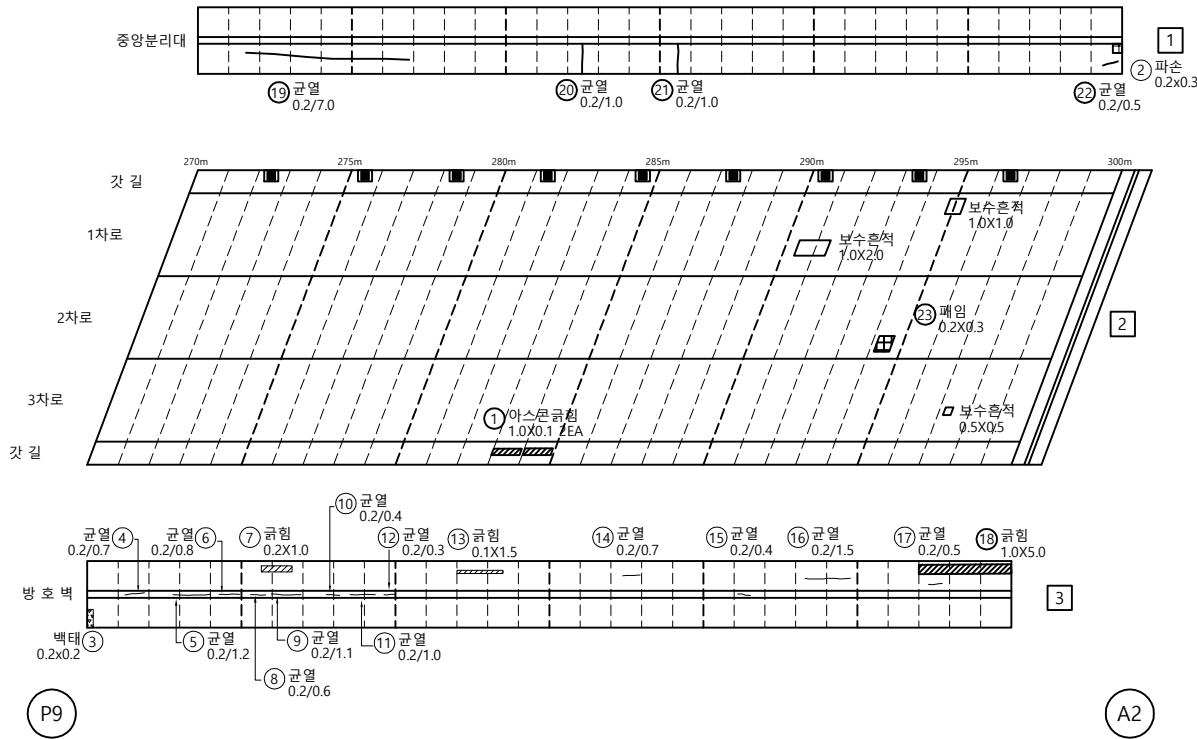
| 번호 | 신/구 | 부재명 | 손 상 원 황 | 손 상 규 모 | | | | | 비고 |
|---|---|---|---|---|---|---|---|---|---|
| 1 | 신/구 | 방호벽 | 포장 균열 | | 1.0 | 0.1 | 2 | m | 0.20 |
| 4 | 구 | 방호벽 | 균열 | 0.2 | 0.7 | | 1 | m | 0.70 |
| 5 | 구 | 방호벽 | 균열 | 0.2 | 1.2 | | 1 | m | 1.20 |
| 6 | 구 | 방호벽 | 균열 | 0.2 | 0.8 | | 1 | m | 0.80 |
| 7 | 구 | 방호벽 | 균열 | | 0.2 | 1.0 | 1 | m | 0.20 |
| 8 | 구 | 방호벽 | 균열 | 0.2 | 0.6 | | 1 | m | 0.60 |
| 9 | 구 | 방호벽 | 균열 | 0.2 | 1.1 | | 1 | m | 1.10 |
| 10 | 구 | 방호벽 | 균열 | 0.2 | 0.4 | | 1 | m | 0.40 |
| 11 | 구 | 방호벽 | 균열 | 0.2 | 1.0 | | 1 | m | 1.00 |
| 12 | 구 | 방호벽 | 균열 | 0.2 | 0.3 | | 1 | m | 0.30 |
| 13 | 구 | 방호벽 | 균열 | | 0.1 | 1.5 | 1 | m | 0.15 |
| 14 | 구 | 방호벽 | 균열 | 0.2 | 0.7 | | 1 | m | 0.70 |
| 15 | 구 | 방호벽 | 균열 | 0.2 | 0.4 | | 1 | m | 0.40 |
| 16 | 구 | 방호벽 | 균열 | 0.2 | 1.5 | | 1 | m | 1.50 |
| 17 | 구 | 방호벽 | 균열 | 0.2 | 0.5 | | 1 | m | 0.50 |
| 18 | 구 | 방호벽 | 균열 | 1.0 | 5.0 | | 1 | m | 5.00 |
| 19 | 신 | 방호벽 | 균열 | 0.2 | 7.0 | | 1 | m | 7.00 |
| 20 | 구 | 방호벽 | 균열 | 0.2 | 1.0 | | 1 | m | 1.00 |
| 21 | 구 | 방호벽 | 균열 | 0.2 | 1.0 | | 1 | m | 1.00 |

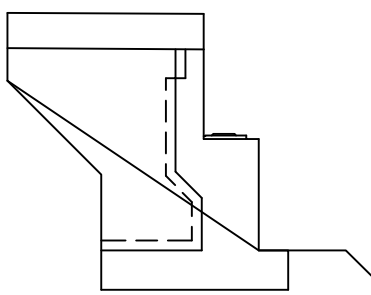
용소천교(울산) 교대 A1

| 교대 | | | | | | | | | |
|---|---|---|---|---|---|---|---|---|---|
| 1 | 구 | 교대 | 균열 | 0.2 | 2.0 | | 1 | m | 2.00 |
| 2 | 선 | 교대 | 누수 | | | | 3 | EA | 3.00 |

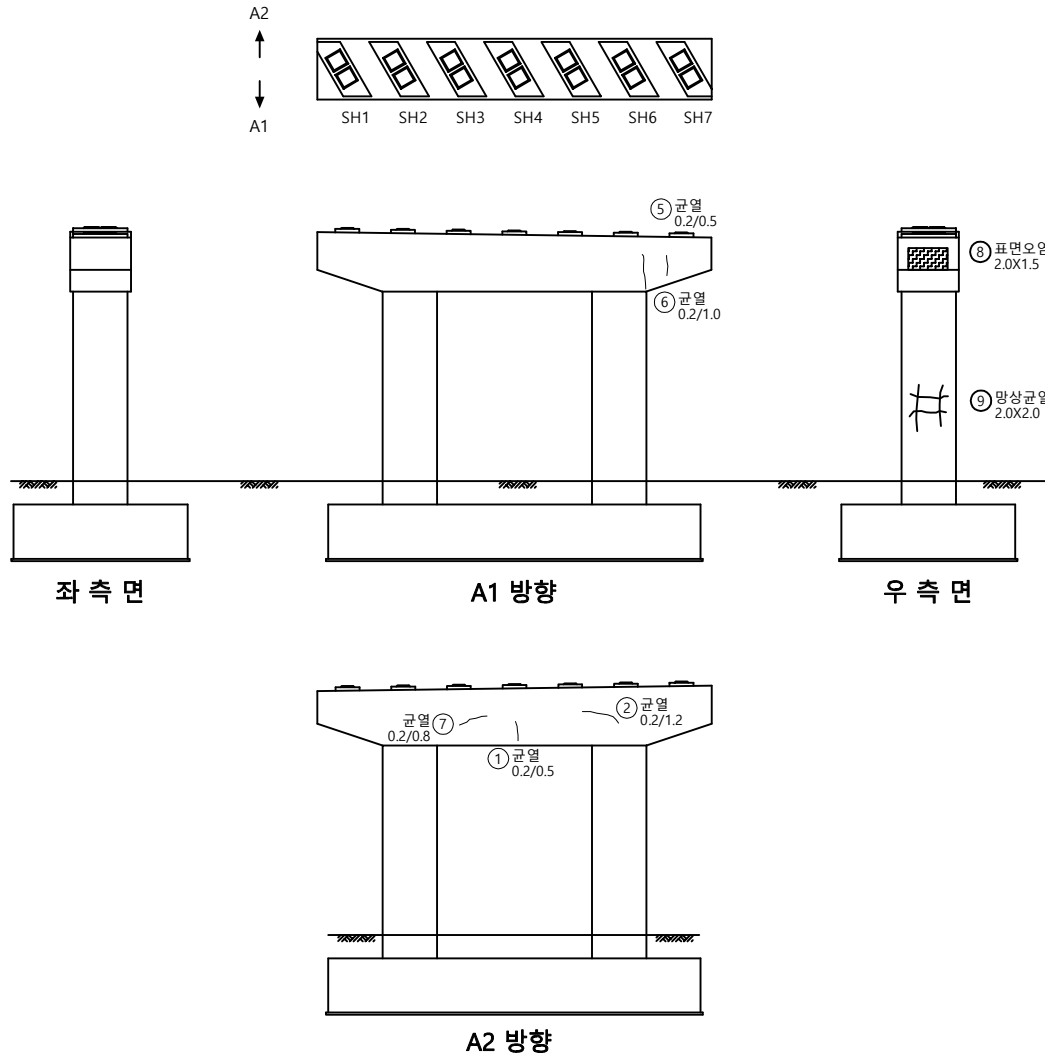
P3

| 번호 | 선/구 | 부재명 | 손 상 현 황 | 손 상 규 모 | | | | | 비고 |
|---|---|---|---|---|---|---|---|---|---|
| 1 | 구 | 교각 | 균열 | 0.2 | 0.5 | | 1 | m | 0.50 |
| 2 | 구 | 교각 | 균열 | 0.2 | 1.2 | | 1 | m | 1.20 |
| 4 | 구 | 교각 | 방상균열 | | 2.0 | 2.0 | 1 | m <sup>2</sup> | 4.00 |
| 5 | 구 | 교각 | 균열 | 0.2 | 0.5 | | 1 | m | 0.50 |
| 6 | 구 | 교각 | 균열 | 0.2 | 1.0 | | 1 | m | 1.00 |
| 7 | 구 | 교각 | 균열 | 0.2 | 0.8 | | 1 | m | 0.80 |

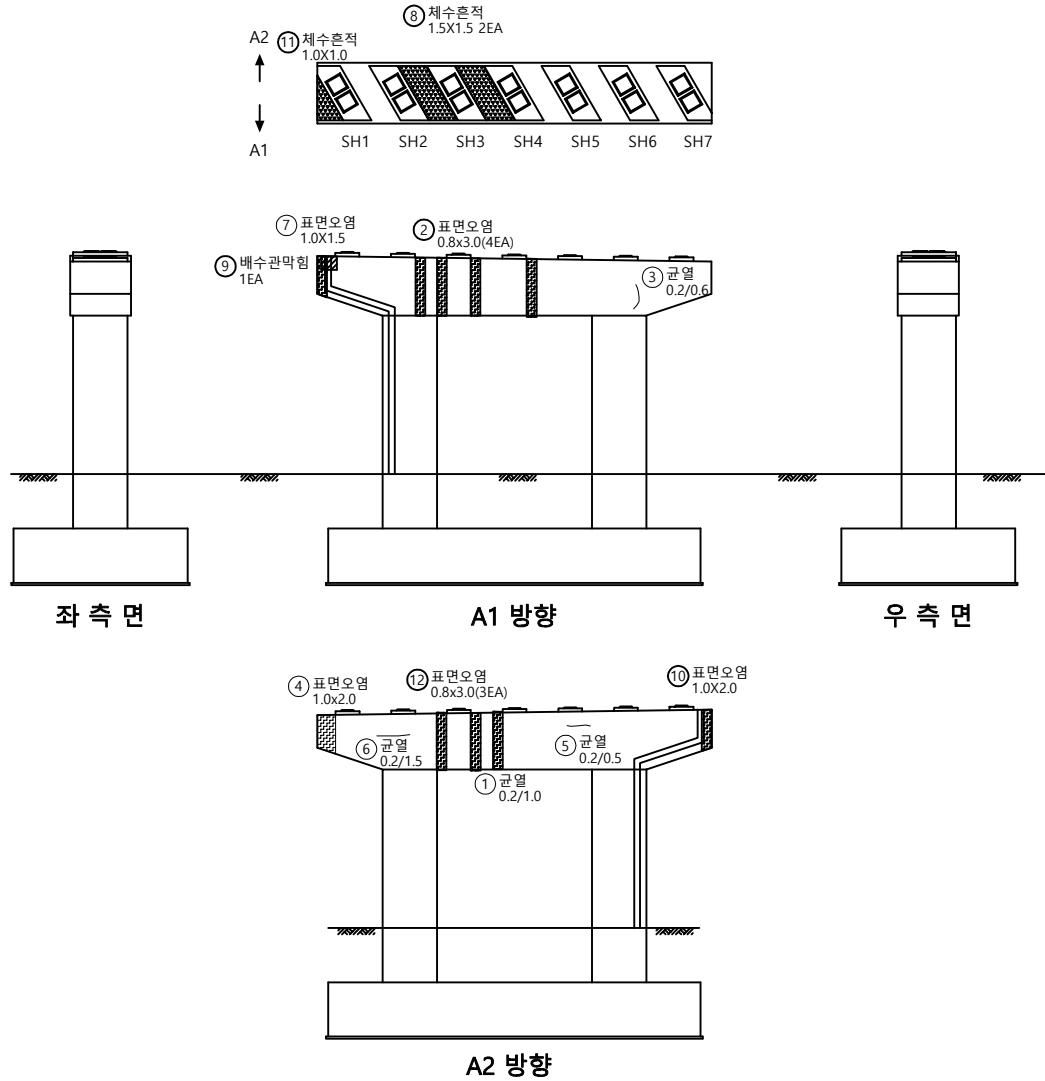
| 변조 | | 신/구 | | 부재명 | 손상현황 | 손상규모 | | | | | | 비고 |
|---|---|---|--|---|---|---|---|---|---|---|---|---|
| 1 | 구 | 교각 | | 균열 | | 0.2 | 1.0 | | 1 | m | 1.00 | |
| 3 | 구 | 교각 | | 균열 | | 0.2 | 0.6 | | 1 | m | 0.60 | |
| 5 | 구 | 교각 | | 균열 | | 0.2 | 0.5 | | 1 | m | 0.50 | |
| 6 | 구 | 교각 | | 균열 | | 0.2 | 1.5 | | 1 | m | 1.50 | |

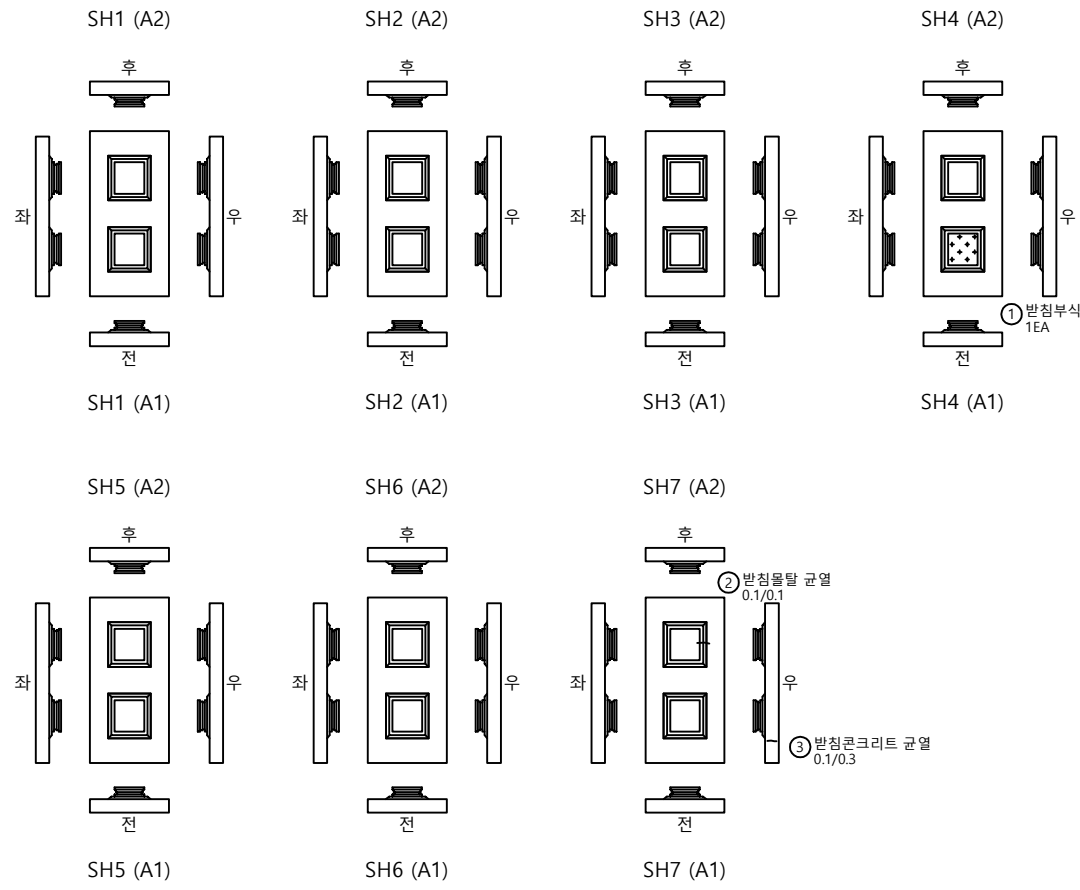
| 받침장치 | | | | | | | | | | |
|---|---|---|---|---|---|---|---|---|---|---|
| P7 | | | | | | | | | | |

| 받침장치 | | | | | | | | | | |
|---|---|---|---|---|---|---|---|---|---|---|
| 1 | 구 | 교량받침 | 플레이트 부식 | | | | 1 | EA | 1.00 | |
| 2 | 신 | 교량받침 | 받침물발 균열 | 0.1 | 0.1 | | 1 | m | 0.10 | |
| 3 | 신 | 교량받침 | 받침콘크리트 균열 | 0.1 | 0.1 | | 1 | m | 0.10 | |

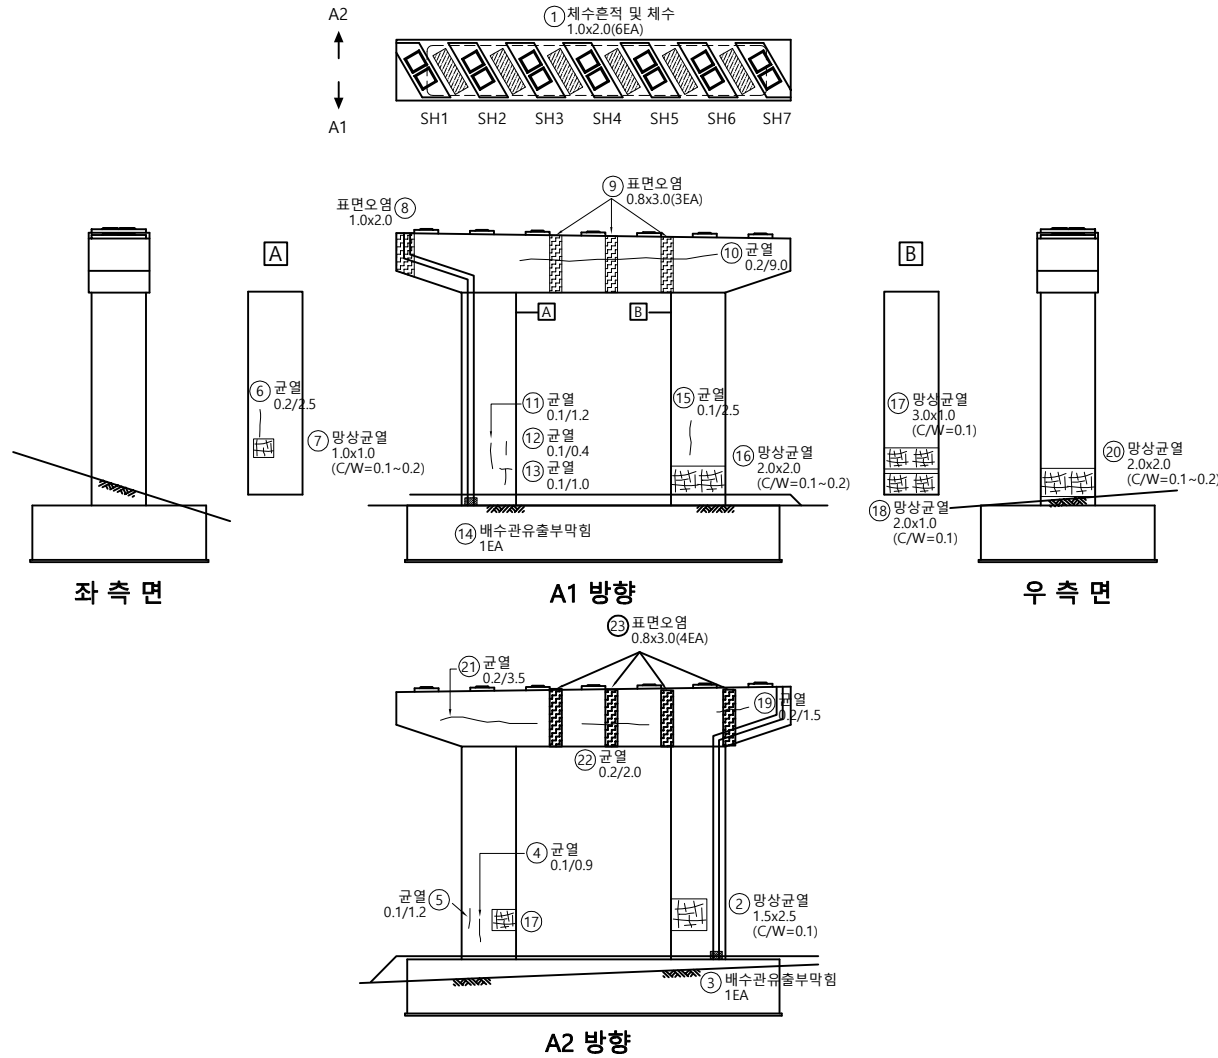
| 교각 | | | | | | | | | | |
|---|---|---|---|---|---|---|---|---|---|---|
| P8 | | | | | | | | | | |

| 교각 | | | | | | | | | | |
|---|---|---|---|---|---|---|---|---|---|---|
| 2 | 구 | 교각 | 망상균열 | | 1.5 | 2.5 | 1 | m² | 3.75 | |
| 4 | 구 | 교각 | 균열 | 0.1 | 1.9 | | 1 | m | 1.90 | |
| 6 | 구 | 교각 | 균열 | 0.2 | 2.5 | | 1 | m | 2.50 | |
| 10 | 구 | 교각 | 균열 | 0.2 | 9.0 | | 1 | m | 9.00 | |
| 16 | 구 | 교각 | 망상균열 | | 2.0 | 2.0 | 1 | m² | 4.00 | |
| 17 | 구 | 교각 | 망상균열 | | 3.0 | 1.0 | 1 | m² | 3.00 | |
