# 화성1송수관로 [2구간]

## 1. 관로 매설환경조사

## 2. 밸브.밸브실 조사

### 3. 관로 부식환경조사

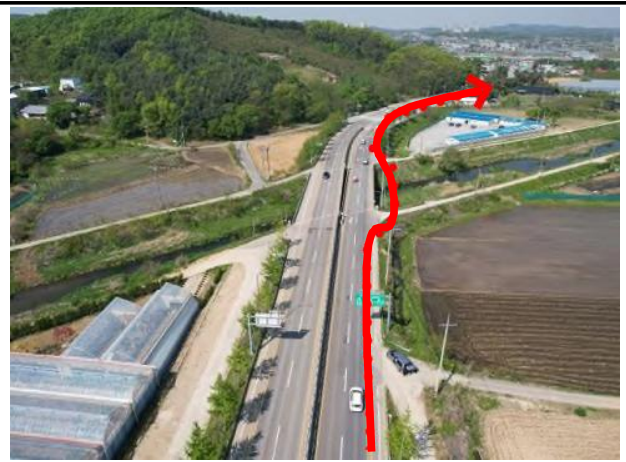
송수계통, 02(01)구간, Sta. No. 0+0.00  
관로노선 현황

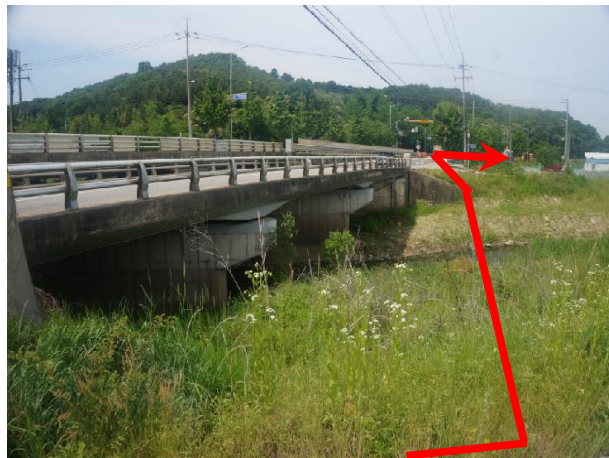
송수계통, 02(01)구간, Sta. No. 2+10.50  
동화천 횡단구간

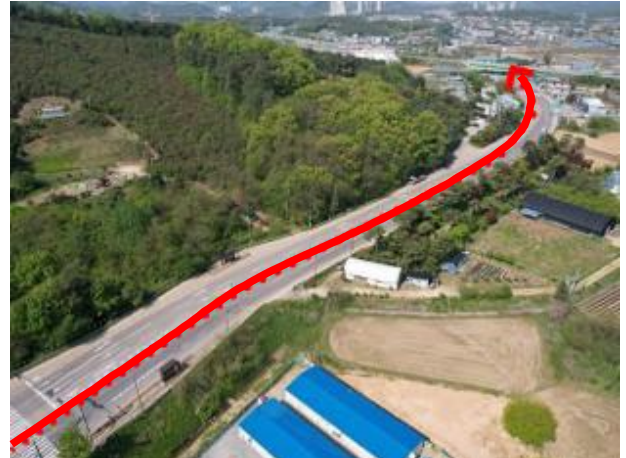
송수계통, 02(01)구간, Sta. No. 6+0.00  
관로노선 현황

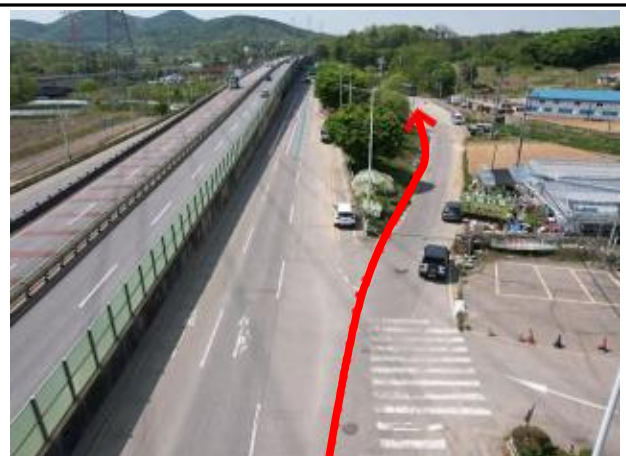
송수계통, 02(02)구간, Sta. No. 28+31.00  
관로노선 현황

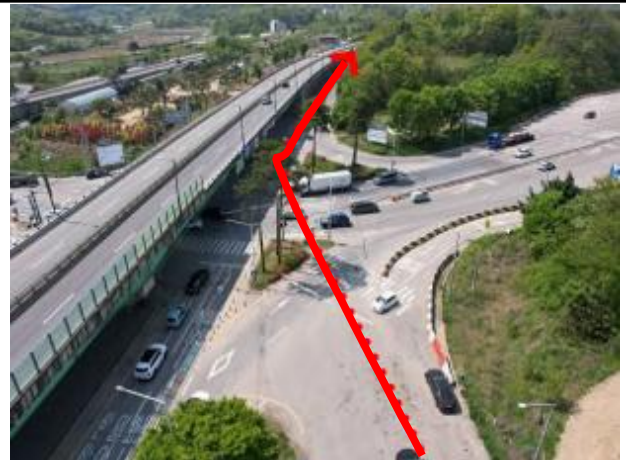
송수계통, 02(02)구간, Sta. No. 34+0.00  
관로노선 현황

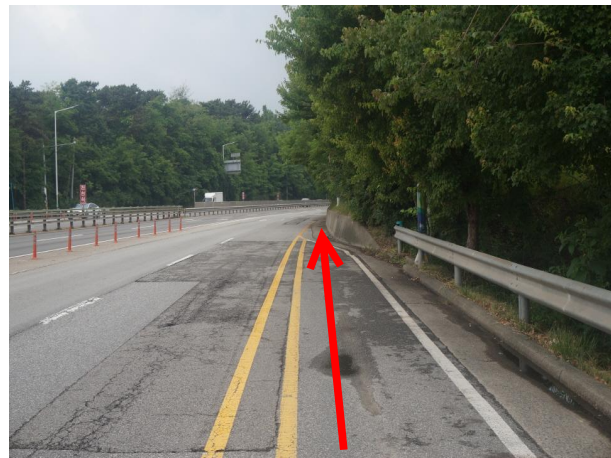
송수계통, 02(02)구간, Sta. No. 45+8.30  
관로노선 현황

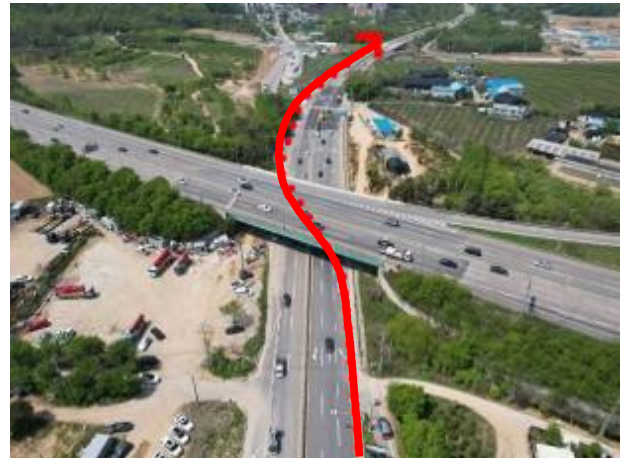
송수계통, 02(03)구간, Sta. No. 55+0.00  
관로노선 현황

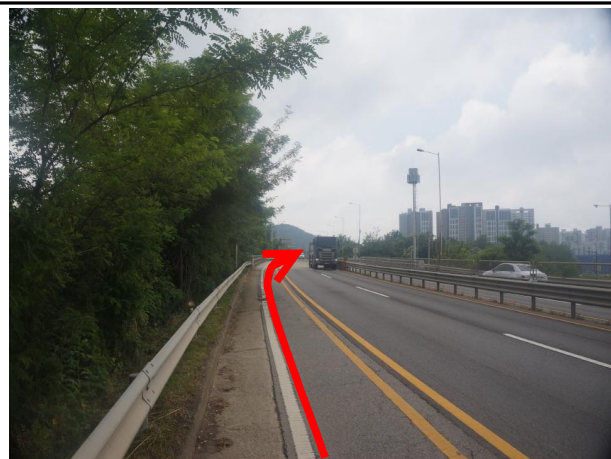
송수계통, 02(03)구간, Sta. No. 65+25.0  
관로노선 현황

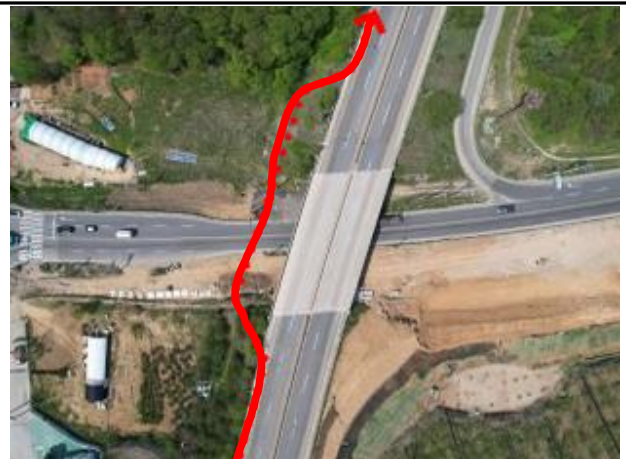
송수계통, 02(03)구간, Sta. No. 66+0.00  
관로노선 현황

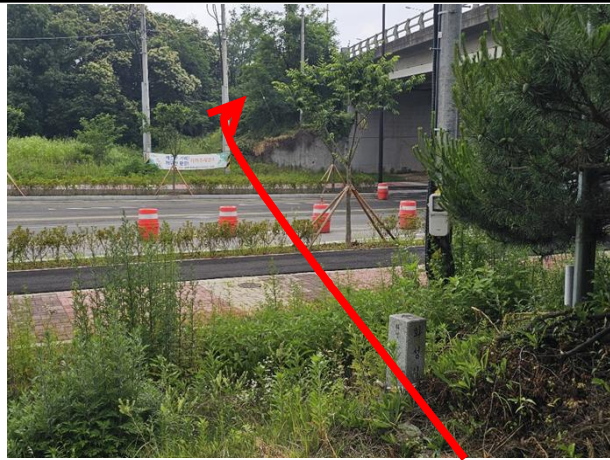
송수계통, 02(03)구간, Sta. No. 66+0.20  
관로노선 현황

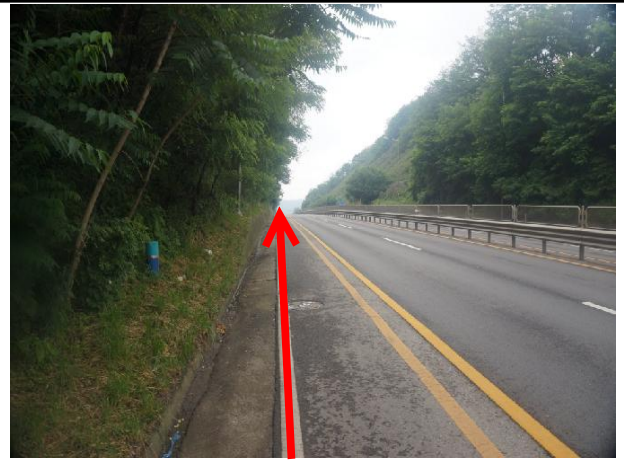
송수계통, 02(03)구간, Sta. No. 84+17.50  
관로노선 현황

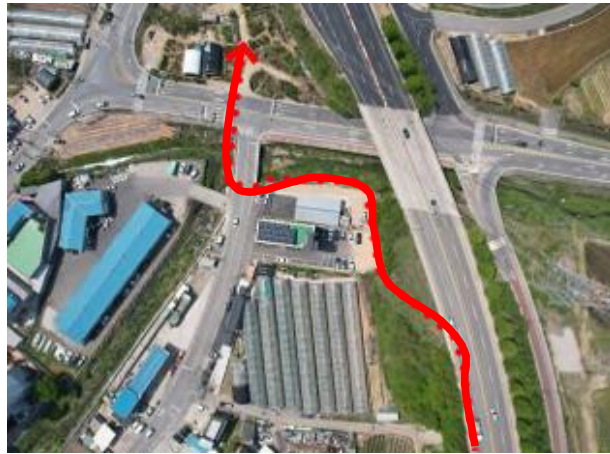
송수계통, 02(04)구간, Sta. No. 104+11.0  
관로노선 현황

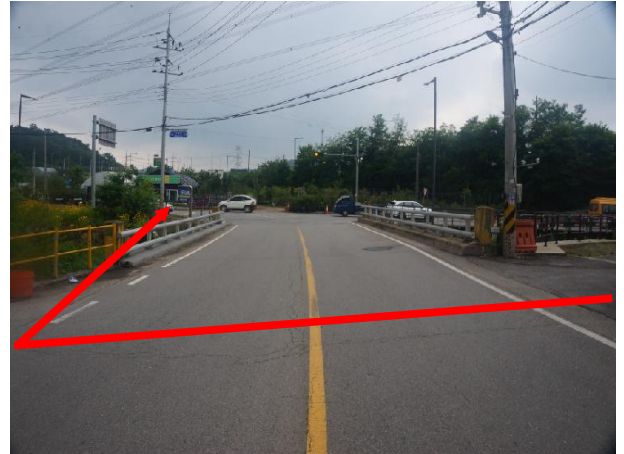
송수계통, 02(04)구간, Sta. No. 104+11.0  
관로노선 현황

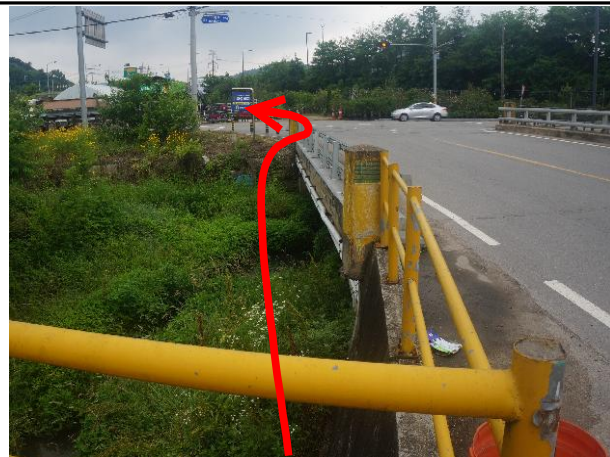
송수계통, 02(04)구간, Sta. No. 104+11.0  
남진천 횡단구간

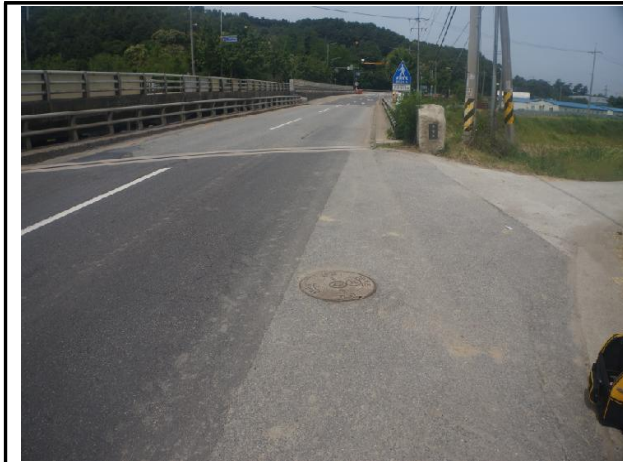
송수계통, 02구간, Sta. No. 1+22.0[A]  
공기밸브 외부 전경

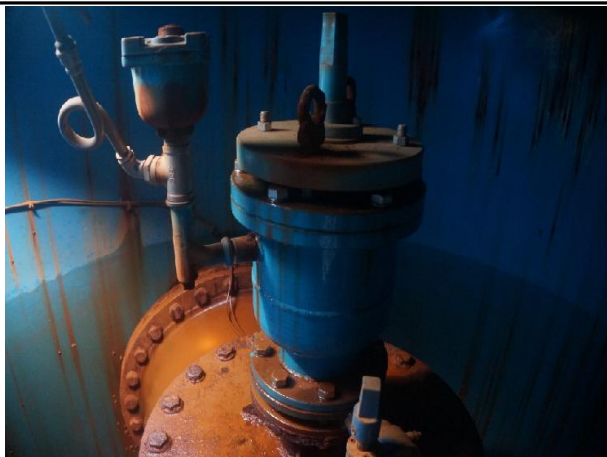
송수계통, 02구간, Sta. No. 1+22.0[A]  
밸브 상태양호

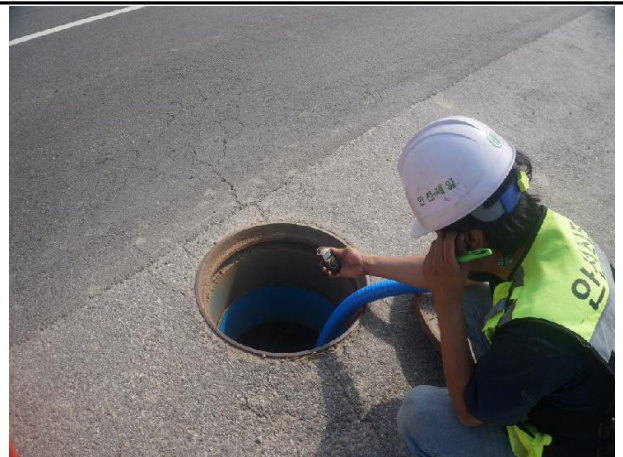
송수계통, 02구간, Sta. No. 1+22.0[A]  
유해가스농도 측정

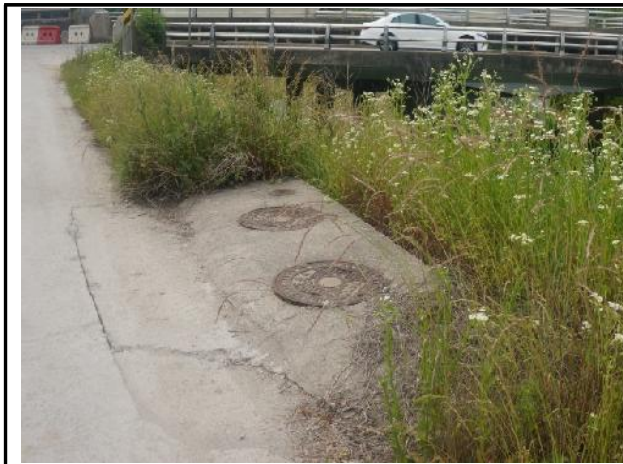
송수계통, 02구간, Sta. No. 2.+17.0[D]  
이토밸브 외부 전경

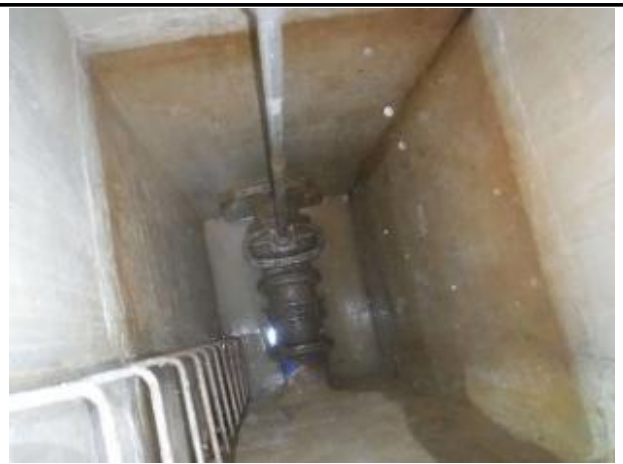
송수계통, 02구간, Sta. No. 2.+17.0[D]  
이토밸브 내부 전경

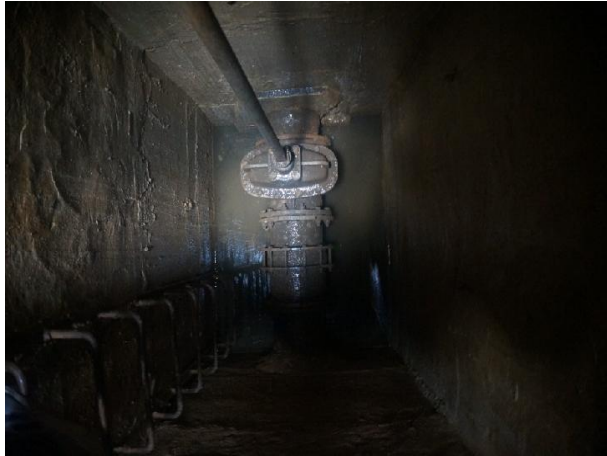
송수계통, 02구간, Sta. No. 2.+17.0[D]  
배관 및 밸브 상태 양호

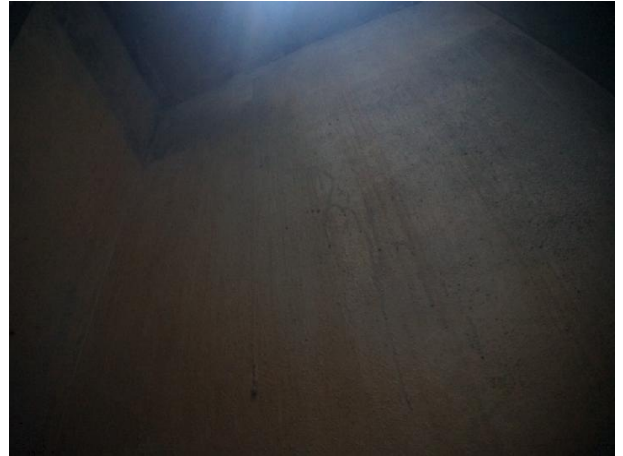
송수계통, 02구간, Sta. No. 2.+17.0[D]  
구조물 상태양호

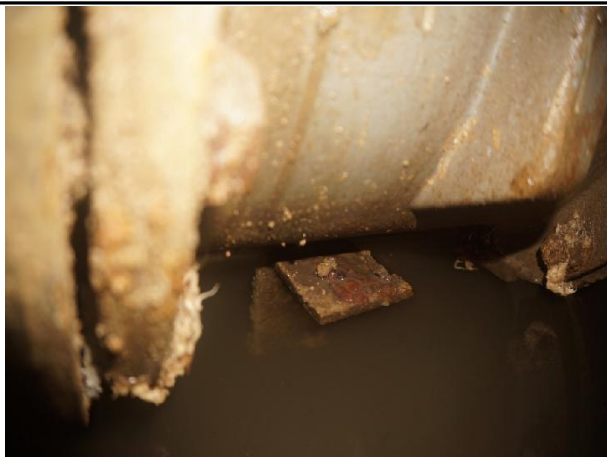
송수계통, 02구간, Sta. No. 2.+17.0[D]  
받침콘크리트 미설치

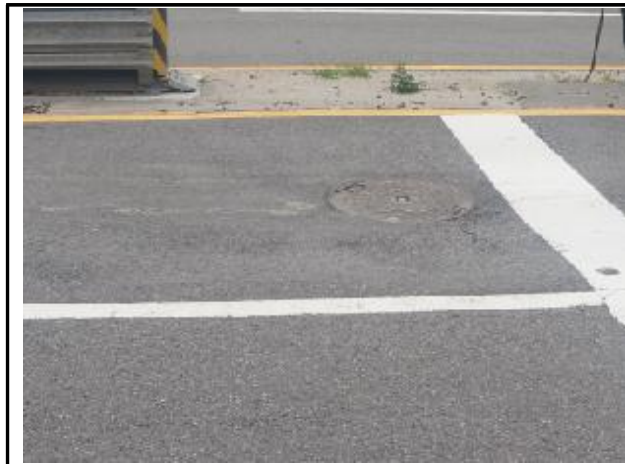
송수계통, 02구간, Sta. No. 15+3.7[A]  
공기밸브실 외부 전경

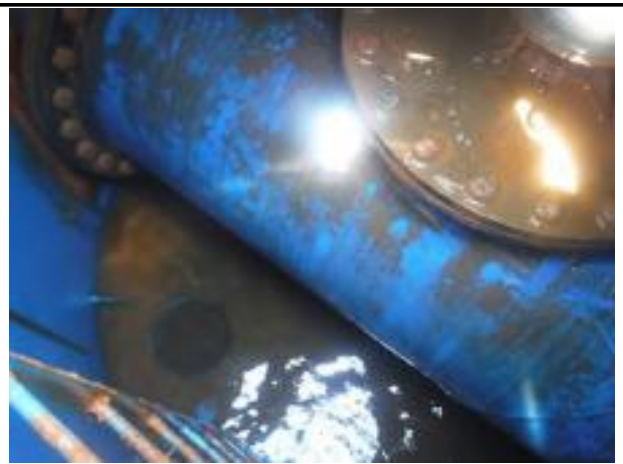
송수계통, 02구간, Sta. No. 15+3.7[A]  
공기밸브실 내부 전경

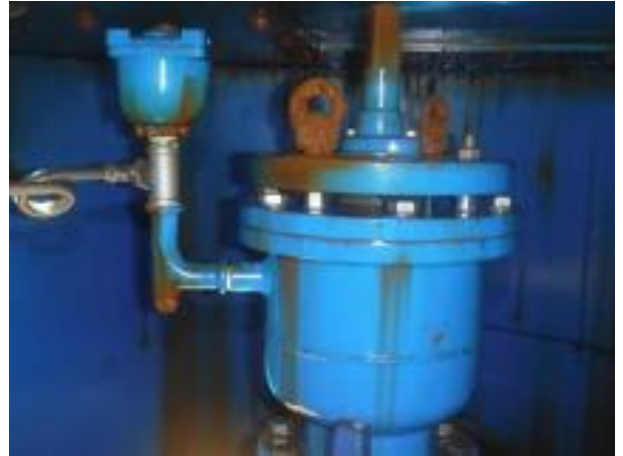
송수계통, 02구간, Sta. No. 15+3.7[A]  
밸브 상태양호

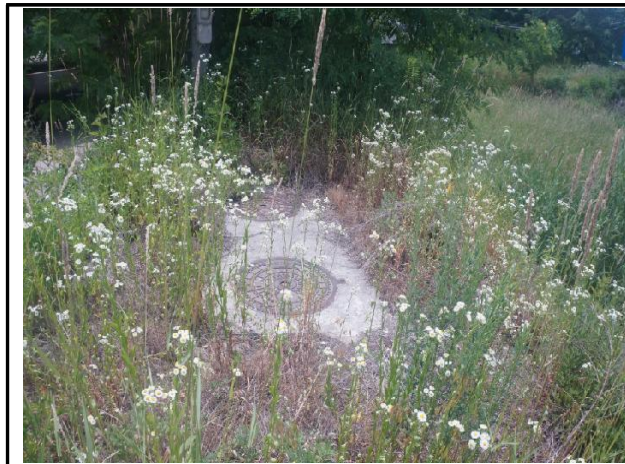
송수계통, 02구간, Sta. No. 31+18.6[D]  
이토밸브실 외부 전경

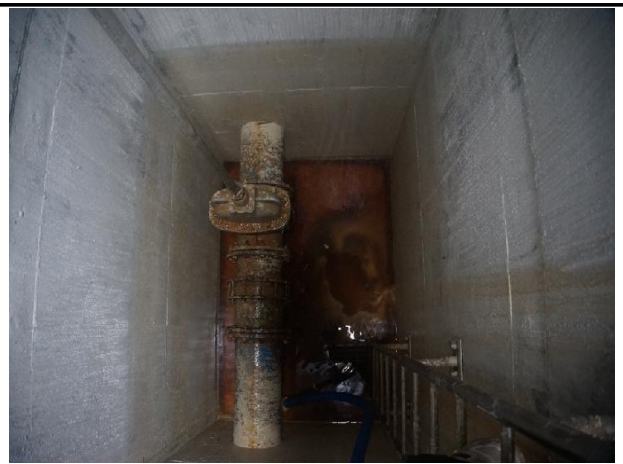
송수계통, 02구간, Sta. No. 31+18.6[D]  
이토밸브실 내부 전경

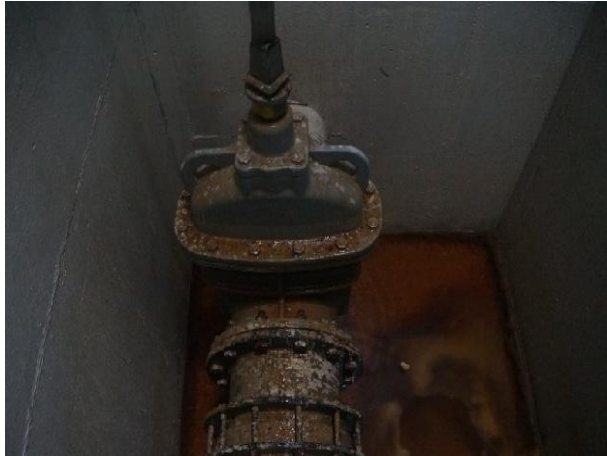
송수계통, 02구간, Sta. No. 31+18.6[D]  
배관 및 밸브 상태양호

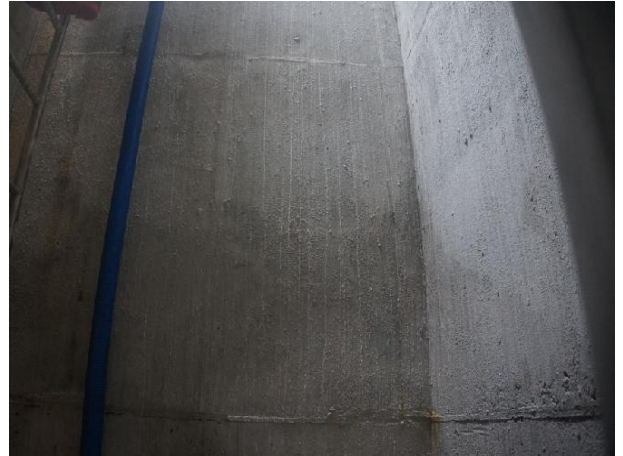
송수계통, 02구간, Sta. No. 31+18.6[D]  
구조물 상태양호

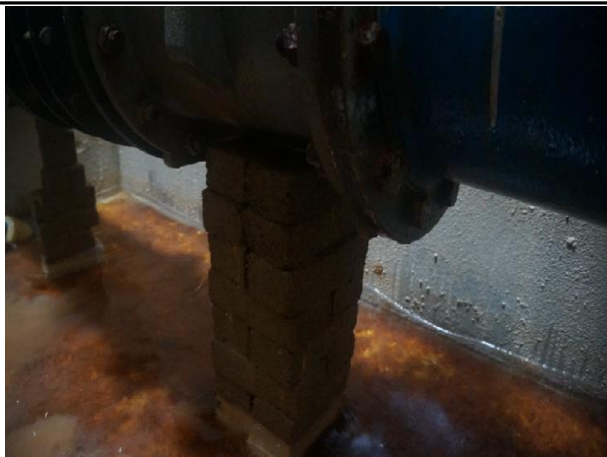
송수계통, 02구간, Sta. No. 31+18.6[D]  
밸브 받침콘크리트 조적시공

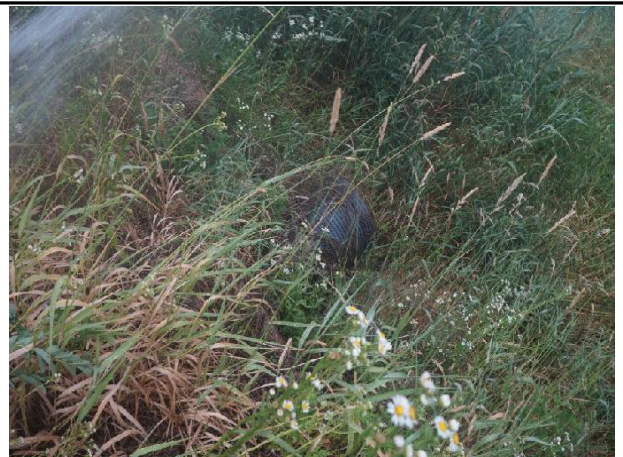
송수계통, 02구간, Sta. No. 31+18.6[D]  
토출구 및 배출수역 상태양호

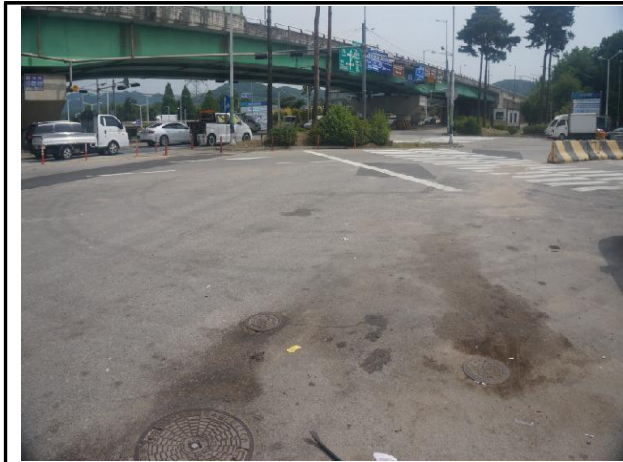
송수계통, 02구간, Sta. No. 34+0.0[M]  
제수밸브실 외부 전경

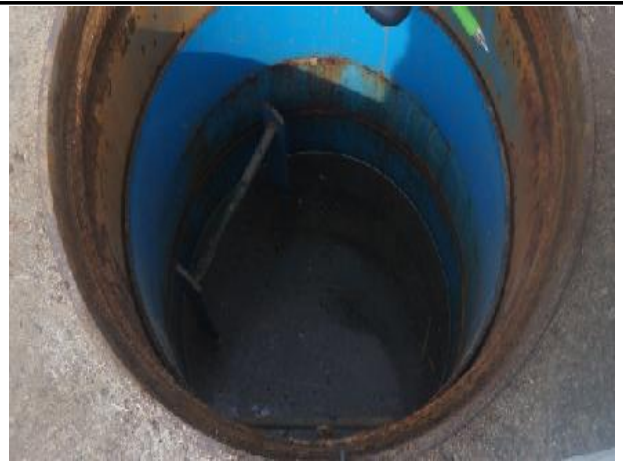
송수계통, 02구간, Sta. No. 34+0.0[M]  
제수밸브실 내부 전경

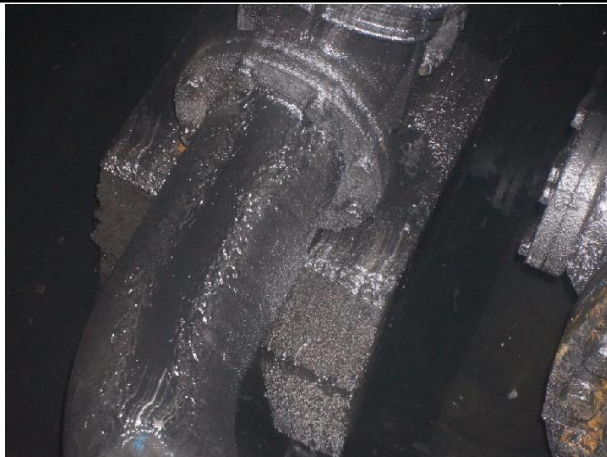
송수계통, 02구간, Sta. No. 34+0.0[M]  
밸브 받침콘크리트 상태양호

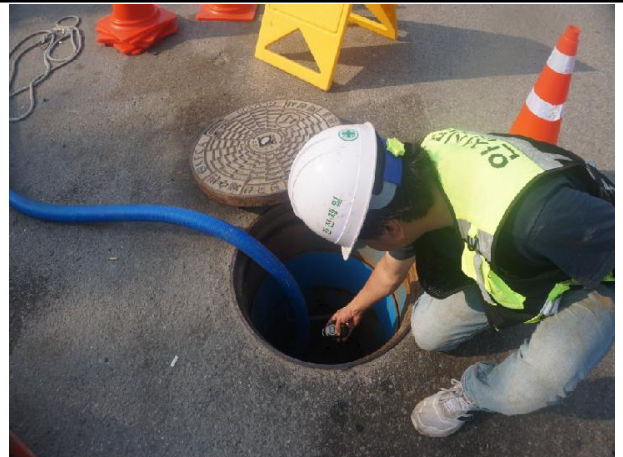
송수계통, 02구간, Sta. No. 34+0.0[M]  
유해가스농도 측정

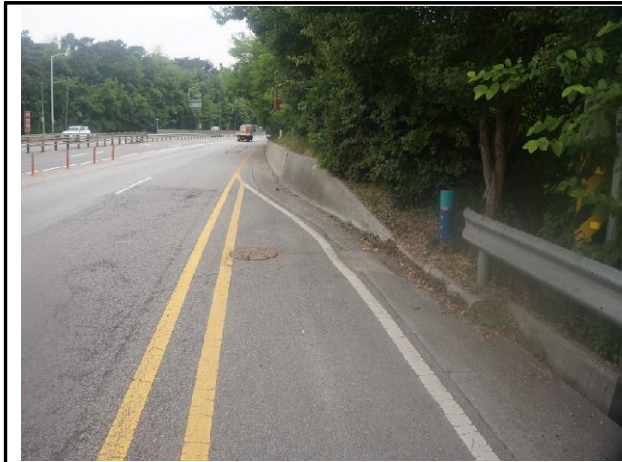
송수계통, 02구간, Sta. No. 45+8.3[A]  
공기밸브실 외부 전경

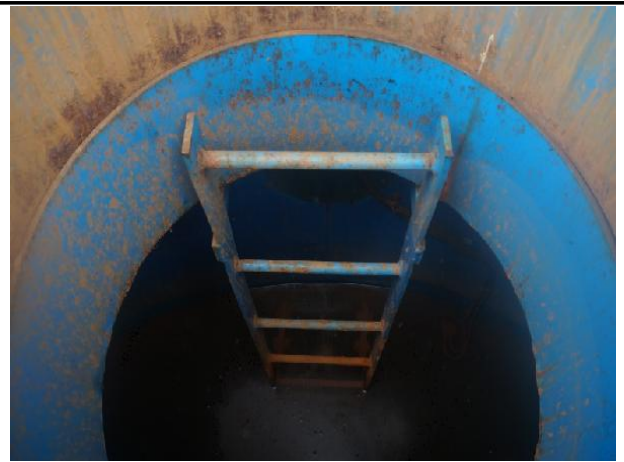
송수계통, 02구간, Sta. No. 45+8.3[A]  
공기밸브실 내부 전경

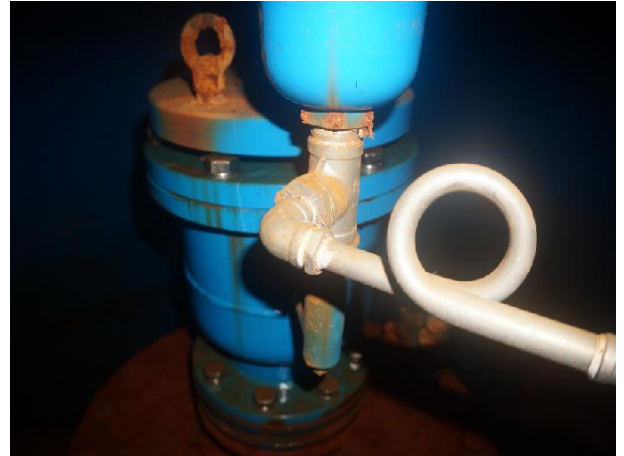
송수계통, 02구간, Sta. No. 45+8.3[A]  
밸브 상태양호

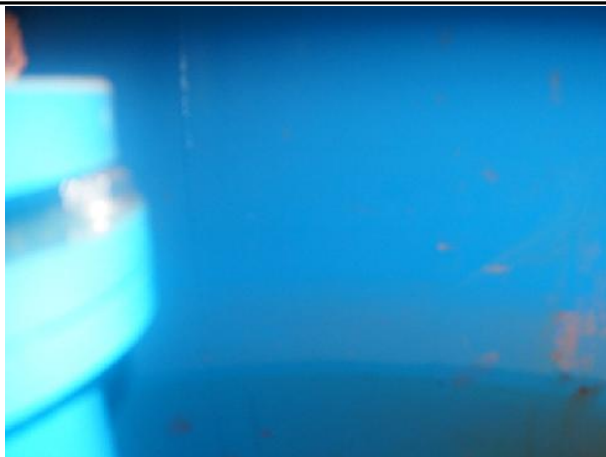
송수계통, 02구간, Sta. No. 45+8.3[A]  
강제구조물 상태양호

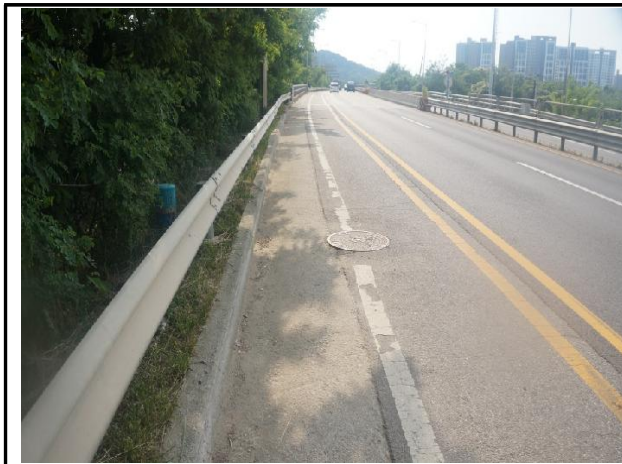
송수계통, 02구간, Sta. No. 65+25.0[A]  
공기밸브실 외부 전경

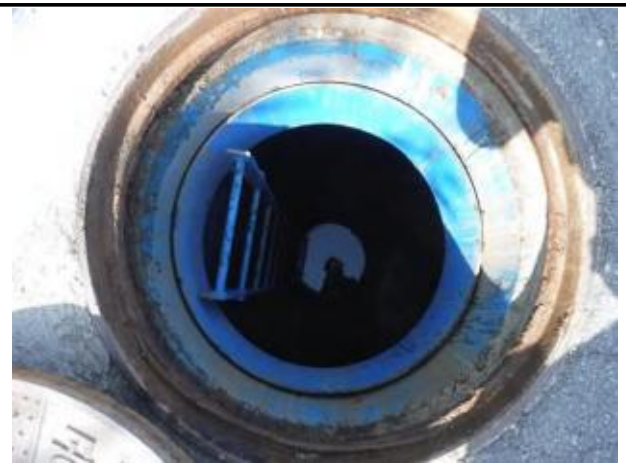
송수계통, 02구간, Sta. No. 65+25.0[A]  
공기밸브실 내부 전경

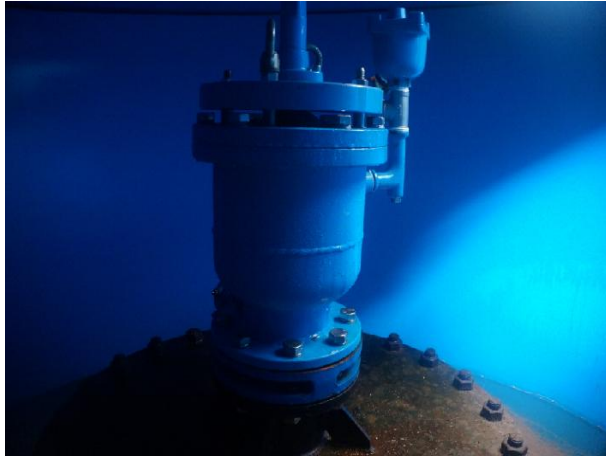
송수계통, 02구간, Sta. No. 65+25.0[A]  
밸브 상태양호

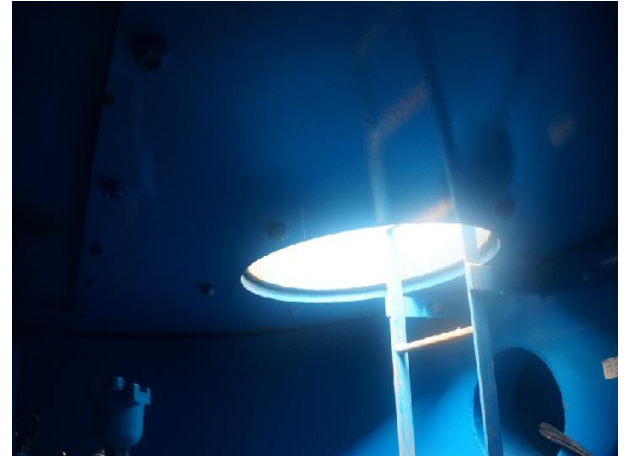
송수계통, 02구간, Sta. No. 65+25.0[A]  
구조물 상태양호

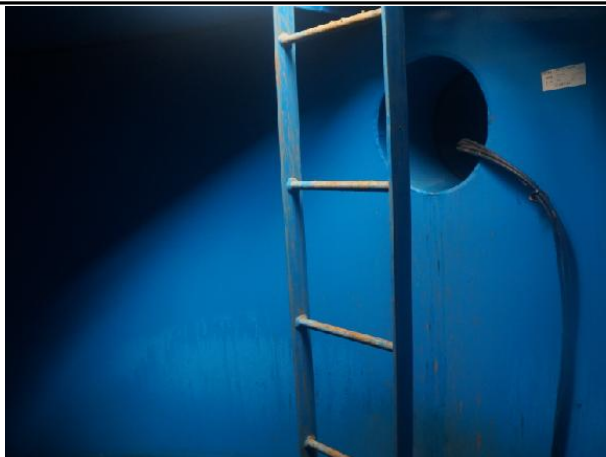
송수계통, 02구간, Sta. No. 65+25.0[A]  
사다리 상태양호

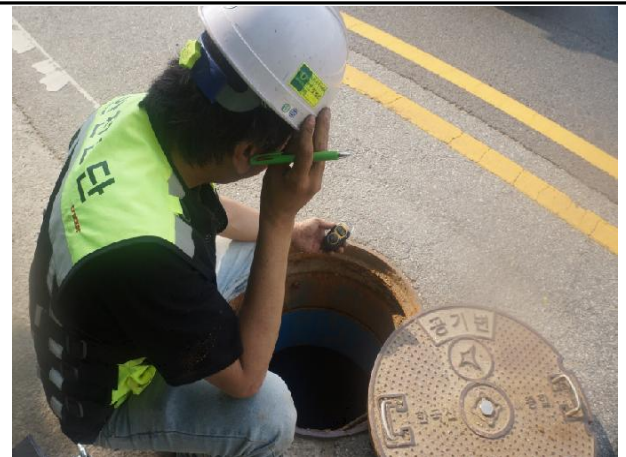
송수계통, 02구간, Sta. No. 65+25.0[A]  
유해가스농도 측정

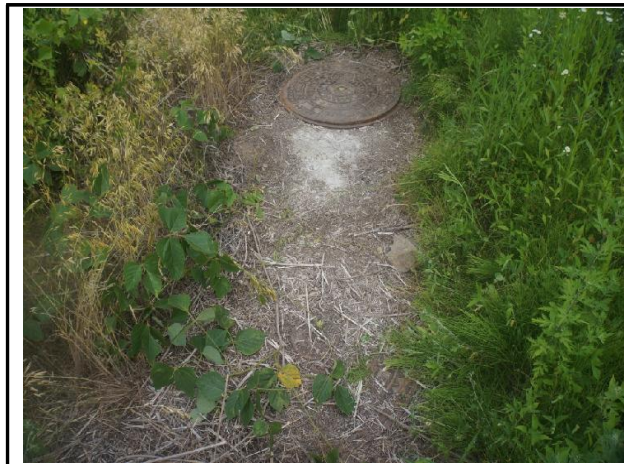
송수계통, 02구간, Sta. No. 67+32.6[D]  
이토밸브실 외부 전경

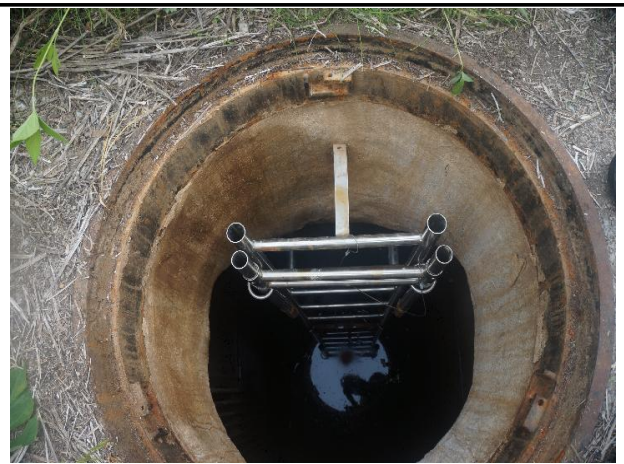
송수계통, 02구간, Sta. No. 67+32.6[D]  
이토밸브실 내부 전경

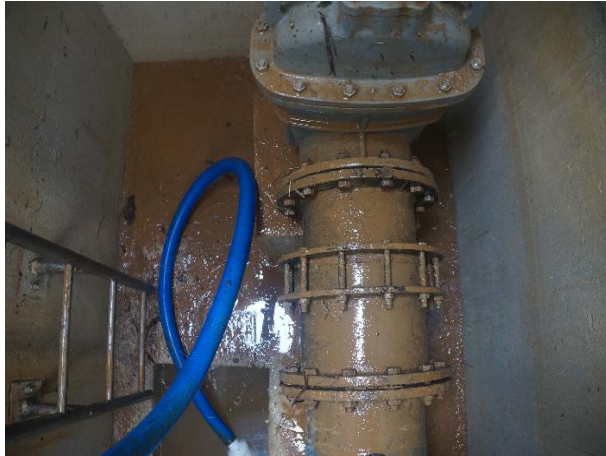
송수계통, 02구간, Sta. No. 67+32.6[D]  
배관 및 밸브 상태양호

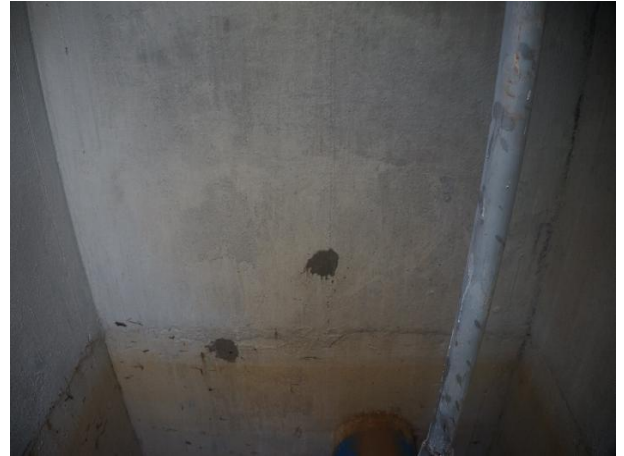
송수계통, 02구간, Sta. No. 67+32.6[D]  
구조물 상태양호

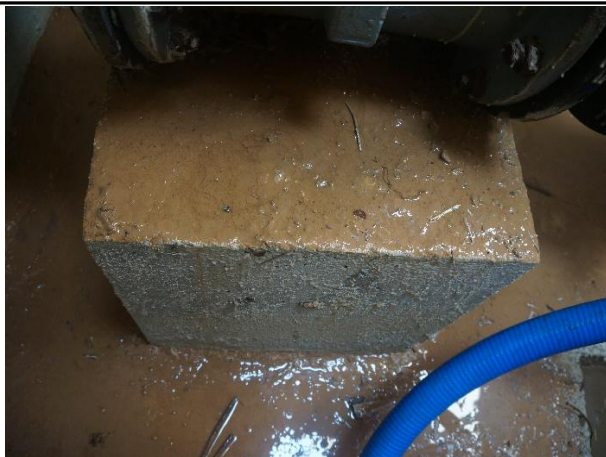
송수계통, 02구간, Sta. No. 67+32.6[D]  
이토밸브실 받침콘크리트 상태양호

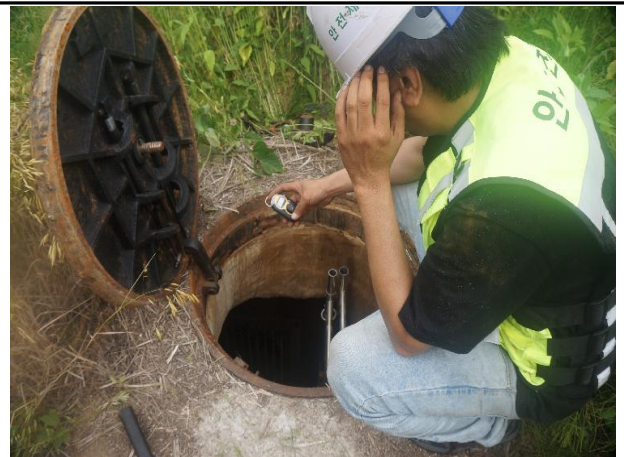
송수계통, 02구간, Sta. No. 67+32.6[D]  
유해가스농도 측정

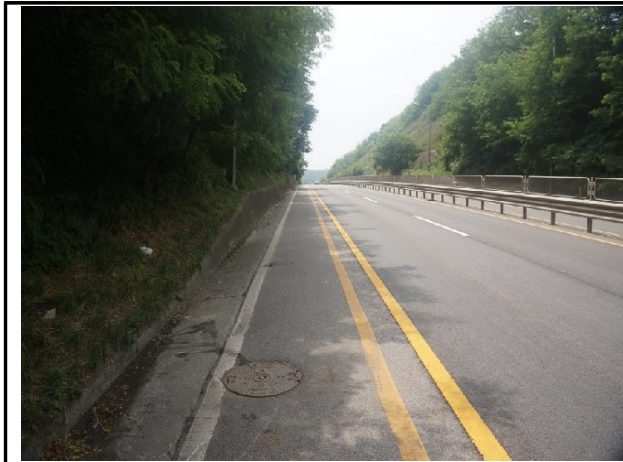
송수계통, 02구간, Sta. No. 84+17.5[A]  
공기밸브실 외부 전경

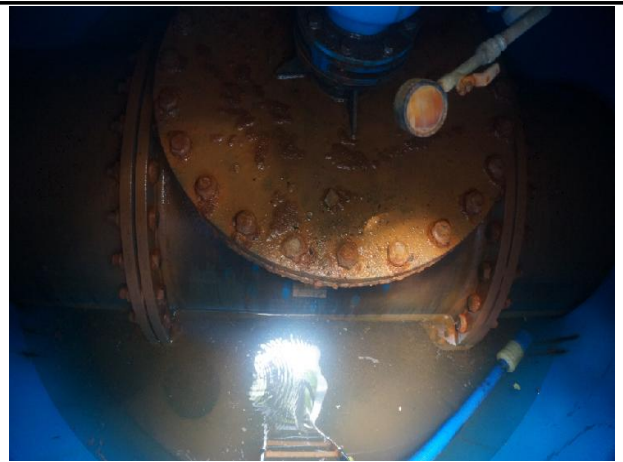
송수계통, 02구간, Sta. No. 84+17.5[A]  
공기밸브실 내부 전경

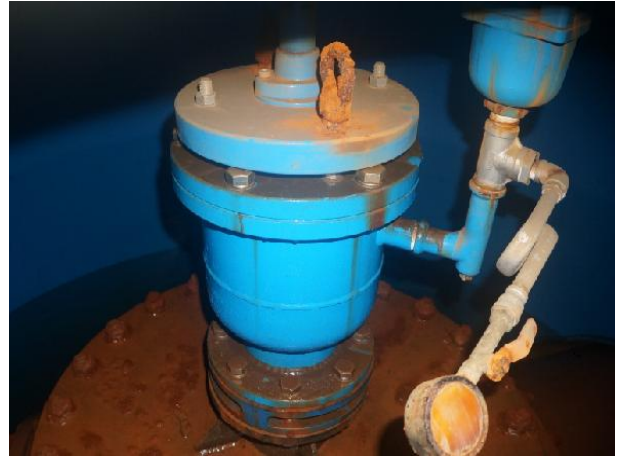
송수계통, 02구간, Sta. No. 84+17.5[A]  
밸브 상태양호

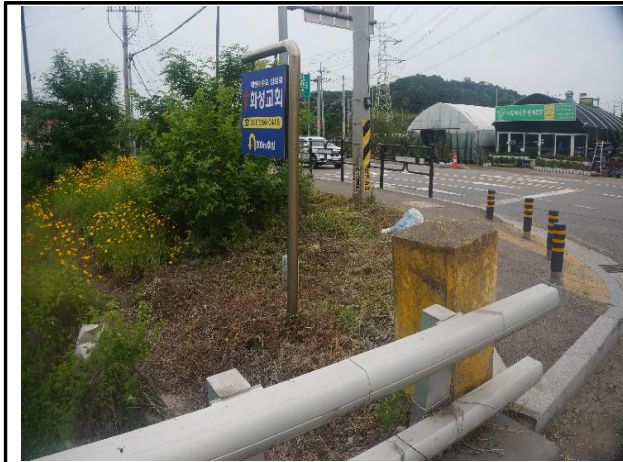
송수계통, 02구간, Sta. No. 108+4.0[D]  
이토밸브실 외부 전경

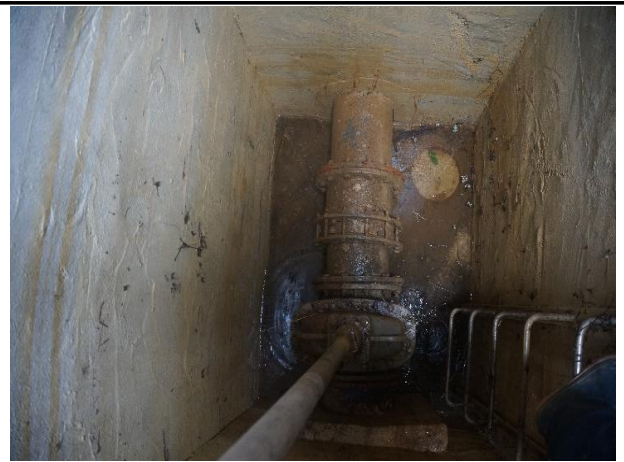
송수계통, 02구간, Sta. No. 108+4.0[D]  
이토밸브실 내부 전경

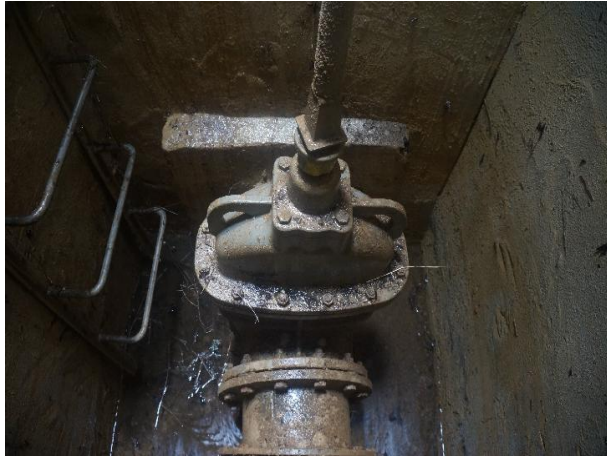
송수계통, 02구간, Sta. No. 108+4.0[D]  
배관 및 밸브 상태양호

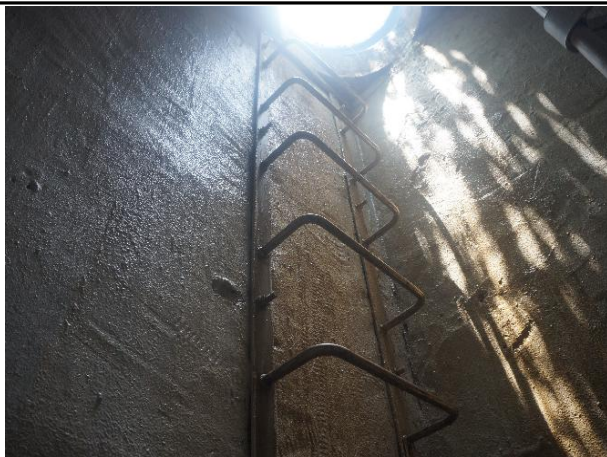
송수계통, 02구간, Sta. No. 108+4.0[D]  
사다리 상태양호

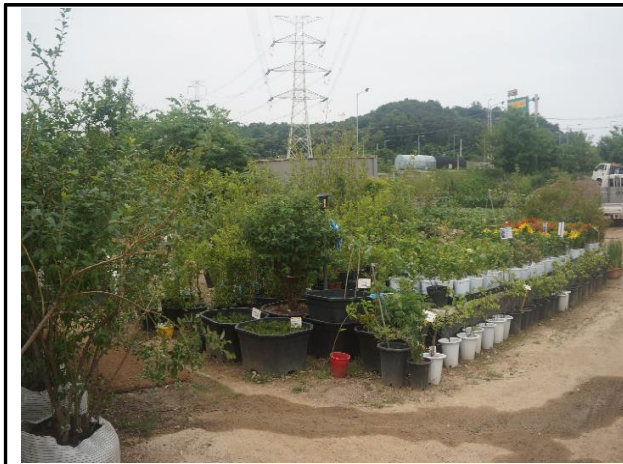
송수계통, 02구간, Sta. No. 109+3.1[Mb]  
제수밸브실 외부 전경

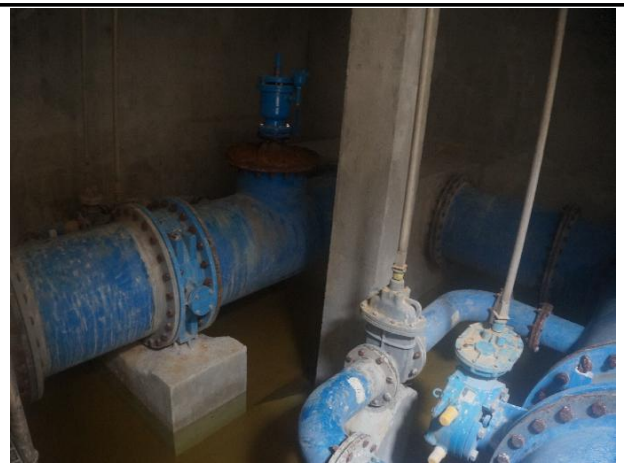
송수계통, 02구간, Sta. No. 109+3.1[Mb]  
제수밸브실 내부 전경

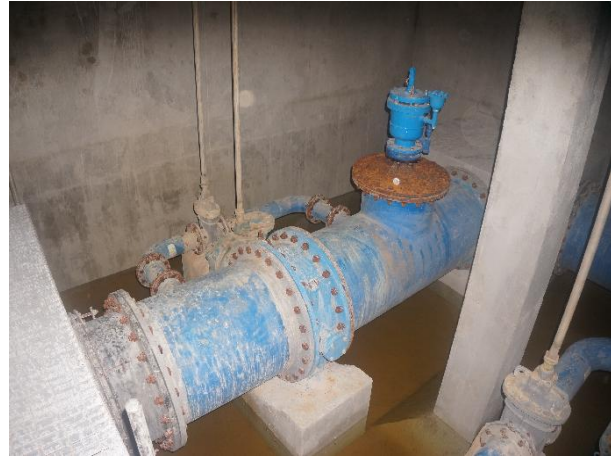
송수계통, 02구간, Sta. No. 109+3.1[Mb]  
배관 및 밸브 상태양호

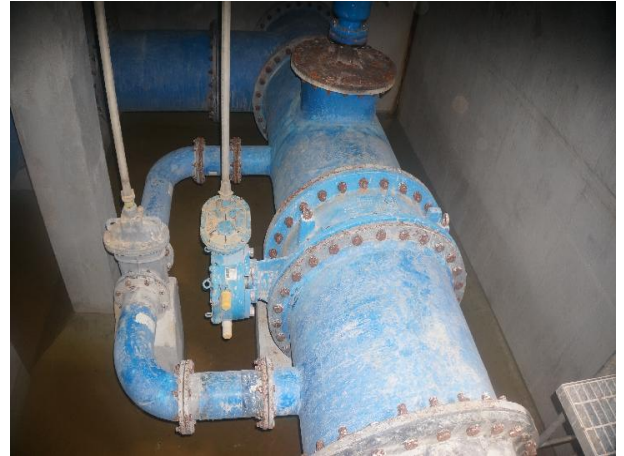
송수계통, 02구간, Sta. No. 109+3.1[Mb]  
부관 및 밸브 상태양호

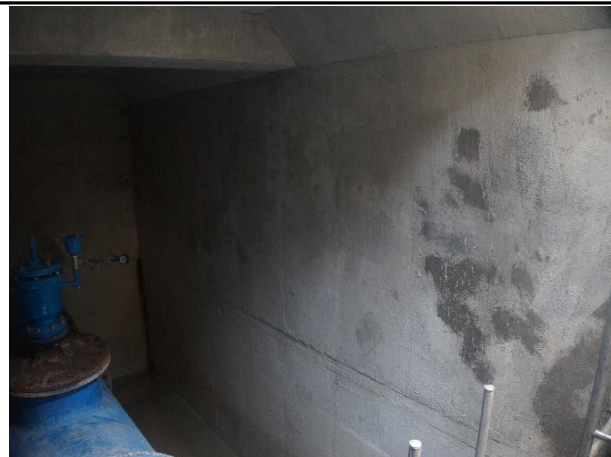
송수계통, 02구간, Sta. No. 109+3.1[Mb]  
구조물 상태양호

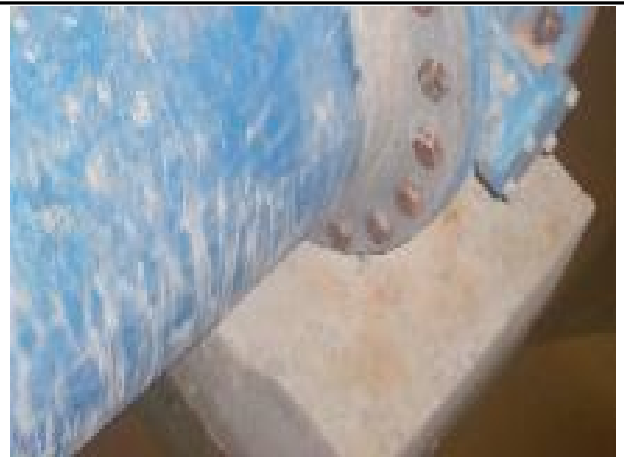
송수계통, 02구간, Sta. No. 109+3.1[Mb]  
받침콘크리트 상태양호

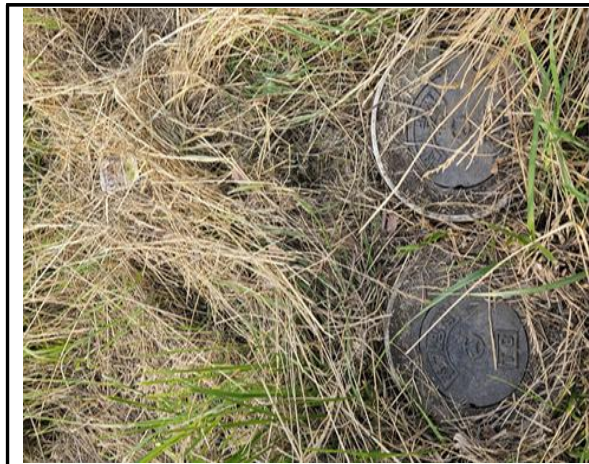
송수계통, 02(01)구간, Sta. No. 1+22.0[A]  
공기밸브실 T/B 전경

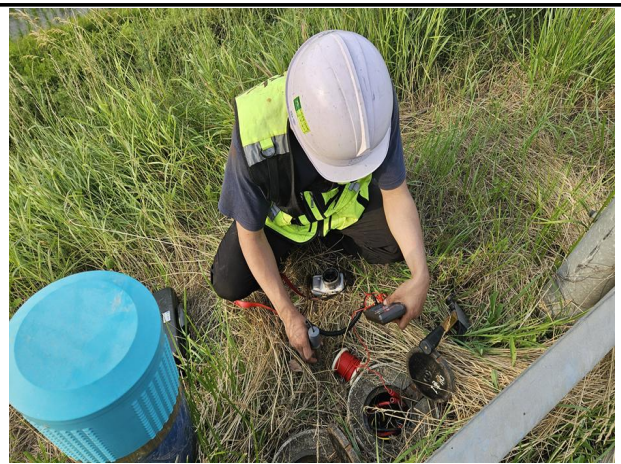
송수계통, 02(01)구간, Sta. No. 1+22.0[A]  
공기밸브실 관대지 전위차 측정

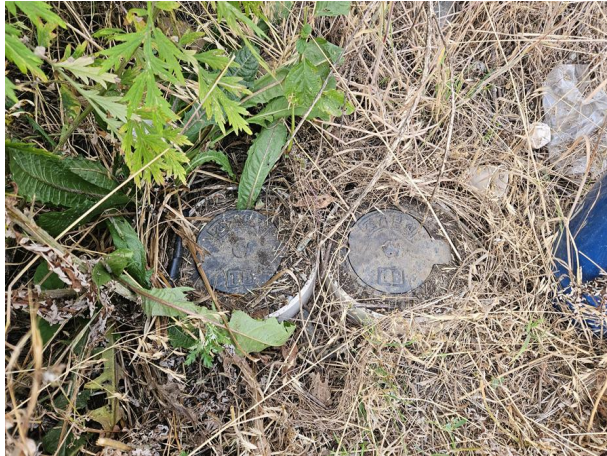
송수계통, 02(01)구간, Sta. No. 15+3.7[A]  
공기밸브실 T/B 전경

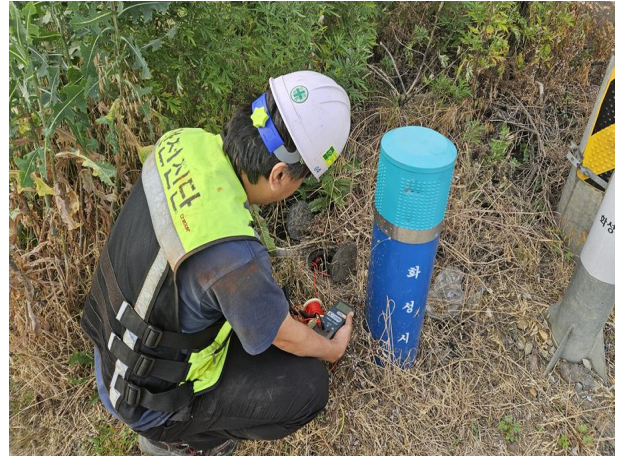
송수계통, 02(01)구간, Sta. No. 15+3.7[A]  
공기밸브실 관대지 전위차 측정

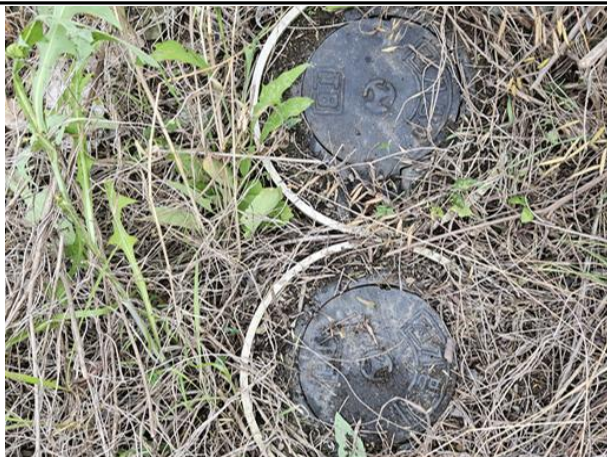
송수계통, 02(02)구간, Sta. No.34+0.0[M]  
제수밸브실 T/B 전경

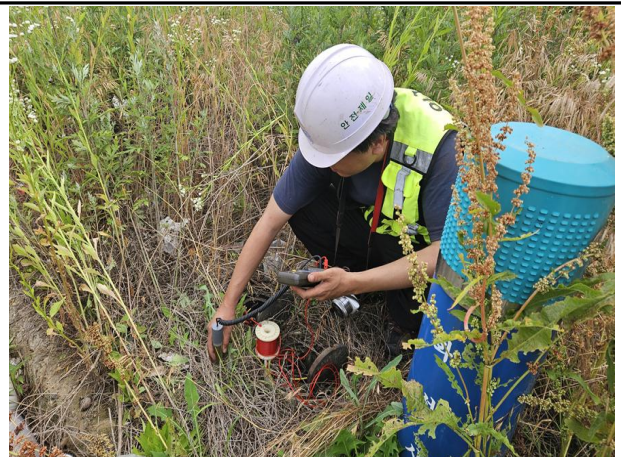
송수계통, 02(02)구간, Sta. No.34+0.0[M]  
제수밸브실 관대지 전위차 측정

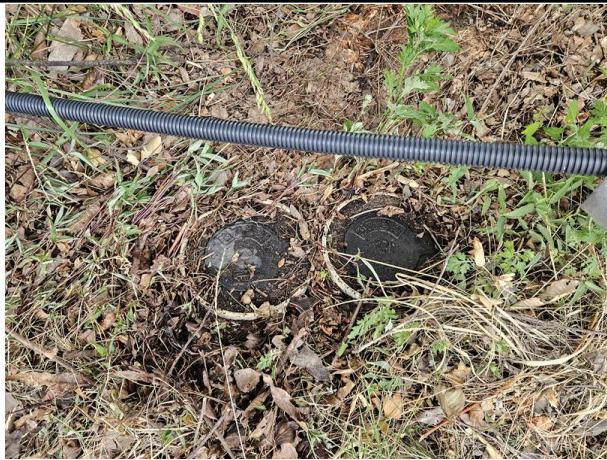
송수계통, 02(03)구간, Sta. No. 45+8.3[A]  
공기밸브실 T/B 전경

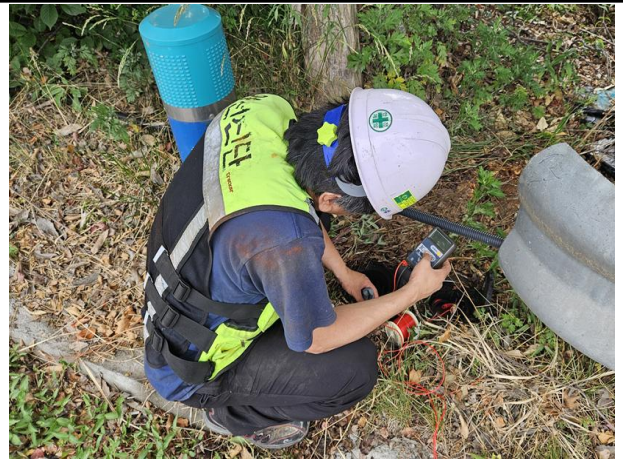
송수계통, 02(03)구간, Sta. No. 45+8.3[A]  
공기밸브실 관대지 전위차 측정

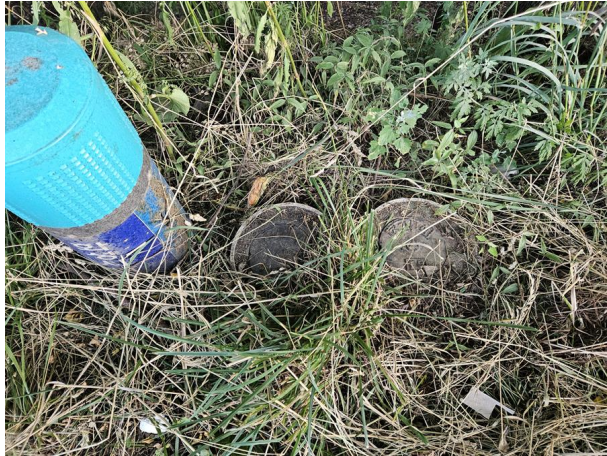
송수계통, 02(03)구간, Sta. No. 67+25.0[A]  
공기밸브실 T/B 전경

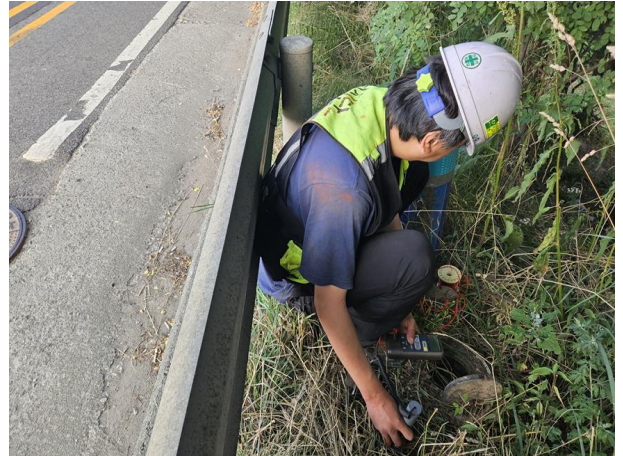
송수계통, 02(03)구간, Sta. No. 67+25.0[A]  
공기밸브실 관대지 전위차 측정

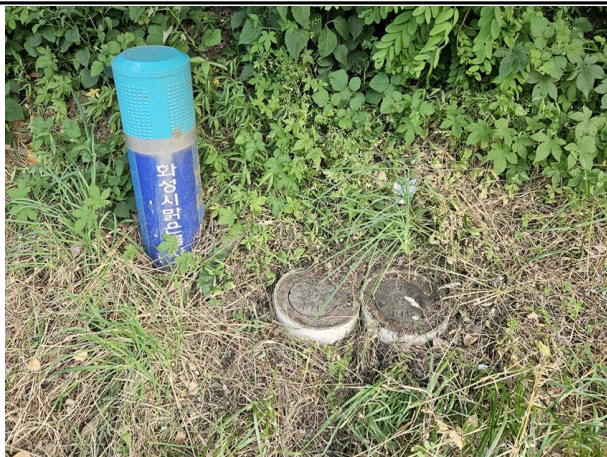
송수계통, 02(03)구간, Sta. No.84+17.5[A]  
공기밸브실 T/B 전경

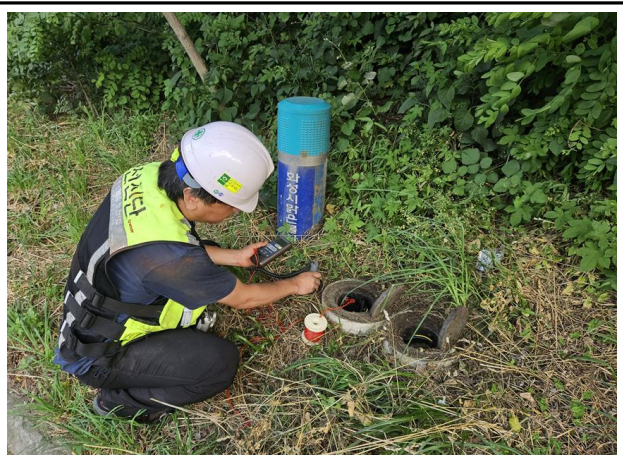
송수계통, 02(03)구간, Sta. No.84+17.5[A]  
공기밸브실 관대지 전위차 측정
