## 9. 서문9교(서울방향)

## 손상현황 사진

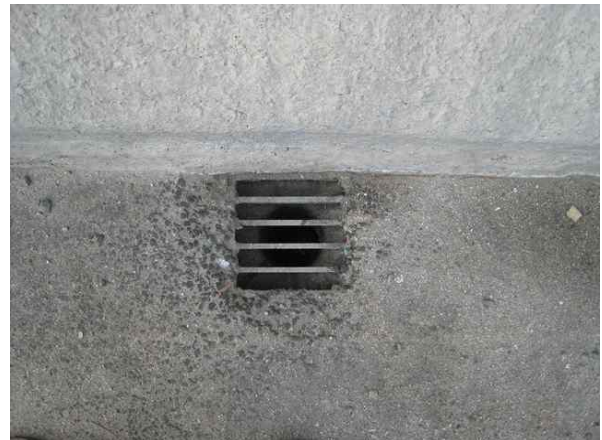
배수구 상태 양호

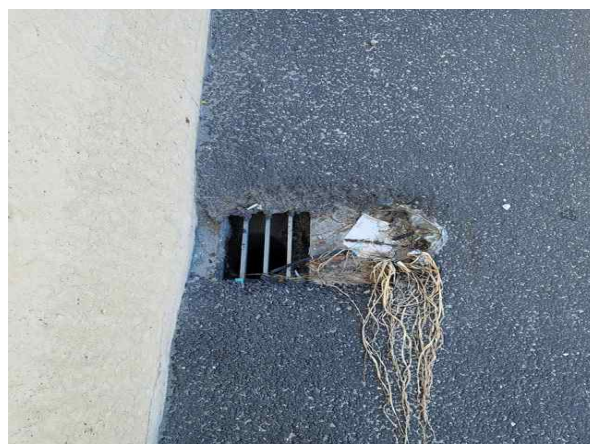
배수구 상태 양호

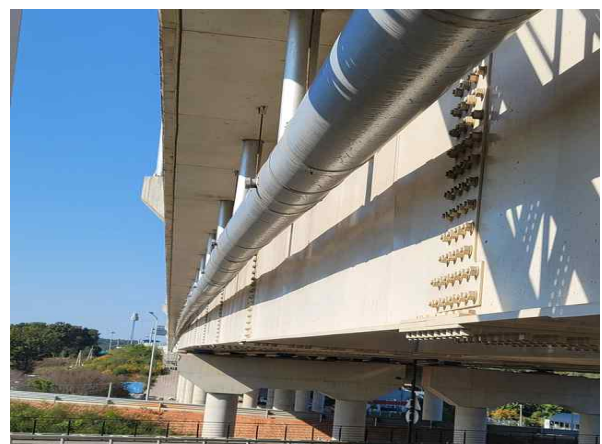
배수구 상태 양호 - 금회
