범안대교

## 범안대교

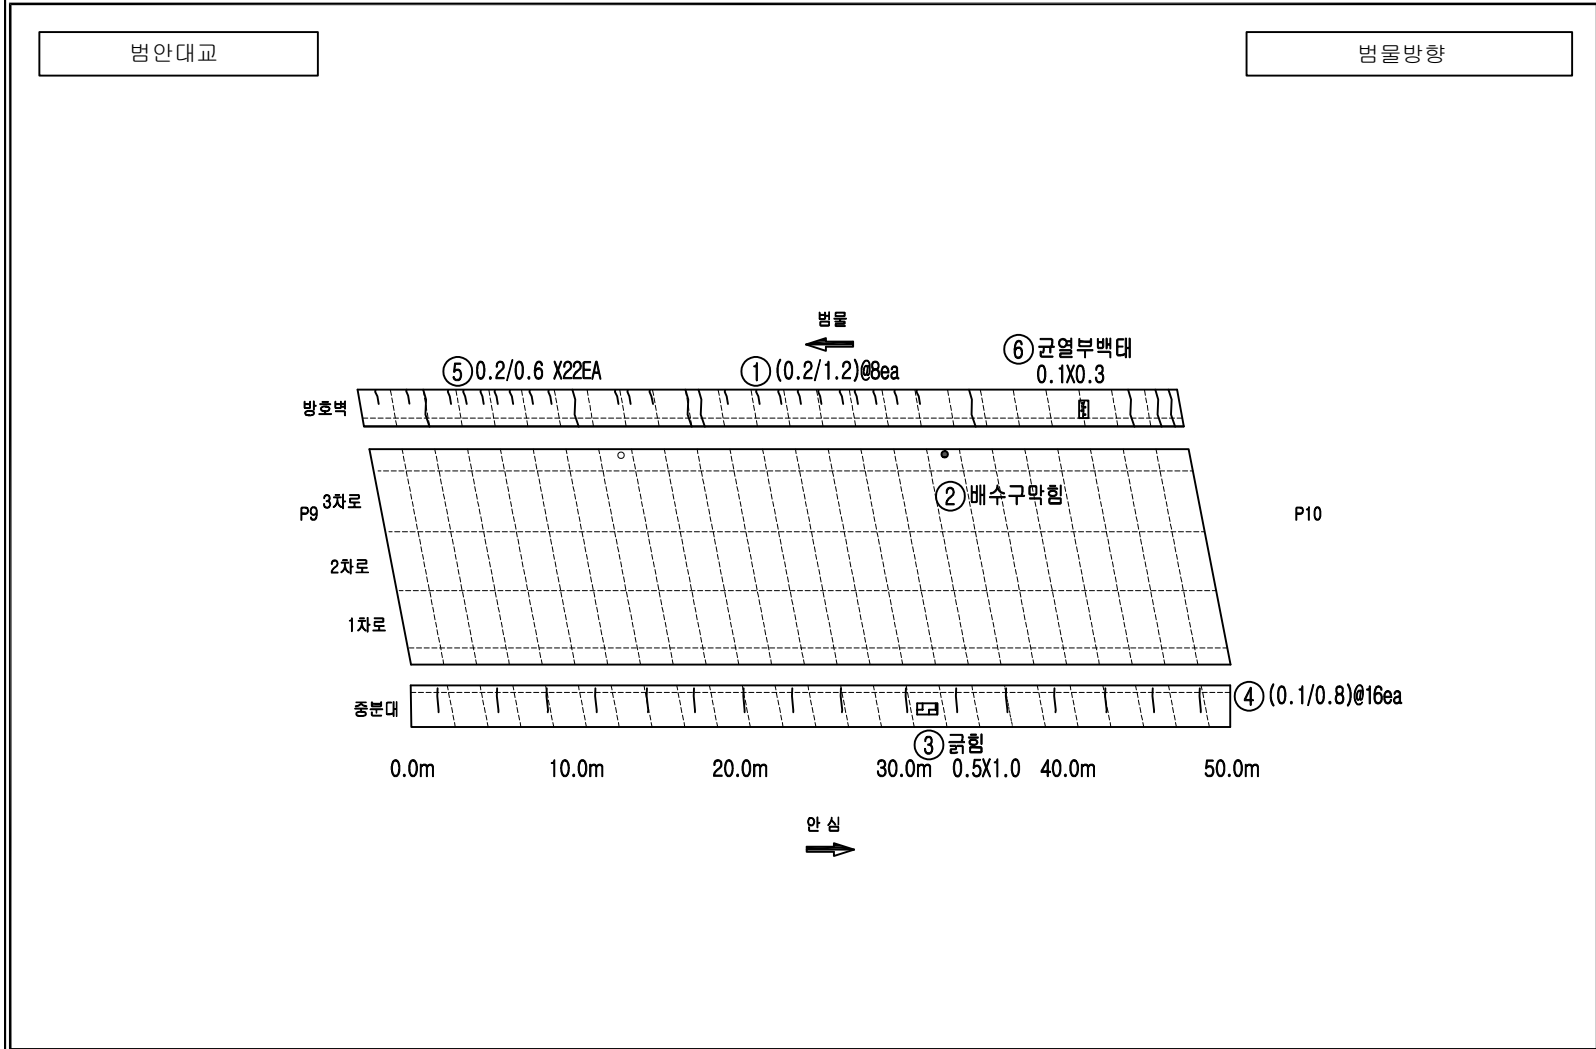
손상물량표

| 번호 | 위치 | 손상내용 | 손상물량 | | | | | 보수보강방안 |
|---|---|---|---|---|---|---|---|---|
| 1 | 방호벽 | 균열 | 0.2 | 1.2 | 8 | m | 9.6 | 주의관찰 |
| 3 | 중분대 | 균열 | 0.5 | 1.0 | 1 | m | 0.5 | 주의관찰 |
| 4 | 중분대 | 균열 | 0.1 | 0.8 | 16 | m | 12.8 | 주의관찰 |
| 5 | 방호벽 | 균열 | 0.2 | 0.6 | 22 | m | 13.2 | 신규 |
| 6 | 방호벽 | 균열부백대 | 0.1 | 0.3 | 1 | m | 0.03 | 신규 |

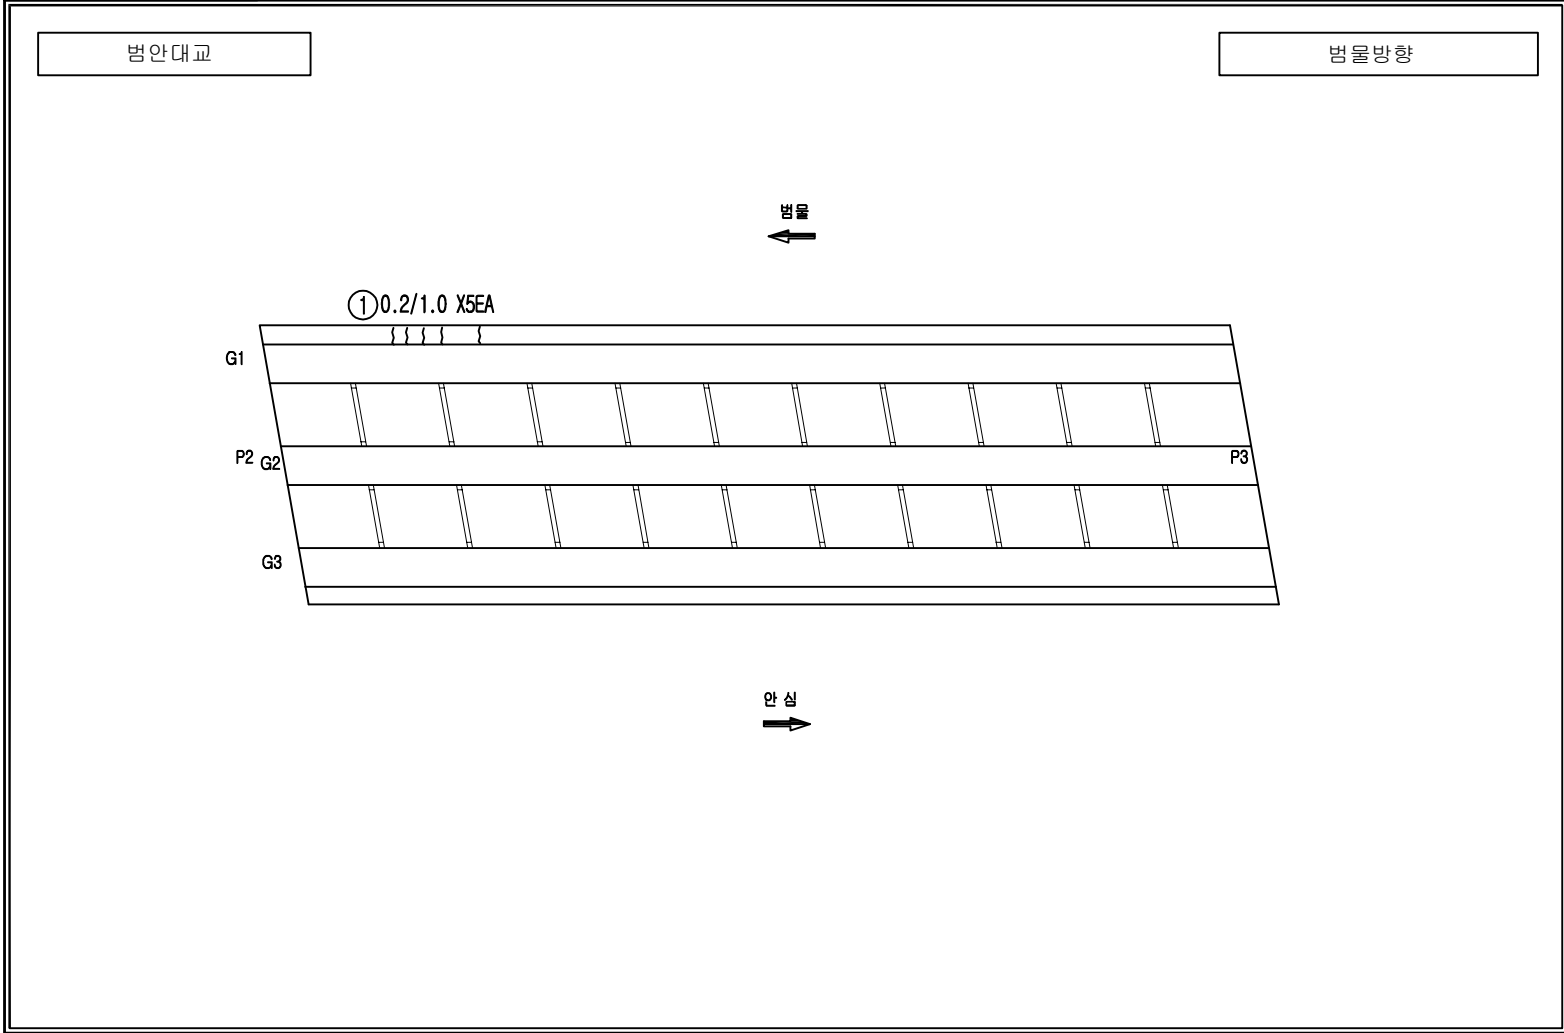
### 손상물량표

| 번호 | 위치 | 손상내용 | 손상물량 | | | | | 보수보강방안 |
|---|---|---|---|---|---|---|---|---|
| 1 | 바닥판 하면 | 균열 | 0.2 | 1.0 | 5 | m | 5.0 | 신규 |
