# 여의도공동구 (의사당로A)

2019년 공동구 정밀점검용역 (여의도공동구)

의사당로 A 전력구 외관조사망도

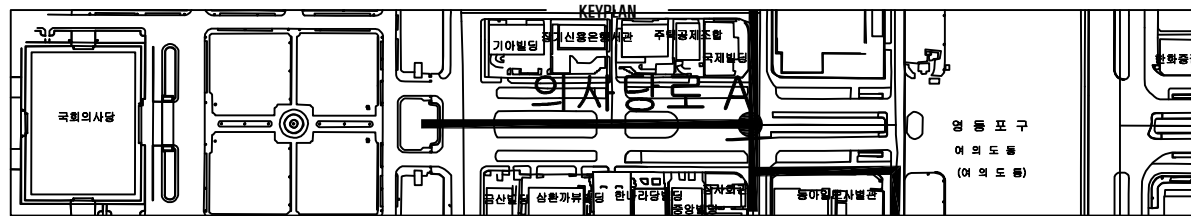
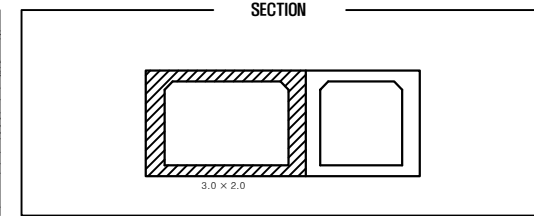
# 여의도 공동구 - 의사당로 A 전력구 (STA. 0+020 m ~ 0+040m)

| 연번 | 연도 | 행위내용 | 정밀검역 | | | | | 최종보수내역 | | 비고 |
|---|---|---|---|---|---|---|---|---|---|---|
| 3 | 2017 | 철근노출 | 0.1 | 0.10 | 0.02 | m | 2 | | - | 중요 |
| 8 | 2015 | 보수부 관설 | 0.2 | 2.10 | 2.10 | m | 1 | | - | 재결합 |
| 17 | 2017 | 철근노출 | 0.3 | 0.40 | 0.12 | m | 1 | | - | 중요 |

| 연번 | 연도 | 행위내용 | 정밀검역 | | | | | 최종보수내역 | | 비고 |
|---|---|---|---|---|---|---|---|---|---|---|
| 9 | 2015 | 보수부 관설 | 0.5 | 2.80 | 2.80 | m | 1 | 2016 주입보수공법 | 3.36 | |
| 11 | 2015 | 보수부 관설 | 0.4 | 3.20 | 3.20 | m | 1 | 2016 주입보수공법 | 3.84 | |
| 15 | 2015 | 관설 | 0.4 | 4.00 | 4.00 | m | 1 | 2016 주입보수공법 | 4.80 | |
| 16 | 2015 | 보수부 관설 | 0.5 | 3.10 | 3.10 | m | 1 | 2016 주입보수공법 | 3.72 | |

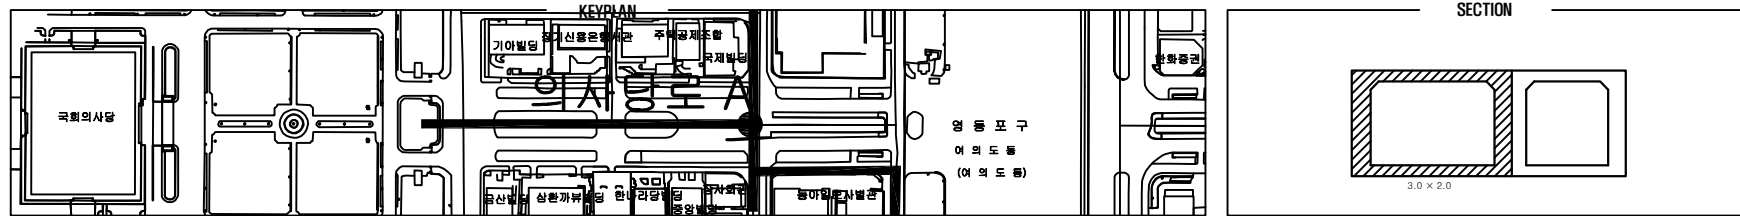
# 여의도 공동구 - 의사당로 A 전력구 (STA. 0+100 m ~ 0+120m)

| 연번 | 연도 | 행위내용 | 결함구도 | | | | 최종보수내역 | | 비고 |
|---|---|---|---|---|---|---|---|---|---|
| 9 | 2013 | 균열 | 0.3 | 2.00 | 2.00 | m | 1 | | 중요 |
| 12 | 2017 | 철근노출 | 0.1 | 0.40 | 0.04 | m | 1 | | 중요 |
| 13 | 2017 | 철근노출 | 0.1 | 0.20 | 0.12 | m | 6 | | 중요 |

| 연번 | 연도 | 행위내용 | 결함구도 | | | | 최종보수내역 | | 비고 |
|---|---|---|---|---|---|---|---|---|---|
| 8 | 2015 | 균열 | 0.3 | 15.00 | 15.00 | m | 1 | 주입보수공법 | 18.00 |
| 11 | 2015 | 철근노출 | 0.1 | 0.10 | 0.01 | m | 1 | 단면복귀방정 | 0.01 |

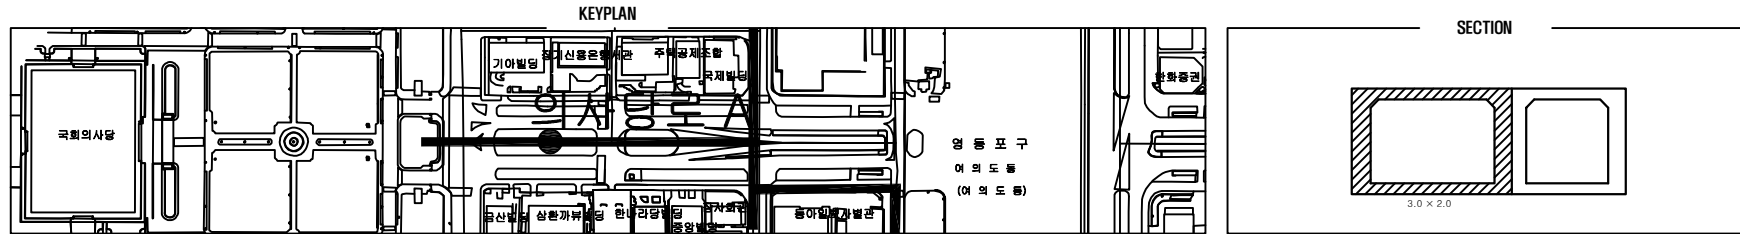
# 여의도 공동구 - 의사당로 A 전력구 (STA. 0+280 m ~ 0+300 m)

| 연번 | 연도 | 행위내용 | 정밀구분 | | | | 최종보수내역 | | | | 비고 |
|---|---|---|---|---|---|---|---|---|---|---|---|
| 4 | 2015 | 누수흔적 | 0.2 | 0.20 | m | 1 | | | | - | |
| 5 | 2015 | 누수흔적 | 0.3 | 1.50 | m | 1 | | | | - | |
| 8 | 2015 | 누수(면상) 백태 | 0.1 | 2.00 | m | 1 | | | | - | |

| 연번 | 연도 | 행위내용 | 정밀구분 | | | | 최종보수내역 | | | | 비고 |
|---|---|---|---|---|---|---|---|---|---|---|---|
| 9 | 2015 | 보수부 누수 백태 | 0.1 | 1.00 | m | 1 | 2016 | 누수보수공법 | 0.12 | | |
