# 여의도공동구 (순환선)

2019년 공동구 정밀점검용역 (여의도공동구)

순환선 전력구 외관조사망도

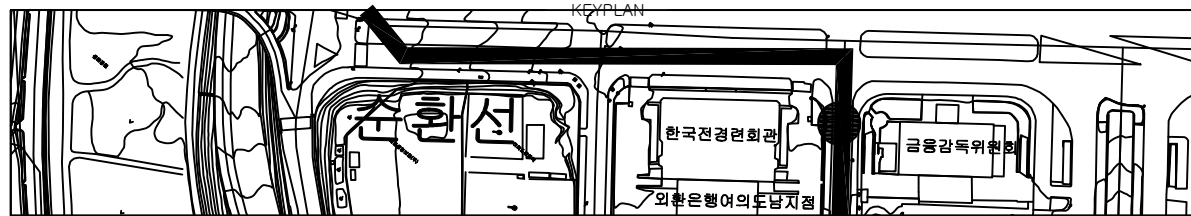
# 여의도 공동구 - 순환선 전력구 (STA. 0+980m ~ 1+000m)

| 연번 | 연도 | 발생내용 | 결함구분 | | | | | 최종보수내역 | | 비고 | |
|---|---|---|---|---|---|---|---|---|---|---|---|
| 1 | 2007 | 배출림 | 25.0 | 1.00 | | 50.00 | m | 2 | | - | |
| 2 | 2015 | 벽막 | 0.3 | 0.60 | | 0.18 | m | 1 | 2018 | 단면복구공법 | 0.22 |
| 3 | 2017 | 유도배수관 누수 | | 3.00 | | 3.00 | m | 1 | | - | |
| 4 | 2017 | 채수 | 0.7 | 2.00 | | 1.40 | m | 1 | | - | |
| 5 | 2017 | 누수 | | | | 1.40 | m | 1 | 2017 | 누수보수공법 | 1.68 |

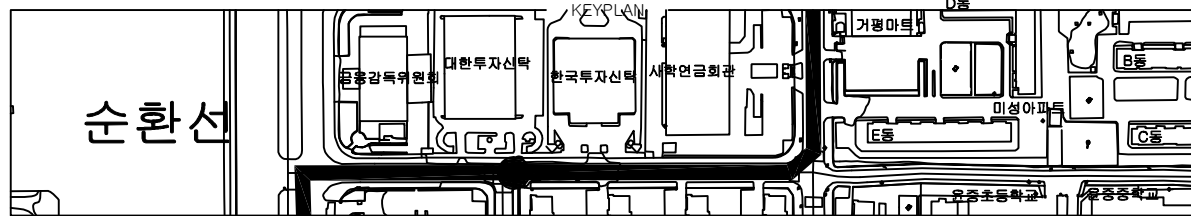
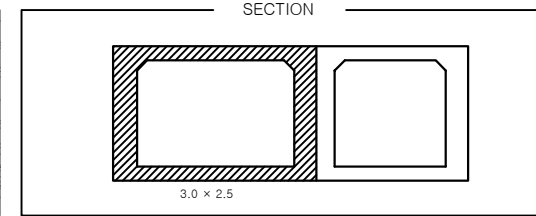
# 여의도 공동구 - 순환선 전력구 (STA. 1+100m ~ 1+120m)

| 연번 | 연도 | 발생내용 | 발생구분 | | | | | 최종보수내역 | | |
|---|---|---|---|---|---|---|---|---|---|---|
| 1 | 2011 | 균열 | 0.2 | 2.30 | 2.30 | m | 1 | | - | |
| 2 | 2011 | 균열 | 0.2 | 2.30 | 2.30 | m | 1 | | - | |
| 3 | 2011 | 균열 | 0.2 | 2.50 | 2.50 | m | 1 | | - | |
| 4 | 2019 | 침하 | 0.1 | 3.00 | 0.30 | m | 1 | | - | 신규 |

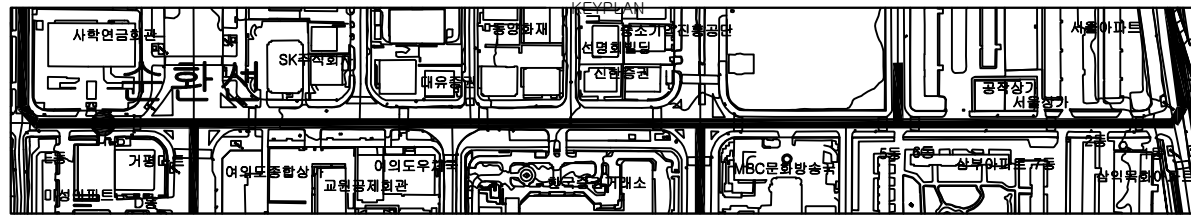
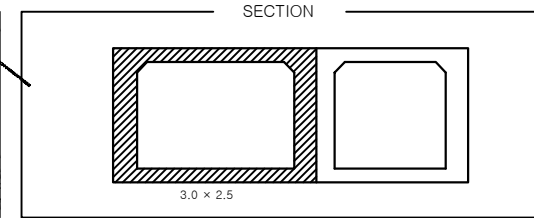
# 여의도 공동구 - 순환선 전력구 (STA. 1+420 m ~ 1+440 m)

| 연도 | 구분 | 구분 | 구분 | | | | 구분 | | 비고 |
|---|---|---|---|---|---|---|---|---|---|
| 1 | 2007 | 구분 | 0.2 | 1.40 | 1.40 | m | 1 | | - |
| 2 | 2007 | 구분 | 0.2 | 0.80 | 0.80 | m | 1 | | - |
| 3 | 2015 | 누수, 벽면 | 1.8 | 1.20 | 2.16 | m | 1 | 2016 | 누수보수공법 |
| 4 | 2015 | 누수, 벽면 | 0.8 | 0.70 | 0.42 | m | 1 | 2016 | 누수보수공법 |
| 5 | 2015 | 누수, 벽면 | 0.4 | 1.00 | 0.40 | m | 1 | 2016 | 누수보수공법 |
| 6 | 2017 | 보수부 벽면 | 1.8 | 1.20 | 2.16 | m | 1 | 2016 | 누수보수공법 |

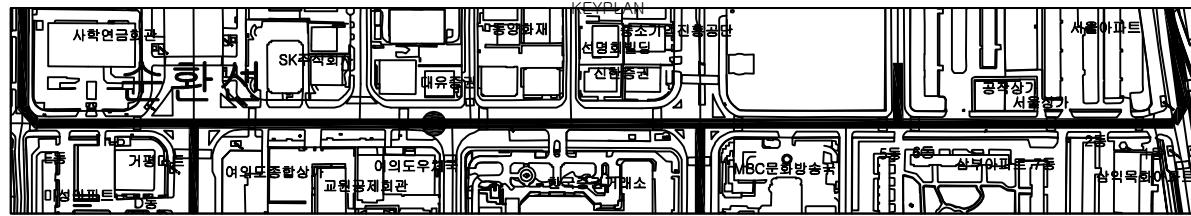
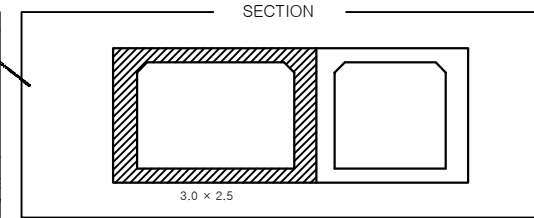
# 여의도 공동구 - 순환선 전력구 (STA. 1+720m ~ 1+740m)

| 연번 | 연도 | 발생내용 | 원인구분 | | | | 최종보수내역 | | 비고 |
|---|---|---|---|---|---|---|---|---|---|
| 1 | 2013 | 유도배수관 누수(선상) | 1.00 | 1.00 | m | 1 | 1 | 2017 | 누수보수공법 |
| 2 | 2013 | 누수, 백태 | 0.3 | 0.80 | | 1 | 1 | 2017 | 누수보수공법 |
| 3 | 2015 | 누수, 백태 | 0.3 | 2.50 | | 1 | 1 | 2017 | 누수보수공법 |
| 4 | 2015 | 누수(면상), 백태 | 0.7 | 2.50 | | 1 | 1 | 2017 | 누수보수공법 |
| 5 | 2017 | 누수 | | | | 2.01 | 1 | 2017 | 누수보수공법 |
| 6 | 2017 | 누수 | | 0.97 | | 1 | 1 | 2017 | 누수보수공법 |
| 7 | 2019 | 유도배수관 누수(선상) | 3.00 | 3.00 | m | 1 | 1 | 2017 | 누수보수공법 |

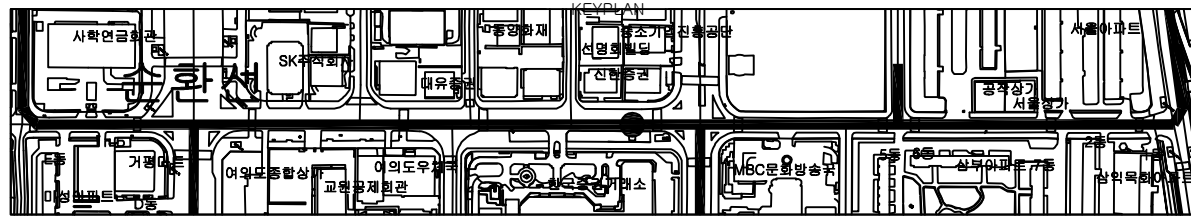
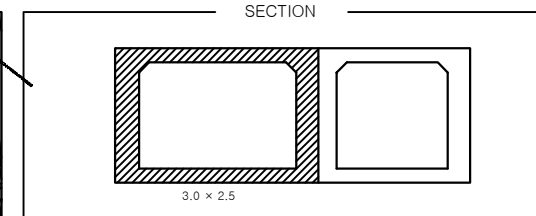
# 여의도 공동구 - 순환선 전력구 (STA. 1+900m ~ 1+920m)

| 연번 | 연도 | 발생내용 | 원형규모 | | | | 최종보수내역 | | 비고 |
|---|---|---|---|---|---|---|---|---|---|
| 1 | 2011 | 관주변누수 | 0.2 | 1.40 | 2.00 | EA | 2 | - | - |
| 2 | 2007 | 균열 | 0.2 | 1.40 | 1.40 | m | 1 | - | - |
| 3 | 2013 | 제수 | 1.5 | 3.00 | 4.50 | m | 1 | - | - |
| 4 | 2015 | 보수부 누수(연식) | 1.0 | 2.00 | 2.00 | m | 1 | - | 재결합 |
| 5 | 2017 | 보수부 누수(연식) | 2.0 | 2.00 | 4.00 | m | 1 | - | 재결합 |
| 6 | 2018 | 철근노출 | 0.1 | 0.50 | 0.05 | m | 1 | - | 신규 |
| 7 | 2019 | 철근노출 | 0.1 | 0.10 | 0.02 | m | 2 | - | 신규 |

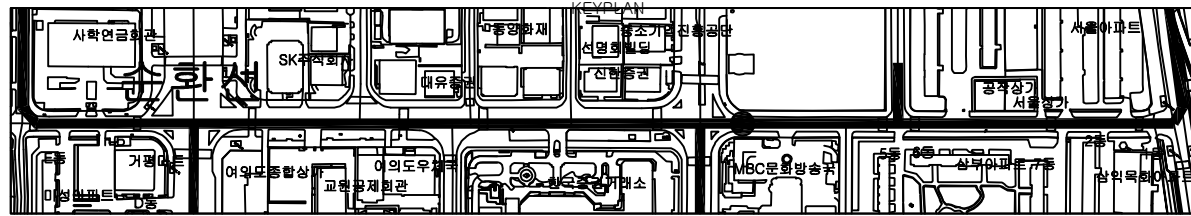
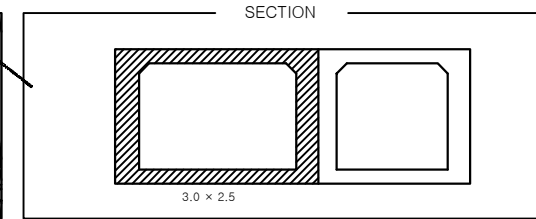
# 여의도 공동구 - 순환선 전력구 (STA. 2+000m ~ 2+020m)

| 연번 | 연도 | 발생내용 | 발생구분 | | | | 최종보수내역 | | 비고 |
|---|---|---|---|---|---|---|---|---|---|
| 1 | 2007 | 균열 | 1.0 | 3.00 | 3.00 | m | 1 | 주입보수공법 | 3.60 |
| 2 | 2013 | 균열 | 1.0 | 2.00 | 2.00 | m | 1 | 주입보수공법 | 2.40 |
| 3 | 2013 | 균열 | 0.2 | 2.50 | 2.50 | m | 1 | | - |
| 4 | 2013 | 균열 | 0.2 | 3.50 | 3.50 | m | 1 | | - |
| 5 | 2017 | 철근노출 | 0.1 | 0.20 | 0.08 | m | 4 | 단면복구(방청) | 0.10 |
| 6 | 2018 | 물품 | 0.5 | 1.00 | 0.50 | m | 1 | | - 신규 |

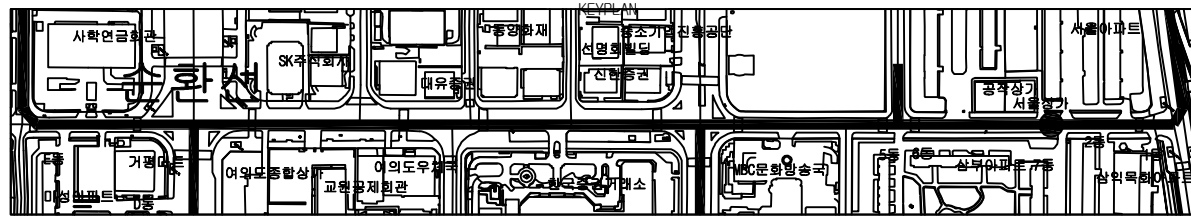
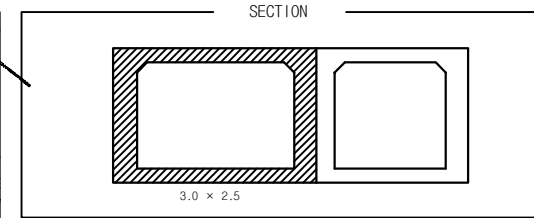
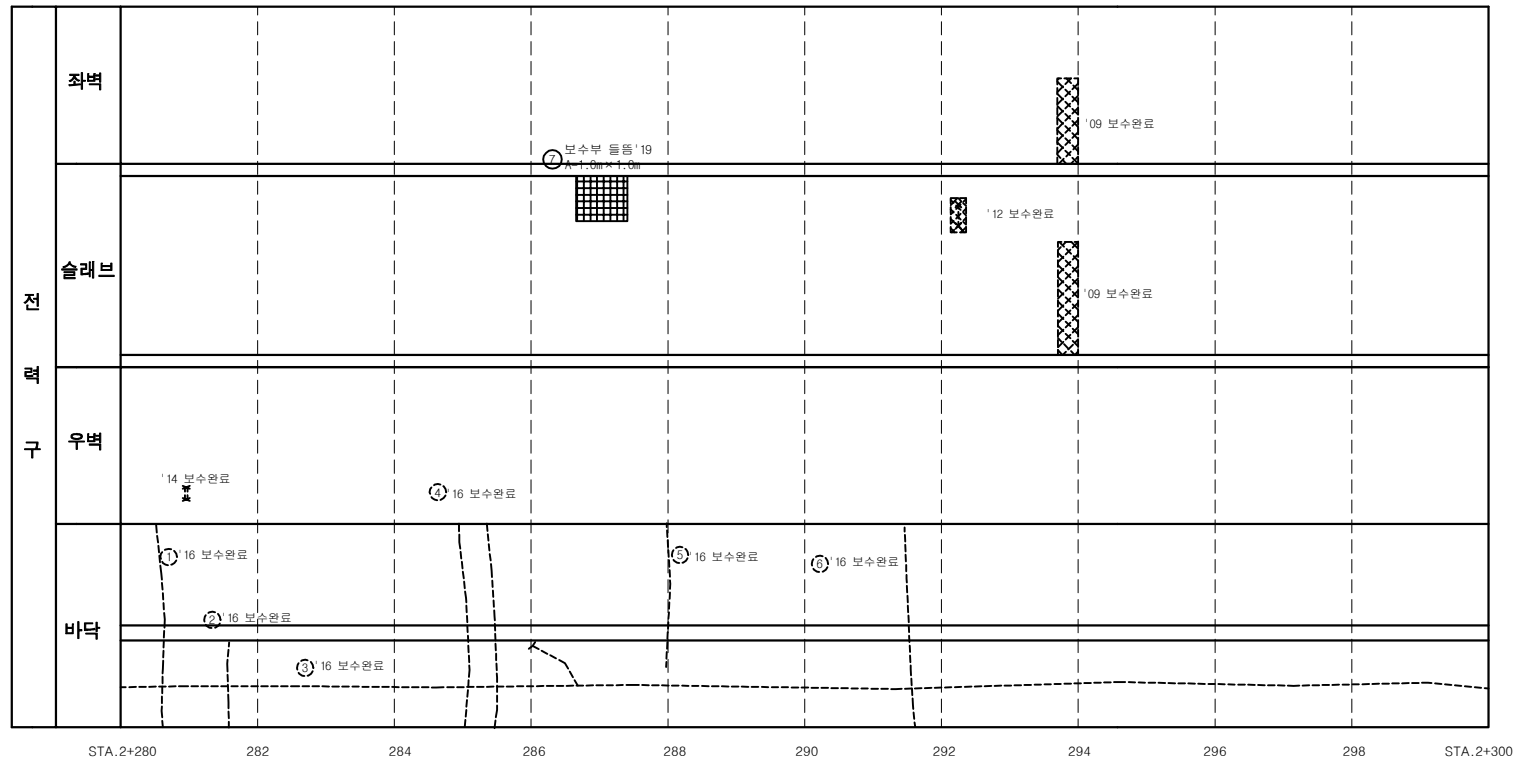
# 여의도 공동구 - 순환선 전력구 (STA. 2+280 m ~ 2+300 m)

| 연번 | 연도 | 발생내용 | 원형구도 | | | | 최종보수내역 | | |
|---|---|---|---|---|---|---|---|---|---|
| 1 | 2013 | 관열 | 0.3 | 2.40 | 2.40 | m | 1 | 2016 | 주원보수공법 2.88 |

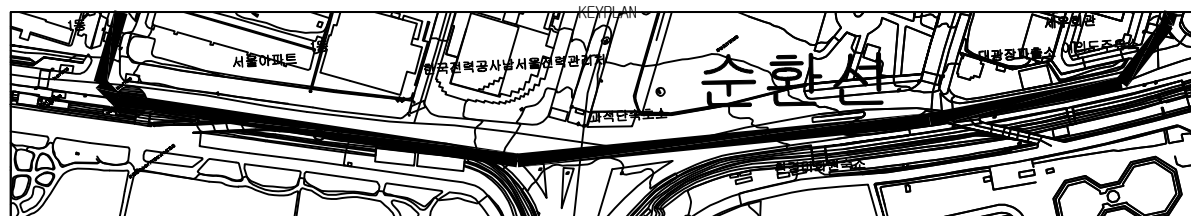
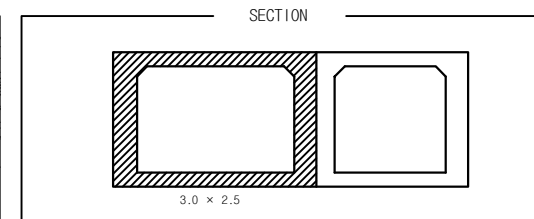
## 여의도 공동구 - 순환선 전력구 (STA. 2+420m ~ 2+440m)

| | 슬래브 | <div><div><div>○ 균열 '13<br/>C, W= 0.1mm<br/>L= 3.0m</div></div></div> | | | | | | | | | | |
| | 우벽 | <div><div><div>'04 보수원료<br/>(유진)</div></div><div><div>'14 보수원료</div></div></div> | | | | | | | | | | |
| | 바닥 | <div><div><div>'14 보수원료</div></div></div> | | | | | | | | | | |

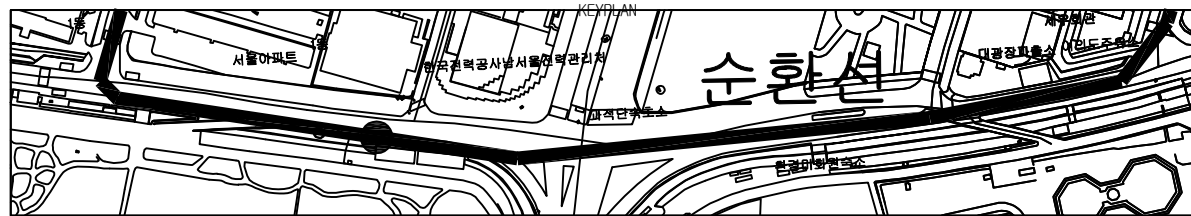
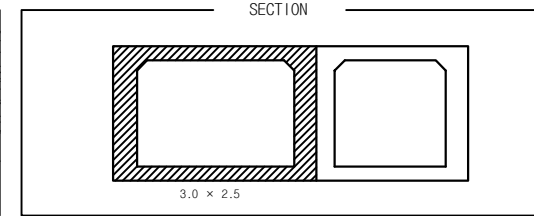
# 여의도 공동구 - 순환선 전력구 (STA. 2+600m ~ 2+620m)

| 연번 | 연도 | 발생내용 | 발생구분 | | | | | 최종보수내역 | | 비고 |
|---|---|---|---|---|---|---|---|---|---|---|
| 1 | 2013 | 균열 | 0.3 | 3.00 | 3.00 | m | 1 | 주입보수공법 | 3.00 | |
| 2 | 2013 | 균열 | 0.3 | 3.00 | 3.00 | m | 1 | 주입보수공법 | 3.00 | |
| 3 | 2013 | 균열 | 0.3 | 3.00 | 3.00 | m | 1 | 주입보수공법 | 3.00 | |

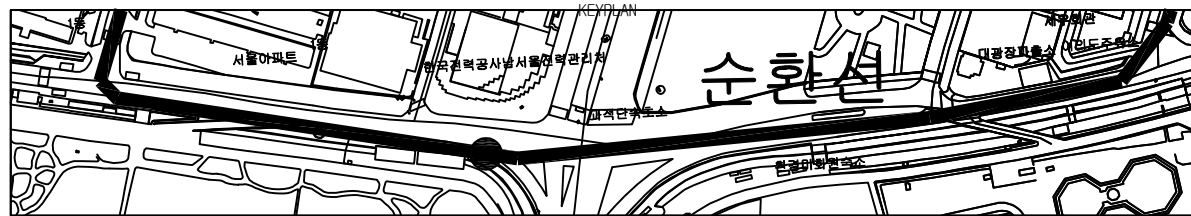
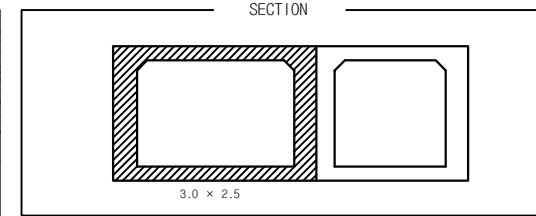
# 여의도 공동구 - 순환선 전력구 (STA. 2+680m ~ 2+700m)

| 연번 | 연도 | 발생내용 | 결함구분 | | | | | 최종보수내역 | | 비고 | |
|---|---|---|---|---|---|---|---|---|---|---|---|
| 2 | 2013 | 균열 | 0.1 | 1.50 | | 1.50 | m | 1 | | | - |
| 3 | 2013 | 균열 | 0.1 | 2.00 | | 4.00 | m | 2 | | | - |

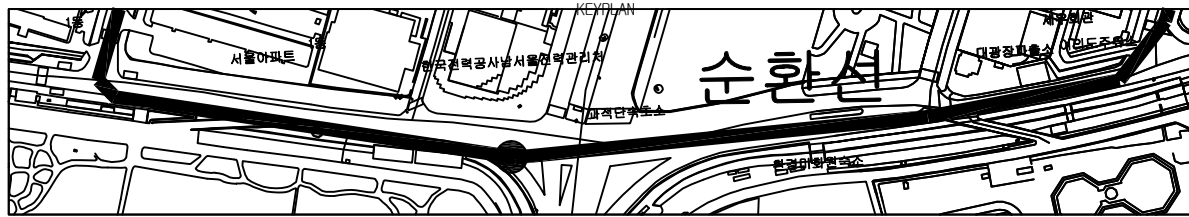
# 여의도 공동구 - 순환선 전력구 (STA. 2+700m ~ 2+720m)

⑦ 유도배수관 부식 '19  
L= 8.0m

| 연번 | 연도 | 발생내용 | 구분 | 길이 | 깊이 | 단위 | 개소 | 공사년도 | 공법명 | 수량 | 비고 |
|---|---|---|---|---|---|---|---|---|---|---|---|
| 7 | 2019 | 유도배수관 부식 | 구분 | 8.00 | 8.00 | m | 1 | | | - | 신규 |

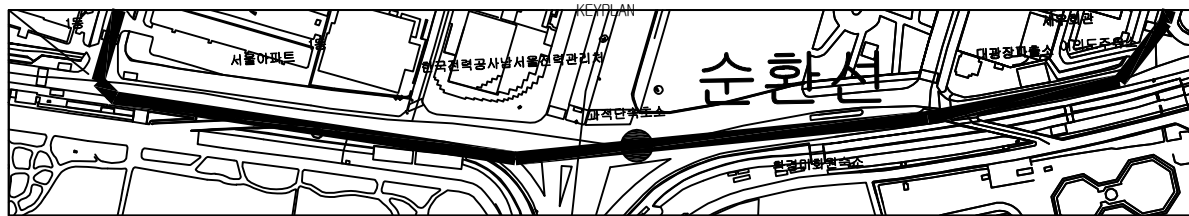
# 여의도 공동구 - 순환선 전력구 (STA. 2+800m ~ 2+820m)

| 연번 | 연도 | 발생내용 | 발생구분 | | | | | 최종보수내역 | | 비고 |
|---|---|---|---|---|---|---|---|---|---|---|
| 1 | 2013 | 균열 | 0.3 | 19.00 | 38.00 | m | 2 | 2016 | 주입보수공법 | 45.60 |
| 2 | 2013 | 균열 | 0.3 | 3.00 | 3.00 | m | 1 | 2016 | 주입보수공법 | 3.60 |
| 3 | 2013 | 균열 | 0.2 | 3.00 | 3.00 | m | 1 | | | - |

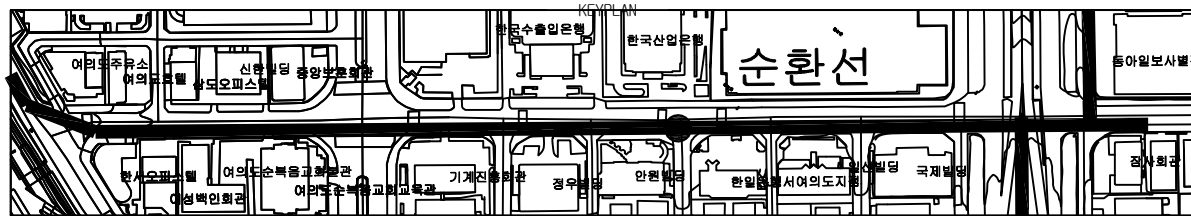
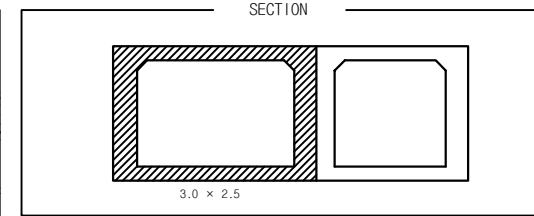
# 여의도 공동구 - 순환선 전력구 (STA. 3+620m ~ 3+640m)

| 연번 | 연도 | 발생내용 | 발생구분 | | | | 최종보수내역 | | 비고 |
|---|---|---|---|---|---|---|---|---|---|
| 1 | 2013 | 균열 | 0.1 | 3.00 | 3.00 | m | 1 | | - |
| 2 | 2013 | 균열 | 0.3 | 3.00 | 3.00 | m | 1 | | - |
| 3 | 2017 | 보수부 균열 | 0.2 | 2.00 | 2.00 | m | 1 | 표면치리공법 | - |
| 4 | 2017 | 균열 | 0.3 | 0.80 | 0.80 | m | 1 | 주입보수공법 | 0.98 |

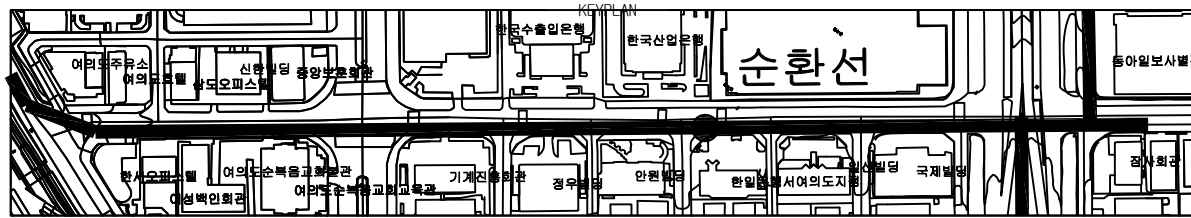
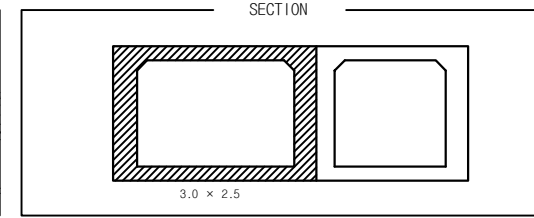
# 여의도 공동구 - 순환선 전력구 (STA. 3+640m ~ 3+660m)

| 연번 | 연도 | 발생내용 | 원형구도 | | | | 최종보수내역 | | 비고 |
|---|---|---|---|---|---|---|---|---|---|
| 1 | 2007 | 균열 | 0.2 | 2.20 | 2.20 | m | 1 | | - |
| 2 | 2011 | 균열 | 0.3 | 0.70 | 0.70 | m | 1 | 2016 주입보수공법 | 0.84 |
| 3 | 2013 | 균열 | 0.1 | 7.00 | 7.00 | m | 1 | | - |
| 4 | 2013 | 균열 | 0.3 | 16.00 | 16.00 | m | 1 | 2016 주입보수공법 | 16.00 |
| 5 | 2013 | 균열 | 0.1 | 2.50 | 2.50 | m | 1 | | - |
| 6 | 2013 | 균열 | 0.1 | 2.20 | 2.20 | m | 1 | | - |
| 8 | 2017 | 균열 | 1.0 | 10.00 | 10.00 | m | 1 | | - |
